Nomination Form
Anadromous Waters Catalog

Name of Waterway Snowslide Creek USGS Name Local Name

SUBJECT: Snowslide Creek

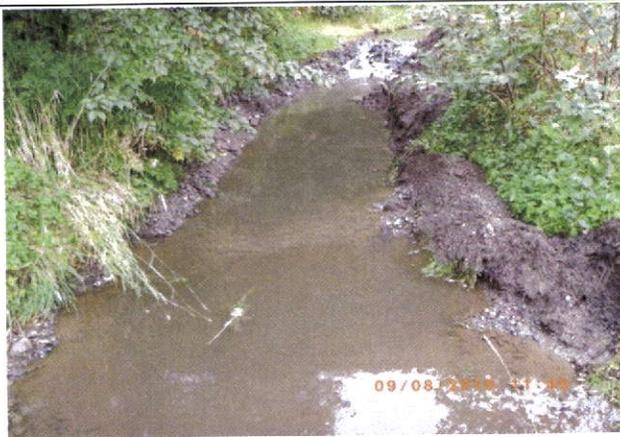
Figure 1: Excavation of Snowslide Creek.

Based on the results of my trapping efforts and the condition of the stream prior to excavation, I recommend that culvert replacement mitigation and stream bank restoration be implemented on this anadromous fish stream. The stream should be revisited periodically to monitor erosion on the left bank.

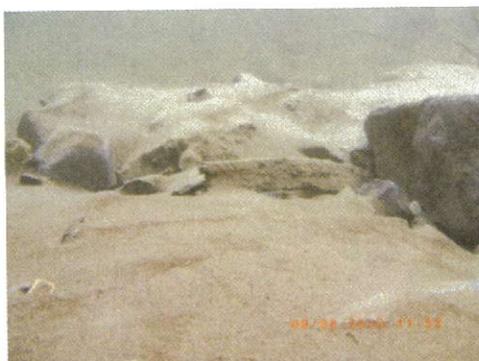
Figure 2: Sediment covering gravels in Snowslide creek.

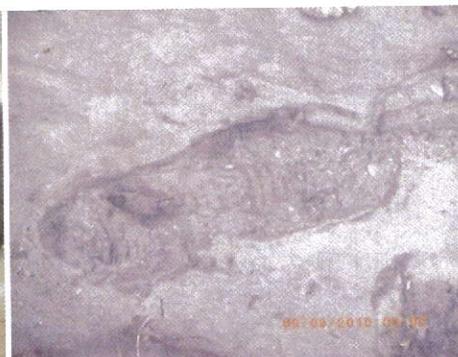
Figure 3: Footprint in thick sediment covering gravels in Snowslide creek

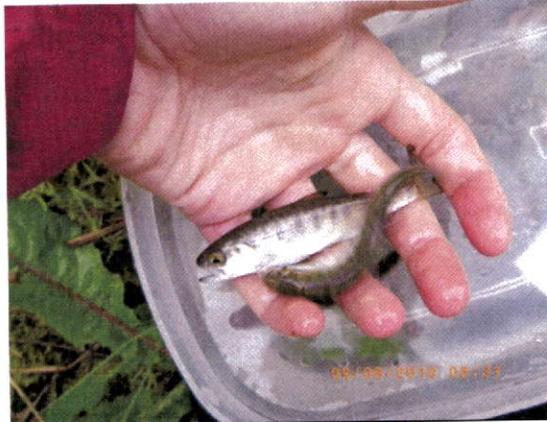
I returned the next morning to check the trap and found it filled with 45-50 sculpin and four smolting coho salmon. I photographed them and released them. The sediment had settled to the bottom of the stream and the water was running clear, although any disturbance clouded the water with the fine sediment.

Figure 4: Coho smolts in Snowslide creek.

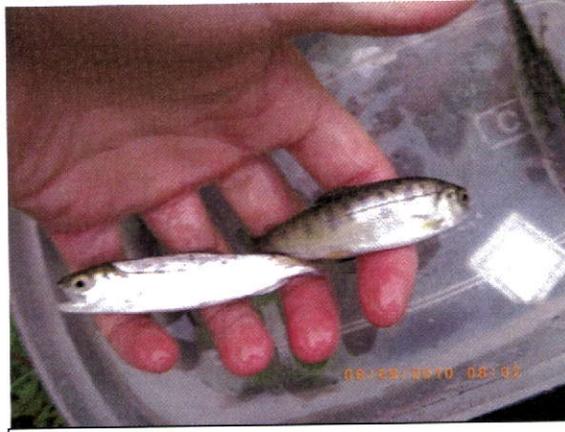
Figure 5: Coho smolts in Snowslide creek.

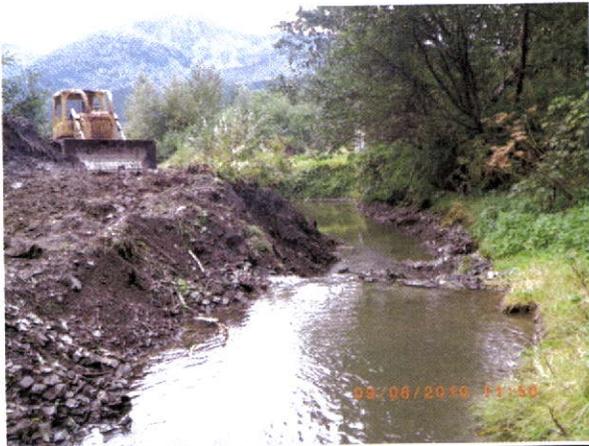
Figure 6: Equipment and devegetation on the bank of Snowslide creek

I began the track line of the stream at the intertidal and walked upstream. I set two traps above the perched culvert: one at the inlet and one farther upstream at the end of possible anadromy. There is a bedrock and scree fish barrier that is approximately 12-15 feet tall that marks the upstream extent of anadromy. There is grassy vegetation on the river-right bank, but no grass or overhanging vegetation on the left side. The bank, as seen in figure 6, is steep with loose dirt and rock, and subject to erosion during heavy rain events.

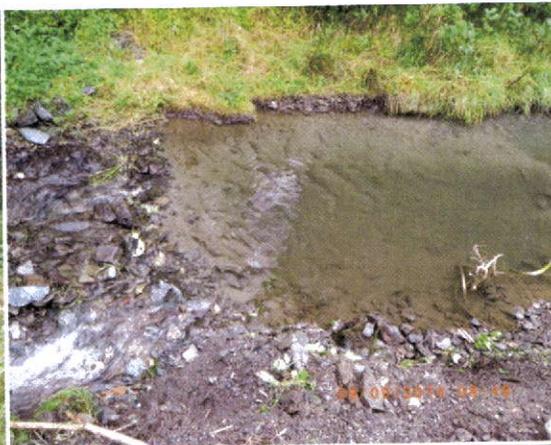
I spoke with Chris Hickock who is overseeing the project and asked about the mitigative measures he was taking to minimize impacts to the stream. He pointed out the sediment catchment pools they had created to filter sediment while they worked on the bank with excavators and backhoes. Mr. Hickock said they don't plan to be working in the stream again because they are focusing the berm work farther up the slope.

Figure 7: Sediment pool on Snowslide creek

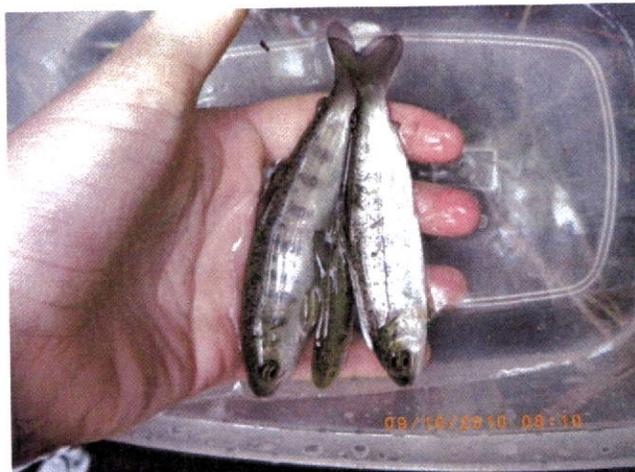
I returned the next morning (September 10th, 2010) to find three smolting coho in the trap at the inlet of the culvert and one smolting coho at the upper extent before a steep rocky cascade. Their sizes ranged from 85mm to 140mm. They were healthy and looked very well-fed. The former overhanging trees and brush apparently provided a good population of bugs for rearing salmon.

Figure 8: Coho salmon caught in minnow trap at inlet of corrugated metal culvert.

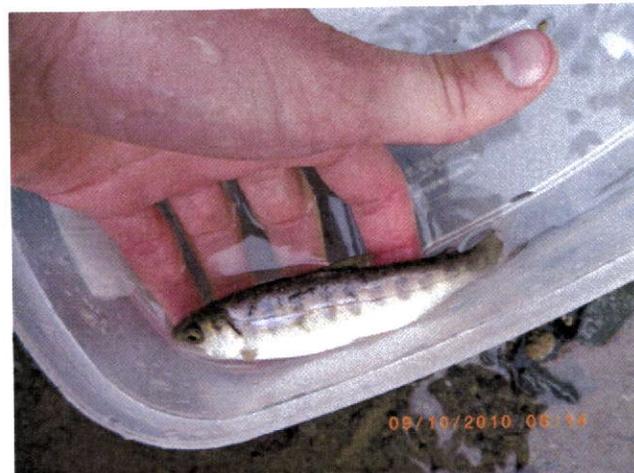
Figure 9: Coho salmon caught in minnow trap at upper extent of Snowslide creek.

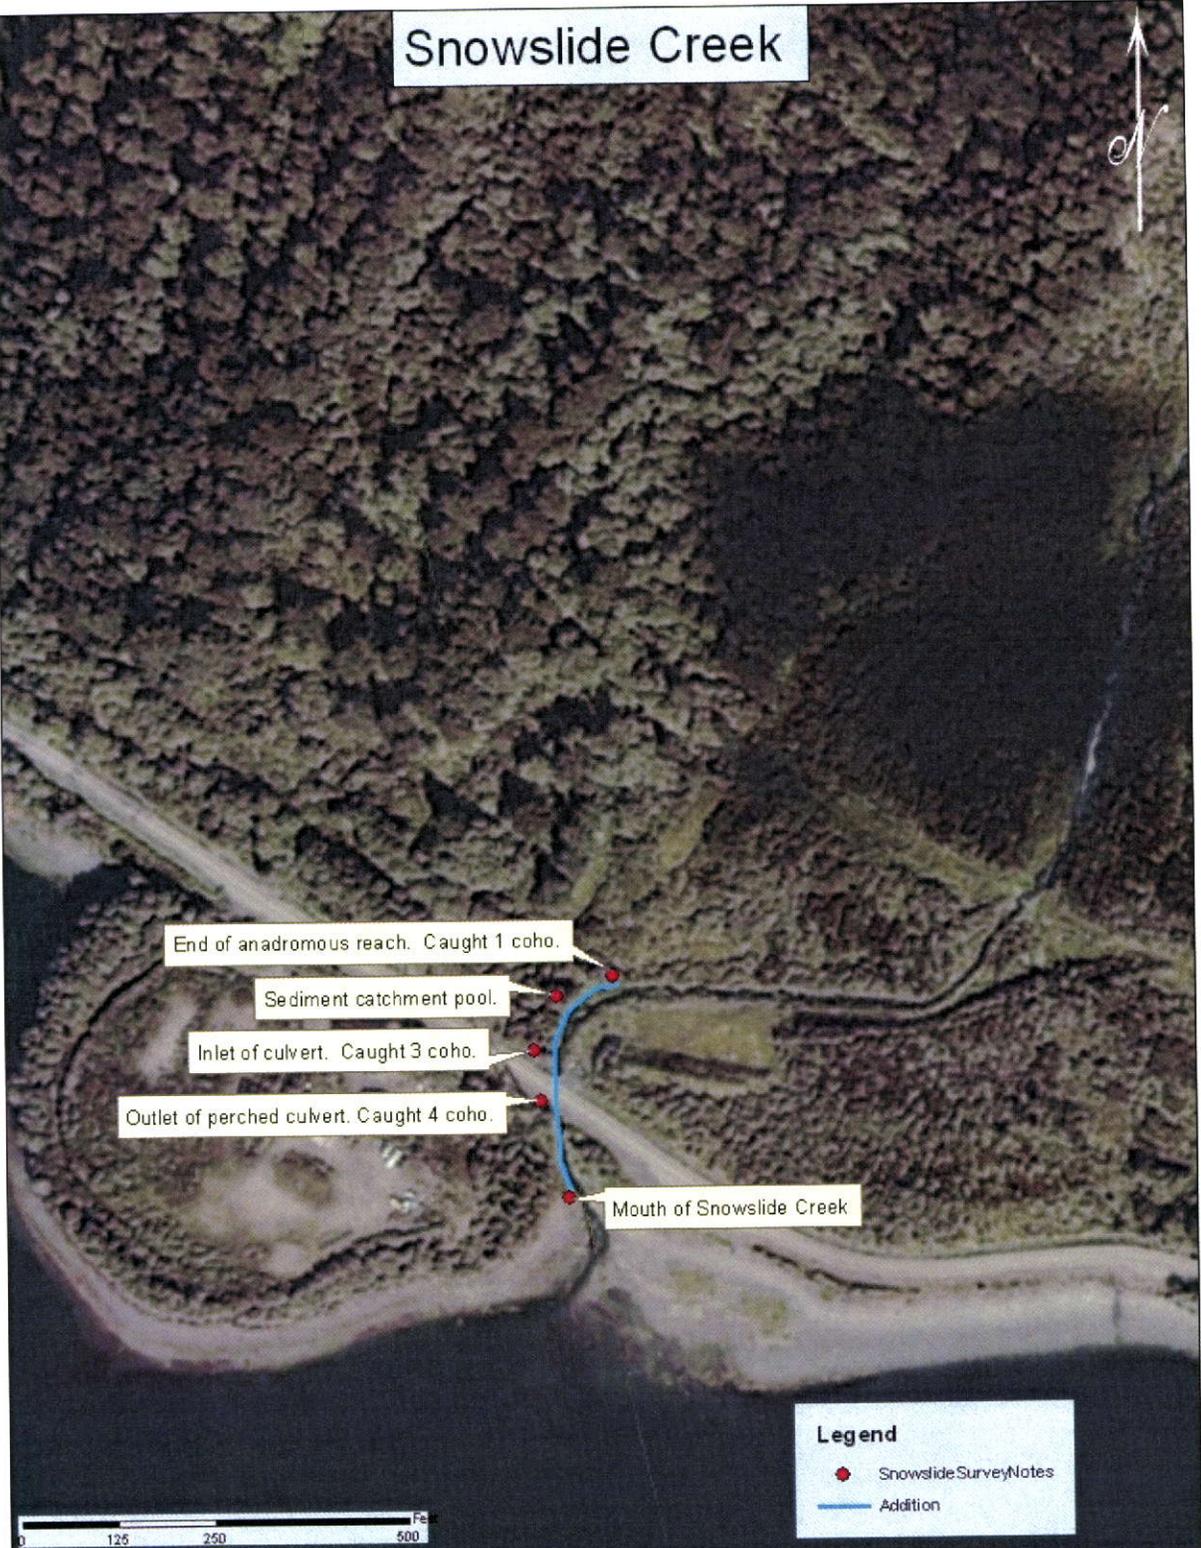
Figure 10 illustrates trapping effort results and the following map provides trap and feature locations.

End of anadromous reach. Caught 1 coho.

Sediment catchment pool.

Inlet of culvert. Caught 3 coho.

Outlet of perched culvert. Caught 4 coho.

Mouth of Snowslide Creek
