Nomination Form
Anadromous Waters Catalog

Region Southcentral USGS Quad(s) SEWARD B-1
 Anadromous Waters Catalog Number of Waterway 227-20-17590-2003 - 0010, 0020
 Name of Waterway Rocky Creek USGS Name Local Name
 Addition Deletion Correction Backup Information

ROCKY BAY MAINTENANCE MONITORING AND EVALUATION TRIP

1995 FISHWAY MAINTENANCE & MONITORING EVALUATION

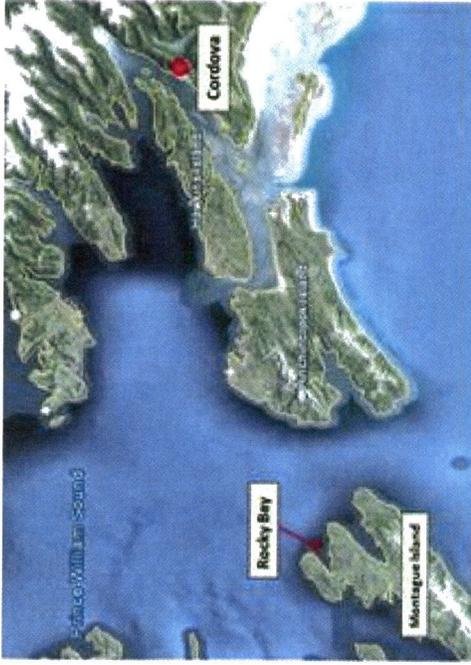
ADF&G Anadromous Waters Catalog Nomination
 Coho salmon spawning and rearing 227-20-17590-2003.
 Ken Hodges, Fisheries biologist
 USDA Forest Service, Cordova Ranger District
 9/12/2014

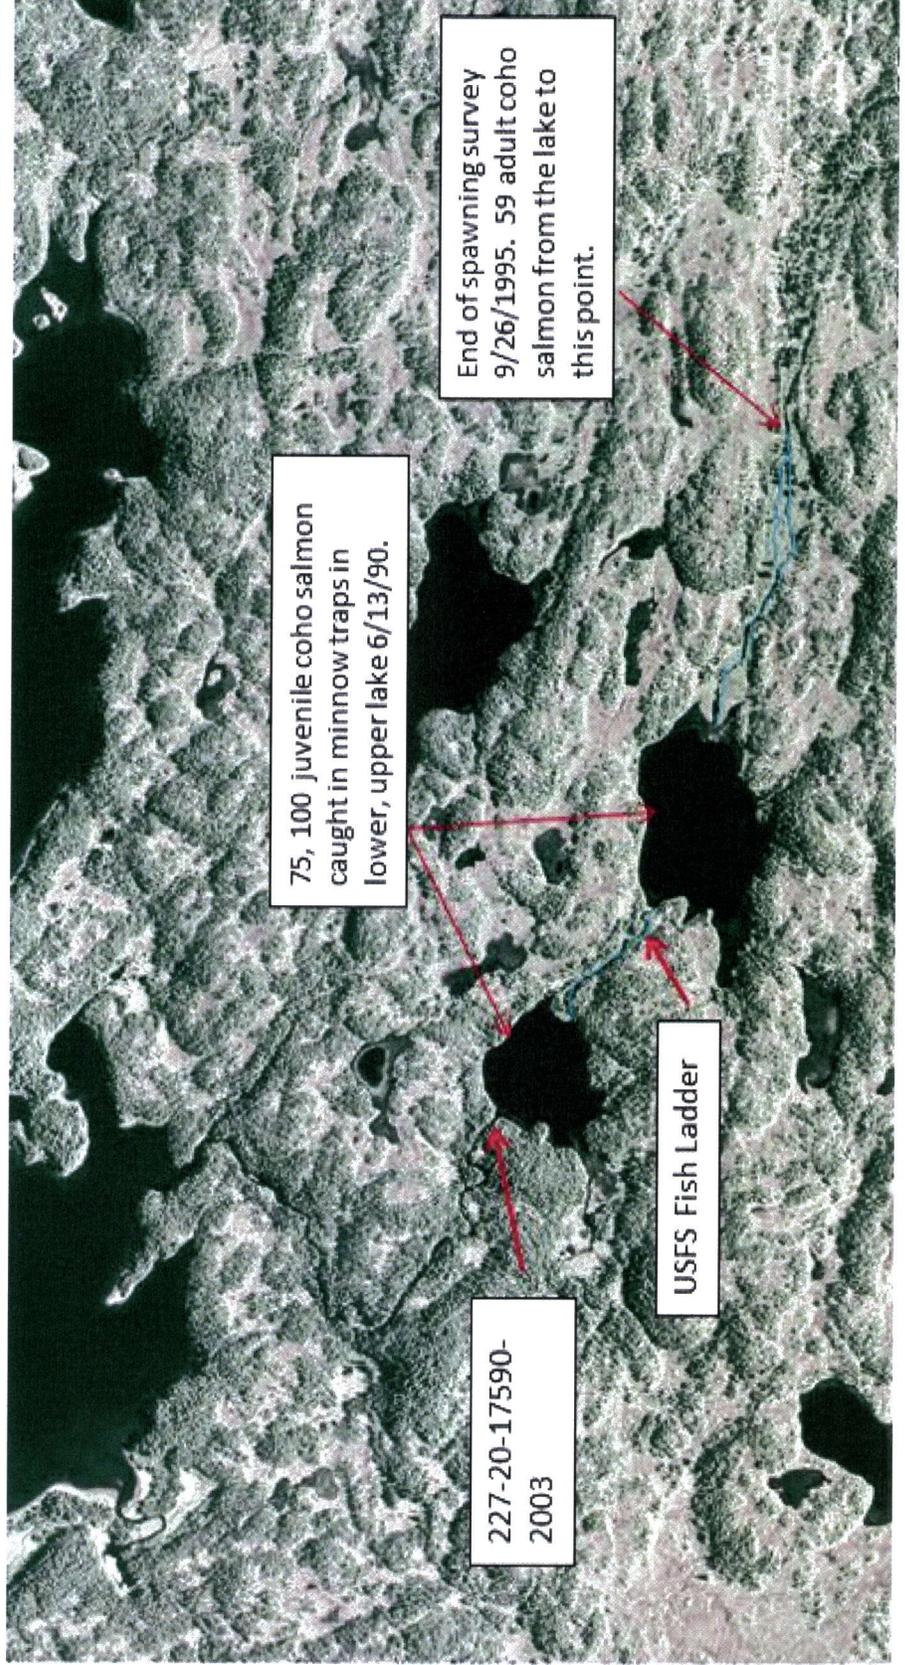
227-20-17590-2003

USFS Fish Ladder

75, 100 juvenile coho salmon caught in minnow traps in lower, upper lake 6/13/90.

End of spawning survey 9/26/1995. 59 adult coho salmon from the lake to this point.

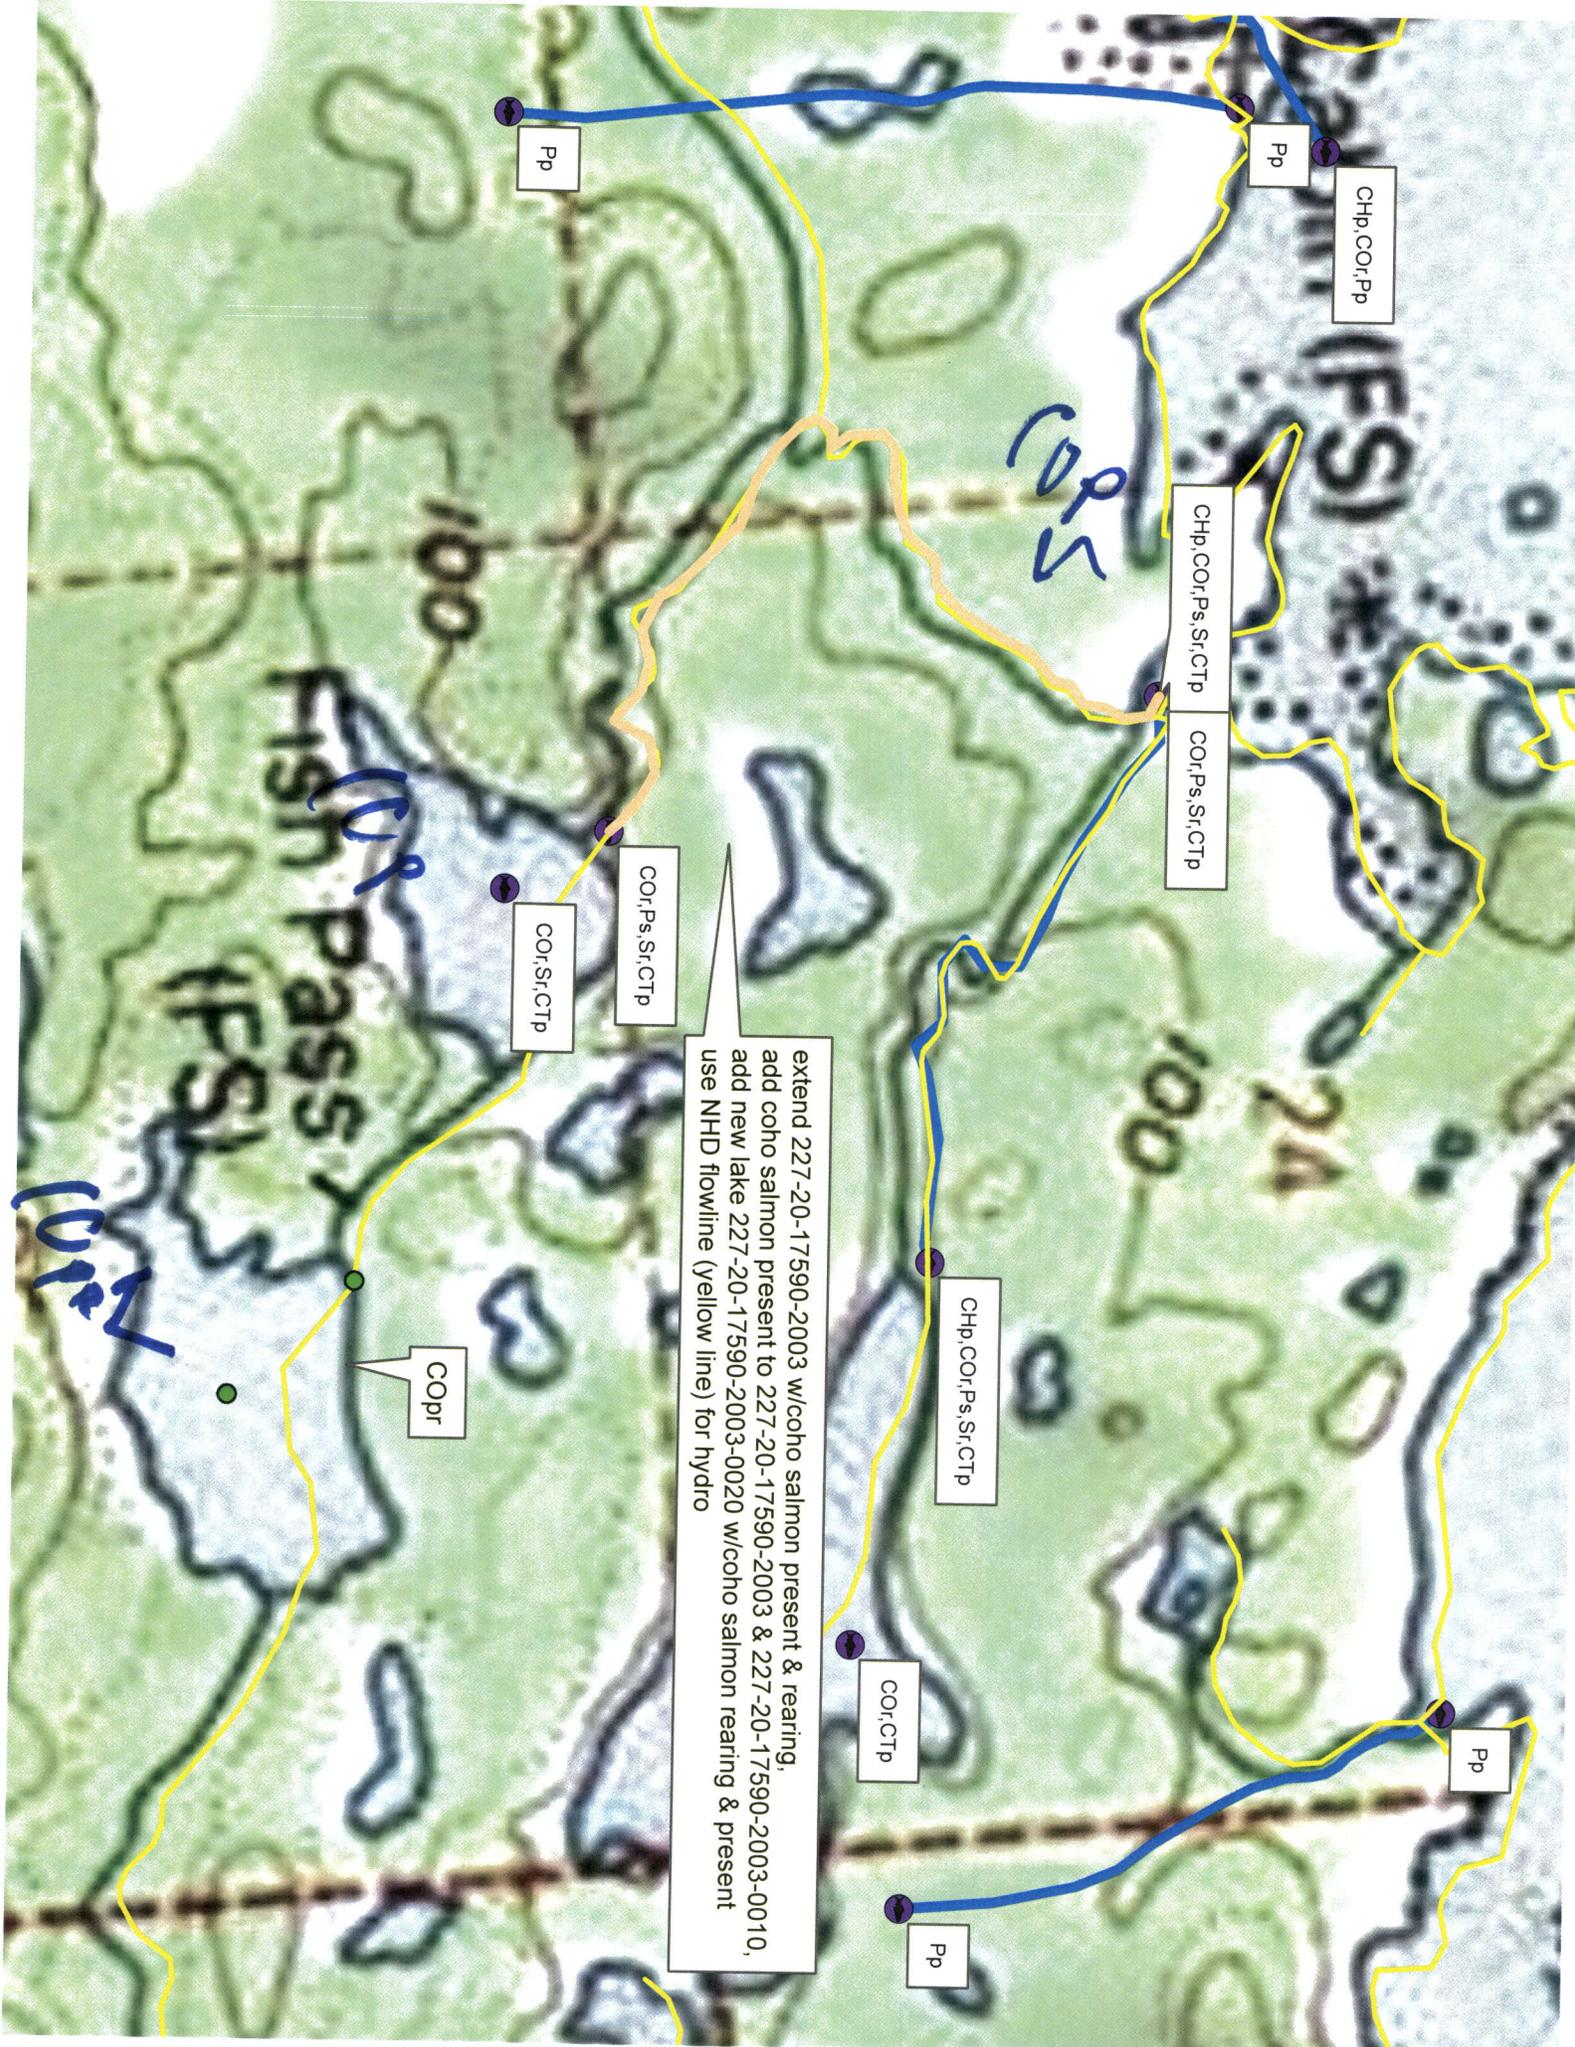
extend 227-20-17590-2003 w/coho salmon present & rearing,
 add coho salmon present to 227-20-17590-2003 & 227-20-17590-2003-0010,
 add new lake 227-20-17590-2003-0020 w/coho salmon rearing & present
 use NHD flowline (yellow line) for hydro
