State of Alaska
Department of Fish and Game
Habitat and Restoration Division

Nomination for Waters
Important to Anadromous Fish

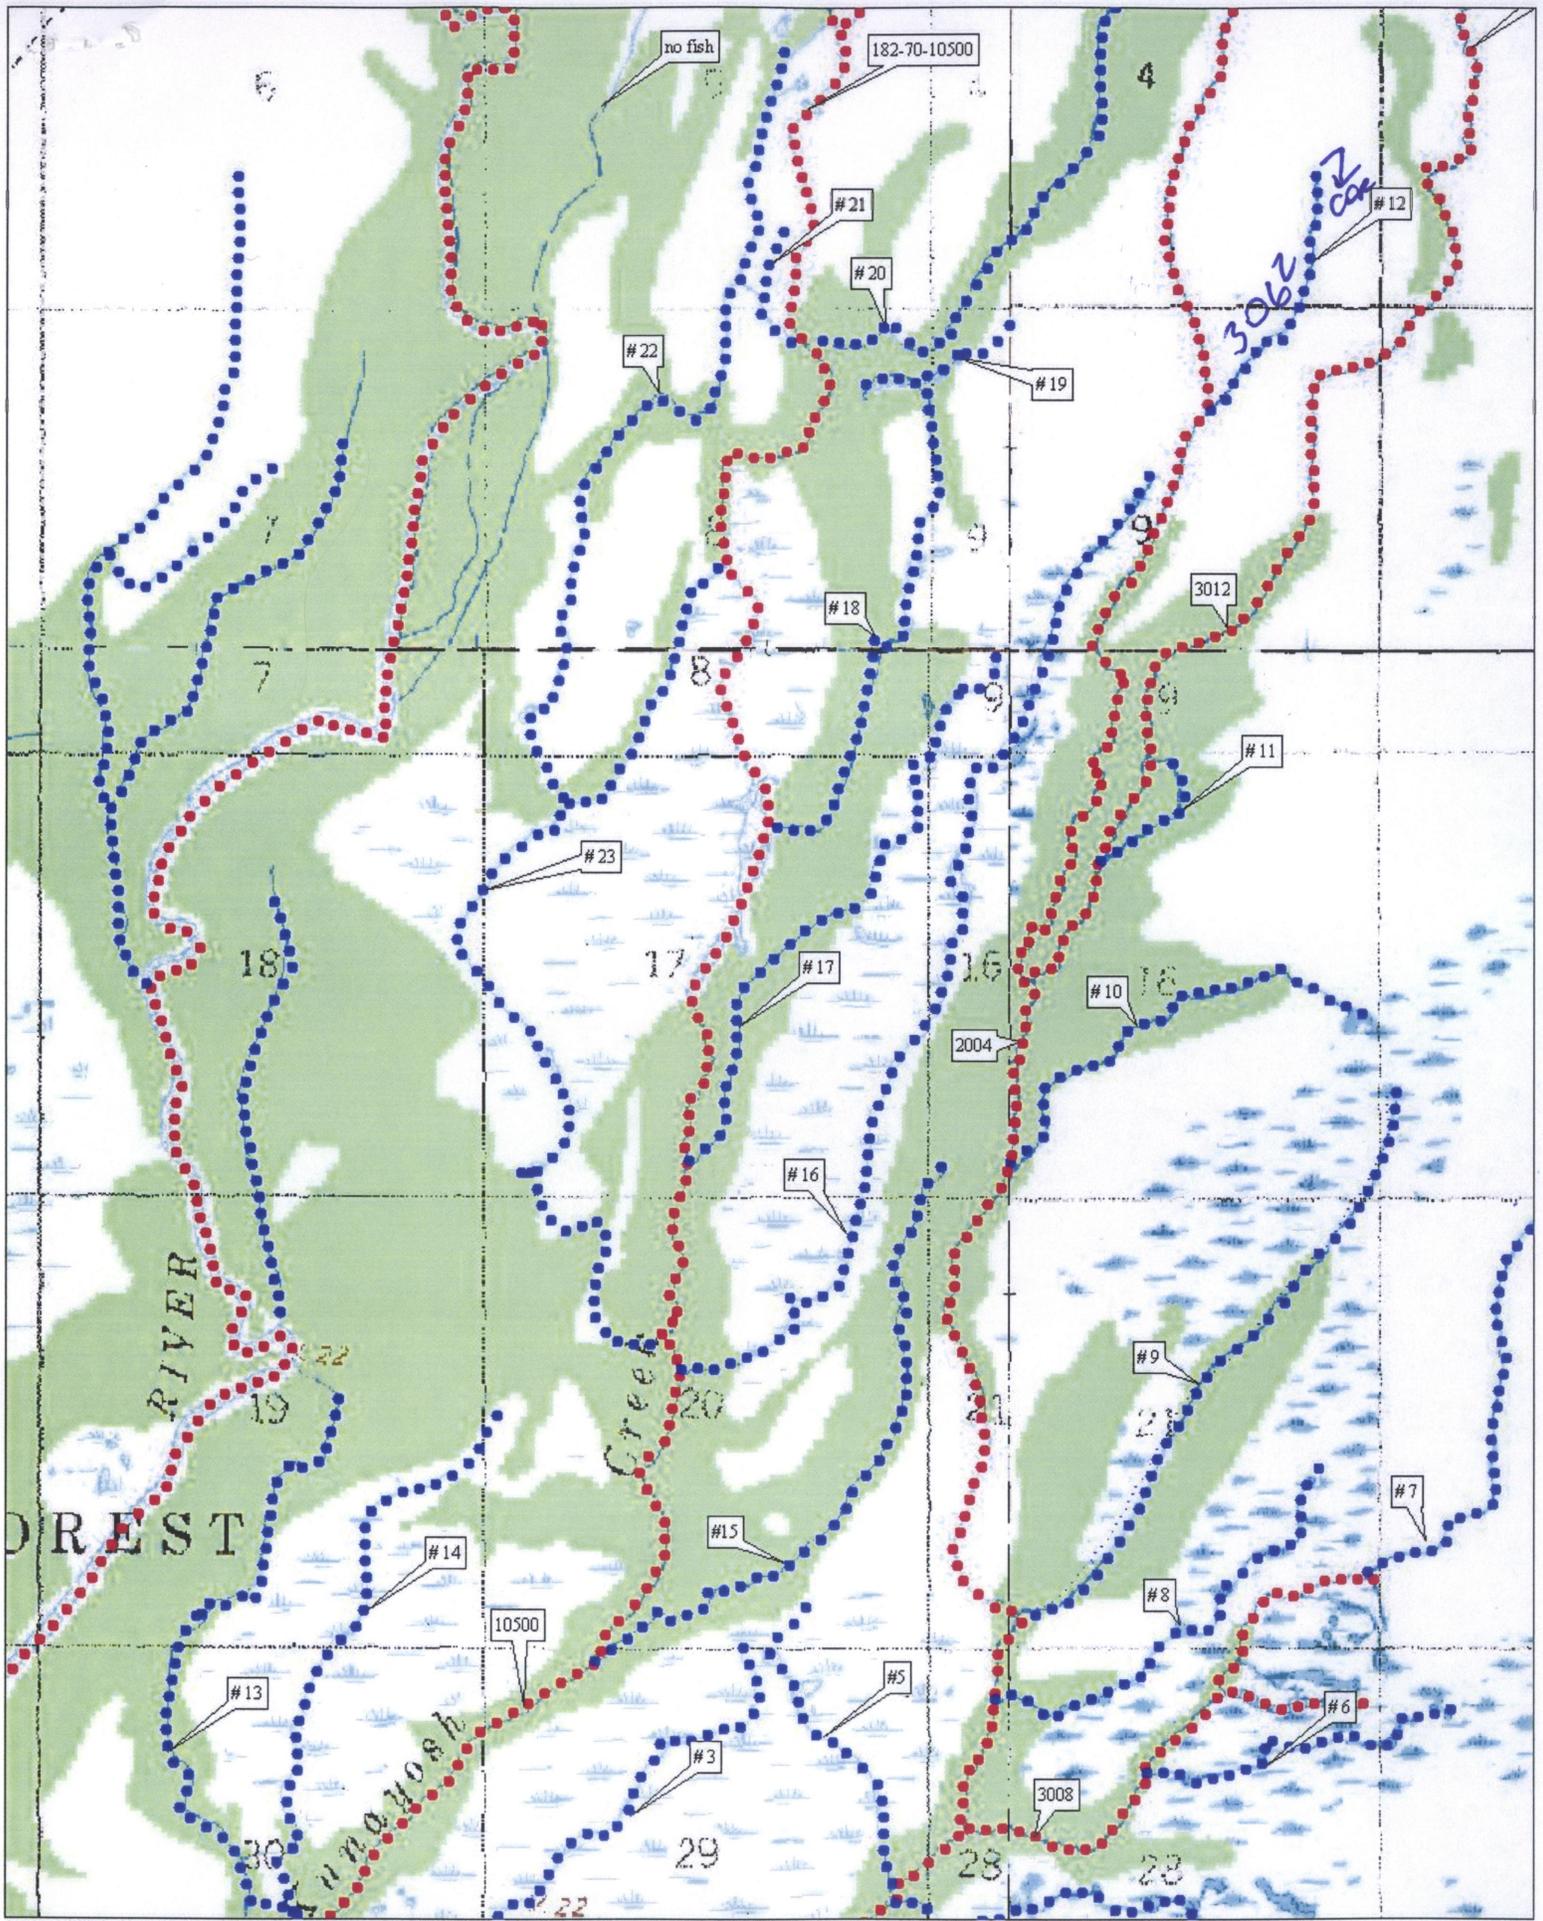
Comments: Location; Township 28S Range 35E Section NE 1/4 9 ; Latitude N59 degrees , Longitude W139 degrees 29.221 (NAD27). Stream is number 12 on the map.
