Nomination Form  
Fish Distribution Database

Name of Waterway Log Salmon Creek  USGS Name  Local Name  
 Addition  Deletion  Correction  Backup Information

SUBJECT: Dry Bay ORV Trails  
Trip Report

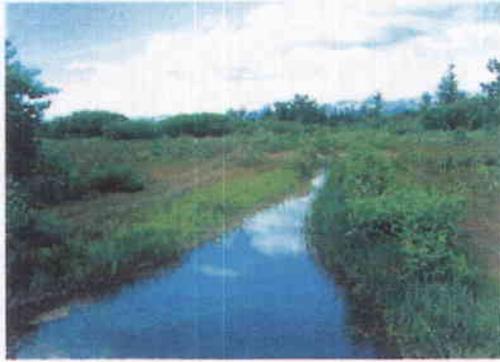
Photo 1. Doame River wetland drainage.

We located an un-cataloged, low-flow drainage about 600' west of the Doame River that flooded an abandoned ORV trail (see Photo 1). Several salmonids were observed swimming in the tire-track channel, we captured coho and stickleback in five traps. This ephemeral channel probably connects to the Doame River or neighboring streams during high flows or floods, and is created by channeling water from nearby wetlands. If the deeply incised abandoned ORV trail was not present, I doubt this channel would exist. New ORV trails that bypass the drainage are established on both sides of the channel and do not cross the drainage.

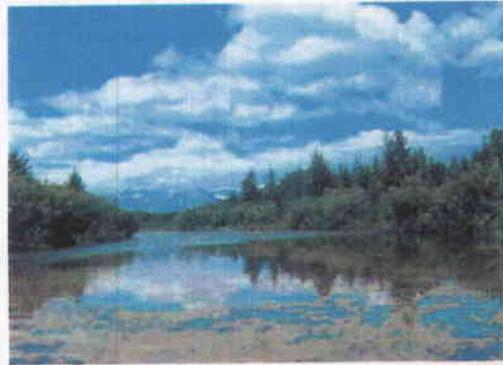
Photo 2. Lake southeast of the EAR.

About 300' southeast of the EAR crossing, we located an un-cataloged lake that drains adjacent wetlands and may provide overflow relief to the EAR during flood events (see Photo 2). Three traps set in the lake captured coho and sockeye salmon and stickleback. Aerial photographs suggest that the lake's two stream outlets drain directly to the EAR. The adjacent ORV trail probably does not impact this lake system, except if trail erosion runoff drains to the lake during wet conditions. I will nominate this lake and outlet stream for inclusion in the Catalog.

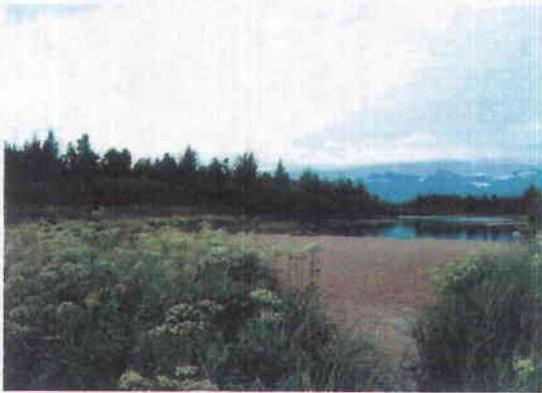
Photo 3. Lake southwest of the EAR.

Along the ORV trail about ¼ mile southwest from the EAR crossing, the trail crosses a 10' wide, un-cataloged lake and outlet drainage (see Photo 3). Aerial photographs indicate that the outlet drains directly to the EAR a few hundred feet downstream, although we did not verify this. Seven traps set in the lake and outlet captured coho and sockeye salmon and stickleback. Some bank undercutting near the narrow crossing entrances are evident, and small rock appears to have been placed in the streambed to strengthen the crossing. If this crossing remains open, it should be clearly marked and the banks sculpted for entry and hardened. Additional hardening of the streambed may also be beneficial. I will nominate this lake and outlet drainage for inclusion in the Catalog.

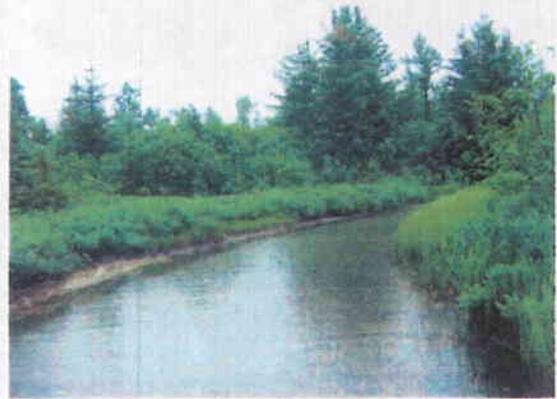
Photo 4. Small pool in the ORV trail.

About 1 mile west of EAR along the trail, we observed several dead coho and stickleback in a small isolated pool in the trail (see Photo 4). A 2-minute seine tow of about ½ the pool captured coho and sockeye salmon and stickleback. Most of the fish appeared unhealthy, having large heads and skinny bodies, which is probably due to competition within the small pool. We could not identify a nearby

anadromous water body where the fish might have originated, and speculate that the pool would probably not exist if the trail was not deeply incised. The connection might be more obvious during higher flows and could warrant further investigation before making trail maintenance recommendations at this location.

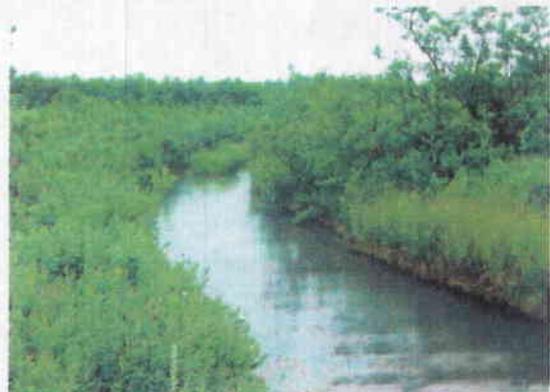
Photo 5. Lower EAR wetland drainage (trail).

This drainage has experienced significant bank erosion from ORV crossings, from wave action undercutting the banks and a deeply incised track, causing the drainage to backwater along the perpendicular trail (see Photo 5). Two seine tows captured hundreds coho and sockeye salmon and stickleback. Due to the erosion situation and because the western portion of this loop trail provides access to the area, this crossing should be closed. I will nominate this drainage for inclusion in the Catalog.

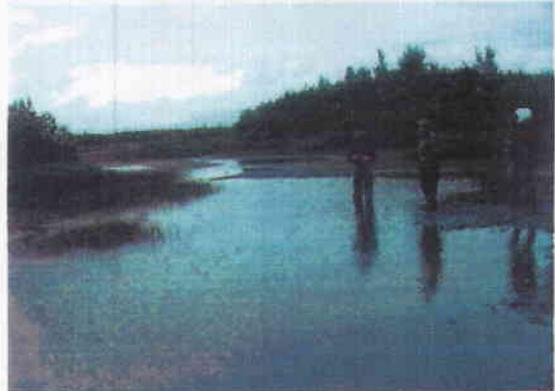
Photo 6. Lower Dog Salmon Creek drainage.

Although we did not sample for fish, this drainage probably does not connect to Dog Salmon Creek (see Photo 6). Stickleback were observed several hundred feet up and downstream of the crossing. Primary streambed substrate is small rock. Because a safer, more defined crossing is available in the upper reach of Dog Salmon Creek, this crossing should also be closed.

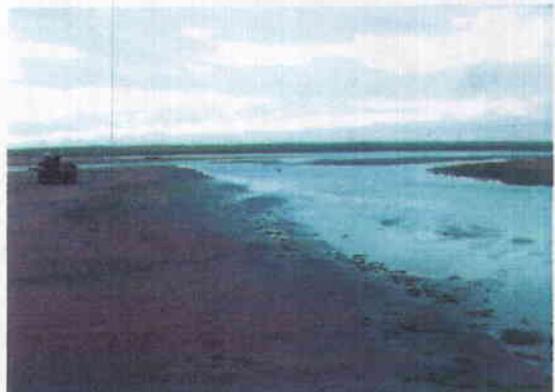
Photo 7. Dog Salmon Creek estuary.

The estuarine crossing of Dog Salmon is heavily tidally influenced (see Photo 7), and only accessible during low tide and low flows. Evidence of any ORV crossing is washed away with each tidal cycle. Due to the limited access, ORV crossings probably only occur when few fish are present, thereby causing minimal impacts to salmonids. Stream substrate at the crossing consisted of sand with some natural gravel, and may cause temporary increased sedimentation during ORV crossings. Efforts to stabilize or clearly mark the crossing would probably be washed away in the next tide or flood. We did not sample for fish.

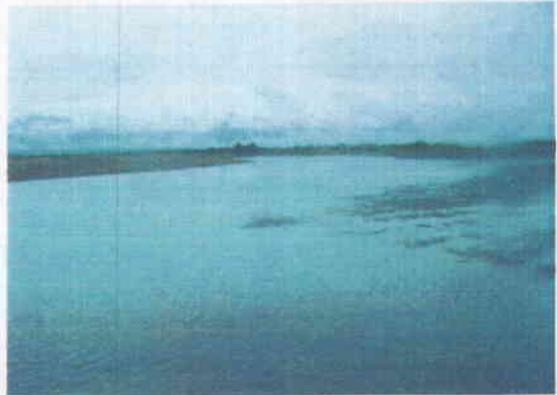
Photo 8. East slough of Alsek River.

Two seine tows captured starry flounders and staghorn sculpin, no salmonids were observed. This backwatered slough is cataloged as part of Alsek River (see Photo 8). Stream crossing access is only available during low tides and low flows, as this reach is heavily tidally influenced. The substrate of this crossing site and of the greater tidal flats area is loose sand and silt. Thus, other than increased sedimentation, ORV crossings at this slough probably have few long-term impacts to fish. Efforts to stabilize or clearly mark the crossing site would probably be washed away during the next tide or flood.

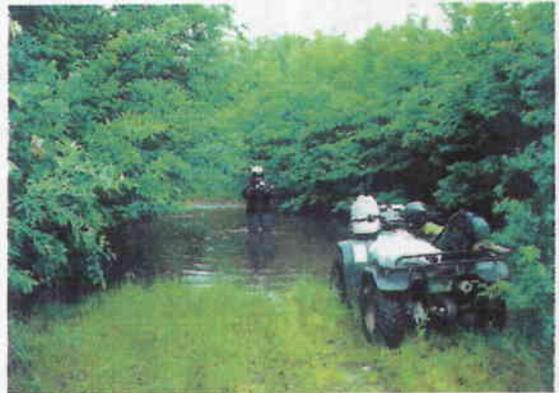
Photo 9. Isolated pools on abandoned trail.

We located several small pools flooding an abandoned trail, the largest pool was about knee-deep and 20' x 20' (see Photo 9). The pools probably result from lack of trail maintenance; trail access is now obtained along the tidal flats. Although we did not sample for fish, we did not observe any salmonids and doubt any connection to anadromous waters occurs. However, during high water the pools may connect to one another and flood the trail.
