Nomination Form
Fish Distribution Database

Name of Waterway Dog Salmon Creek USGS Name Local Name

SUBJECT: Dry Bay ORV Trails
Trip Report

The National Park Service (NPS) is publishing an Off-Road-Vehicle Environmental Assessment for the Dry Bay area in preparation for formally designating off road vehicle (ORV) trails and stream crossings. The ORV trails are used to access remote hunting and fishing sites and several lodges. Dry Bay resources are primarily used for sport fish and hunting purposes, although some historic commercial fishery operations remain. During July 19-22, I accompanied in the field Gordie Woods and George Weekley with Fish & Game, and the following staff with NPS: Glen Yankus, Chad Soiseth, Allison Banks, Bud Rice, Bill Eichenlaub, and Dry Bay Ranger Jim Capra.

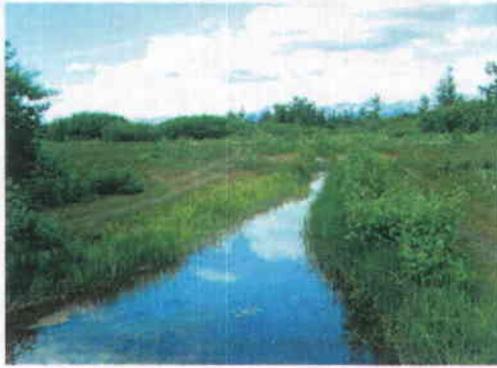
Photo 1. Doame River wetland drainage.

We located an un-cataloged, low-flow drainage about 600' west of the Doame River that flooded an abandoned ORV trail (see Photo 1). Several salmonids were observed swimming in the tire-track channel, we captured coho and stickleback in five traps. This ephemeral channel probably connects to the Doame River or neighboring streams during high flows or floods, and is created by channeling water from nearby wetlands. If the deeply incised abandoned ORV trail was not present, I doubt this channel would exist. New ORV trails that bypass the drainage are established on both sides of the channel and do not cross the drainage.

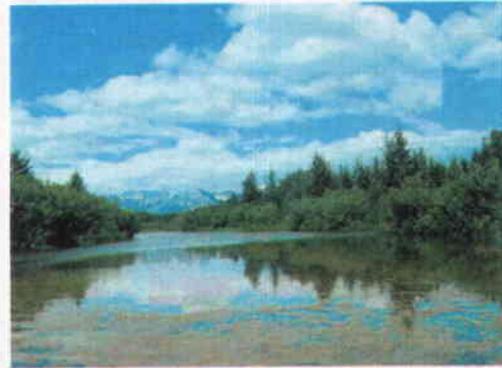
Photo 2. Lake southeast of the EAR.

About 300' southeast of the EAR crossing, we located an un-cataloged lake that drains adjacent wetlands and may provide overflow relief to the EAR during flood events (see Photo 2). Three traps set in the lake captured coho and sockeye salmon and stickleback. Aerial photographs suggest that the lake's two stream outlets drain directly to the EAR. The adjacent ORV trail probably does not impact this lake system, except if trail erosion runoff drains to the lake during wet conditions. I will nominate this lake and outlet stream for inclusion in the Catalog.

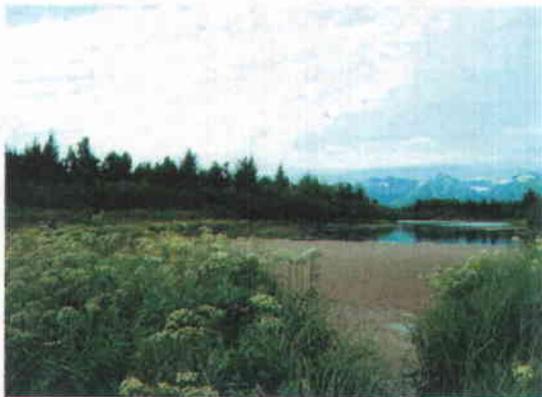
Photo 3. Lake southwest of the EAR.

Along the ORV trail about ¼ mile southwest from the EAR crossing, the trail crosses a 10' wide, un-cataloged lake and outlet drainage (see Photo 3). Aerial photographs indicate that the outlet drains directly to the EAR a few hundred feet downstream, although we did not verify this. Seven traps set in the lake and outlet captured coho and sockeye salmon and stickleback. Some bank undercutting near the narrow crossing entrances are evident, and small rock appears to have been placed in the streambed to strengthen the crossing. If this crossing remains open, it should be clearly marked and the banks sculpted for entry and hardened. Additional hardening of the streambed may also be beneficial. I will nominate this lake and outlet drainage for inclusion in the Catalog.

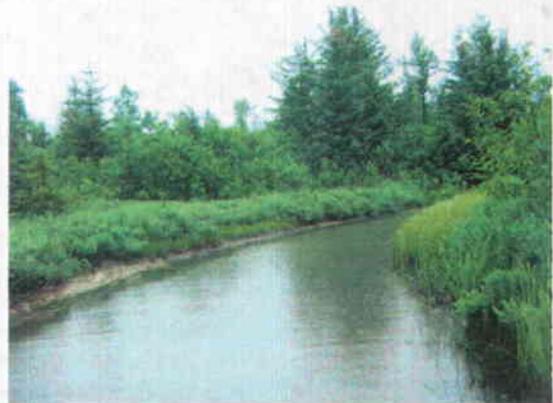
Photo 4. Small pool in the ORV trail.

About 1 mile west of EAR along the trail, we observed several dead coho and stickleback in a small isolated pool in the trail (see Photo 4). A 2-minute seine tow of about ½ the pool captured coho and sockeye salmon and stickleback. Most of the fish appeared unhealthy, having large heads and skinny bodies, which is probably due to competition within the small pool. We could not identify a nearby

anadromous water body where the fish might have originated, and speculate that the pool would probably not exist if the trail was not deeply incised. The connection might be more obvious during higher flows and could warrant further investigation before making trail maintenance recommendations at this location.

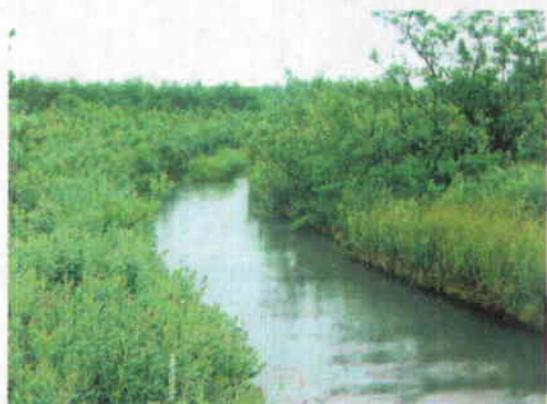
Photo 5. Lower EAR wetland drainage (trail).

This drainage has experienced significant bank erosion from ORV crossings, from wave action undercutting the banks and a deeply incised track, causing the drainage to backwater along the perpendicular trail (see Photo 5). Two seine tows captured hundreds coho and sockeye salmon and stickleback. Due to the erosion situation and because the western portion of this loop trail provides access to the area, this crossing should be closed. I will nominate this drainage for inclusion in the Catalog.

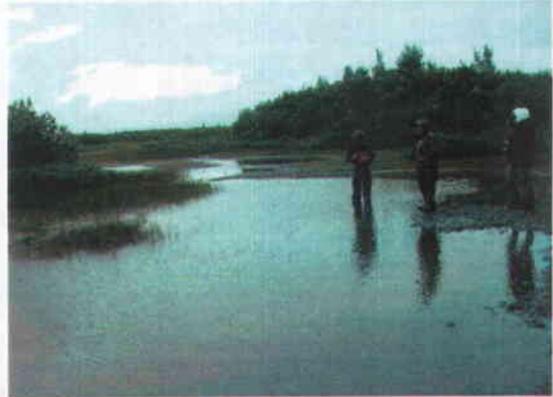
Photo 6. Lower Dog Salmon Creek drainage.

Although we did not sample for fish, this drainage probably does not connect to Dog Salmon Creek (see Photo 6). Stickleback were observed several hundred feet up and downstream of the crossing. Primary streambed substrate is small rock. Because a safer, more defined crossing is available in the upper reach of Dog Salmon Creek, this crossing should also be closed.

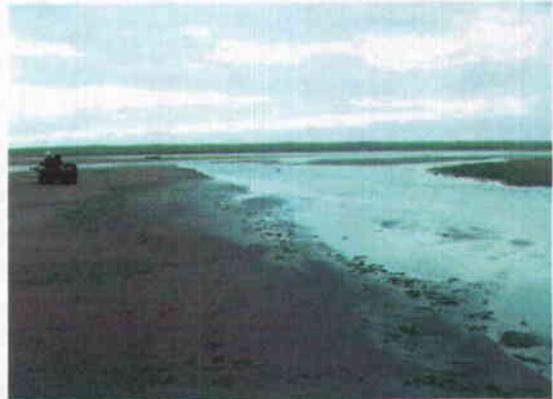
Photo 7. Dog Salmon Creek estuary.

The estuarine crossing of Dog Salmon is heavily tidally influenced (see Photo 7), and only accessible during low tide and low flows. Evidence of any ORV crossing is washed away with each tidal cycle. Due to the limited access, ORV crossings probably only occur when few fish are present, thereby causing minimal impacts to salmonids. Stream substrate at the crossing consisted of sand with some natural gravel, and may cause temporary increased sedimentation during ORV crossings. Efforts to stabilize or clearly mark the crossing would probably be washed away in the next tide or flood. We did not sample for fish.

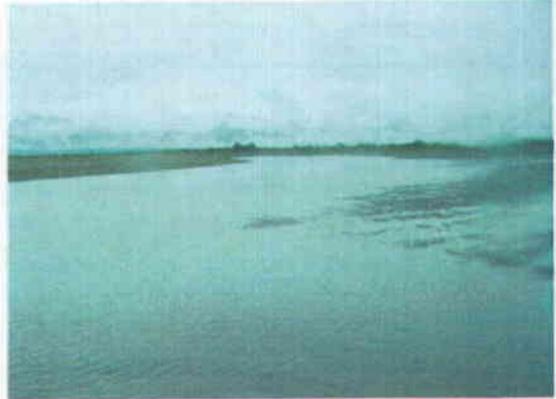
Photo 8. East slough of Alsek River.

Two seine tows captured starry flounders and staghorn sculpin, no salmonids were observed. This backwatered slough is cataloged as part of Alsek River (see Photo 8). Stream crossing access is only available during low tides and low flows, as this reach is heavily tidally influenced. The substrate of this crossing site and of the greater tidal flats area is loose sand and silt. Thus, other than increased sedimentation, ORV crossings at this slough probably have few long-term impacts to fish. Efforts to stabilize or clearly mark the crossing site would probably be washed away during the next tide or flood.

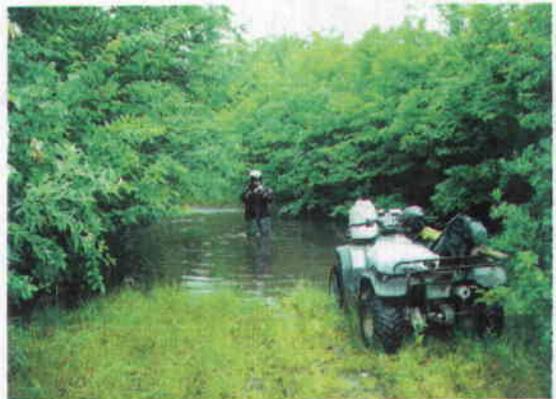
Photo 9. Isolated pools on abandoned trail.

We located several small pools flooding an abandoned trail, the largest pool was about knee-deep and 20' x 20' (see Photo 9). The pools probably result from lack of trail maintenance; trail access is now obtained along the tidal flats. Although we did not sample for fish, we did not observe any salmonids and doubt any connection to anadromous waters occurs. However, during high water the pools may connect to one another and flood the trail.
