State of Alaska  
Department of Fish and Game  
Sportfish Division

Nomination Form  
Fish Distribution Database

Region Southeast USGS Quad(s) Yakutat A-2  
 Fish Distribution Database Number of Waterway 182-20-10100 -2001  
 Name of Waterway East Alsek River  USGS Name  Local Name  
 Addition  Deletion  Correction  Backup Information

SUBJECT: Dry Bay ORV Trails  
Trip Report

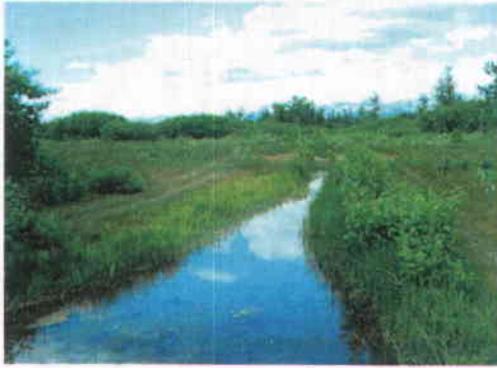
Photo 1. Doame River wetland drainage.

We located an un-cataloged, low-flow drainage about 600' west of the Doame River that flooded an abandoned ORV trail (see Photo 1). Several salmonids were observed swimming in the tire-track channel, we captured coho and stickleback in five traps. This ephemeral channel probably connects to the Doame River or neighboring streams during high flows or floods, and is created by channeling water from nearby wetlands. If the deeply incised abandoned ORV trail was not present, I doubt this channel would exist. New ORV trails that bypass the drainage are established on both sides of the channel and do not cross the drainage.

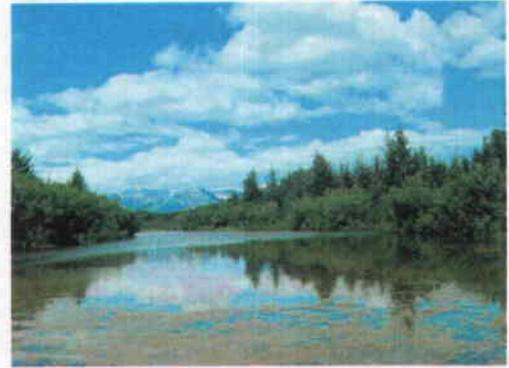
Photo 2. Lake southeast of the EAR.

About 300' southeast of the EAR crossing, we located an un-cataloged lake that drains adjacent wetlands and may provide overflow relief to the EAR during flood events (see Photo 2). Three traps set in the lake captured coho and sockeye salmon and stickleback. Aerial photographs suggest that the lake's two stream outlets drain directly to the EAR. The adjacent ORV trail probably does not impact this lake system, except if trail erosion runoff drains to the lake during wet conditions. I will nominate this lake and outlet stream for inclusion in the Catalog.

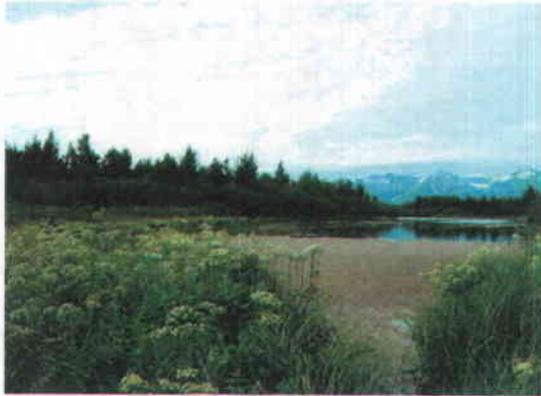
Photo 3. Lake southwest of the EAR.

Along the ORV trail about ¼ mile southwest from the EAR crossing, the trail crosses a 10' wide, un-cataloged lake and outlet drainage (see Photo 3). Aerial photographs indicate that the outlet drains directly to the EAR a few hundred feet downstream, although we did not verify this. Seven traps set in the lake and outlet captured coho and sockeye salmon and stickleback. Some bank undercutting near the narrow crossing entrances are evident, and small rock appears to have been placed in the streambed to strengthen the crossing. If this crossing remains open, it should be clearly marked and the banks sculpted for entry and hardened. Additional hardening of the streambed may also be beneficial. I will nominate this lake and outlet drainage for inclusion in the Catalog.

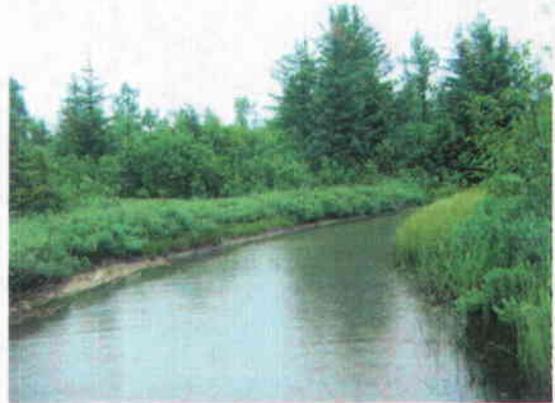
Photo 4. Small pool in the ORV trail.

About 1 mile west of EAR along the trail, we observed several dead coho and stickleback in a small isolated pool in the trail (see Photo 4). A 2-minute seine tow of about ½ the pool captured coho and sockeye salmon and stickleback. Most of the fish appeared unhealthy, having large heads and skinny bodies, which is probably due to competition within the small pool. We could not identify a nearby

anadromous water body where the fish might have originated, and speculate that the pool would probably not exist if the trail was not deeply incised. The connection might be more obvious during higher flows and could warrant further investigation before making trail maintenance recommendations at this location.

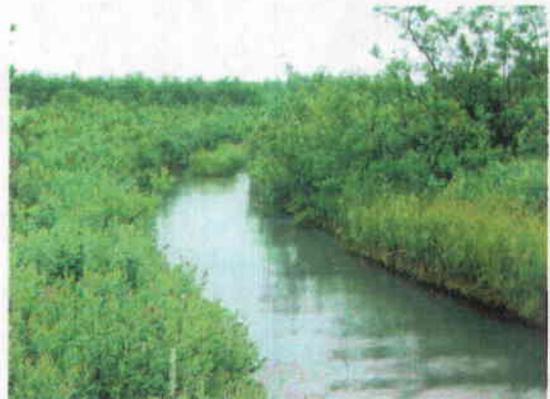
Photo 5. Lower EAR wetland drainage (trail).

**Site 7: Lower EAR wetland drainage (not cataloged)**  
This drainage has experienced significant bank erosion from ORV crossings, from wave action undercutting the banks and a deeply incised track, causing the drainage to backwater along the perpendicular trail (see Photo 5). Two seine tows captured hundreds coho and sockeye salmon and stickleback. Due to the erosion situation and because the western portion of this loop trail provides access to the area, this crossing should be closed. I will nominate this drainage for inclusion in the Catalog.

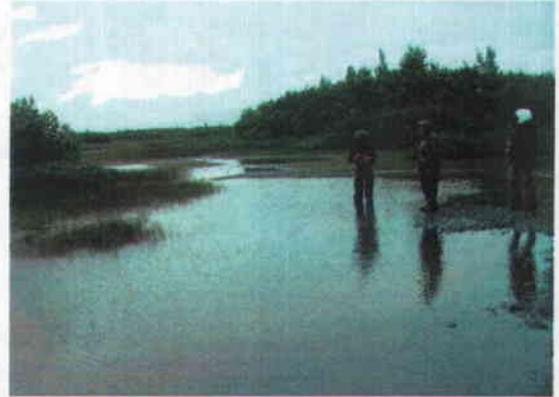
Photo 6. Lower Dog Salmon Creek drainage.

Although we did not sample for fish, this drainage probably does not connect to Dog Salmon Creek (see Photo 6). Stickleback were observed several hundred feet up and downstream of the crossing. Primary streambed substrate is small rock. Because a safer, more defined crossing is available in the upper reach of Dog Salmon Creek, this crossing should also be closed.

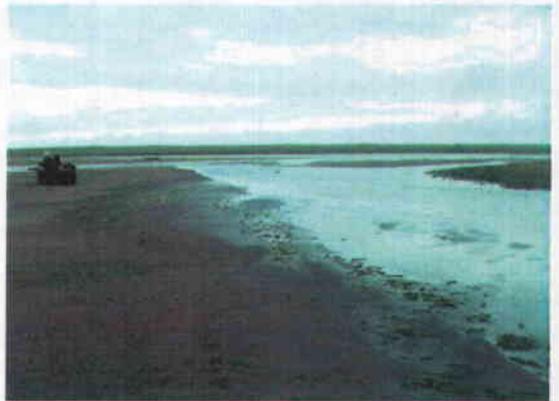
Photo 7. Dog Salmon Creek estuary.

The estuarine crossing of Dog Salmon is heavily tidally influenced (see Photo 7), and only accessible during low tide and low flows. Evidence of any ORV crossing is washed away with each tidal cycle. Due to the limited access, ORV crossings probably only occur when few fish are present, thereby causing minimal impacts to salmonids. Stream substrate at the crossing consisted of sand with some natural gravel, and may cause temporary increased sedimentation during ORV crossings. Efforts to stabilize or clearly mark the crossing would probably be washed away in the next tide or flood. We did not sample for fish.

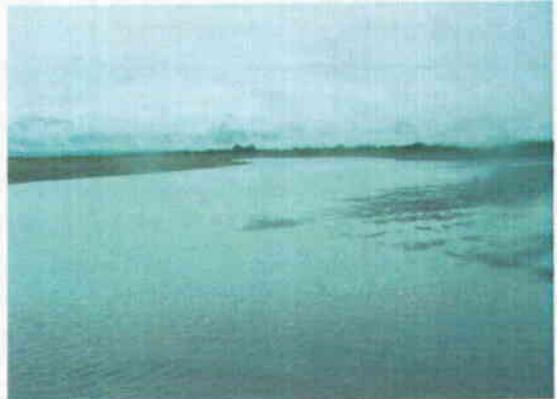
Photo 8. East slough of Alsek River.

Two seine tows captured starry flounders and staghorn sculpin, no salmonids were observed. This backwatered slough is cataloged as part of Alsek River (see Photo 8). Stream crossing access is only available during low tides and low flows, as this reach is heavily tidally influenced. The substrate of this crossing site and of the greater tidal flats area is loose sand and silt. Thus, other than increased sedimentation, ORV crossings at this slough probably have few long-term impacts to fish. Efforts to stabilize or clearly mark the crossing site would probably be washed away during the next tide or flood.

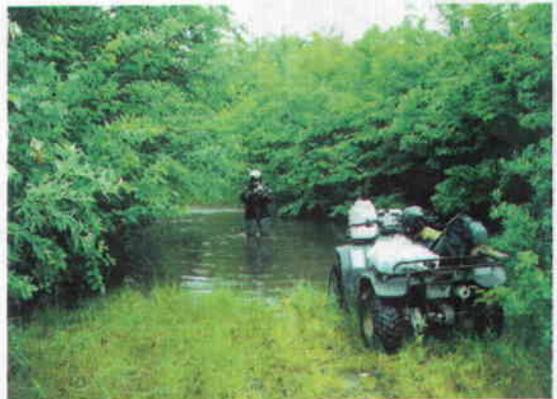
Photo 9. Isolated pools on abandoned trail.

We located several small pools flooding an abandoned trail, the largest pool was about knee-deep and 20' x 20' (see Photo 9). The pools probably result from lack of trail maintenance; trail access is now obtained along the tidal flats. Although we did not sample for fish, we did not observe any salmonids and doubt any connection to anadromous waters occurs. However, during high water the pools may connect to one another and flood the trail.

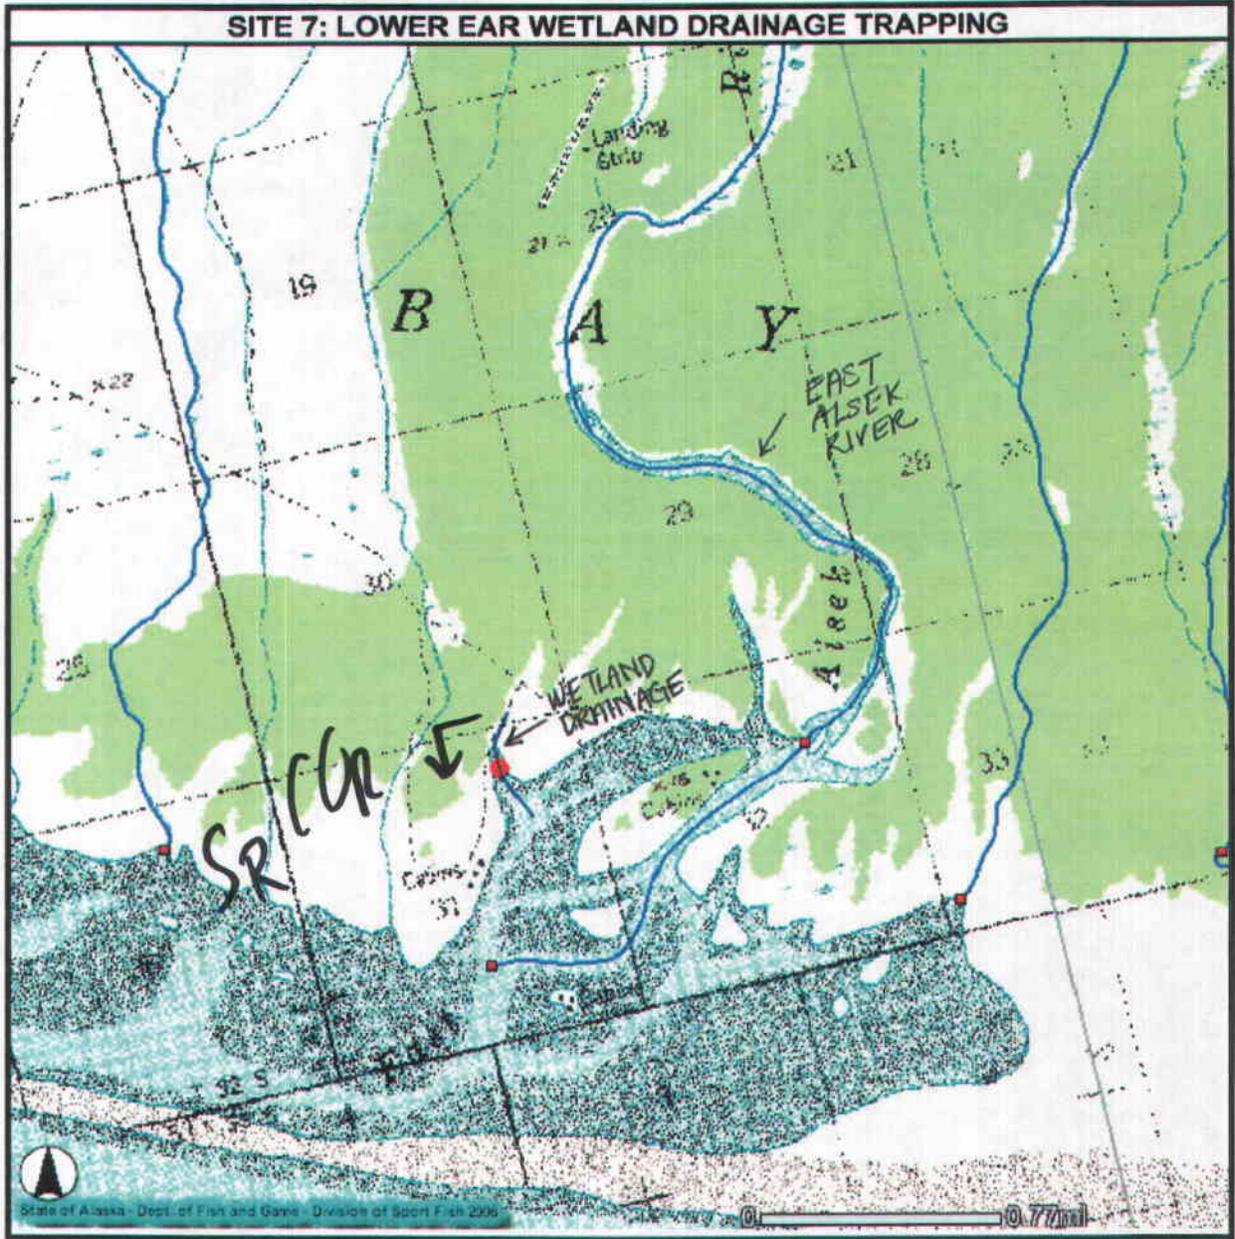
Add new stream 182-20-10100-2001  
w/ COR & SR  
Use line drawing for hydrography
