Nomination Form  
Fish Distribution Database

Name of Waterway Chilkat River  USGS Name  Local Name  
 Addition  Deletion  Correction  Backup Information

SUBJECT: Haines Hwy MP 3.5-25.3  
Trip Report

The Department of Transportation and Public Facilities (DOTPF) is proposing to widen and realign the Haines Highway between MP 3.5 and 25.3 to bring the highway up to National Highway System standards. The project would impact the Chilkat River and numerous smaller anadromous and resident fish streams. Fish Habitat permits would be required for stream crossings, relocation, and bank stabilization. A *Stream and Habitat Inventory* (SHI) was conducted in 2005 by Inter-Fluve, Inc. that identified fish streams impacted by the project. While many of the streams are documented in the *Catalog of Waters Important to the Spawning, Rearing or Migration of Anadromous Fishes* (Catalog), the survey found anadromous fish in many streams that are not in the Catalog. We conducted a field survey May 9-16, 2006 to supplement the Inter-Fluve survey, and to nominate additional anadromous fish streams to the Catalog.

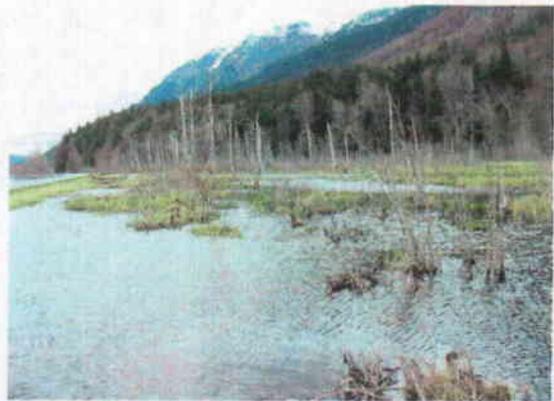
Photo 1. Station 271+25

What we believe to be the tributary on the river side of the highway (#115-32-10250-2008-3005) was dry upstream of the culvert at Station 271+25, and may not support fish at this time.

- Include the wetland as part of Waterfall Creek (map as polygon) in the Catalog
- Extend the upstream extent to just below the waterfall, in the Catalog
- Add king salmon rearing habitat to the Catalog
- Update stream location in the Catalog
- Revisit dry stream segment #115-32-10250-2008-3005 to determine if it should be removed from the Catalog
- Design all stream crossings for fish passage

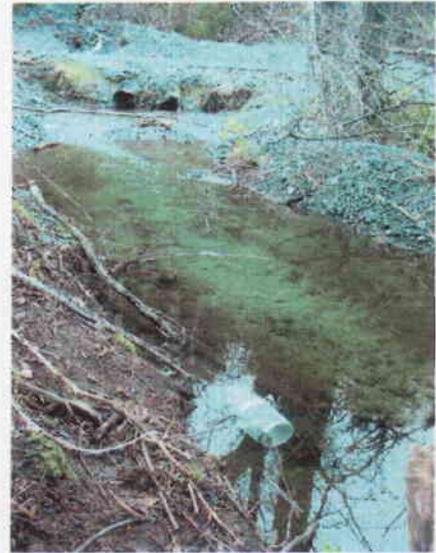
Photo 2. Station 315+50

This stream was identified in the SHI as habitat for rearing coho and Dolly Varden, and potential spawning (redds were observed). Upstream fish habitat is limited to about 50' upstream of the culvert.

A trap set about 40' upstream of the double 24" culverts caught coho salmon, cutthroat trout and Dolly Varden. A trap set about 30' downstream from the outlets caught king and coho salmon, and Dolly Varden (see Photo 2).

- Add to the Catalog as supporting rearing coho and king salmon, cutthroat trout and Dolly Varden
- Design the stream crossing for fish passage

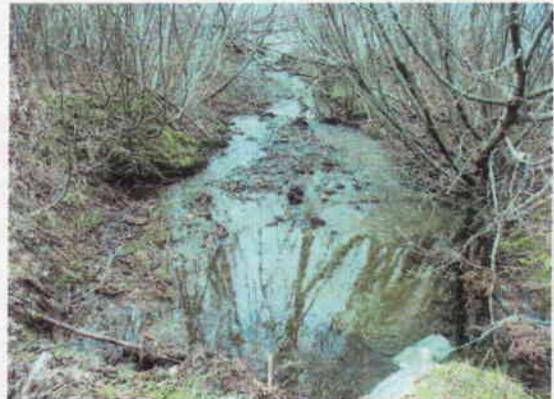
Photo 3. Station 339+00

This stream is below the site of an old cabin located uphill of the highway. It was not identified in the SHI. The clear water channel below the culvert outlet is about 8' wide and up to about 1' deep (see Photo 3). The culvert inlet was about 80% buried. Stream habitat is limited to the channel between the culvert and the Chilkat River (about 30 feet).

- Add to the Catalog as supporting rearing coho and Dolly Varden below the culvert
- Fish passage not required at stream crossing

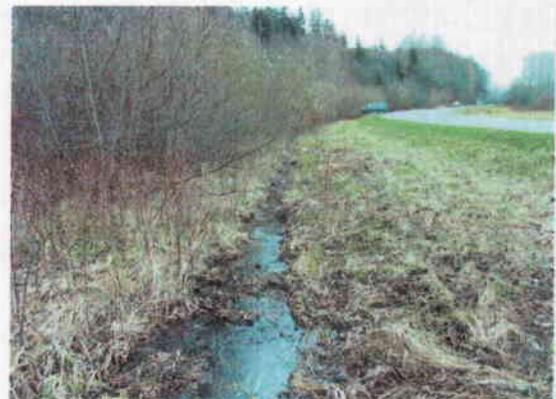
Photo 4. Station 342+00

The SHI identified this stream as supporting rearing coho and Dolly Varden. Coho and king salmon were trapped 300' upstream of the 36" culvert crossing. The culvert is perched and unraveling. The stream meanders along the road upstream of the culvert for about 300', before turning inland (see Photo 4). Potential fish habitat terminates in a high-gradient reach just below a waterfall.

- Add to the Catalog as supporting rearing coho and king salmon

- Design the stream crossing for fish passage

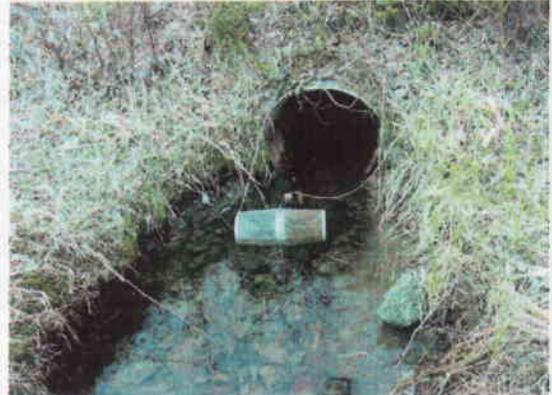
Photo 5. Station 389+25

The SHI identified this stream as supporting rearing coho and Dolly Varden. The stream crosses the highway through a 24" culvert. Coho salmon were trapped at the culvert outlet (see Photo 5), coho and cutthroat were trapped at the inlet. Upstream fish habitat is limited to about 40 feet because of a steep cascade.

- Add to the Catalog as supporting rearing coho salmon and cutthroat trout
- Design the stream crossing for fish passage

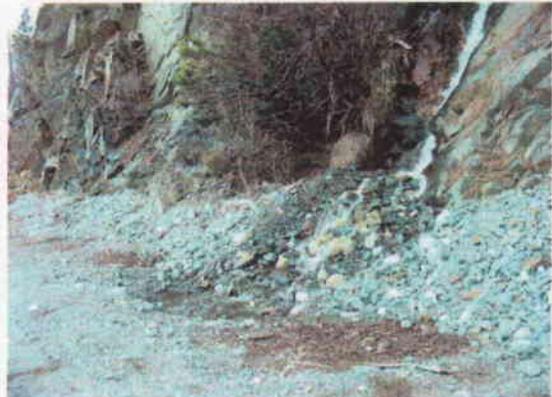
Photo 6. Station 391+75

The SHI identified this stream as providing rearing habitat for coho and Dolly Varden. The stream terminates in a waterfall just upstream of the 24" culvert (see Photo 6). A 10-foot diameter pool identified in the SHI at the bottom of the waterfall was filled with gravel and the stream flowed to the culvert through a shallow gravelly channel. There was no usable habitat above the culvert inlet. The channel above and below the culvert was too shallow to trap. Although not documented, the short stream reach below the culvert probably provides rearing habitat for coho salmon and Dolly Varden char, and good spawning gravels.

- Stream crossing does not need to be designed for fish passage

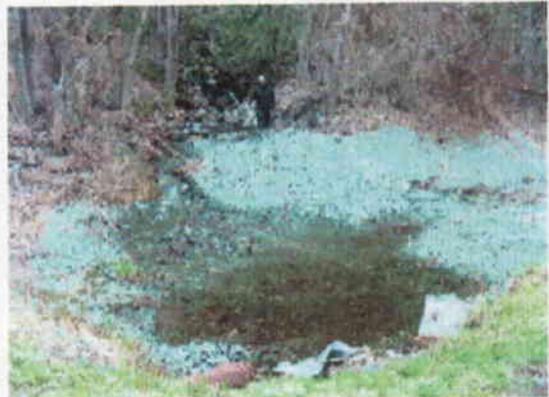
Photo 7. Station 442+75

The SHI identified this stream as supporting rearing coho and Dolly Varden, and possible spawning habitat. The stream crosses the highway through twin 24" culverts that were perched about 6". Fish habitat ends about 75' upstream at a steep cascade (see Photo 7). There was evidence of water flowing across the road as a result of plugged culverts. Coho salmon, steelhead, and cutthroat trout were trapped about 60 feet upstream of the culvert inlet. Coho salmon were trapped just below the outlet.

- Add to the Catalog as supporting rearing coho, cutthroat and steelhead
- Design the stream crossing for fish passage

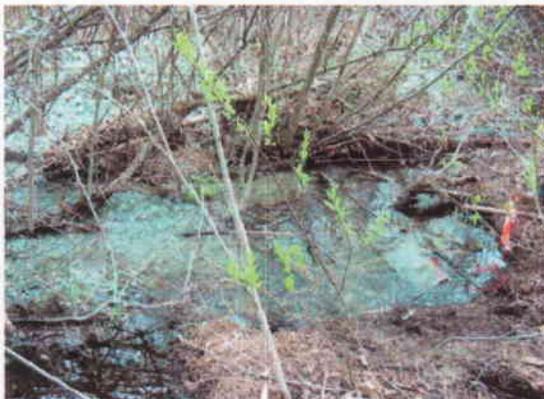
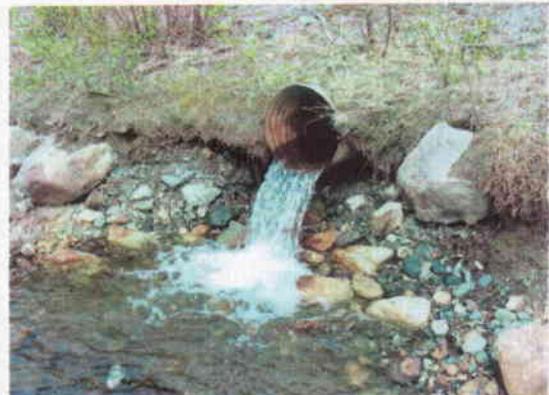
Photo 8. Station 632+00

This stream was not identified in the SHI. A trap placed about 100' upstream from the 24" culvert caught cutthroat and Dolly Varden (see Photo 8). Shortly beyond this point the gradient increases significantly. The culvert is perched about 1' and discharges directly to the Chilkat River (see Photo 9). There is enough good upstream habitat to make it worthwhile replacing the culvert with one that improves fish passage.

- Add to the catalog as supporting rearing cutthroat and Dolly Varden
- Design the stream crossing for fish passage

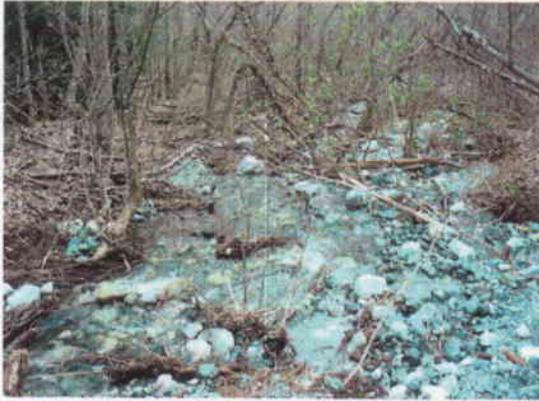
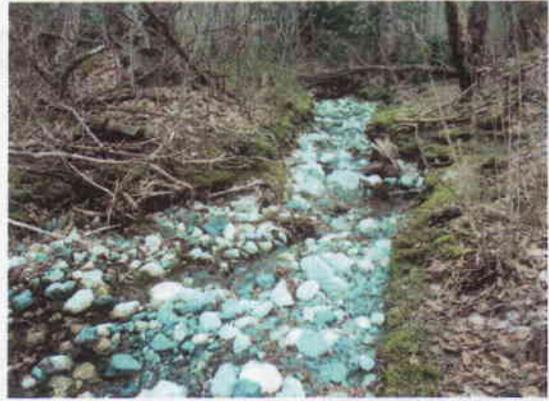
Photo 10. Station 670+00

A recent debris flow has blocked the main channel so that a majority of the flow now goes through a new channel near Station 677+00 (see Photo 10), and flows along the road to twin 36-inch culverts near Station 670+00. We observed three cutthroat trout (about 18", 12" and 4") in the new stream channel about 30' upstream from the road. No fish were caught in traps set farther up in this channel. King salmon and cutthroat trout were trapped in the original main channel about 400' upstream from the culverts. There is an opportunity to improve fish passage in this area. The stream flow is now divided into many channels that are filled with gravels to the extent that flow remains subsurface for much of the way. Habitat could be improved by focusing the flow either back into the old main channel (see Photo 11), or improving the new channel.

We confirmed that Inter-Fluve's description of the area was correct. Debris flows have reduced habitat in the main channel and created new channels. These changes have likely reduced the habitat quality because of the more dispersed flows and sediment accumulation. Stream channel improvements here would be appropriate mitigation for the project. This area will require a more detailed look to determine the best approach to habitat improvements, once road alignment plans have been finalized for this area. The current proposed realignment would move the highway upstream of most of the fish habitat.

- Update Catalog to document the new channel locations and upstream extent of cutthroat spawning, and king and coho salmon rearing.
- Design the stream crossing(s) for fish passage

- Consider channel improvements as mitigation
- Take a detailed look at the hydrology and channel morphology to determine where best to route the flows and which channels to improve

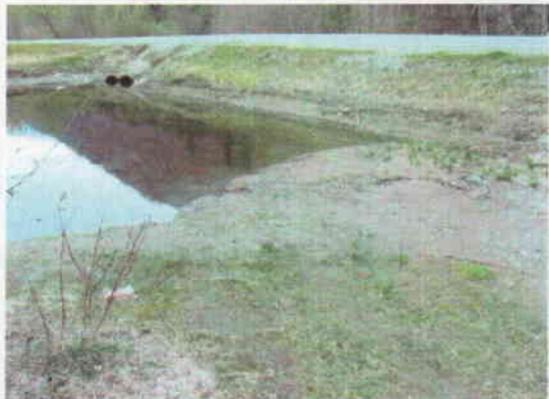
Photo 12. Station 733+50

This stream is cataloged as providing rearing and spawning habitat for coho salmon and Dolly Varden. A slough of the Chilkat River just below the two 36" culverts is used as an informal boat launch area (see Photo 12), resulting in degradation of the stream banks and bed. A trap 45' upstream of the culvert caught coho and king salmon, and Dolly Varden.

This is the location of the informal boat launching area.

- Update the Catalog to add king salmon rearing
- Design the stream crossing for fish passage

- Realign stream to cross more perpendicular to the highway
- Rehabilitate degraded habitat below culvert
- Improve the boat launch area by hardening to reduce habitat degradation, or
- Develop new launching area at a better location and close out this one

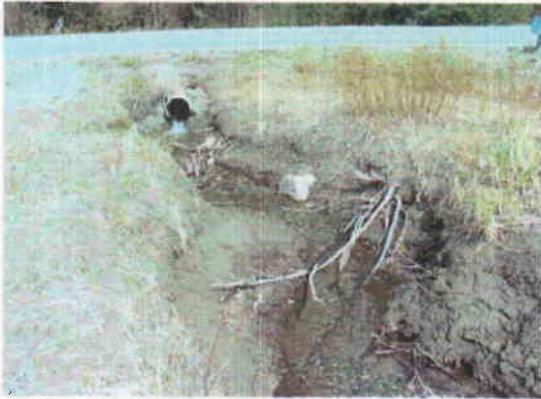
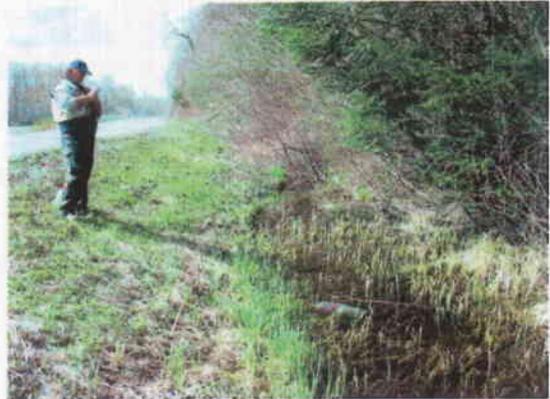
Photo 13. Station 760+00

The SHI identified this stream as supporting rearing coho and Dolly Varden. This un-cataloged stream crosses the highway through a perched 24" culvert (see Photo 13). Three traps set within 175' upstream of the culvert inlet caught king and coho salmon and Dolly Varden (see Photo 14). The stream would be filled by the proposed road alignment.

This short stream that we propose to nominate to the Catalog would be mostly filled by the new road alignment.

- Add to the Catalog as supporting king and coho salmon and Dolly Varden
- Construct new channel on riverside of highway
- Fish passage is not required for this stream crossing

- Re-route water from cascades through a new crossing location and create new stream and potentially wetlands on the river side (culvert would not need to be designed to pass fish).

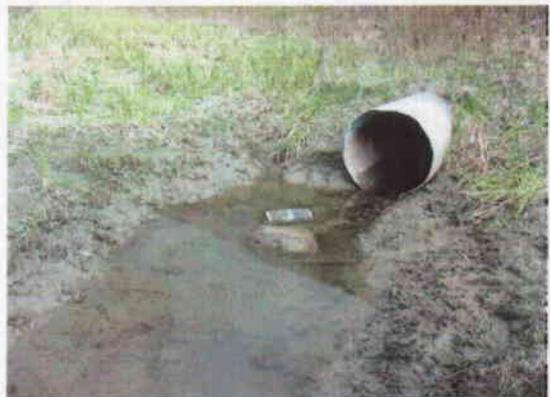
Photo 15. Station 879+75

The SHI identified this stream as supporting rearing coho and Dolly Varden below the culvert. Fish habitat ends at the culvert (see Photo 15). King salmon and Dolly Varden were trapped at the culvert outlet. The stream below the culvert is a slough of the Chilkat River, and is thereby cataloged.

- Fish passage is not required for this stream crossing.

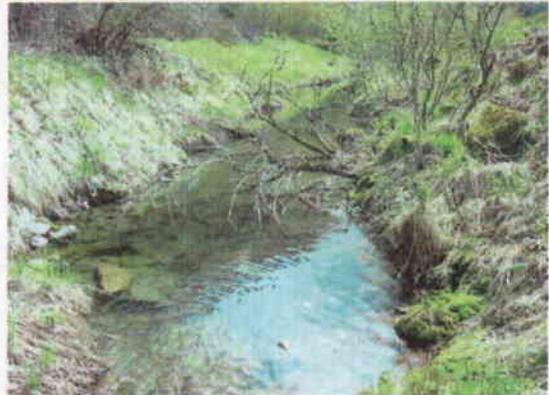
Photo 16. Station 887+90

The Catalog lists this stream as providing rearing habitat for coho salmon and Dolly Varden char, and spawning habitat for coho and chum salmon. The cataloged stream originates from springs on the hillside, and flows through NSRAA's (Northern Southeast Regional Aquaculture Association) incubation boxes. An un-cataloged western tributary collects water from the hillside and joins the cataloged tributary near the culvert inlet (see Photo 16). A trap set in a pond at the uppermost fish habitat extent of the western channel (about 700' upstream of the culvert) didn't catch fish, but king

salmon were caught about 60' downstream of the pond. Dolly Varden char were also trapped in the western tributary.

The road alignment would potentially be moved upslope and would obliterate the existing stream. A new stream would need to be constructed, probably downslope of the existing highway. Additional water that now flows off the hillside and through the highway beyond the existing stream habitat could potentially be intercepted for use in the new stream channel.

- Add the western tributary of 115-32-10250-2060-3002 to the Catalog as supporting rearing king salmon and Dolly Varden char

- Consider intercepting additional water for replacement stream

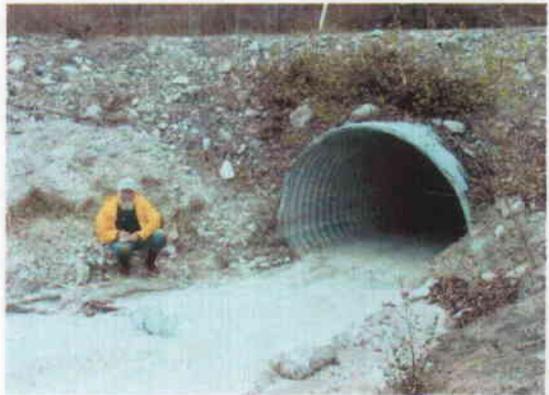
Photo 17. Station 985+00 (dry)

This stream is part of the 19 Mile slide area subject to large influx of gravels from the hillside and upslope streams. The SHI identified this location as rearing habitat for coho salmon and Dolly Varden. The channel was dry upstream and downstream of the culvert to the confluence with Chilkat River (see Photo 17). This is an ephemeral stream that has seasonally heavy flows carrying large amounts of sediment, and may provide fish habitat in the lower vegetated reach.

- Fish passage is not required for this crossing location.

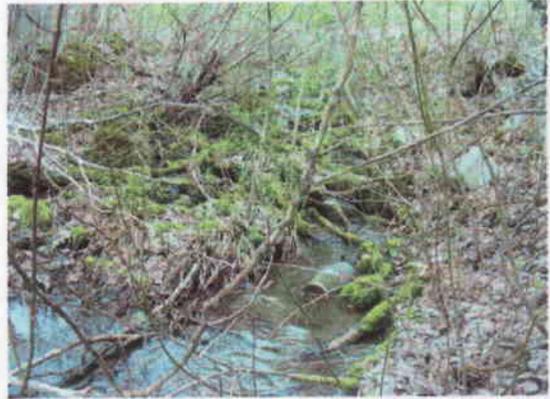
Photo 18. Station 1098+50

This stream may be incorrectly located in the SHI, and is closer to Station 1101+00. The SHI determined that this wasn't a fish stream because a steep drop-off to the Chilkat River. We hiked to the outlet and verified the natural blockage to upstream fish passage. Traps near the culvert outlet (see Photo 18) and 45' upstream of the inlet did not catch fish.

- Fish passage is not required for this crossing location
