State of Alaska  
Department of Fish and Game  
Sportfish Division

Nomination Form  
Fish Distribution Database

Name of Waterway Chilkat River  USGS Name  Local Name

SUBJECT: Haines Hwy MP 3.5-25.3  
Trip Report

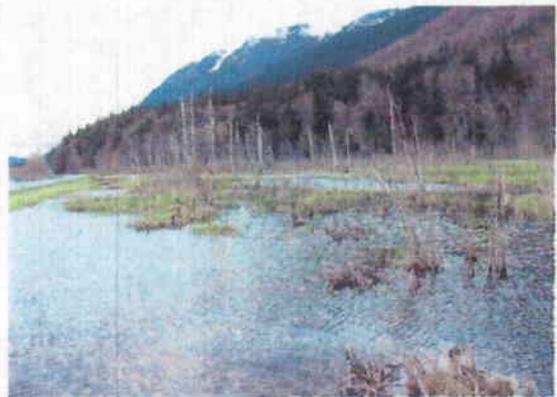
Photo 1. Station 271+25

What we believe to be the tributary on the river side of the highway (#115-32-10250-2008-3005) was dry upstream of the culvert at Station 271+25, and may not support fish at this time.

- Include the wetland as part of Waterfall Creek (map as polygon) in the Catalog
- Extend the upstream extent to just below the waterfall, in the Catalog
- Add king salmon rearing habitat to the Catalog
- Update stream location in the Catalog
- Revisit dry stream segment #115-32-10250-2008-3005 to determine if it should be removed from the Catalog
- Design all stream crossings for fish passage

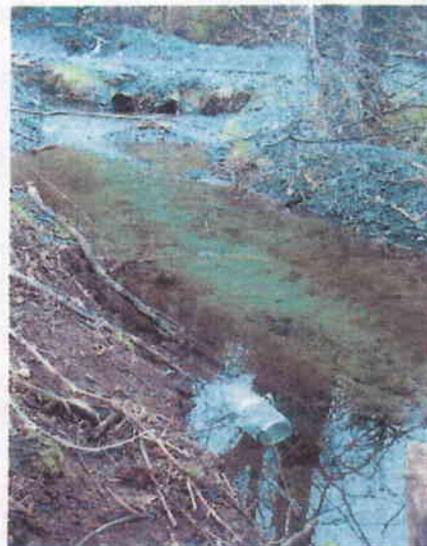
Photo 2. Station 315+50

This stream was identified in the SHI as habitat for rearing coho and Dolly Varden, and potential spawning (redds were observed). Upstream fish habitat is limited to about 50' upstream of the culvert.

A trap set about 40' upstream of the double 24" culverts caught coho salmon, cutthroat trout and Dolly Varden. A trap set about 30' downstream from the outlets caught king and coho salmon, and Dolly Varden (see Photo 2).

- Add to the Catalog as supporting rearing coho and king salmon, cutthroat trout and Dolly Varden
- Design the stream crossing for fish passage

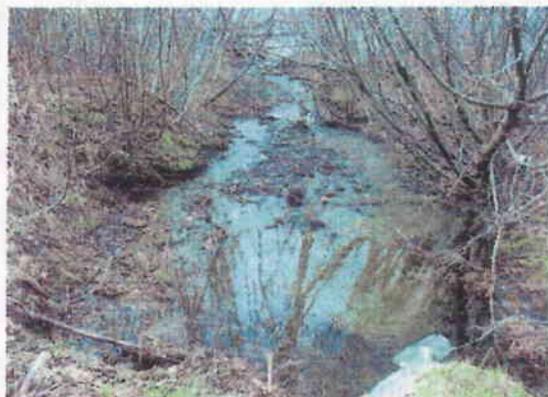
Photo 3. Station 339+00

This stream is below the site of an old cabin located uphill of the highway. It was not identified in the SHI. The clear water channel below the culvert outlet is about 8' wide and up to about 1' deep (see Photo 3). The culvert inlet was about 80% buried. Stream habitat is limited to the channel between the culvert and the Chilkat River (about 30 feet).

- Add to the Catalog as supporting rearing coho and Dolly Varden below the culvert
- Fish passage not required at stream crossing

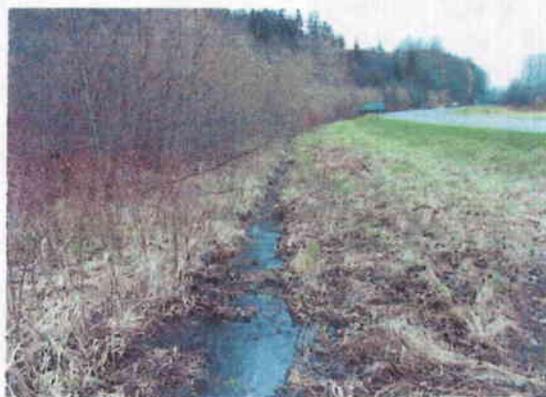
Photo 4. Station 342+00

The SHI identified this stream as supporting rearing coho and Dolly Varden. Coho and king salmon were trapped 300' upstream of the 36" culvert crossing. The culvert is perched and unraveling. The stream meanders along the road upstream of the culvert for about 300', before turning inland (see Photo 4). Potential fish habitat terminates in a high-gradient reach just below a waterfall.

- Add to the Catalog as supporting rearing coho and king salmon

- Design the stream crossing for fish passage

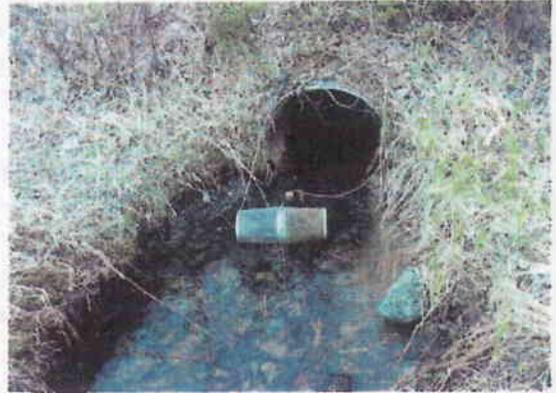
Photo 5. Station 389+25

The SHI identified this stream as supporting rearing coho and Dolly Varden. The stream crosses the highway through a 24" culvert. Coho salmon were trapped at the culvert outlet (see Photo 5), coho and cutthroat were trapped at the inlet. Upstream fish habitat is limited to about 40 feet because of a steep cascade.

- Add to the Catalog as supporting rearing coho salmon and cutthroat trout
- Design the stream crossing for fish passage

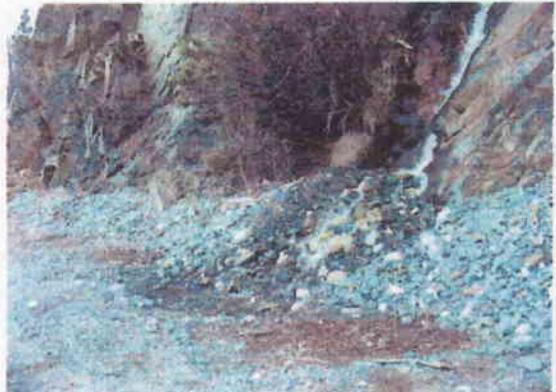
Photo 6. Station 391+75

The SHI identified this stream as providing rearing habitat for coho and Dolly Varden. The stream terminates in a waterfall just upstream of the 24" culvert (see Photo 6). A 10-foot diameter pool identified in the SHI at the bottom of the waterfall was filled with gravel and the stream flowed to the culvert through a shallow gravelly channel. There was no usable habitat above the culvert inlet. The channel above and below the culvert was too shallow to trap. Although not documented, the short stream reach below the culvert probably provides rearing habitat for coho salmon and Dolly Varden char, and good spawning gravels.

- Stream crossing does not need to be designed for fish passage

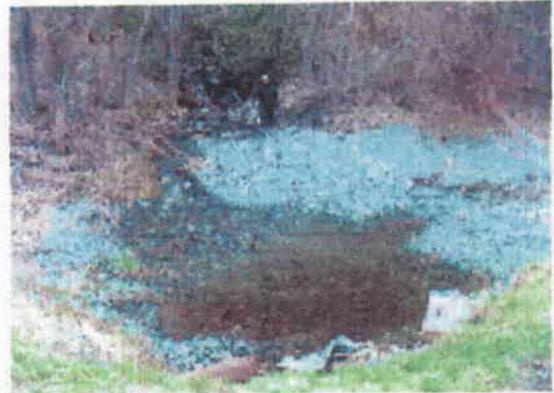
Photo 7. Station 442+75

The SHI identified this stream as supporting rearing coho and Dolly Varden, and possible spawning habitat. The stream crosses the highway through twin 24" culverts that were perched about 6". Fish habitat ends about 75' upstream at a steep cascade (see Photo 7). There was evidence of water flowing across the road as a result of plugged culverts. Coho salmon, steelhead, and cutthroat trout were trapped about 60 feet upstream of the culvert inlet. Coho salmon were trapped just below the outlet.

- Add to the Catalog as supporting rearing coho, cutthroat and steelhead
- Design the stream crossing for fish passage

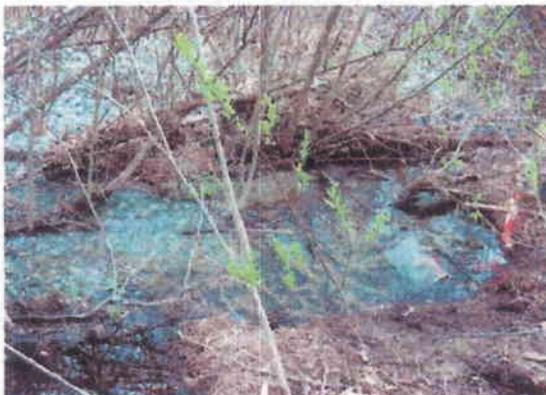
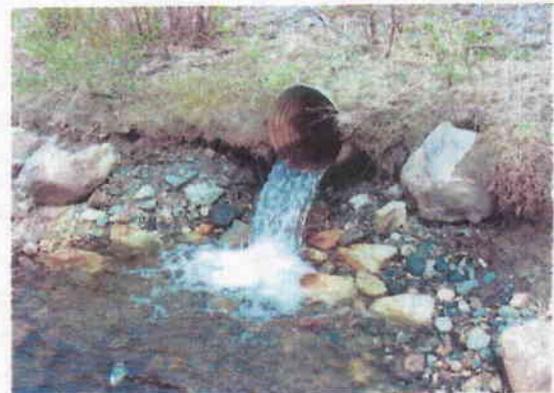
This stream was not identified in the SHI. A trap placed about 100' upstream from the 24" culvert caught cutthroat and Dolly Varden (see Photo 8). Shortly beyond this point the gradient increases significantly. The culvert is perched about 1' and discharges directly to the Chilkat River (see Photo 9). There is enough good upstream habitat to make it worthwhile replacing the culvert with one that improves fish passage.

- Add to the catalog as supporting rearing cutthroat and Dolly Varden
- Design the stream crossing for fish passage

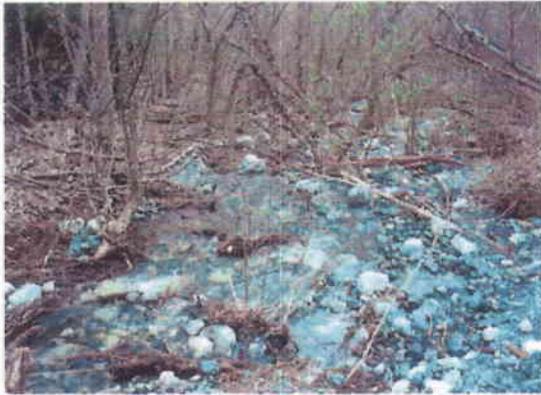
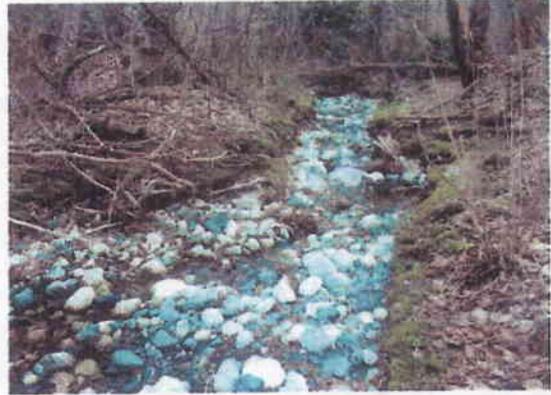
A recent debris flow has blocked the main channel so that a majority of the flow now goes through a new channel near Station 677+00 (see Photo 10), and flows along the road to twin 36-inch culverts near Station 670+00. We observed three cutthroat trout (about 18", 12" and 4") in the new stream channel about 30' upstream from the road. No fish were caught in traps set farther up in this channel. King salmon and cutthroat trout were trapped in the original main channel about 400' upstream from the culverts. There is an opportunity to improve fish passage in this area. The stream flow is now divided into many channels that are filled with gravels to the extent that flow remains subsurface for much of the way. Habitat could be improved by focusing the flow either back into the old main channel (see Photo 11), or improving the new channel.

We confirmed that Inter-Fluve's description of the area was correct. Debris flows have reduced habitat in the main channel and created new channels. These changes have likely reduced the habitat quality because of the more dispersed flows and sediment accumulation. Stream channel improvements here would be appropriate mitigation for the project. This area will require a more detailed look to determine the best approach to habitat improvements, once road alignment plans have been finalized for this area. The current proposed realignment would move the highway upstream of most of the fish habitat.

- Update Catalog to document the new channel locations and upstream extent of cutthroat spawning, and king and coho salmon rearing.
- Design the stream crossing(s) for fish passage

- Consider channel improvements as mitigation
- Take a detailed look at the hydrology and channel morphology to determine where best to route the flows and which channels to improve

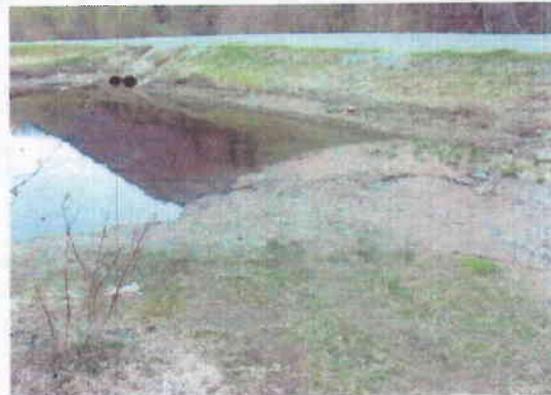
**Photo 12. Station 733+50**

This stream is cataloged as providing rearing and spawning habitat for coho salmon and Dolly Varden. A slough of the Chilkat River just below the two 36" culverts is used as an informal boat launch area (see Photo 12), resulting in degradation of the stream banks and bed. A trap 45' upstream of the culvert caught coho and king salmon, and Dolly Varden.

- Update the Catalog to add king salmon rearing
- Design the stream crossing for fish passage

- Realign stream to cross more perpendicular to the highway
- Rehabilitate degraded habitat below culvert
- Improve the boat launch area by hardening to reduce habitat degradation, or
- Develop new launching area at a better location and close out this one

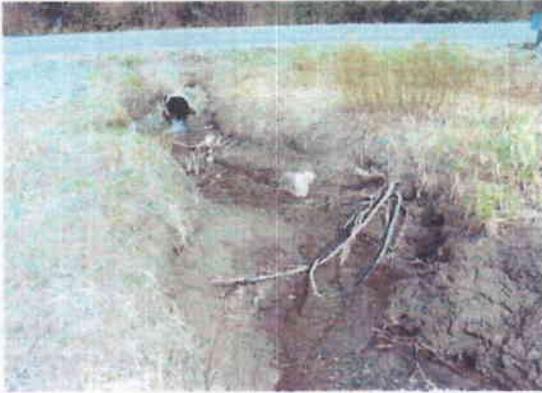
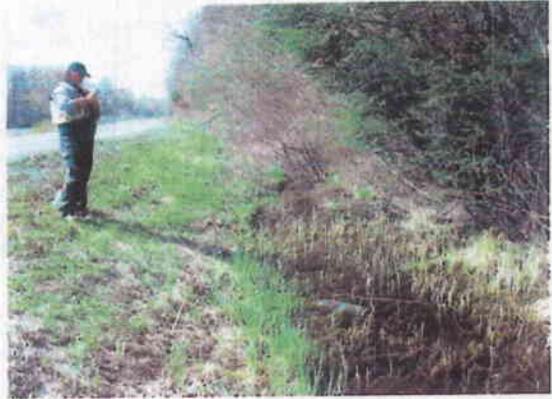
The SHI identified this stream as supporting rearing coho and Dolly Varden. This un-cataloged stream crosses the highway through a perched 24" culvert (see Photo 13). Three traps set within 175' upstream of the culvert inlet caught king and coho salmon and Dolly Varden (see Photo 14). The stream would be filled by the proposed road alignment.

This short stream that we propose to nominate to the Catalog would be mostly filled by the new road alignment.

- Add to the Catalog as supporting king and coho salmon and Dolly Varden
- Construct new channel on riverside of highway
- Fish passage is not required for this stream crossing

- Re-route water from cascades through a new crossing location and create new stream and potentially wetlands on the river side (culvert would not need to be designed to pass fish).

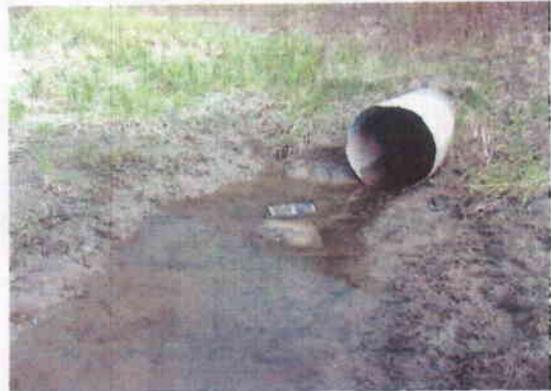
Photo 15. Station 879+75

The SHI identified this stream as supporting rearing coho and Dolly Varden below the culvert. Fish habitat ends at the culvert (see Photo 15). King salmon and Dolly Varden were trapped at the culvert outlet. The stream below the culvert is a slough of the Chilkat River, and is thereby cataloged.

- Fish passage is not required for this stream crossing.

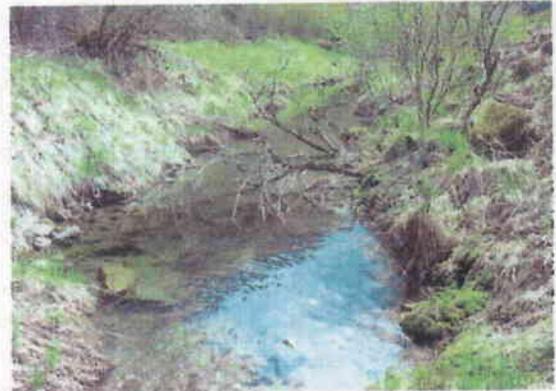
Photo 16. Station 887+90

The Catalog lists this stream as providing rearing habitat for coho salmon and Dolly Varden char, and spawning habitat for coho and chum salmon. The cataloged stream originates from springs on the hillside, and flows through NSRAA's (Northern Southeast Regional Aquaculture Association) incubation boxes. An un-cataloged western tributary collects water from the hillside and joins the cataloged tributary near the culvert inlet (see Photo 16). A trap set in a pond at the uppermost fish habitat extent of the western channel (about 700' upstream of the culvert) didn't catch fish, but king

salmon were caught about 60' downstream of the pond. Dolly Varden char were also trapped in the western tributary.

- Add the western tributary of 115-32-10250-2060-3002 to the Catalog as supporting rearing king salmon and Dolly Varden char

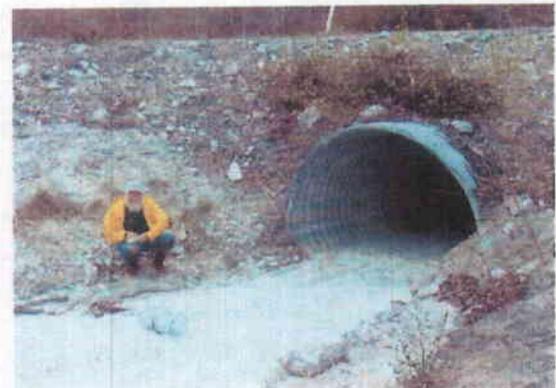
Photo 17. Station 985+00 (dry)

This stream is part of the 19 Mile slide area subject to large influx of gravels from the hillside and upslope streams. The SHI identified this location as rearing habitat for coho salmon and Dolly Varden. The channel was dry upstream and downstream of the culvert to the confluence with Chilkat River (see Photo 17). This is an ephemeral stream that has seasonally heavy flows carrying large amounts of sediment, and may provide fish habitat in the lower vegetated reach.

- Fish passage is not required for this crossing location.

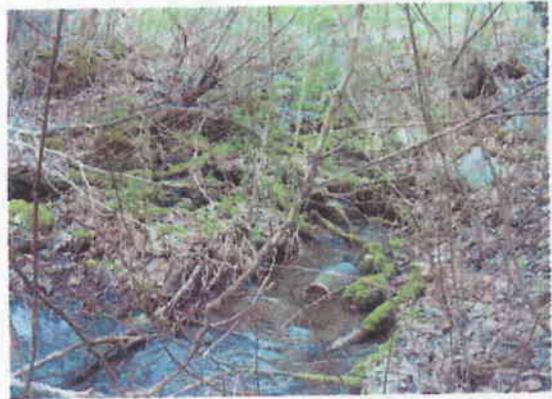
Photo 18. Station 1098+50

This stream may be incorrectly located in the SHI, and is closer to Station 1101+00. The SHI determined that this wasn't a fish stream because a steep drop-off to the Chilkat River. We hiked to the outlet and verified the natural blockage to upstream fish passage. Traps near the culvert outlet (see Photo 18) and 45' upstream of the inlet did not catch fish.

- Fish passage is not required for this crossing location
