State of Alaska
Department of Fish and Game
Sportfish Division

Nomination Form
Anadromous Waters Catalog

Name of Waterway Shelokum Creek USGS Name Local Name

Field Trip Report
Shelokum Creek
Date prepared: September 4, 2009

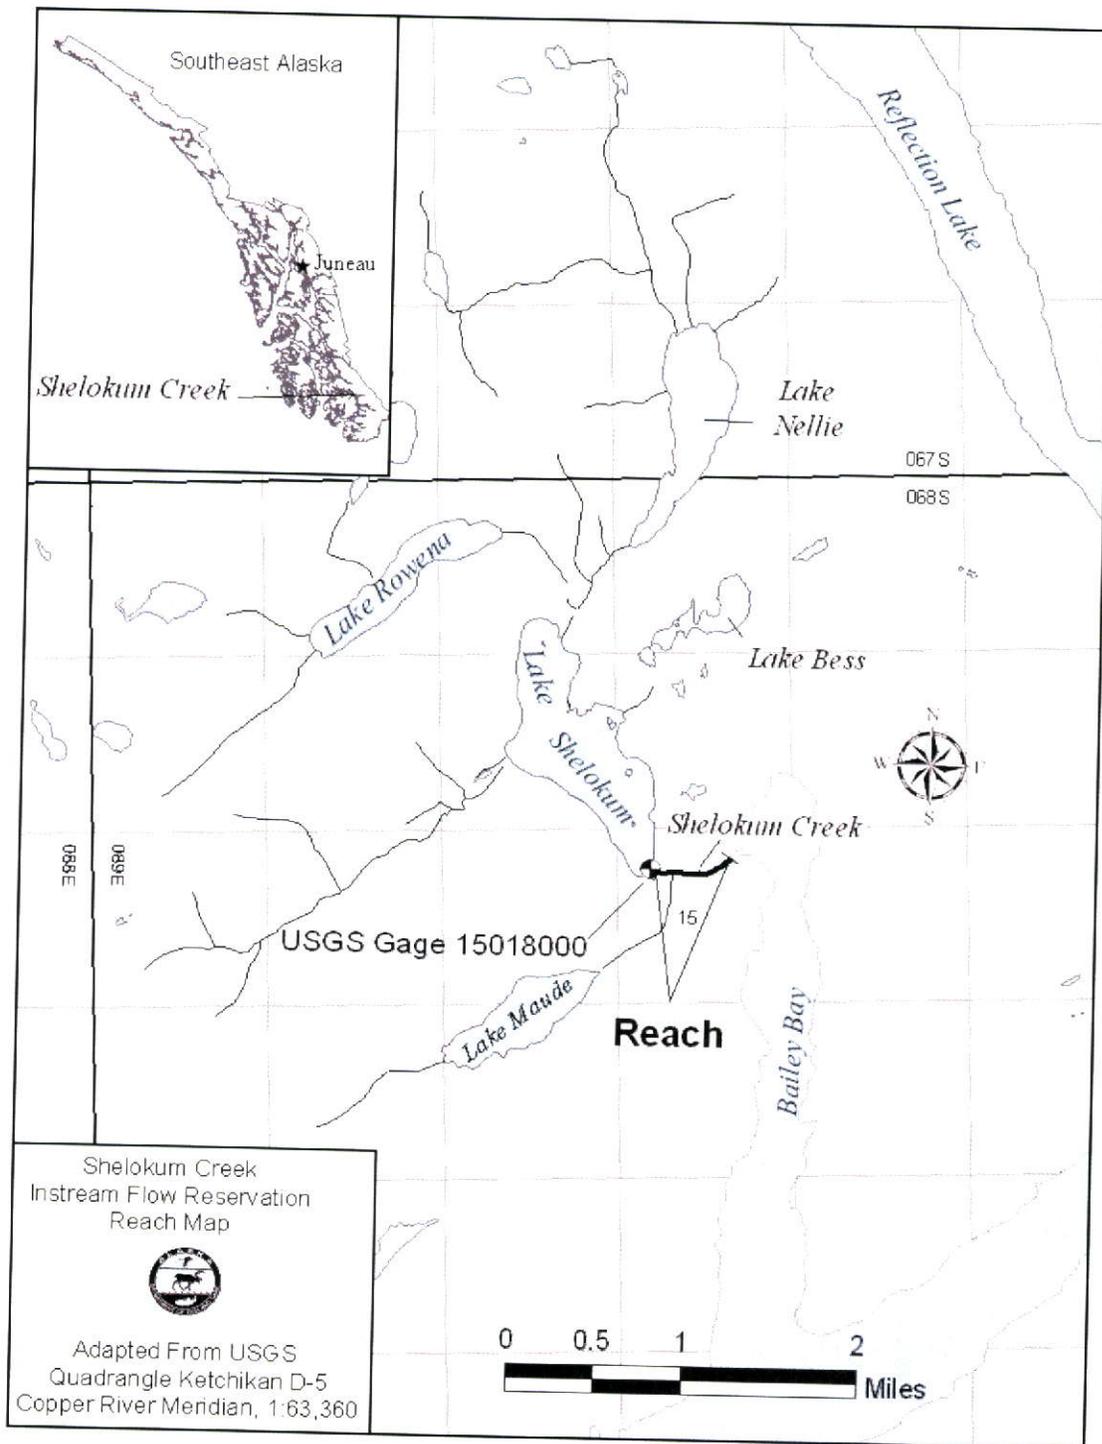
Figure 2. Shelokum Creek ROW Reach Map.

A reservation of water (ROW) application, LAS 5881, was filed by ADF&G for one reach of Shelokum Creek on October 12, 2006. This ROW was filed to reserve water within Shelokum Creek for the purpose of maintaining stream flows for fish migration, habitat, and propagation. The reach boundaries applied for in the ROW (LAS 5881) extend from the downstream end of the creek at mean lower low water upstream to the outlet of Shelokum Lake (Figure 2). Shelokum Creek (AWC # 101-80-10730) has been catalogued by ADF&G for pink and chum salmon in the Anadromous Water Catalog (AWC; Stream # 101-80-10730). The AWC catalog indicates that pink and chum salmon can be found from saltwater to the outlet of Shelokum Lake.

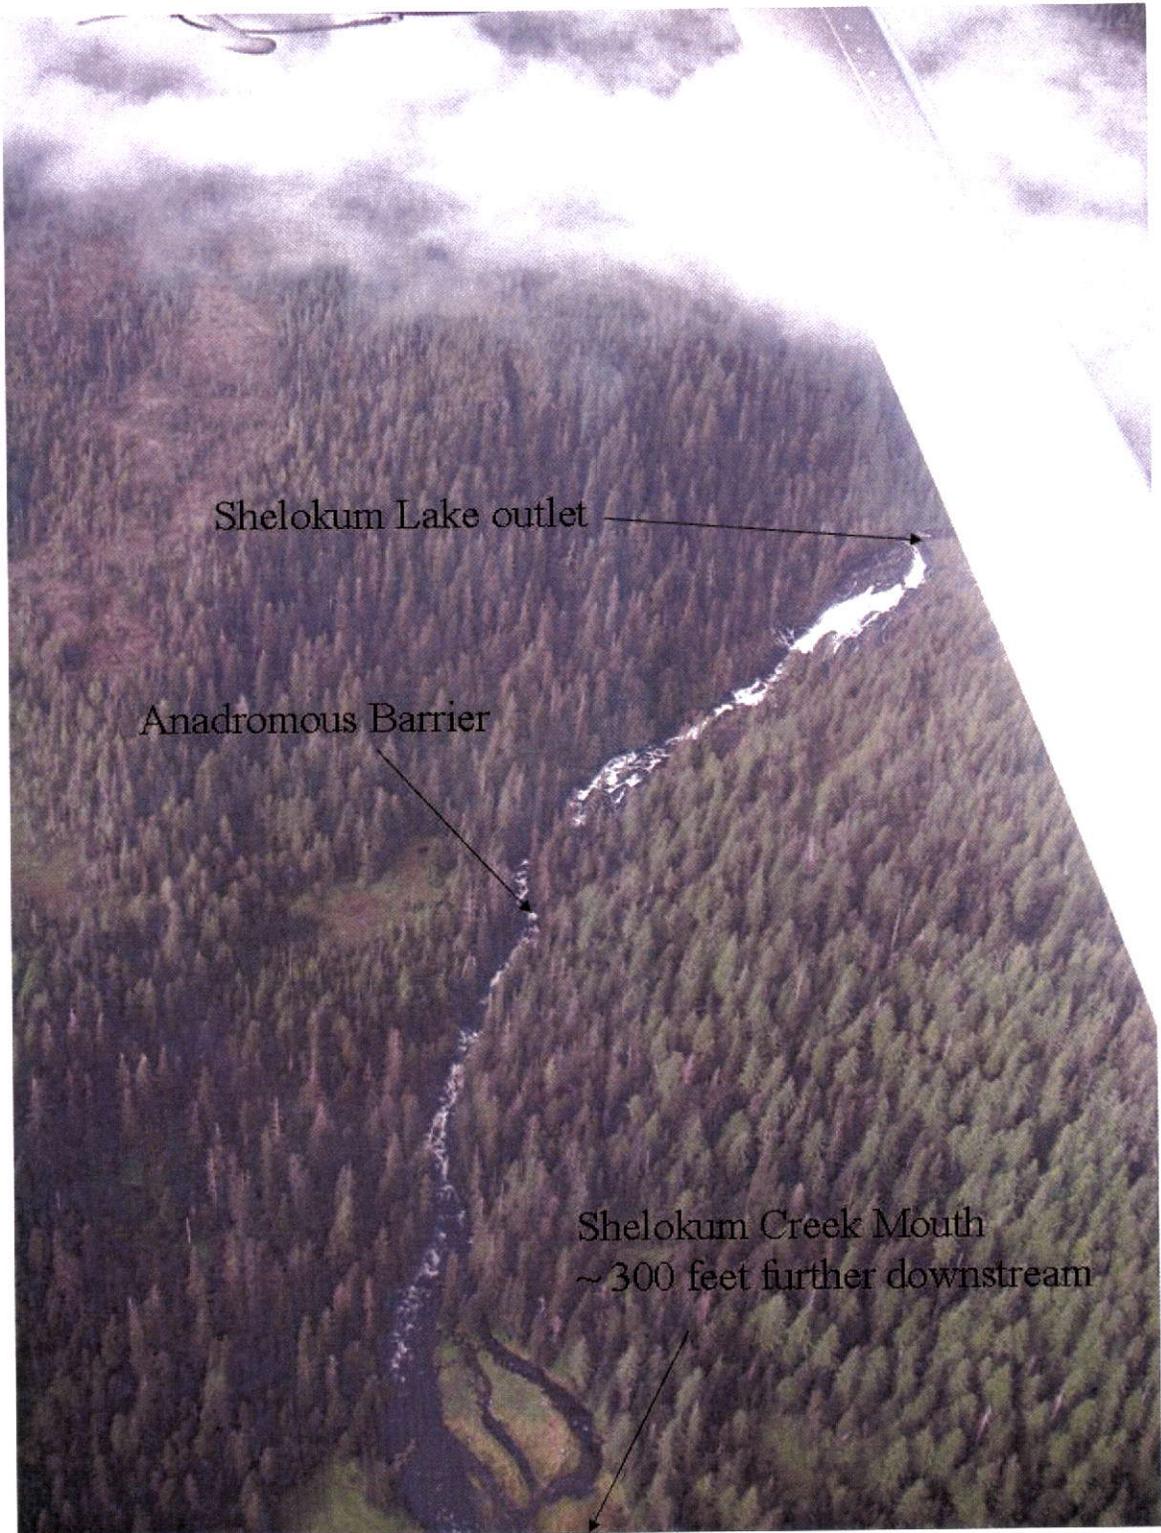
Picture 1. Aerial view of Shelokum Creek from the mouth to the lake outlet with landscape features labeled.

We departed Ketchikan via a Pacific Airways float plane at 8:30 am and arrived at the Shelokum Creek watershed at 9:00 am. Before landing at saltwater we flew around the watershed and took pictures of the creek from saltwater to the outlet of the lake (Picture 1).

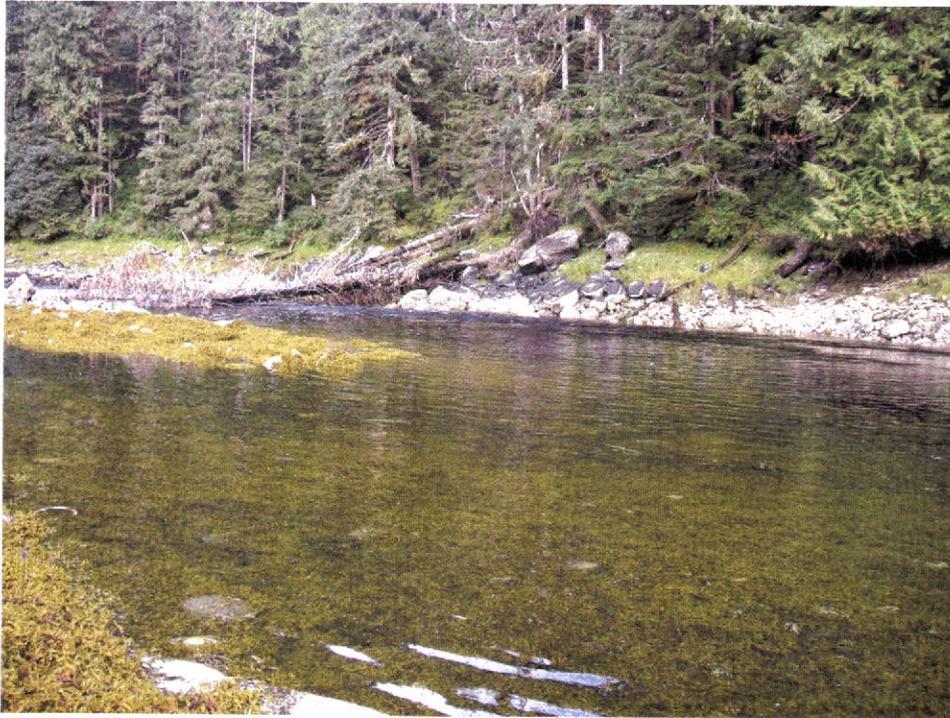
Picture 2. Pink Salmon in saltwater near mouth of Shelokum Creek.

Once on the ground we observed a group of approximately 1,500 pink salmon in saltwater near the mouth of the creek (Picture 2). We walked up the creek from saltwater and observed spawning and dead pink salmon in the intertidal zone (Picture 3). From the intertidal zone we walked upstream (Picture 4) and continued to observe spawning pink salmon through the cascade reach until an anadromous barrier (waterfall) was found approximately 1,000 feet downstream of the lake outlet at WGS 84 N 55.97621° W 131.63136° (Picture 5, 6, and 7). No fish were observed upstream of the barrier. Based on the size and extent of the barrier, it was the professional opinion of both biologists that the barrier was impassable to anadromous fish such that fish passage to the lake was prevented.

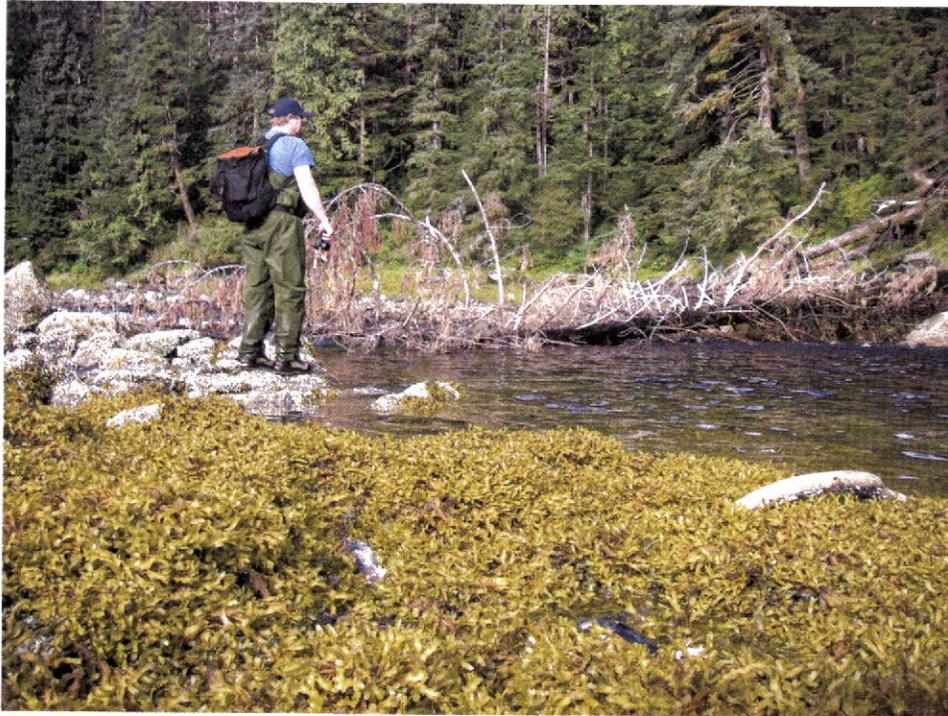
Picture 3. Pink Salmon carcasses near mouth.

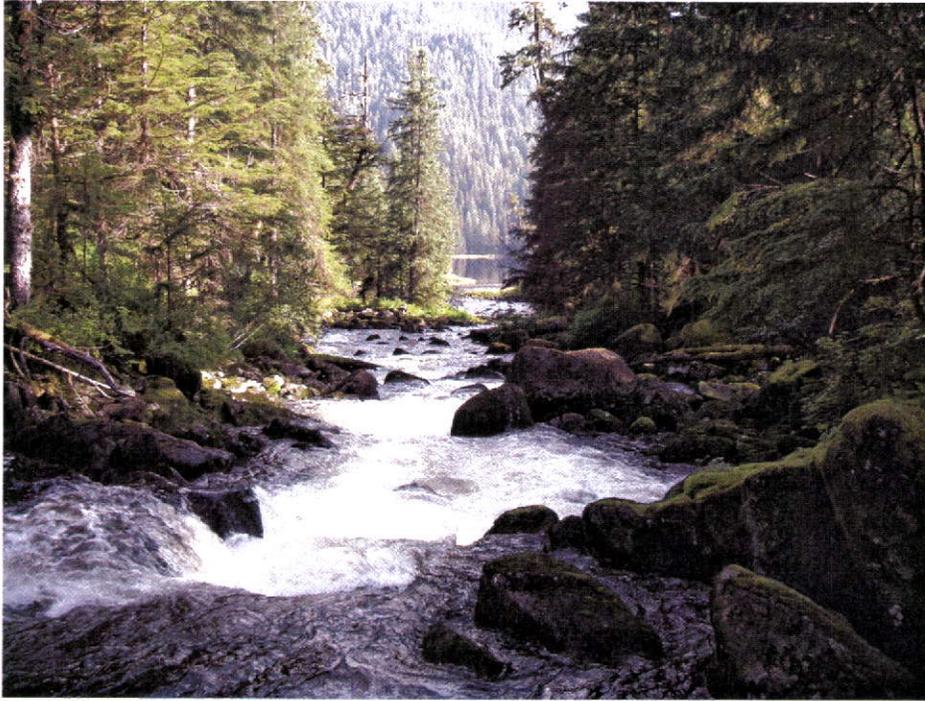
Picture 4. Looking downstream towards mouth of creek.

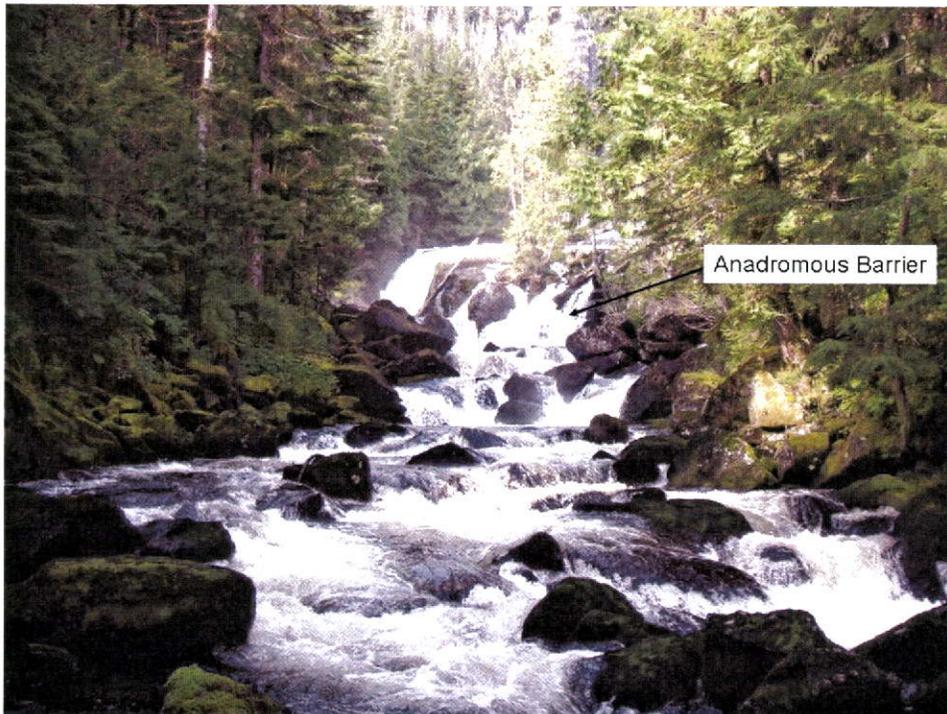
Picture 5. Look upstream at anadromous barrier. The barrier was determined to be the falls at the top of the photo.

The AWC needs to be updated to document that pink salmon were observed upstream to the identified barrier. Pink Salmon utilize Shelokum Creek from saltwater until an anadromous barrier approximately 1,000 feet downstream of the lake outlet at N 55.97621° W 131.63136°. A new nomination will be submitted by Jarrod Sowa.

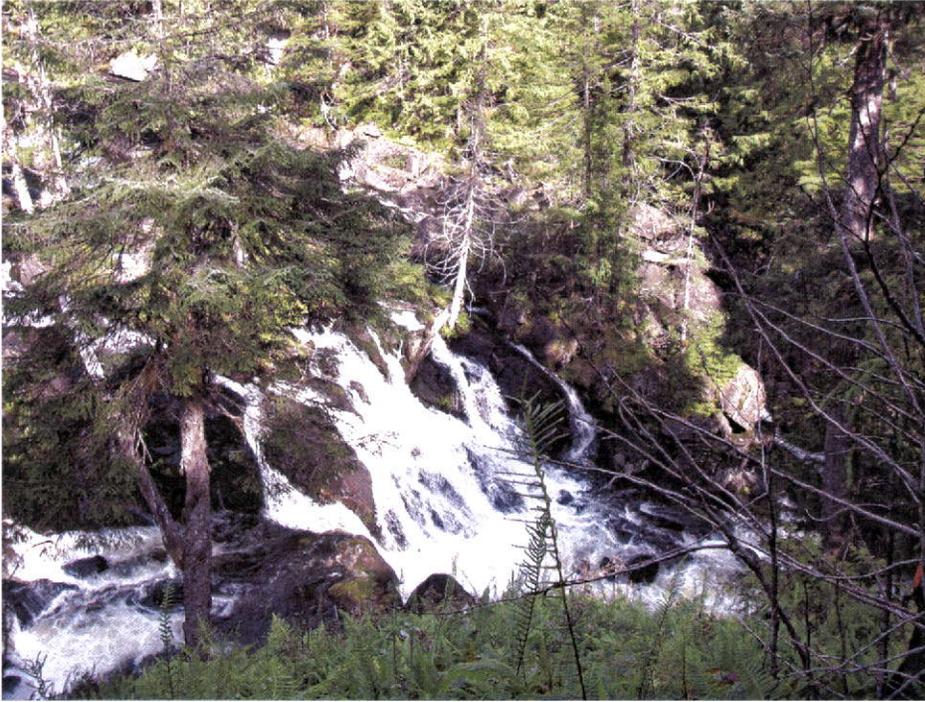
Picture 6. Looking at barrier falls from above creek.

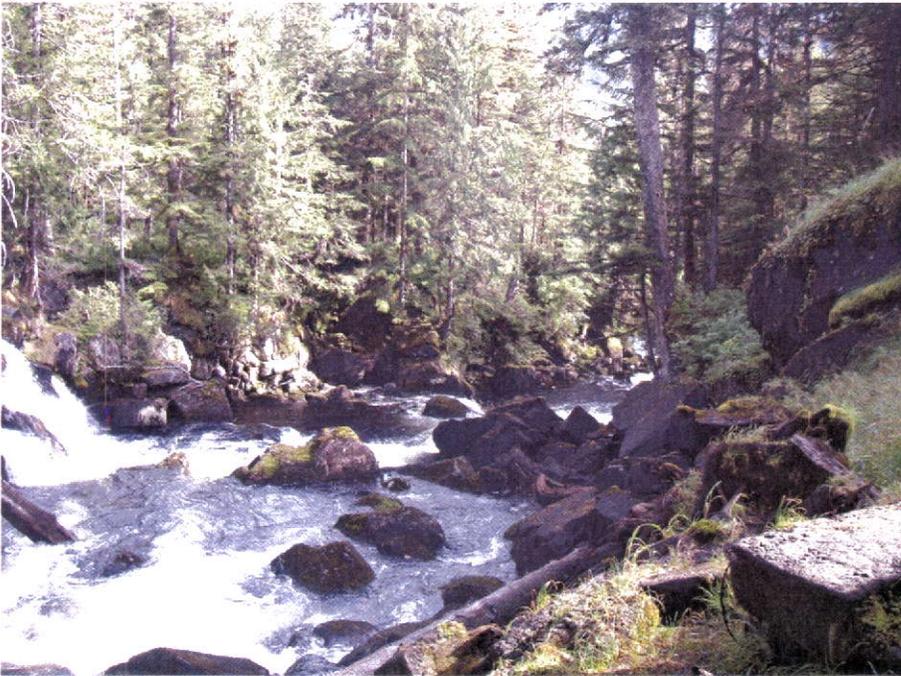
Picture 7. Looking downstream from anadromous barrier.
