Region Southeast USGS Quad(s) Dixon Entrance D-3
 Anadromous Waters Catalog Number of Waterway 103-30-10050
 Name of Waterway — USGS Name Local Name
 Addition Deletion Correction Backup Information

SUBJECT: Long Island Klukwan RCS
Trip Report

Long Island Road Condition Survey May 5-8, 2009

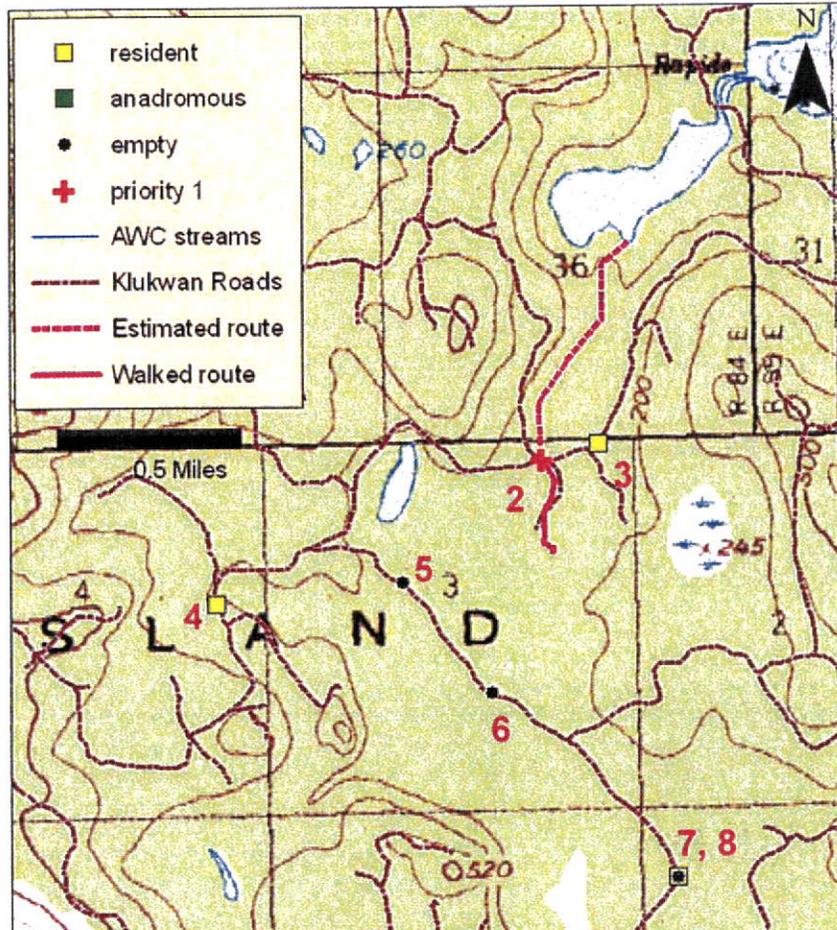
Map 2

Figure 4. Map 2. Points and uncataloged stream draining into Elbow Bay. Perched culvert blocking upstream passage.

2. 54.88145, -132.6889. 5/6/09. Set trap up and downstream of a 36" corrugated metal pipe (CMP) with a perched outlet. Priority 1 pipe
 - Soak time: 4.8 hrs
 - Upstream species: 30 DV (75-170mm)
 - Downstream species: 2 DV (110-140mm), 7 CO (60-95mm)
3. 54.88203, -132.68504. 5/6/09. 48 in CMP
 - Soak time: 5 hrs
 - Species: 7 DV (85-120mm)
4. 54.87607, -132.71117. 5/7/09. Set traps upstream and downstream of 48" CMP.
 - Soak time: 5.2 hrs
 - Upstream species: 2 DV (50-55mm)
 - Downstream species: 1 DV (55mm)

5. 54.87677, -132.69855. 5/7/09. Set traps up and downstream of 18" corrugated plastic pipe (CPP).
 - Soak time: 6.6 hrs
 - Both traps empty

6. 54.87235, -132.69254. 5/7/09. Set traps up and downstream of 18" CPP.
 - Soak time: 7.5 hrs
 - Both traps empty

7. 54.86505, -132.68024. 5/7/09. Set trap downstream 48" CMP.
 - Soak time: 3.3 hrs
 - Downstream species: empty

8. 54.86505, -132.68024. 5/7/09. Set trap upstream 48" CMP.
 - Soak time: 3.3 hrs
 - Upstream species: 1 DV (140 mm)

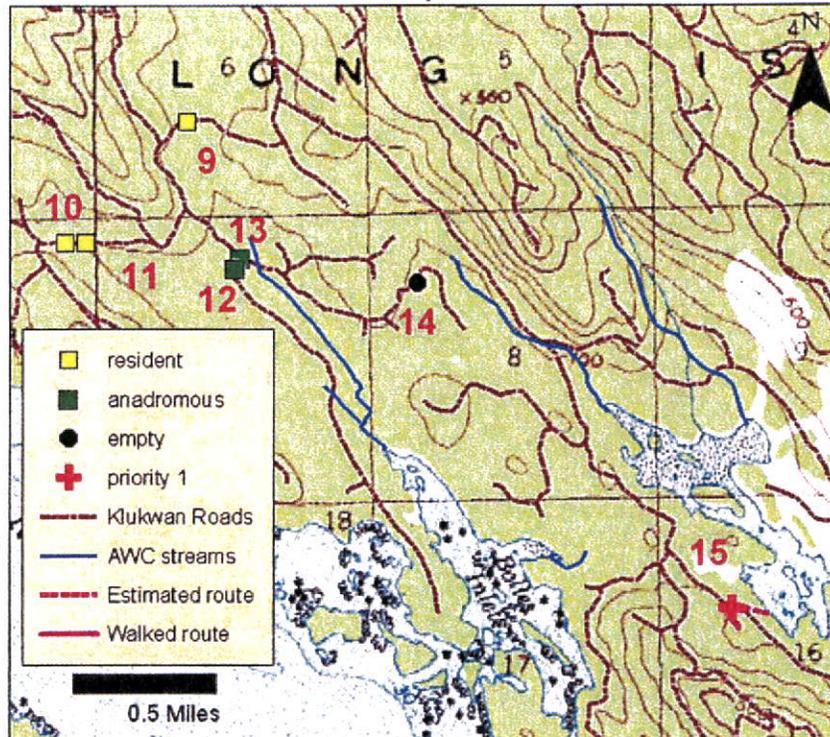
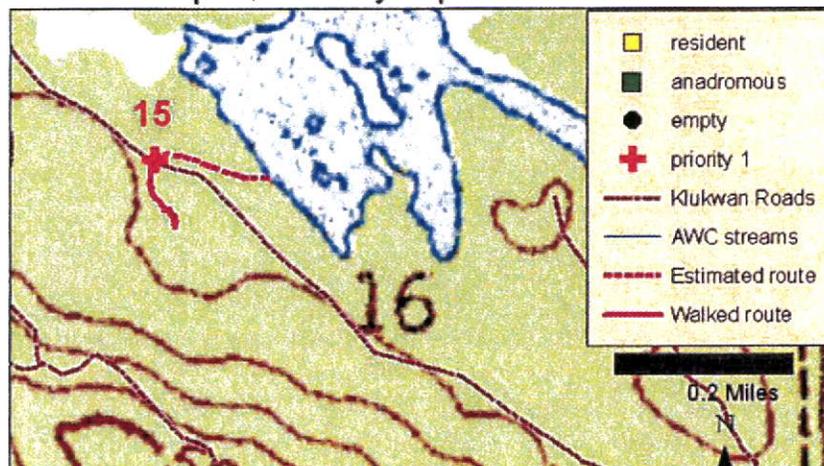
Map 3, Priority 1 perched culvert

Figure 5. Top: Map 3 overview. Bottom: Zoomed in on stream route. Perched culverts blocking up and downstream passage.

9. 54.87252, -132.77371. 5/5/09. Set trap near root wad below culvert in beaver pond upstream of catalogued extend of stream no. 103-30-10100 (CO, P).
- Soak time: 4.5 hrs
 - Species: 11 DV (90-140mm)
10. 54.86643, -132.78461. 5/5/09. Set traps up and downstream of 48" CMP.
- Soak time: 17 hrs

- Upstream species: 3 DV (55-110mm)
- Downstream species: 6 DV (70-120mm)

11. 54.86646, -132.78276. 5/5/09. Set trap downstream small perched 18" CMP.
- Soak time: 1 hrs
 - Species: 1 DV (50mm)
12. 54.86501, -132.76971. 5/5/09. Set 2 traps upstream (1 above beaver dam) of culvert and 1 downstream of 48" CMP. Nominate as tributary to stream 103-30-10100
- Soak time: 2 hrs, 2 hrs, 0.2 hrs respectively
 - Upstream above beaver dam species: trap empty
 - Upstream of culvert, below beaver dam: 1 CO (60 mm)
 - Downstream species: 3 CO (65-80 mm), 1 DV (70 mm)
13. 54.86552, -132.7692. 5/5/09. This point shows the correct location for AWC stream no. 103-30-10100. Saw several hundred pink fry in stream. Submit correction to AWC.

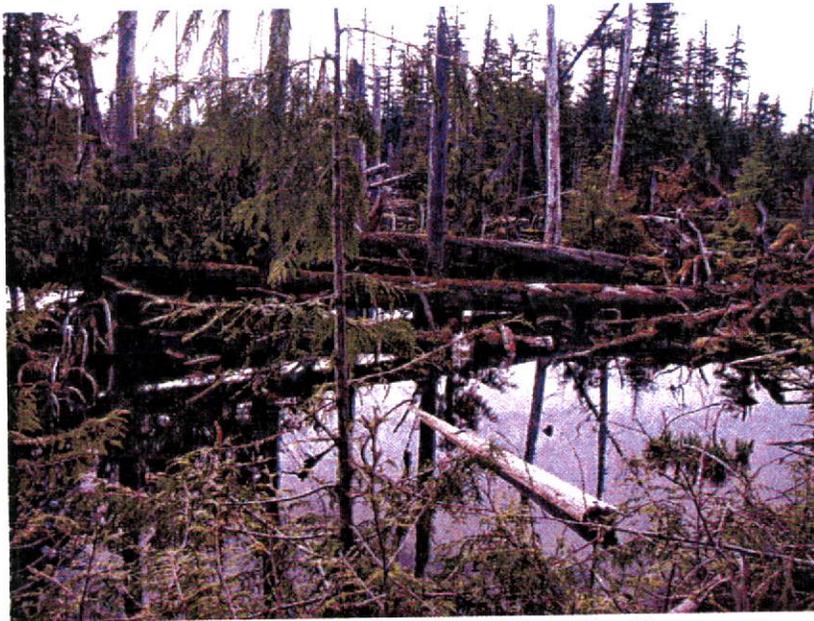
Figure 6. Beaver pond at point 14.

14. 54.8642, -132.75369. 5/5/09. Set trap downstream of log culvert in beaver pond, photo shown in Figure 6.
- Soak time: 0.5 hrs
 - Species: trap empty
15. 54.84751, -132.72646. 5/6/09. Set trap up and downstream of twin 24" CPP that were perched on inlet and outlet. We caught 2 coho smolts in a small pool above the perched pipes. The pipes were recently installed during road repairs. The pipes did not appear passable during any flow stages.
- Soak time: 20 hrs
 - Upstream species: 2 CO (120 mm), 2 SC
 - Downstream species: 2 SC

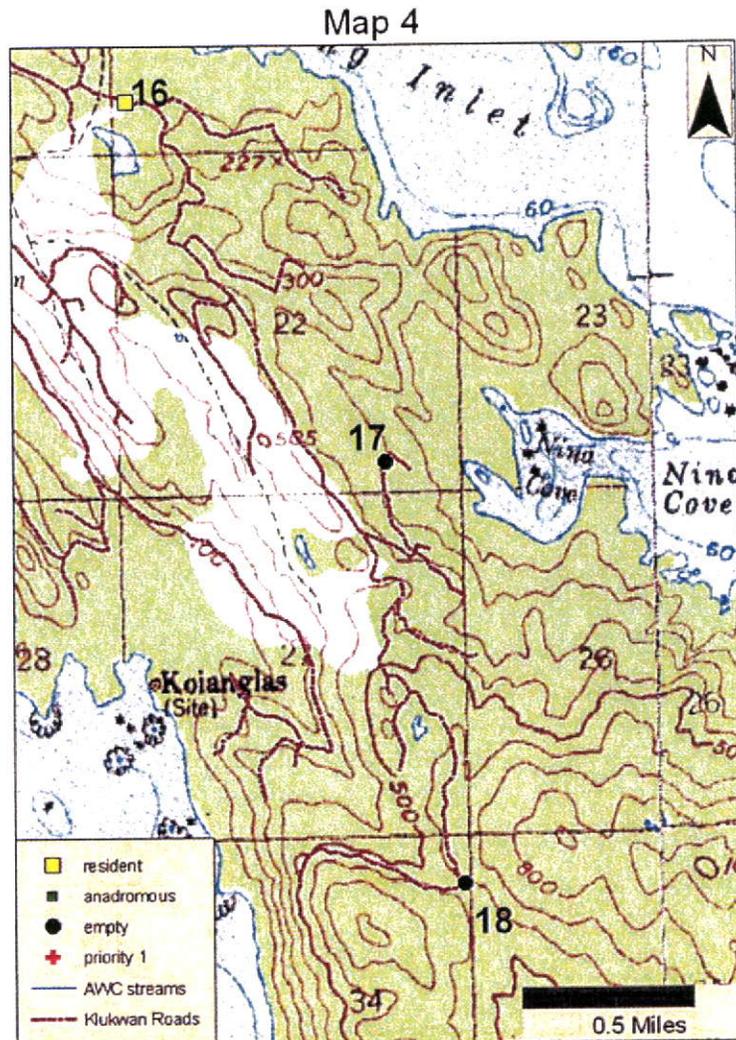
Figure 7. Map 4, southern extent of roads..

16. 54.84089, -132.70654. 5/6/09. Set traps up and downstream of culverts with lots of beaver sign.
- Soak time: 20 hrs
 - Upstream species: 6 DV (65-100mm), 2 TSB, 3 roughback newts
 - Downstream species: 3 DV (80-90mm), 14 TSB, 5 roughback newts
17. 54.82548, -132.68808. 5/6/09. Set trap 80' downstream 48" CMP in beaver pond.
- Soak time: 2.1 hrs
 - Species: trap empty
18. 54.80767, -132.68288. 5/6/09. Set trap up and downstream of French drain around 600' elevation.
- Soak time: 0.8 hrs
 - Both traps empty

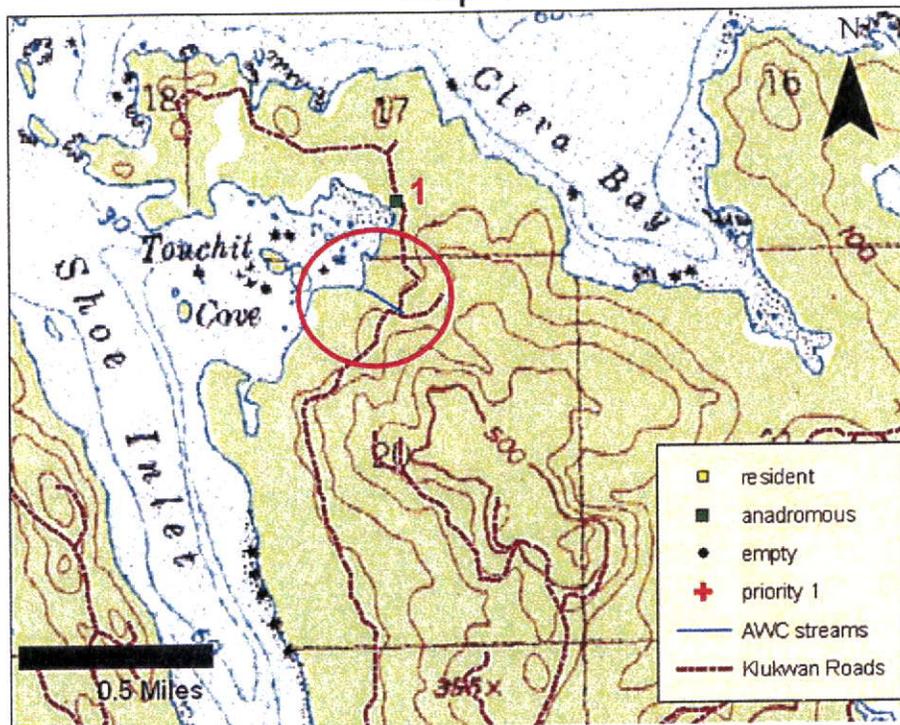
Map 1

Figure 3. Map 1. Red circle around anadromous stream no. 103-30-10050

1. 54.92766, -132.78642. 5/7/09. The red circle shows the catalogued location of anadromous stream no. 103-30-10050. The AWC lists this stream as providing habitat for pink and chum salmon. The earliest nomination I could find for this stream was a correction to delete the upper extent. The comments indicate that the anadromous portion is the intertidal and first 50' of the stream up to a large old beaver dam. Passage is still blocked by the beaver dam and there is little habitat above this reach. The green square (#1) on the map above indicates the correct position of the stream that does not extend beyond the road. I will submit a correction to the AWC to move the stream.

Comments: Stream location mapped incorrectly via Aerial and attached rpt
Stream in wrong location. Move to location shown on page 4 of attached trip report. Upper extent at coord. 54.92766 N, 132.78642 W (WGS 84). Short intertidal stream ends at large old beaver dam. Low flow & poor habitat above.

*delete this portion
leave intertidal area
and 50 ft. of uplands*
