Nomination Form
Anadromous Waters Catalog

Name of Waterway Snowslide Creek USGS Name Local Name

MEMORANDUM

SUBJECT: Snowslide Creek

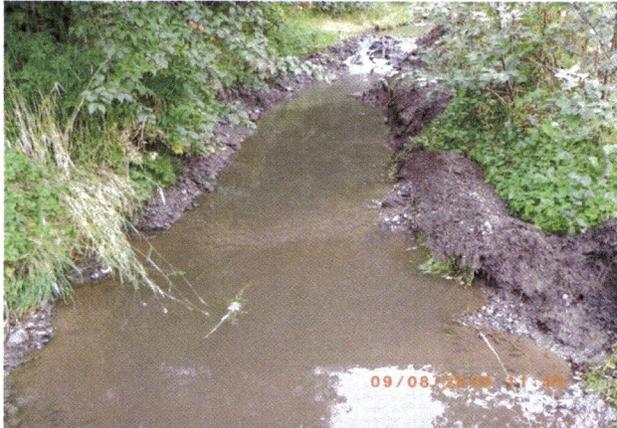
Figure 1: Excavation of Snowslide Creek.

Upon returning to Snowslide creek on Wednesday, September 8th with habitat biologist Johnny Zutz, I found that DOT had begun work on a berm to prevent avalanche debris from reaching Thane road. The stream bank had previously been vegetated with overhanging alder, grasses, and brush and has since been cleared by excavators. The water was murky with fine sediment that settled over the gravel substrate. I set one trap downstream of a perched culvert passing under Thane road. I opted not to set traps above because of operations in and near the stream.

Based on the results of my trapping efforts and the condition of the stream prior to excavation, I recommend that culvert replacement mitigation and stream bank restoration be implemented on this anadromous fish stream. The stream should be revisited periodically to monitor erosion on the left bank.

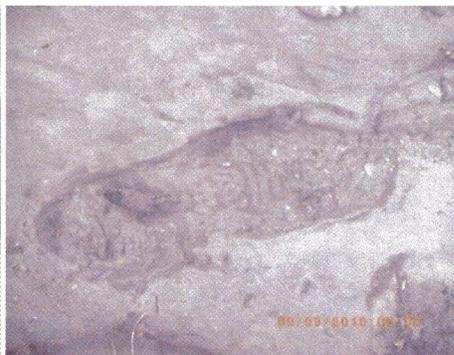
Figure 3: Footprint in thick sediment covering gravels in Snowslide creek

I returned the next morning to check the trap and found it filled with 45-50 sculpin and four smolting coho salmon. I photographed them and released them. The sediment had settled to the bottom of the stream and the water was running clear, although any disturbance clouded the water with the fine sediment.

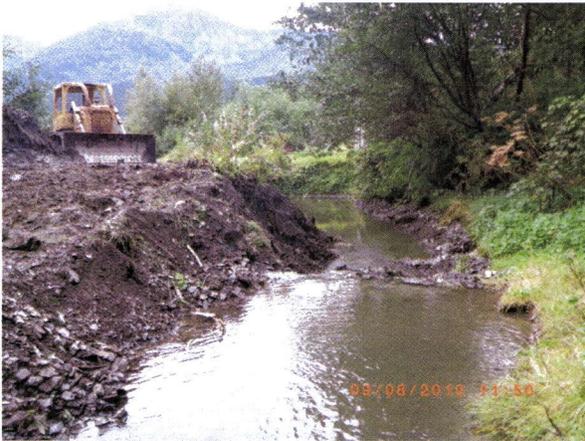
Figure 6: Equipment and devegetation on the bank of Snowslide creek

I began the track line of the stream at the intertidal and walked upstream. I set two traps above the perched culvert: one at the inlet and one farther upstream at the end of possible anadromy. There is a bedrock and scree fish barrier that is approximately 12-15 feet tall that marks the upstream extent of anadromy. There is grassy vegetation on the river-right bank, but no grass or overhanging vegetation on the left side. The bank, as seen in figure 6, is steep with loose dirt and rock, and subject to erosion during heavy rain events.

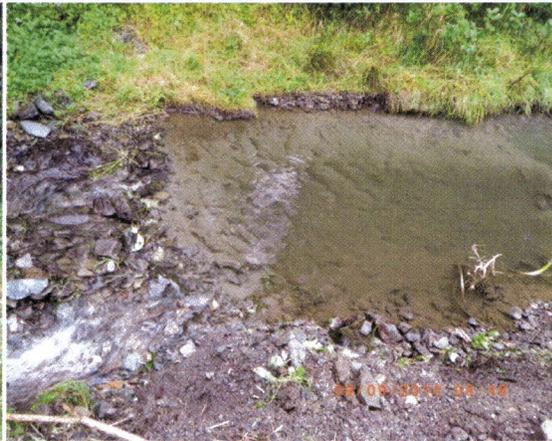
I spoke with Chris Hickock who is overseeing the project and asked about the mitigative measures he was taking to minimize impacts to the stream. He pointed out the sediment catchment pools they had created to filter sediment while they worked on the bank with excavators and backhoes. Mr. Hickock said they don't plan to be working in the stream again because they are focusing the berm work farther up the slope.

Figure 7: Sediment pool on Snowslide creek

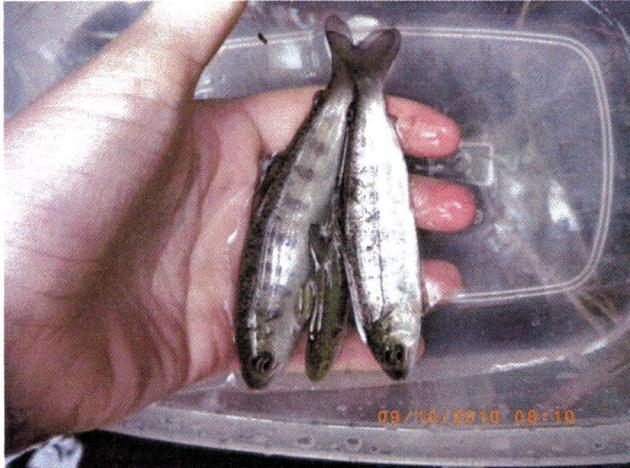
I returned the next morning (September 10th, 2010) to find three smolting coho in the trap at the inlet of the culvert and one smolting coho at the upper extent before a steep rocky cascade. Their sizes ranged from 85mm to 140mm. They were healthy and looked very well-fed. The former overhanging trees and brush apparently provided a good population of bugs for rearing salmon.

Figure 8: Coho salmon caught in minnow trap at inlet of corrugated metal culvert.

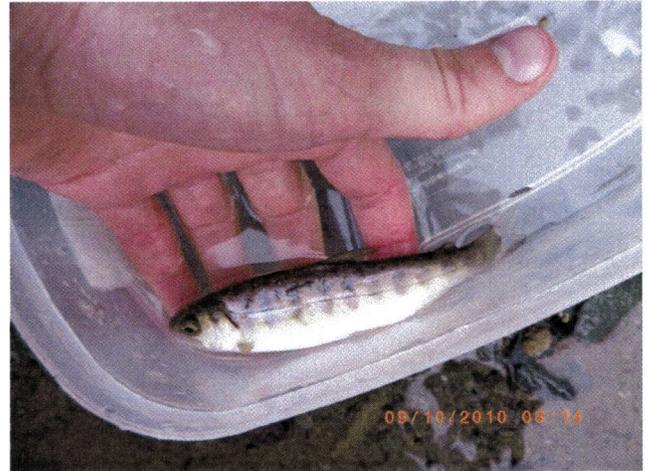
Figure 9: Coho salmon caught in minnow trap at upper extent of Snowslide creek.

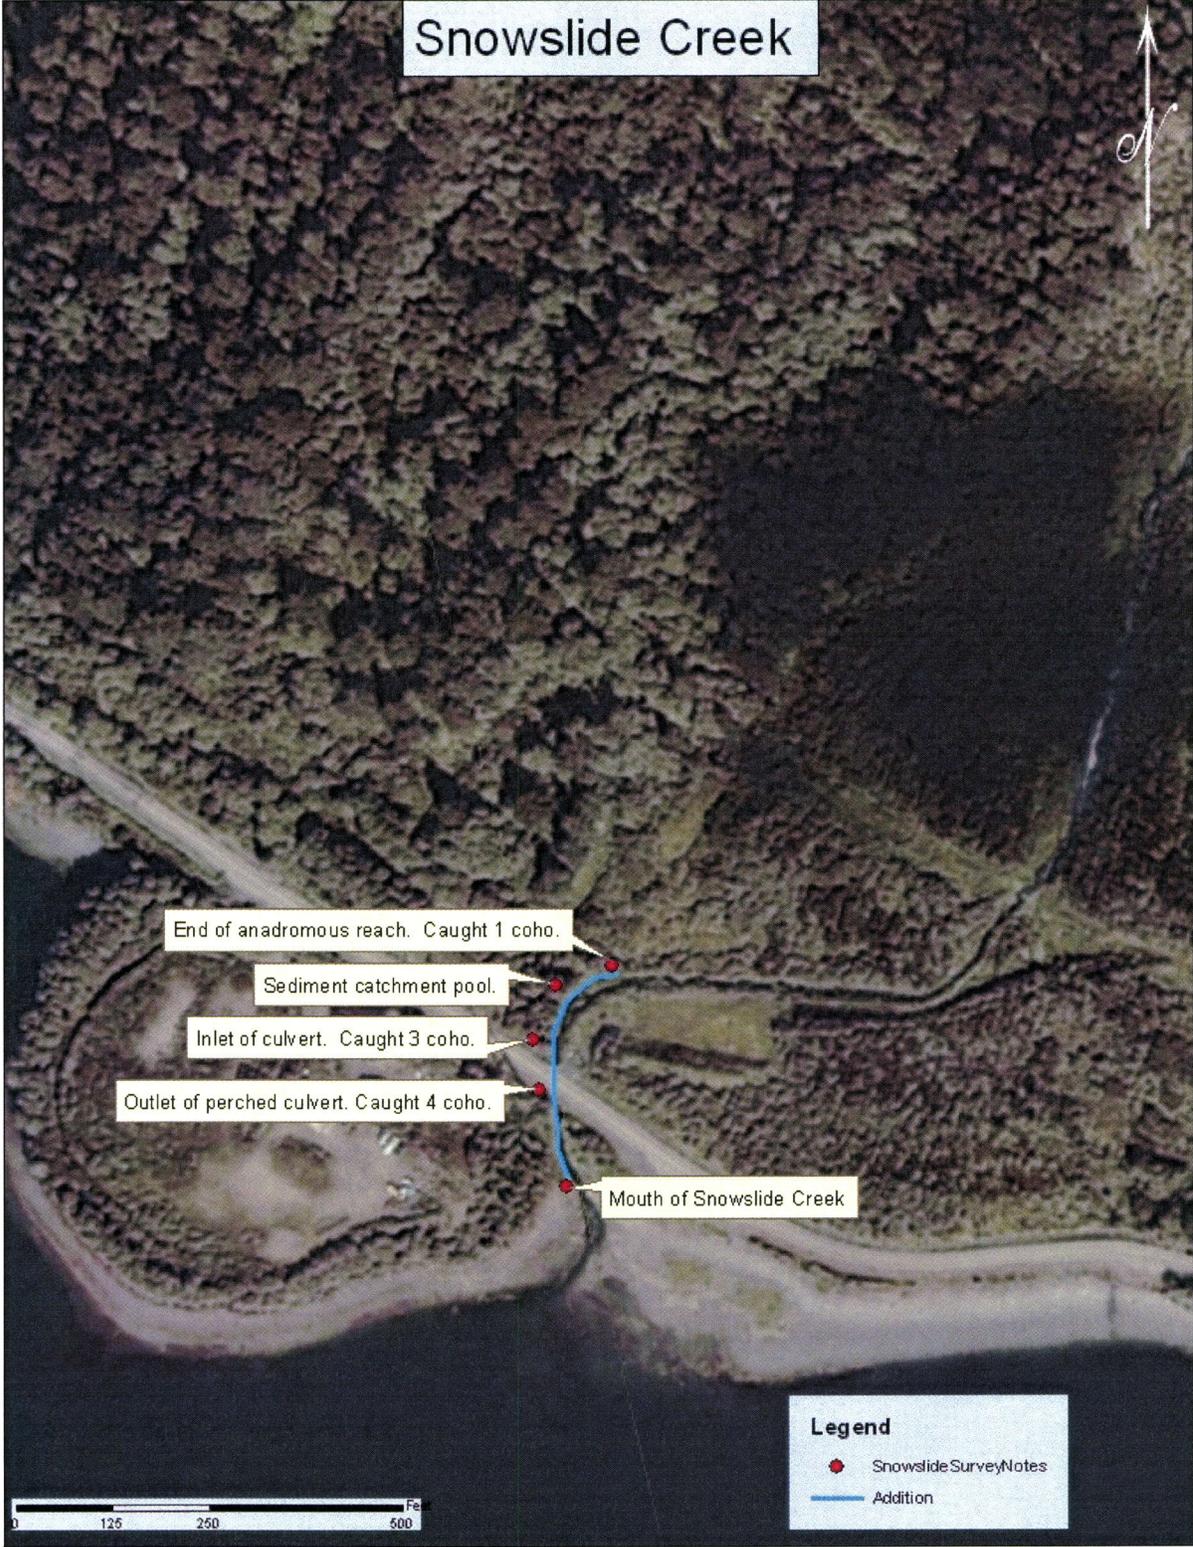
Figure 10 illustrates trapping effort results and the following map provides trap and feature locations.
