State of Alaska
Department of Fish and Game
Sportfish Division

Nomination Form
Anadromous Waters Catalog

Name of Waterway Casa Del Sol USGS Name Local Name

Summary of Coho Spawning Observations in Upper Pederson Hill Creek

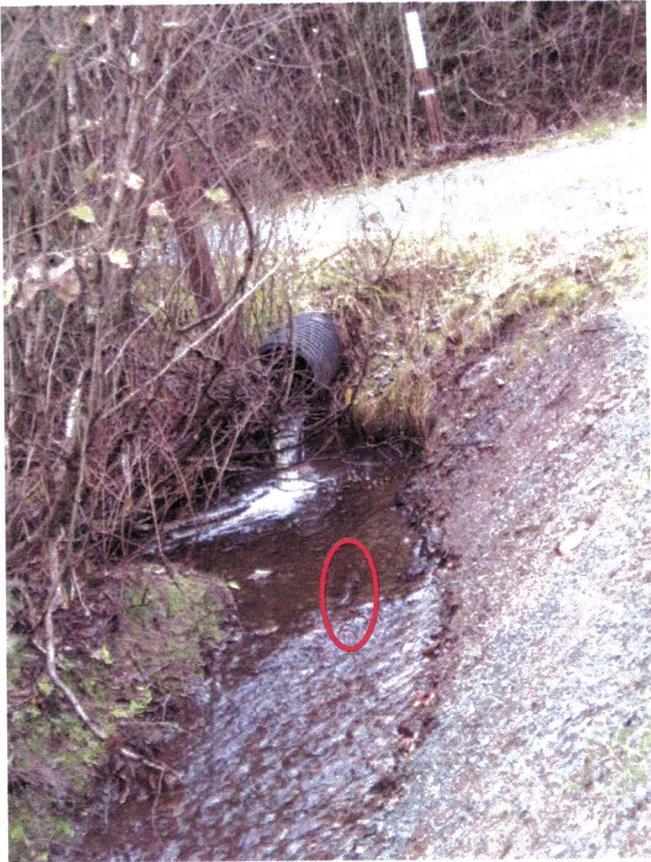
Picture 1: Uppermost plastic pipe culvert on Pederson Hill Creek. Red circle highlights adult coho spawning in the gravel immediately downstream from pipe.

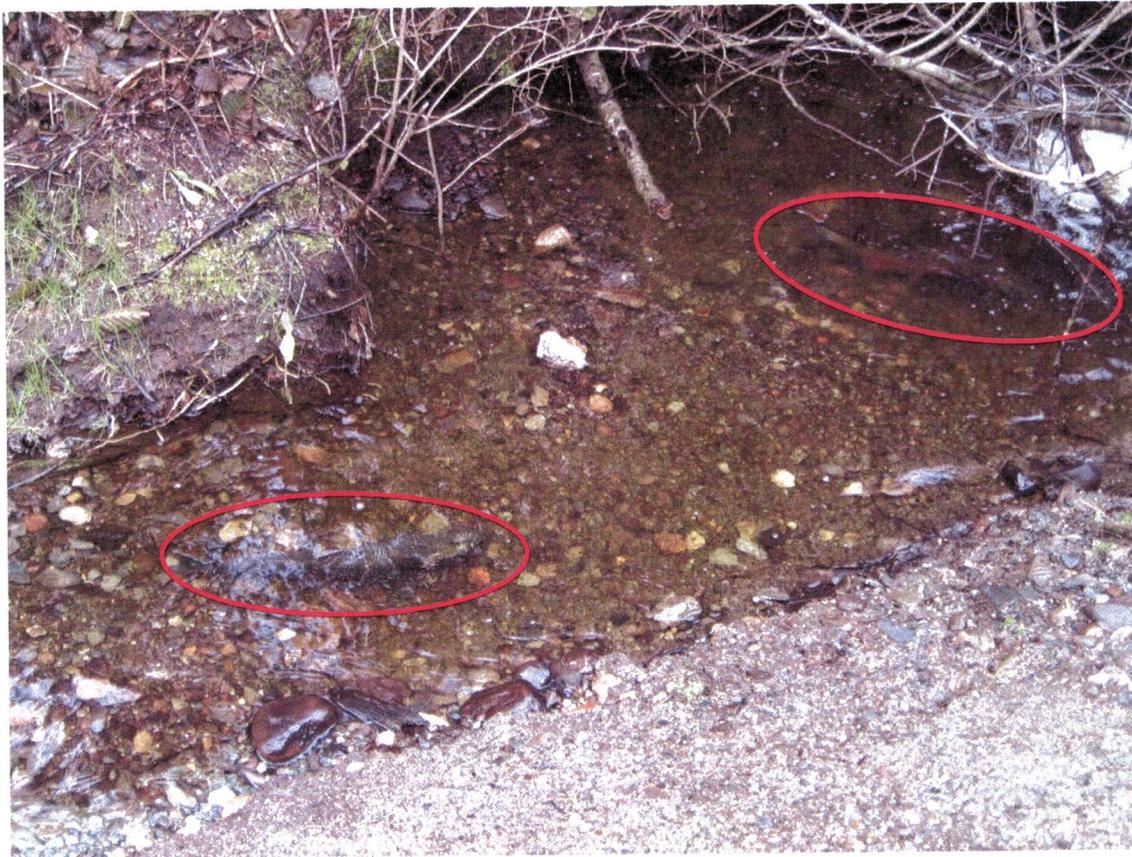
Picture 2: Red circles highlight a male and female coho spawning in the tail-out of the pool immediately below the uppermost pipe culvert. Female coho is situated on a freshly excavated redd.

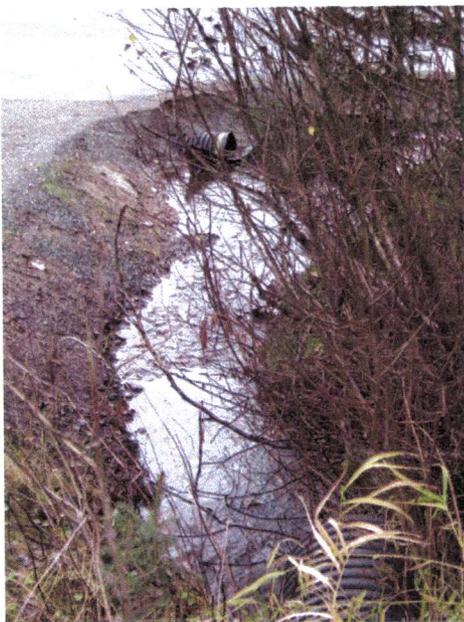
Picture 3: Facing south showing stream reach between uppermost culvert on Pederson Hill Creek and Glacier Hwy.

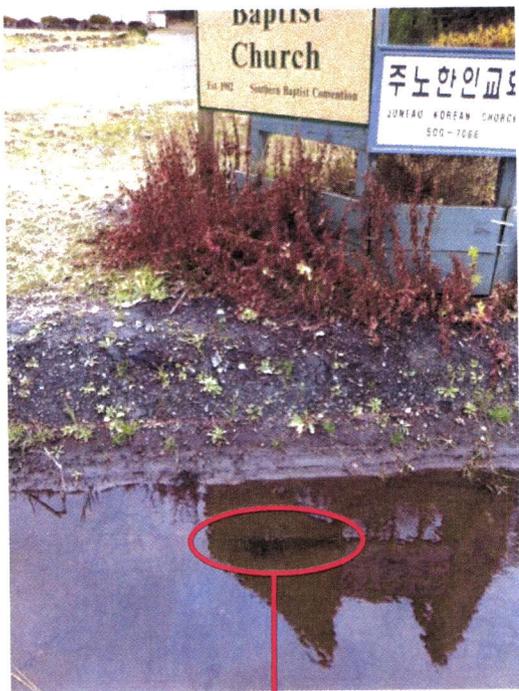
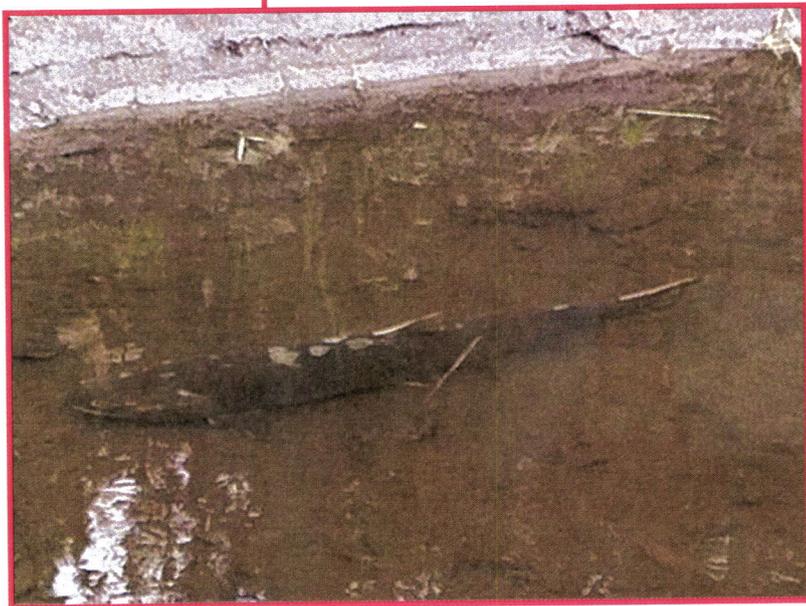
On 11/10/10 I (James Ray, U.S. Fish and Wildlife Service) observed a single female coho holding in a section of Pederson Hill Creek that is currently routed through the ditch line on the north side of Glacier Highway adjacent to the Emmanuel Baptist Church, as indicated on the map below (also see pictures 4&5). It is likely the fish observed on 11/10/10 was one of the four coho observed on 11/5/10 that had fallen back. Although none of the other fish were present, the redd was still clearly visible upstream.

Pictures 4&5: Female coho holding in section of Pederson Hill Creek routed through the ditch on north side of Glacier Hwy adjacent to Emmanuel Baptist Church

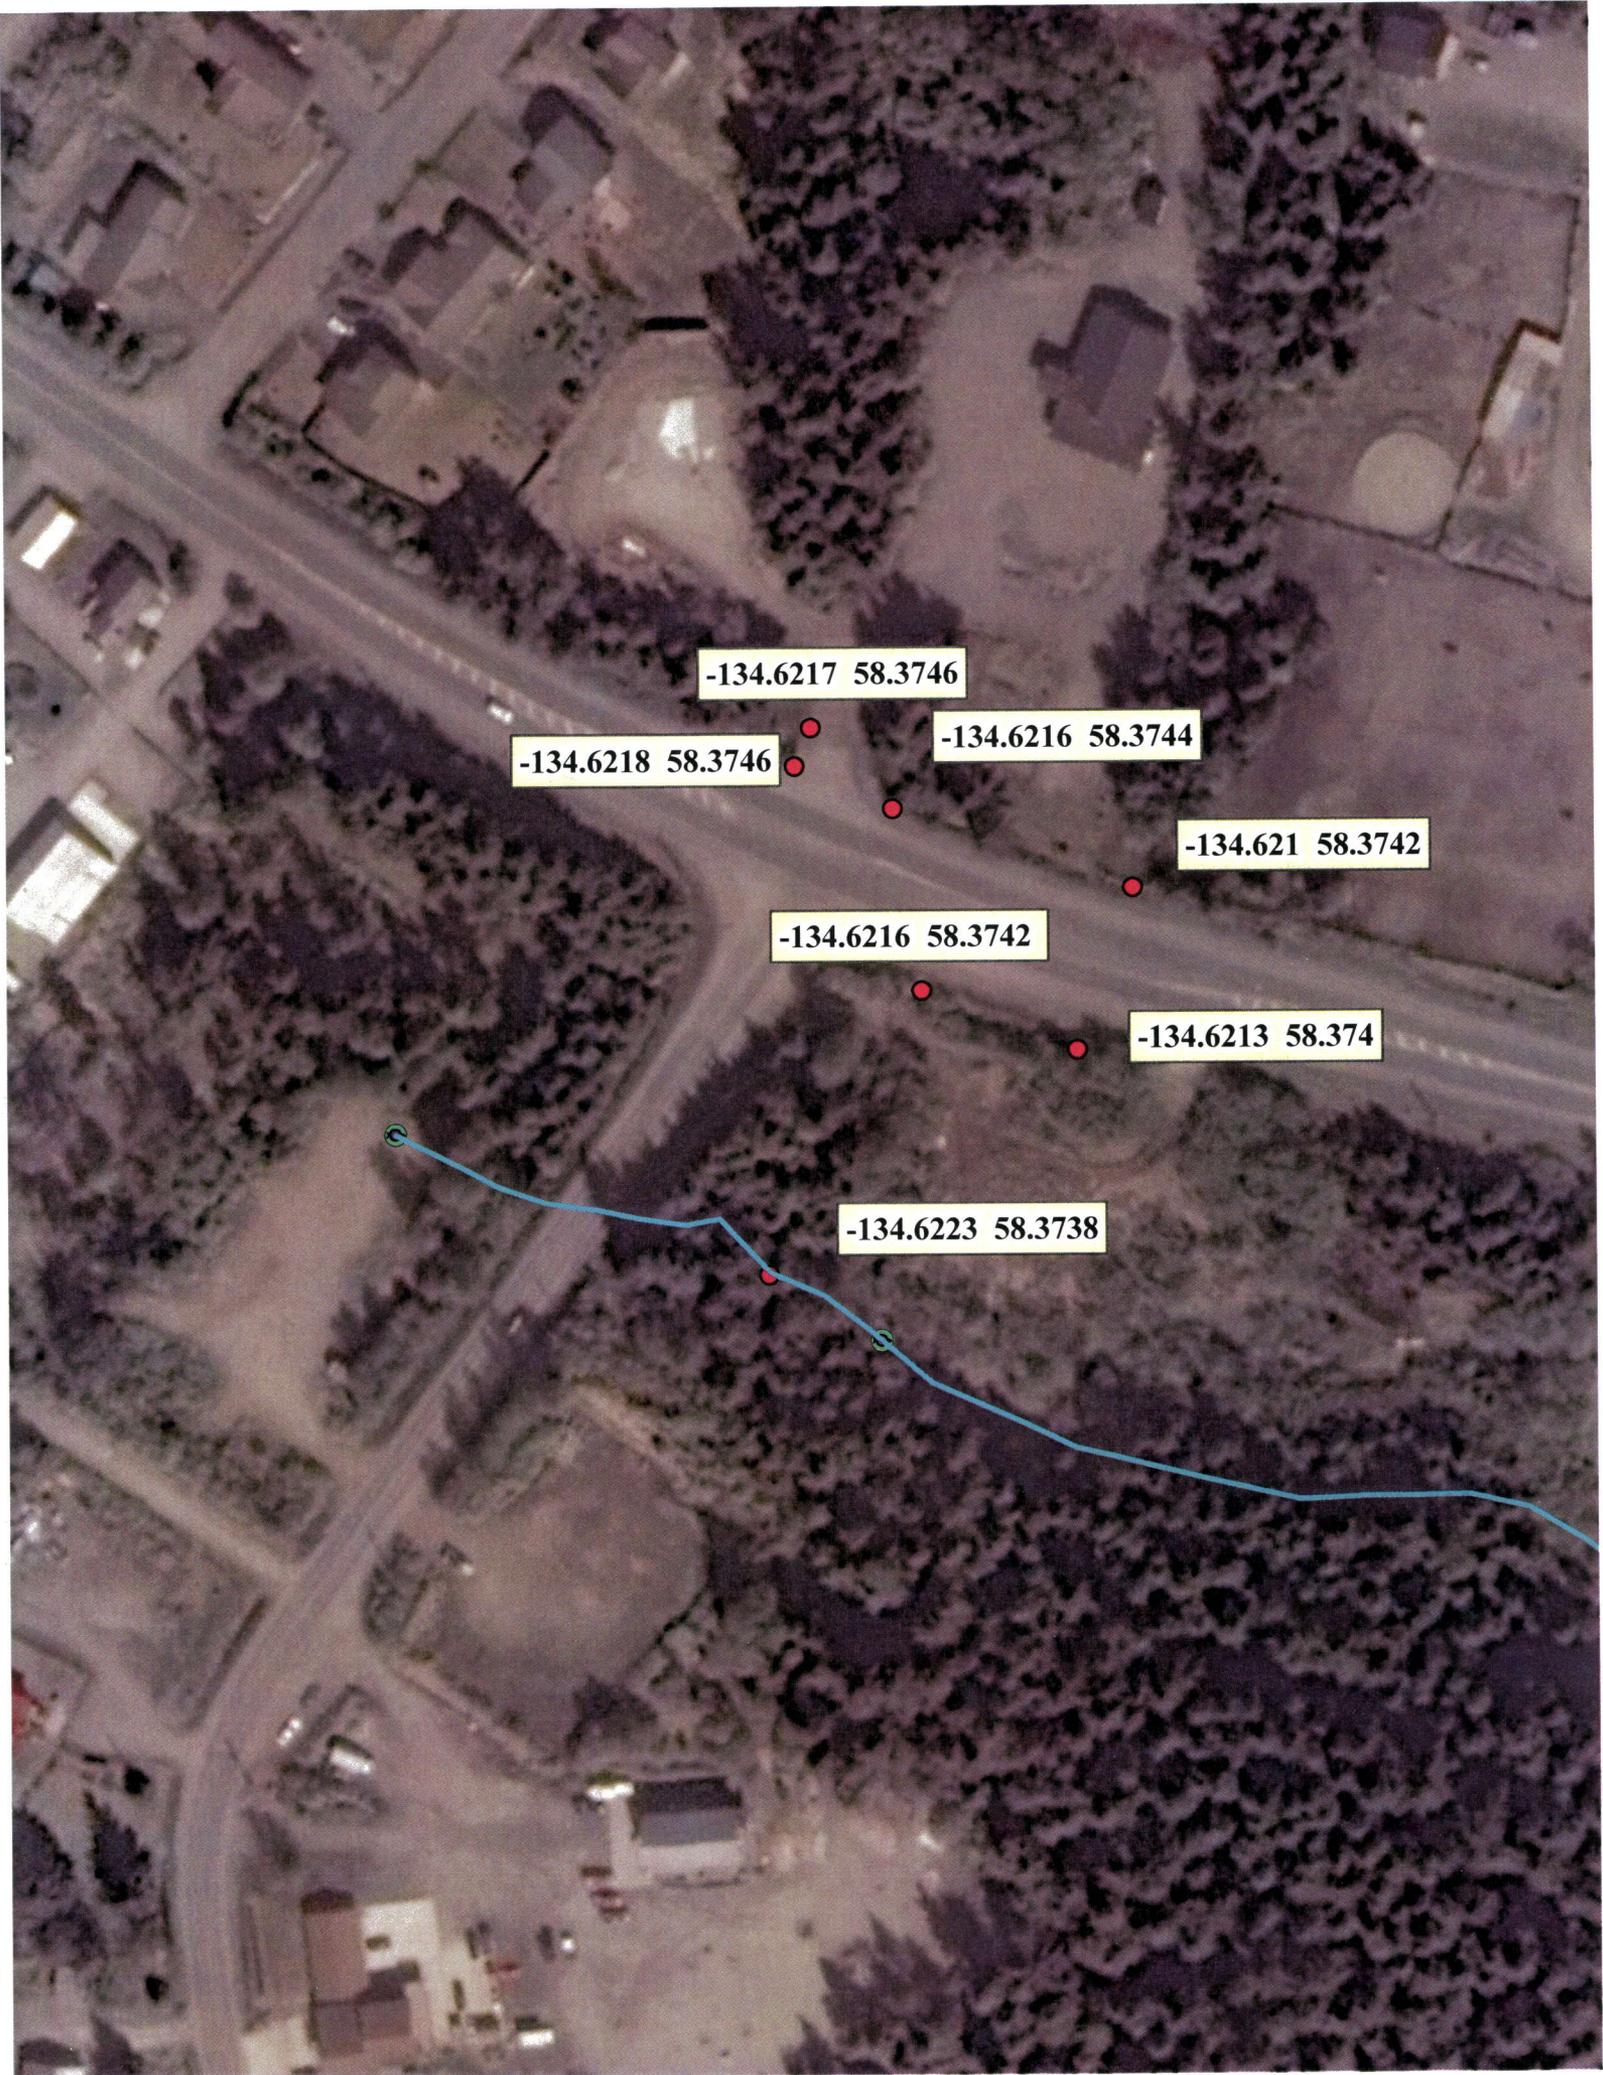
Coho spawning observations in upper Pederson Hill Creek

From the map above it can be seen that Pederson Hill Creek has been routed into the ditch on the north side of Glacier Highway. The Creek is then routed under Glacier Highway into the ditch on the south side of the highway before it passes through a culvert under a private driveway then back into its 'natural' channel. Large amounts of sediment are directly transported into Pederson Hill Creek via the roadside ditch. It is surprising the coho made it to the location they did as the culverts are only designed for water conveyance in the ditch and do not appear adequate to pass adult fish. The uppermost culvert pipe is a blockage to adult fish passage; however, I was unable to determine if there is any additional spawning habitat upstream of this location, as the land is privately owned.
