Nomination Form
Anadromous Waters Catalog

Name of Waterway North Creek USGS Name Local Name

MEMORANDUM

SUBJECT: Excursion Inlet Hydro
Trip Report
8/13/2012

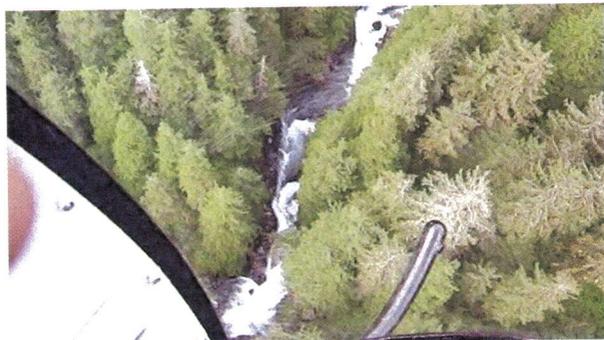
video minute 0:18		
149	Potential Barrier <i>South Creek Fly-over</i> video minute 0:54		S Creek 2
North Creek			
101	ADF&G <i>Anadromous Waters Catalog</i> top of anadromous fish presence		
110		Minnow trap Several coho (CO) juveniles	
111		1 CO, 2 DV	
112	Large Log jam, site of previous low head dam. 2-3% gradient up to here,		1125
113	Side Channel (SC)	9 DV 30-60mm, 2 CO 40, 80mm	1127
114	Some incised banks beginning		
115	2% gradient here, Lunch spot	2 CO, 6 DV	1131
116	2.5% gradient over 200'	2 CO	1132, 1133
118	SC with about 3 Cubic Feet per Second (CFS) of flow	CO numerous	1135
119	Long SC with ~ 30 CFS		1136
120	Top of survey day 1	8" DV hook and line	1138
121	Small tributary		1141
122	Small SC		
123	Good SC and rearing		1143
124	Old dam site and penstock support		1145
125	Old logging road start		
126	Remnant building		
127	High gradient trib. that was followed to stream		
128	SC Top of anadromous fish capture	2 CO, 4 DV	1148

and/or the two falls I marked during the fly-over may be a barrier to anadromous fish migration (Figs 1&3; Table 1; waypoints 148, 149), and requires additional investigation.

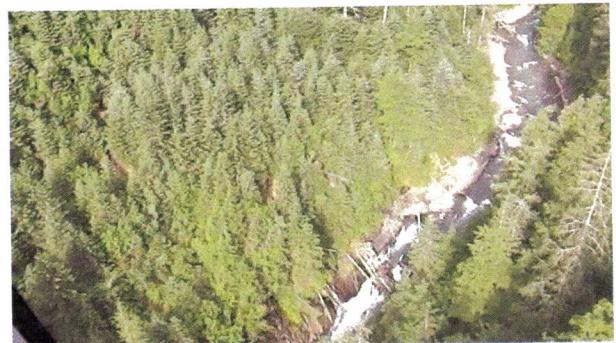
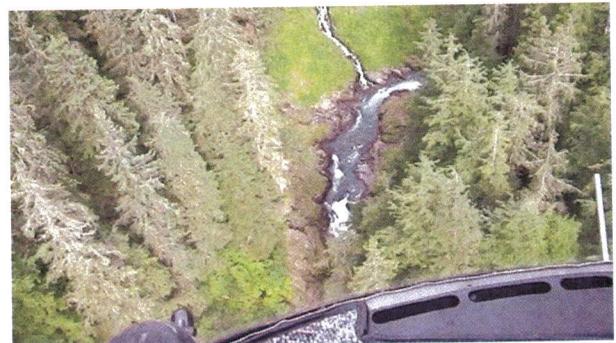
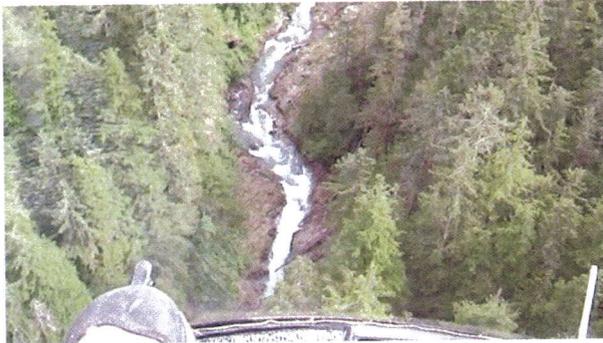
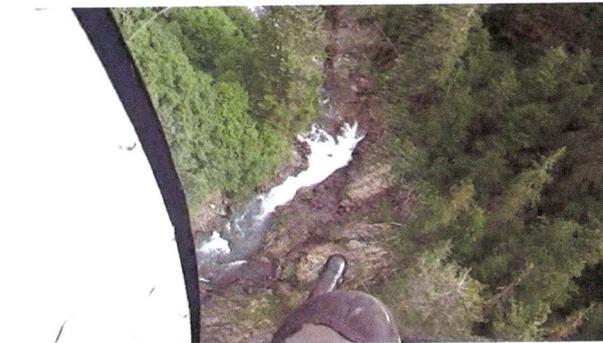
142	Potential Barrier <i>North Creek Fly-over</i> video minute 1:38		N Creek 1
143	Potential Barrier <i>North Creek Fly-over</i> video minute 2:11		N Creek 2
144	Potential Barrier <i>North Creek Fly-over</i> video minute 2:21		N Creek 3
145	Potential Barrier <i>North Creek Fly-over</i> video minute 2:30		N Creek 4
146	Landing site and SCs <i>North Creek Fly-over</i> video minute 2:58		N Creek 5

During the fly-over I was able to land upstream of our survey (river mile 4) and electroshock two large side channel systems (600' total length). Shocking at 450 Volts, 30Hz, and a 15% duty cycle, I captured at least 50 Dolly Varden ranging from 30 to 140mm fork length, but no coho. During the fly-over I marked four structures downstream of this site that require additional investigation as they may be barriers to upstream fish passage (Figs 1&3; Table 1; waypoints 142-145).
