State of Alaska
Department of Fish and Game
Sportfish Division

Nomination Form
Anadromous Waters Catalog

Name of Waterway Indian River USGS Name Local Name
 Addition Deletion Correction Backup Information

SUBJECT: Indian River Coho Fry Index
Trapping Report
August 20-22, 2014

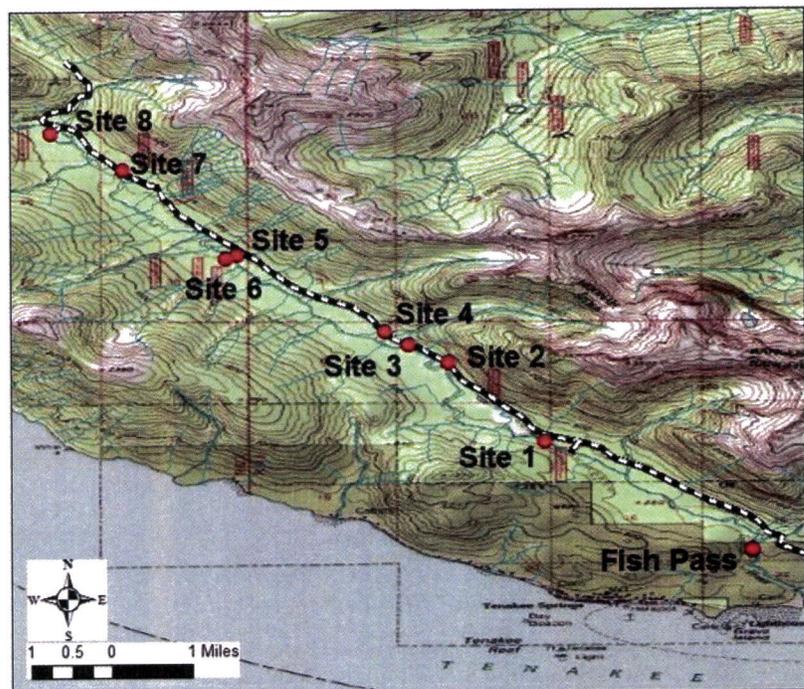
Figure 1.-Site map showing the fish pass and index trapping sites.

Between August 20 and 22, 2014 I trapped coho salmon fry on the Indian River (ADF&G Stream no. 112-42-10080; cataloged for coho, chum and pink salmon, and Dolly Varden char) with US Forest Service (USFS) Fisheries Technicians Joe Serio and Kyle Rosendale. We trapped at index sites established by USFS Sitka Ranger District Staff to monitor fish use following blasting, fish pass construction, and juvenile coho transplanting between 1997 and 2005 (Figure 1).

In 2012, ADF&G issued Fish Habitat Permit FH12-I-0125 to the City of Tenakee for a run-of-the-river hydroelectric project to be installed near the fish pass at Falls 4 on the river (Figure 1). ADF&G Habitat has a shared interest in monitoring the system to assess potential impacts from the hydroelectric project.

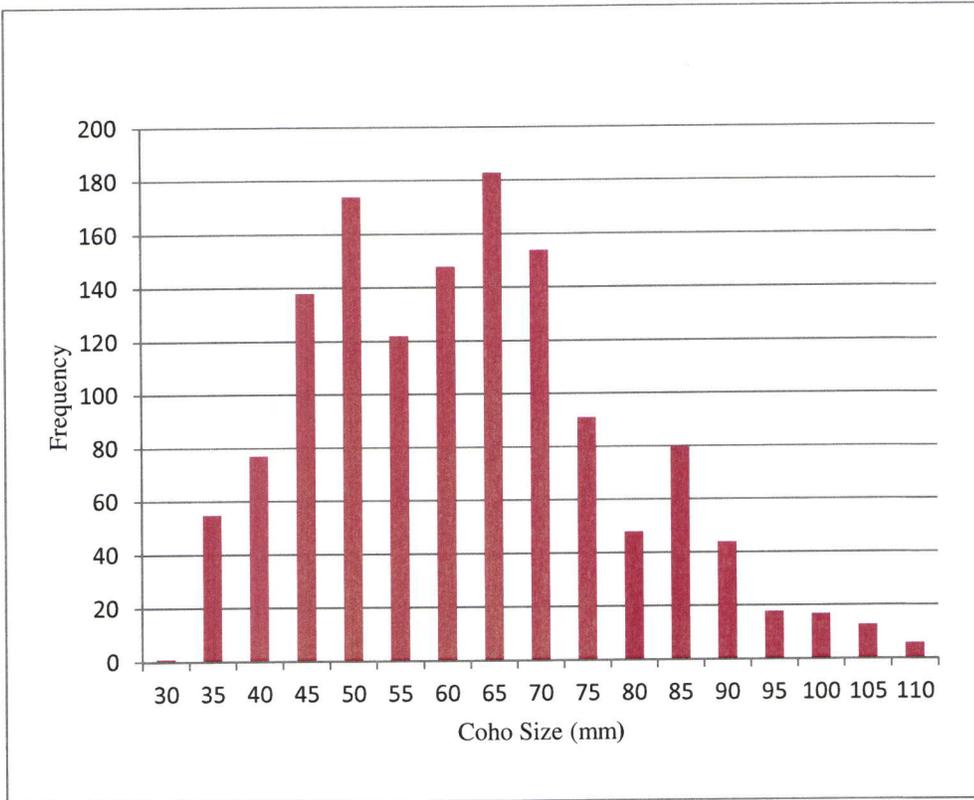
Figure 2.—Size frequency of coho salmon captured at all trapping sites.

We captured 1,369 coho salmon and 1,118 Dolly Varden char at Sites 1–7 (Table 1, Figure 2). Coho salmon captures this year were the highest since the majority of transplanted juveniles left the system in the spring of 2006 (Figure 3, Table 2). Dolly Varden char captures were the second highest out of all years, next to 2012 (Figure 3, Table 3). While visiting the hydro site downstream, I snorkeled pools between the fish pass and the top of Falls1, counting 62 adult coho salmon.

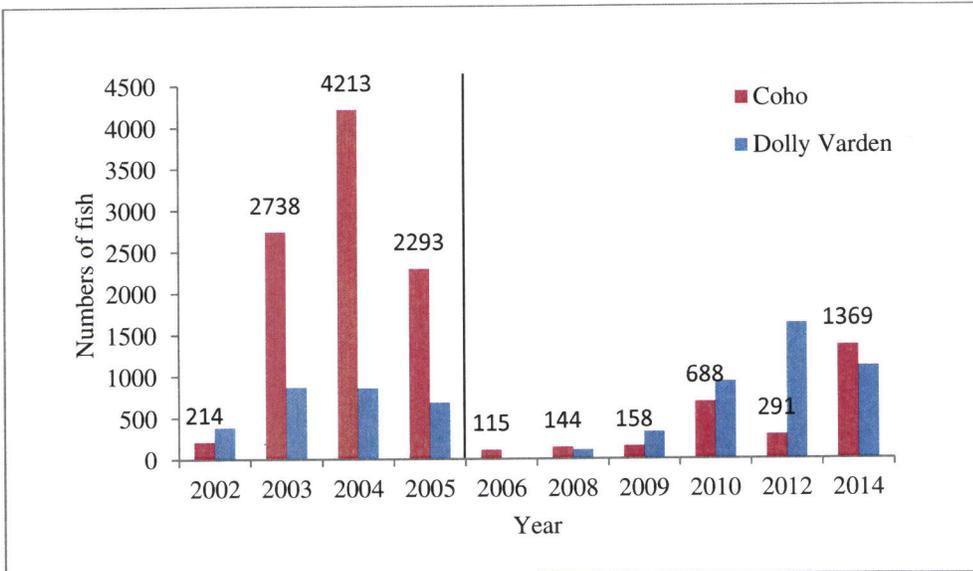
Figure 3.—Coho salmon and Dolly Varden char captures since 2002. Vertical line marks last year of transplanting.

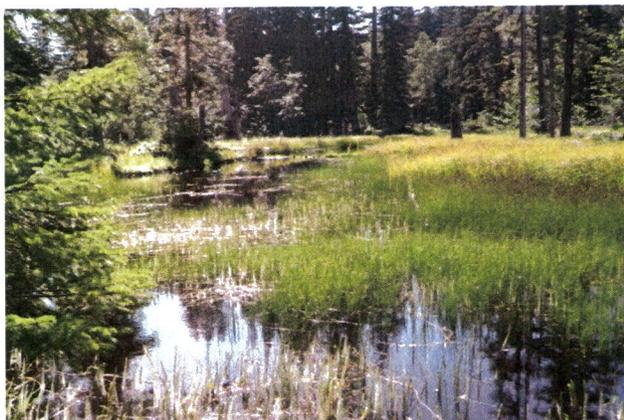
Photo 5.—Beaver pond at Site 4.

Site 4			
Date:	8/20/2014	Traps	30
Crew:	G. Albrecht, J. Serio, K. Rosendale	Soak Time	1325 - 1605
Flows	Moderately low	Coho	9
Weather	Clear and sunny following 2 weeks of rain	Dolly Varden	220
Notes	Beaver pond area. 30 traps were set around the perimeter of the pond and in small adjoining channels. Waypoint S4 – Left side of road about 100 feet through grass meadow. 57.8284, -135.2601		
		Appendix Photos	4046
Site 5			
Date:	8/21/2014	Traps	30
Crew:	G. Albrecht, J. Serio, K. Rosendale	Soak Time	0940 - 1140
Flows	Moderately low	Coho	324
Weather	Clear and sunny following 2 weeks of rain	Dolly Varden	71
Notes	Good rearing habitat in mainstem stretch of river. 15 traps were set within 300 feet upstream and 400 feet downstream (around the bend) of the old LSB location. Waypoint S5 – 300 feet down spur road on left side of road. 57.8423, -135.2866		
Site 6			
Date:	8/21/2014	Traps	30
Crew:	G. Albrecht, J. Serio, K. Rosendale	Soak Time	1205 - 1430

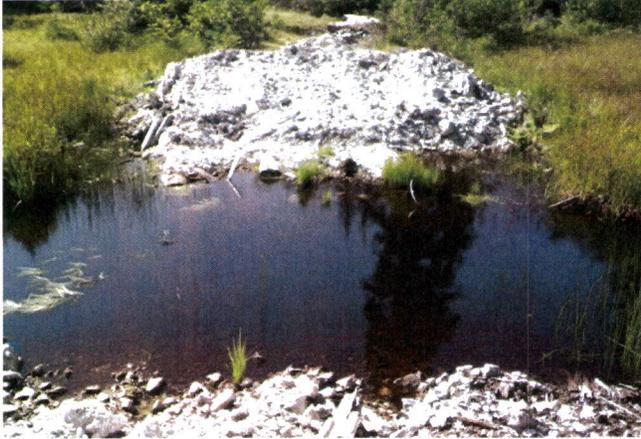
Photo 7.—Former log bridge location at Site 6.

Flows	Moderately low	Coho	28
Weather	Clear and sunny following 2 weeks of rain	Dolly Varden	142
Notes	Good rearing habitat through meadow side channel. 10 traps were set upstream and 20 downstream of the old LSB site within 250 feet. Waypoint S6 – continue down spur road past main stem about 300 feet. 57.8415, -135.2886		
		Appendix Photos	4073, 4075
Site 7			
Date:	8/21/2014	Traps	30
Crew:	G. Albrecht, J. Serio, K. Rosendale	Soak Time	1020 - 1300
Flows	Moderately low	Coho	129
Weather	Clear and sunny following 2 weeks of rain	Dolly Varden	34
Notes	Beaver ponds on both sides of road. Culvert removed and beaver dam ~2 ft tall on uphill side of road. 2 traps set on uphill side and 2 DV and 1 CO captured. 5 were set near the mainstem below a beaver dam, 20 others set in main pond. Waypoint S7 – Adjacent to road with large fence post stuck in tree stump. 57.8577, -135.3070		
		Appendix Photos	4061, 4062

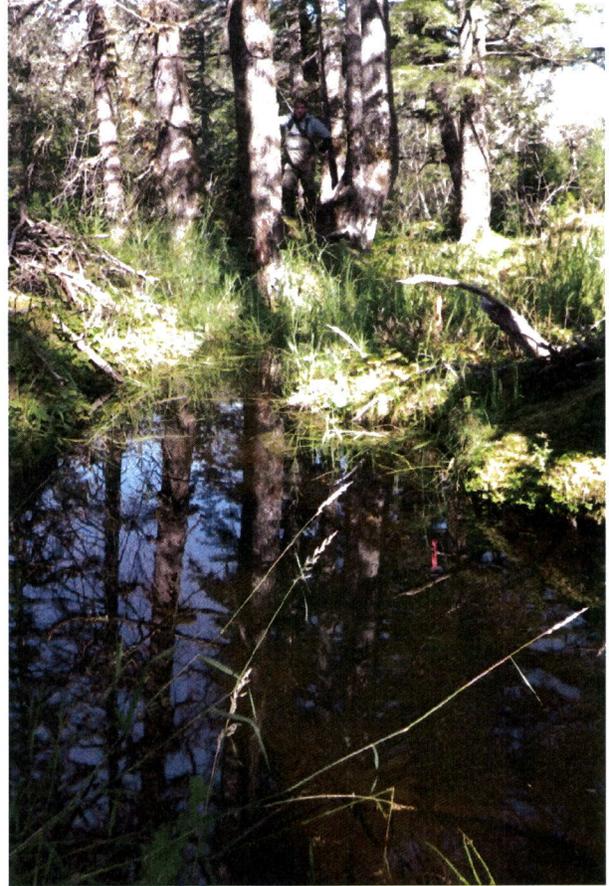
Photo 8.—Beaver pond at Site 6.

Comments:
 28 CO, 142 DV caught in traps between Waypoint 2 and main stem. This is a channelized beaver pond system, trapping site 6 in attached report.
 Coordinates (Lat,Long): Upper(57.8650,-135.32) Lower(57.7800,-135.184)
Add new stream w/ coho salmon REARING

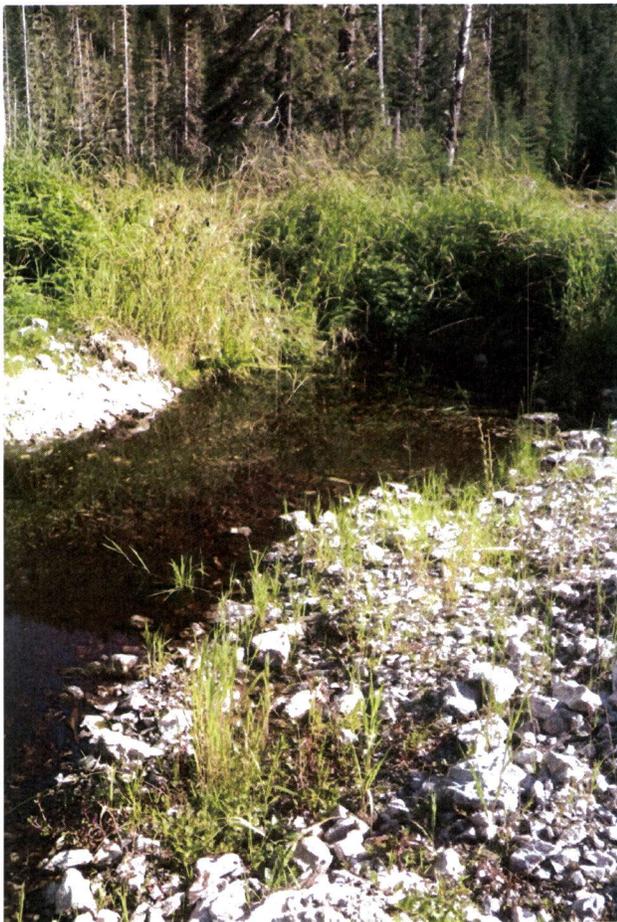
Photo 9.—Former culvert location at Site 7 showing grassy beaver dam.

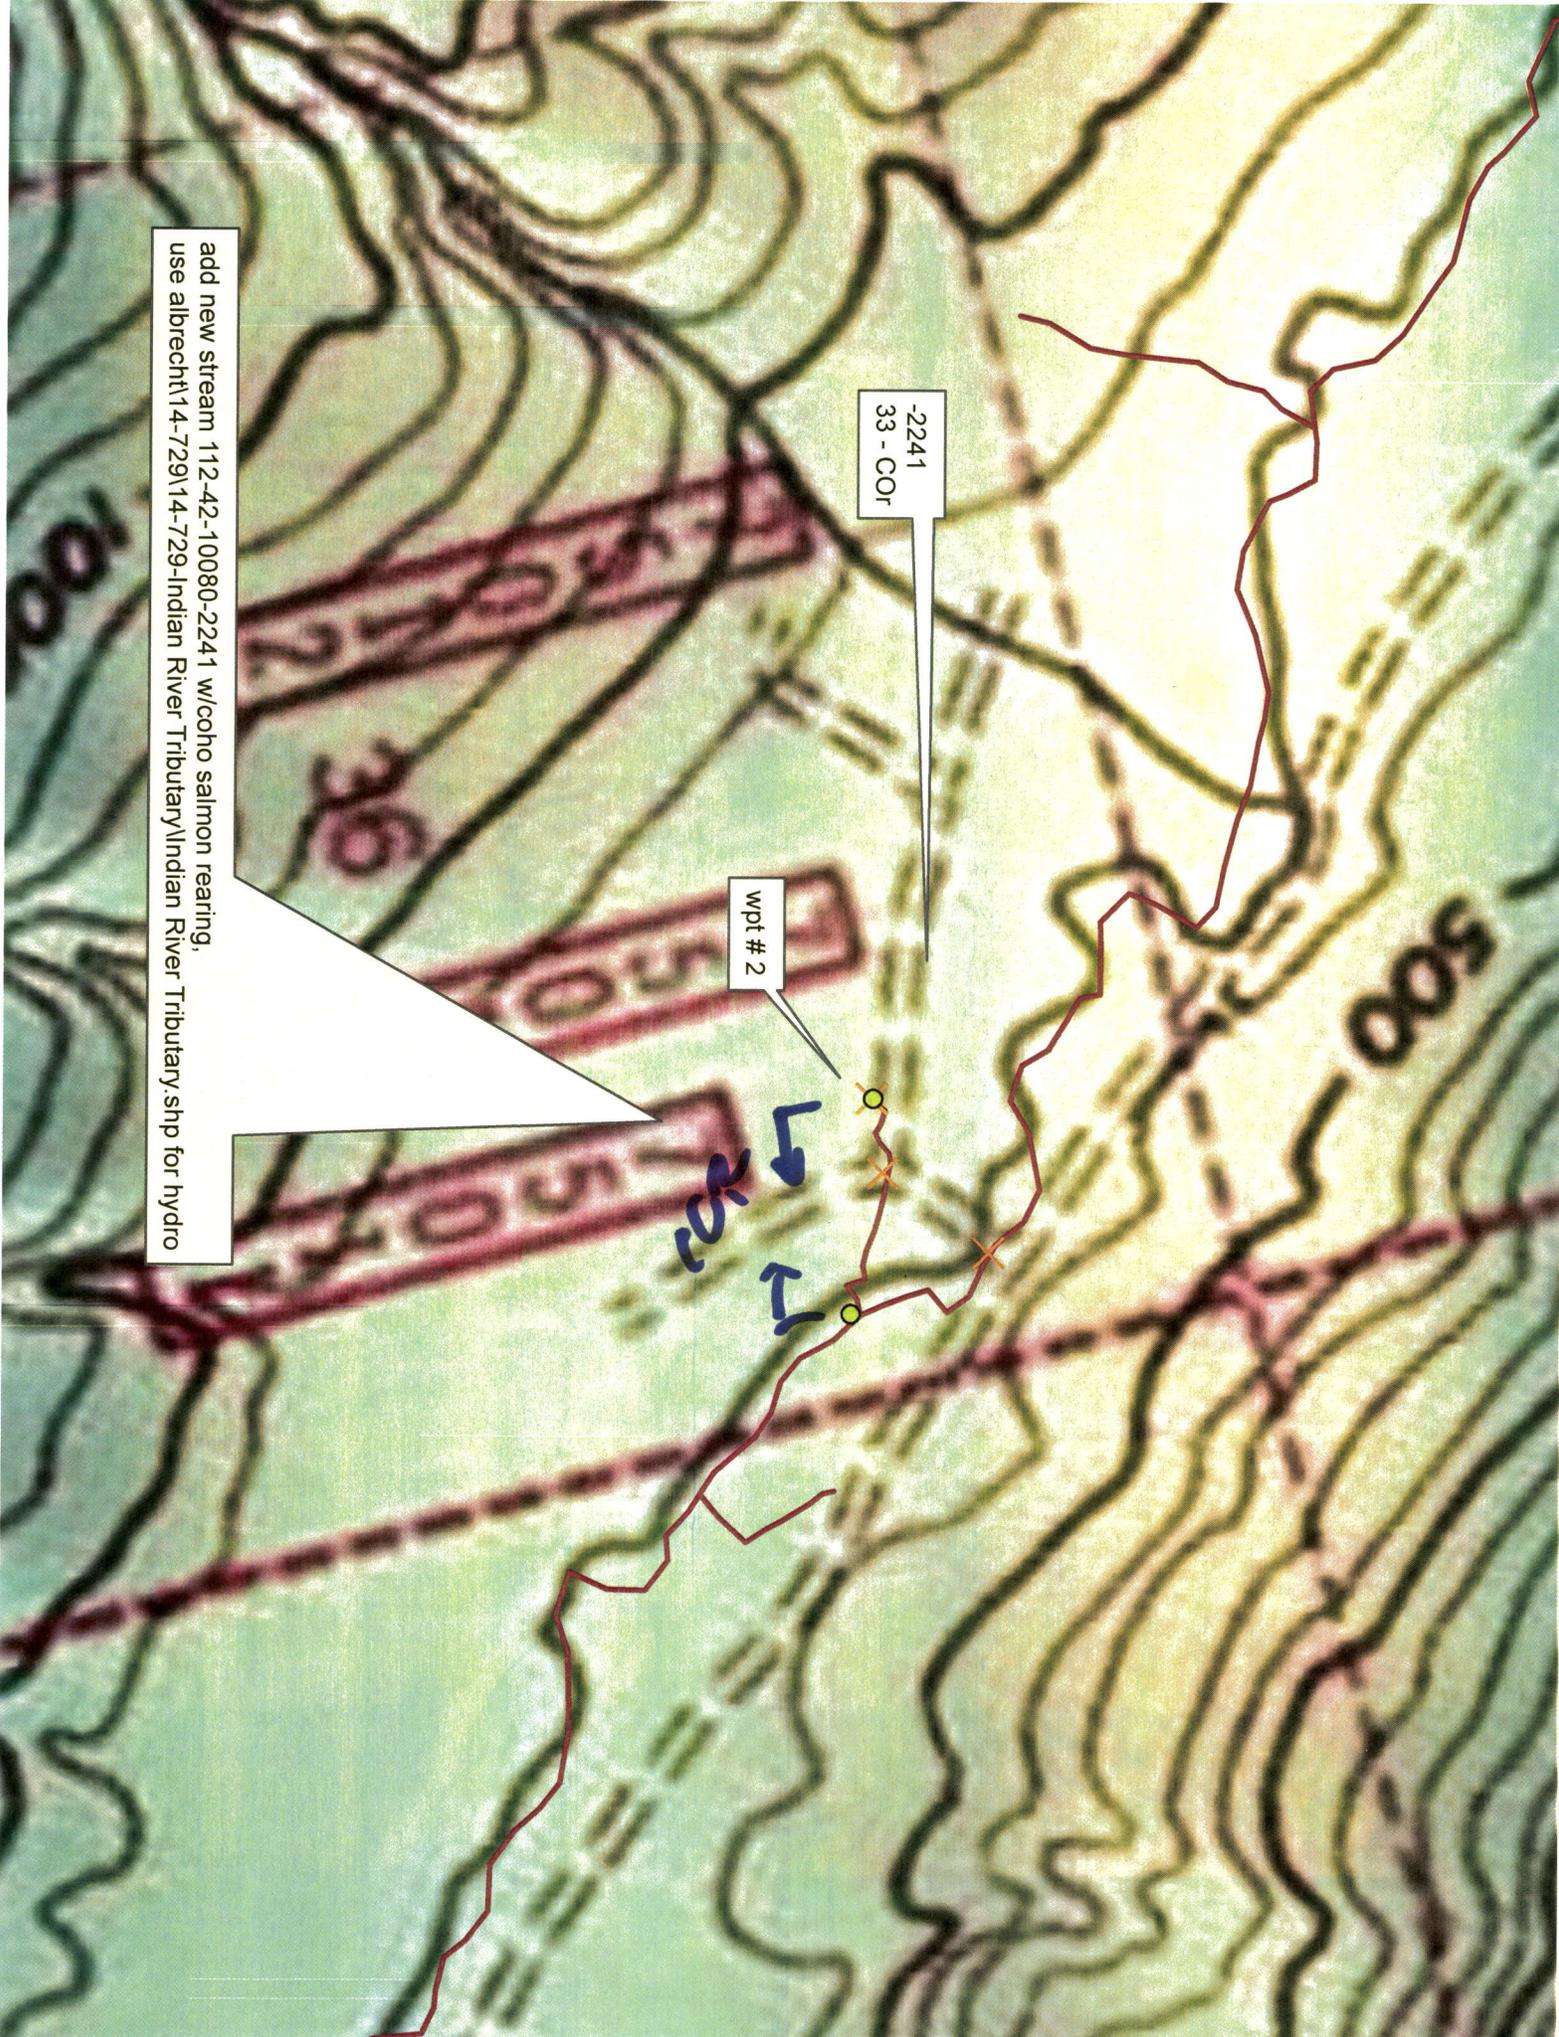
Indian River Tributary Addition

add new stream 112-42-10080-2241 w/coho salmon rearing,
use albrecht\14-729\14-729-Indian River Tributary\Indian River Tributary.shp for hydro
