AWC DATABASE CATALOG/ATLAS
CORRECTION FORM

Describe Change(s): Add new lake w/coho salmon rearing

SUBJECT: Indian River Coho Fry Index
Trapping Report
August 20-22, 2014

Indian River Tributary Addition

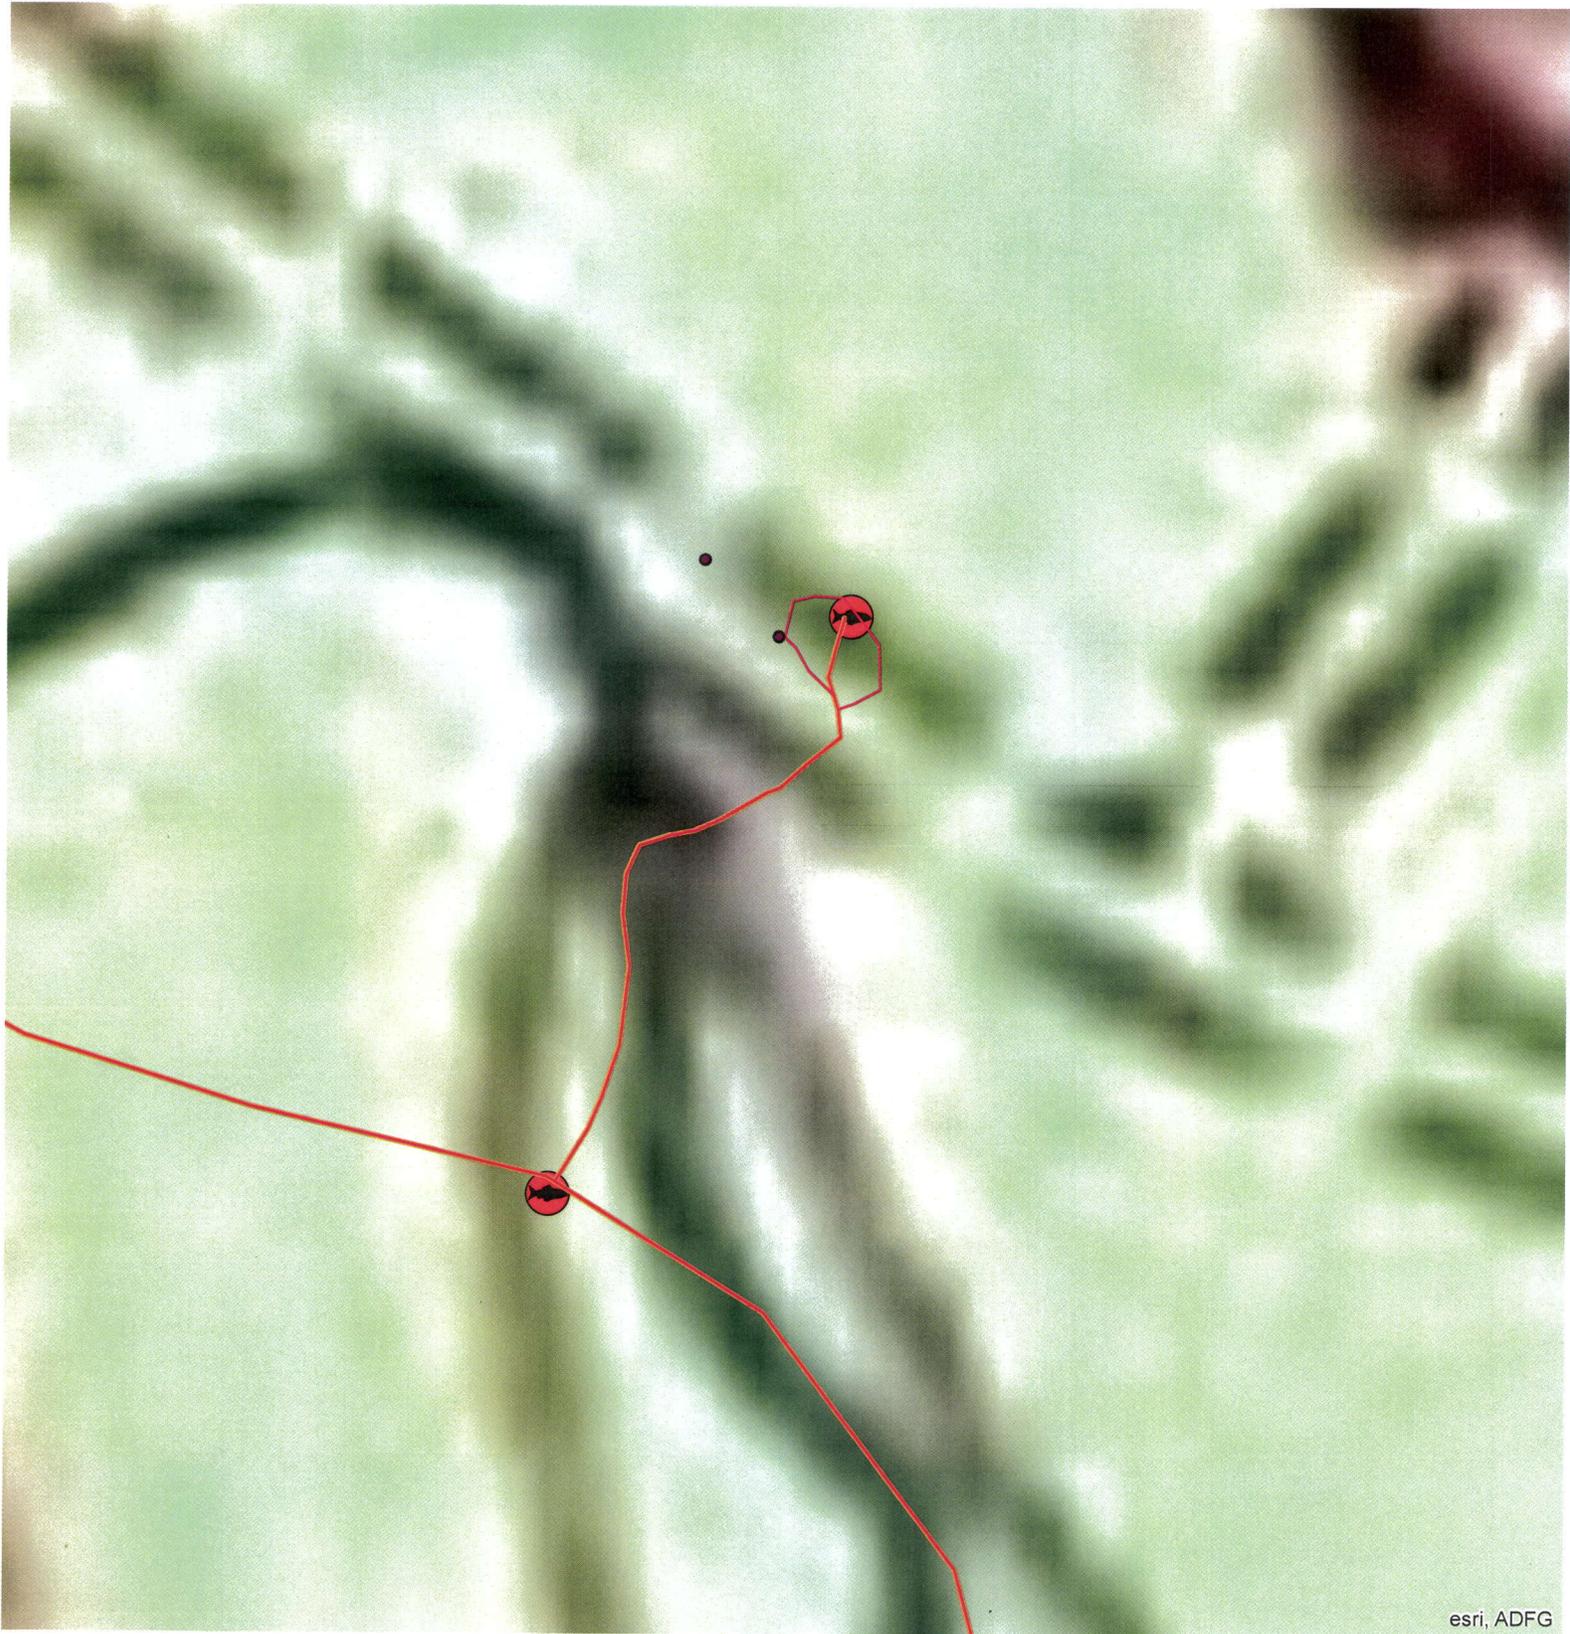
14-730 / Indian River trib

Hi J,
Just checked these over and they look good. Thank you for your efforts and for putting up with nominations from guys like me ;)
One thing that should probably be clarified:
Nomination 14-730 – the upper coho captures were in a beaver pond, as outlined on my map and shape file. Looks like the nomination notes you have just show it as a stream.
Thanks

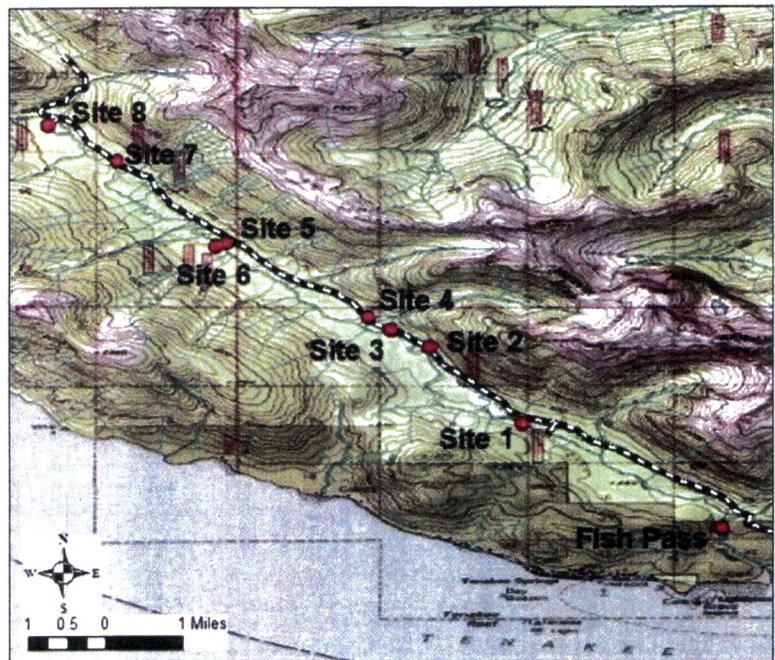
Figure 1.-Site map showing the fish pass and index trapping sites.

In 2012, ADF&G issued Fish Habitat Permit FH12-I-0125 to the City of Tenakee for a run-of-the-river hydroelectric project to be installed near the fish pass at Falls 4 on the river (Figure 1). ADF&G Habitat has a shared interest in monitoring the system to assess potential impacts from the hydroelectric project.

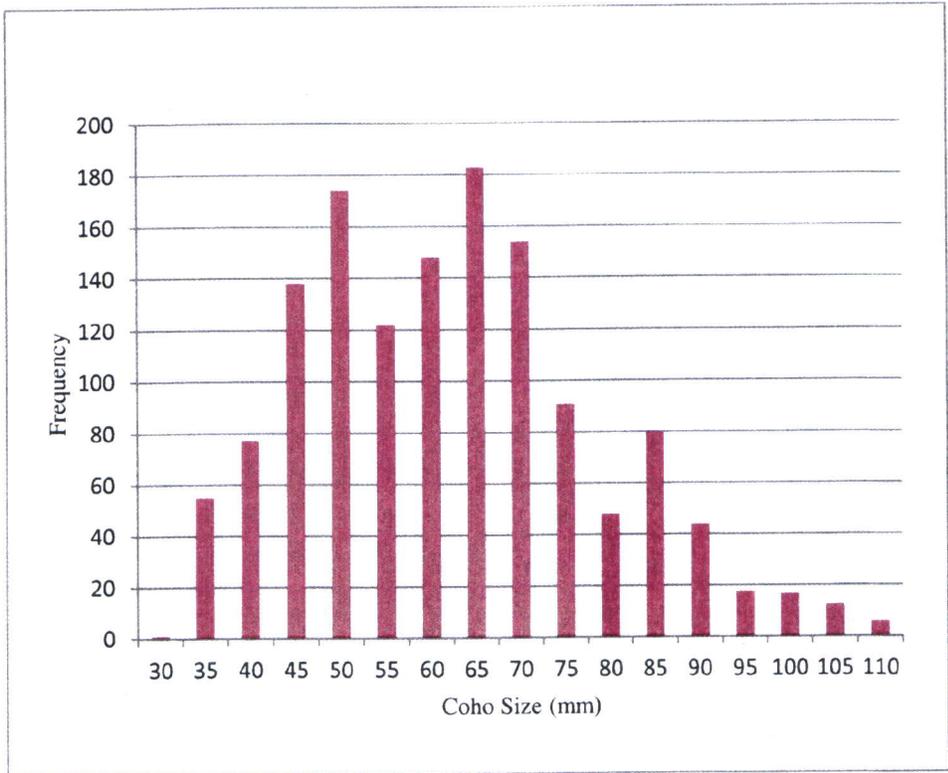
Figure 2.—Size frequency of coho salmon captured at all trapping sites.

We captured 1,369 coho salmon and 1,118 Dolly Varden char at Sites 1–7 (Table 1, Figure 2). Coho salmon captures this year were the highest since the majority of transplanted juveniles left the system in the spring of 2006 (Figure 3, Table 2). Dolly Varden char captures were the second highest out of all years, next to 2012 (Figure 3, Table 3). While visiting the hydro site downstream, I snorkeled pools between the fish pass and the top of Falls1, counting 62 adult coho salmon.

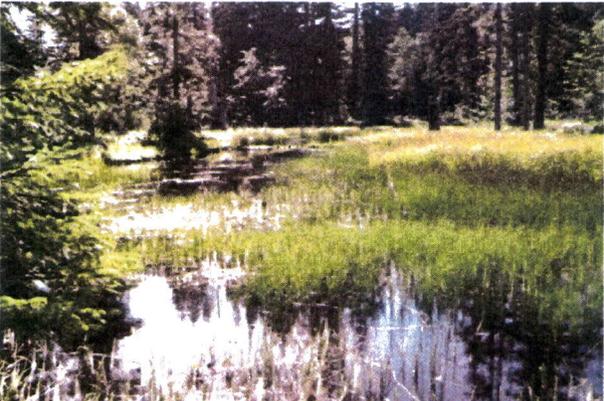
Site 4			
Date:	8/20/2014	Traps	30
Crew:	G. Albrecht, J. Serio, K. Rosendale	Soak Time	1325 - 1605
Flows	Moderately low	Coho	9
Weather	Clear and sunny following 2 weeks of rain	Dolly Varden	220
Notes	Beaver pond area. 30 traps were set around the perimeter of the pond and in small adjoining channels. Waypoint S4 – Left side of road about 100 feet through grass meadow. 57.8284, -135.2601		
		Appendix Photos	4046
Site 5			
Date:	8/21/2014	Traps	30
Crew:	G. Albrecht, J. Serio, K. Rosendale	Soak Time	0940 - 1140
Flows	Moderately low	Coho	324
Weather	Clear and sunny following 2 weeks of rain	Dolly Varden	71
Notes	Good rearing habitat in mainstem stretch of river. 15 traps were set within 300 feet upstream and 400 feet downstream (around the bend) of the old LSB location. Waypoint S5 – 300 feet down spur road on left side of road. 57.8423, -135.2866		
Site 6			
Date:	8/21/2014	Traps	30
Crew:	G. Albrecht, J. Serio, K. Rosendale	Soak Time	1205 - 1430

Photo 5.—Beaver pond at Site 4.

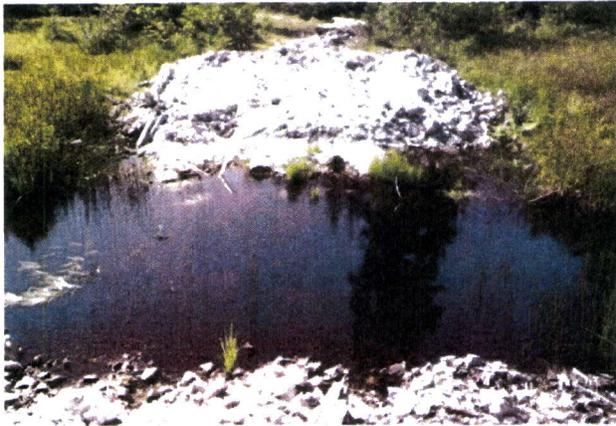
Photo 7.—Former log bridge location at Site 6.

The USFS converted culvert and bridge crossings to ATV fords in 2013. It now takes about 1 hour to travel from tide water to Site 8 on an ATV, with ford and water bar crossings every few hundred feet. I recommend those participating in future trapping events plan for extra drive time and extra time at trapping sites.

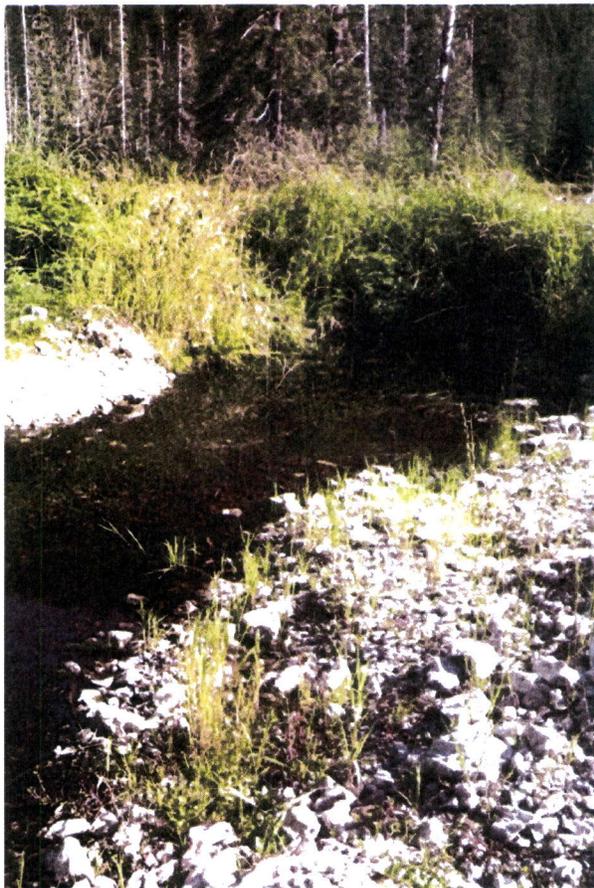
Photo 9.—Former culvert location at Site 7 showing grassy beaver dam.

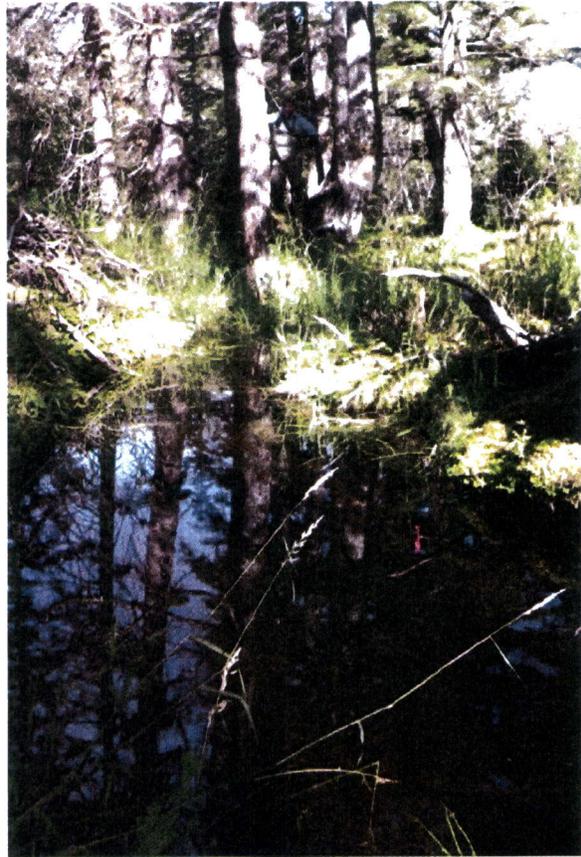
Photo 8.—Beaver pond at Site 6.
