Nomination Form
Anadromous Waters Catalog

Name of Waterway Bear Crk USGS Name Local Name

MEMORANDUM

SUBJECT: Medvijie Hatchery,
Sitka

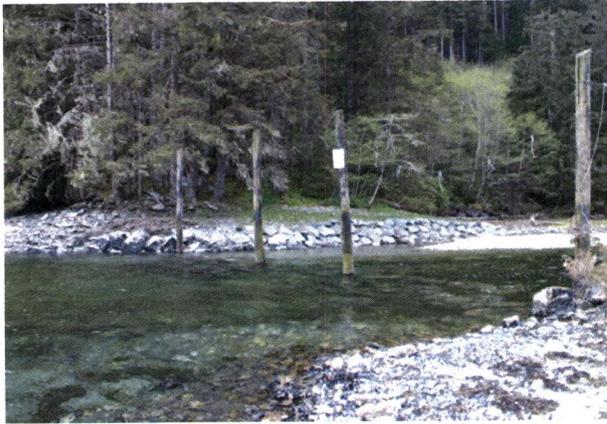
The intertidal picket weir (Figure 1) is what NSRAA plans to rebuild sometime this summer. They will replace the existing piles, and place interlocking jersey blocks (Figure 2) along the stream bed from bank to bank to maintain a consistent grade so that the pickets will sit evenly across the bottom, negating the need for sandbags. This is a seasonal weir that is installed in June and removed in November.

Figure 1.—Lower picket weir piles.

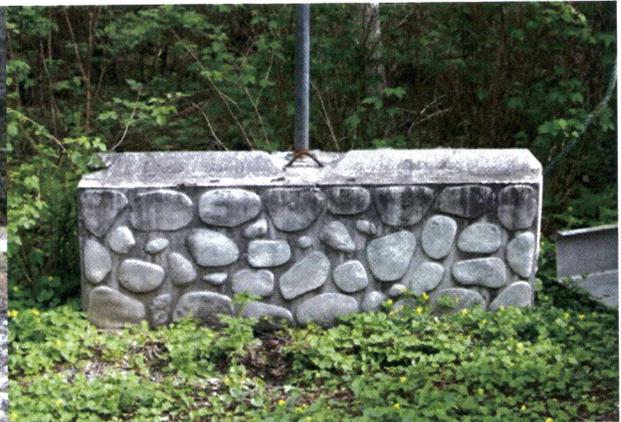
Figure 2.—Interlocking jersey block that will line the bottom of the picket weir.

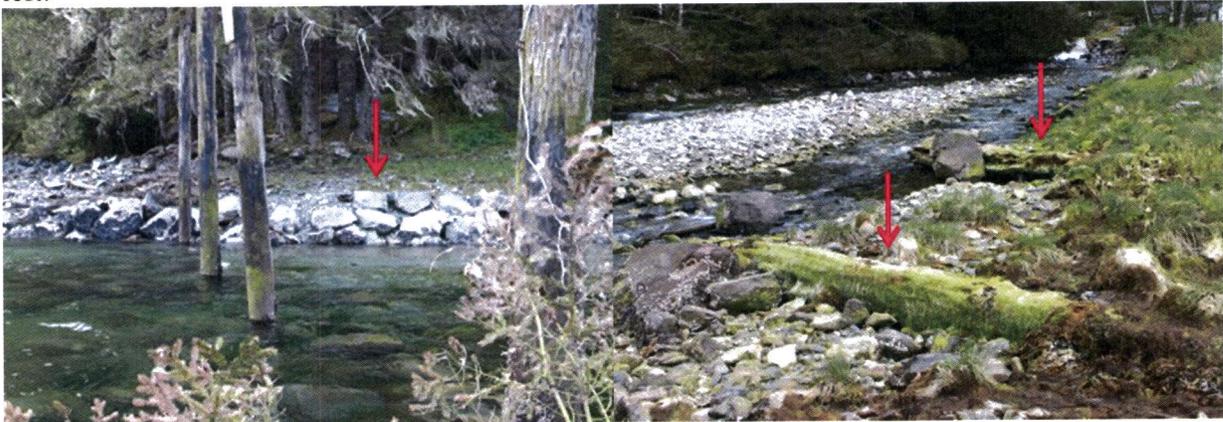
The recent bank stabilization work and stream channelization was completed at the mouth of the creek using riprap on river right (Figure 3) and key wood, toed into the bank (Figure 4) on river left.

Figure 3.—Riprap bank stabilization on river right at the mouth.

Figure 4.—Key wood log revetments placed on river left to maintain channelization.

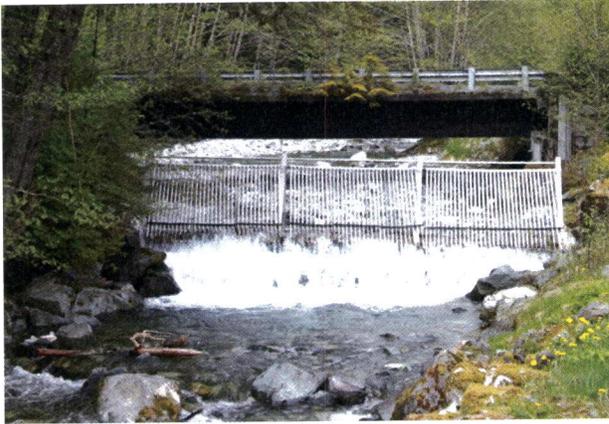
The upper, permanent weir and water intake (Figure 5) is approximately 100 m above the lower weir. The gaps in the weir are large enough to afford downstream migration for resident fish (Figure 6). The water intake is situated behind the weir. It is sufficiently screened to exclude fish (Figure 7), and is self-cleaning; however NSRAA staff periodically removes larger material that piles up.

Figure 5.—Upstream permanent weir.

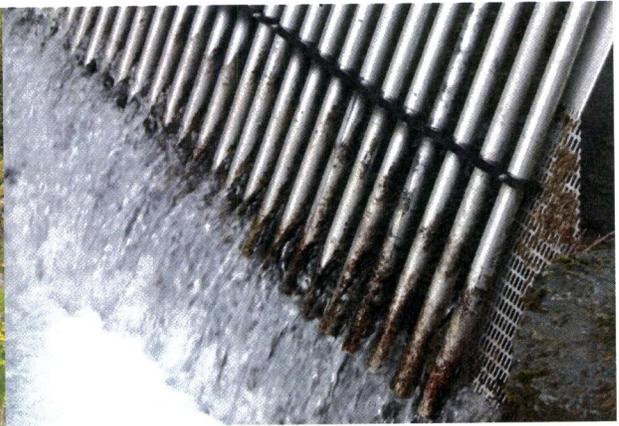
Figure 6.—Upper weir affords downstream fish passage.

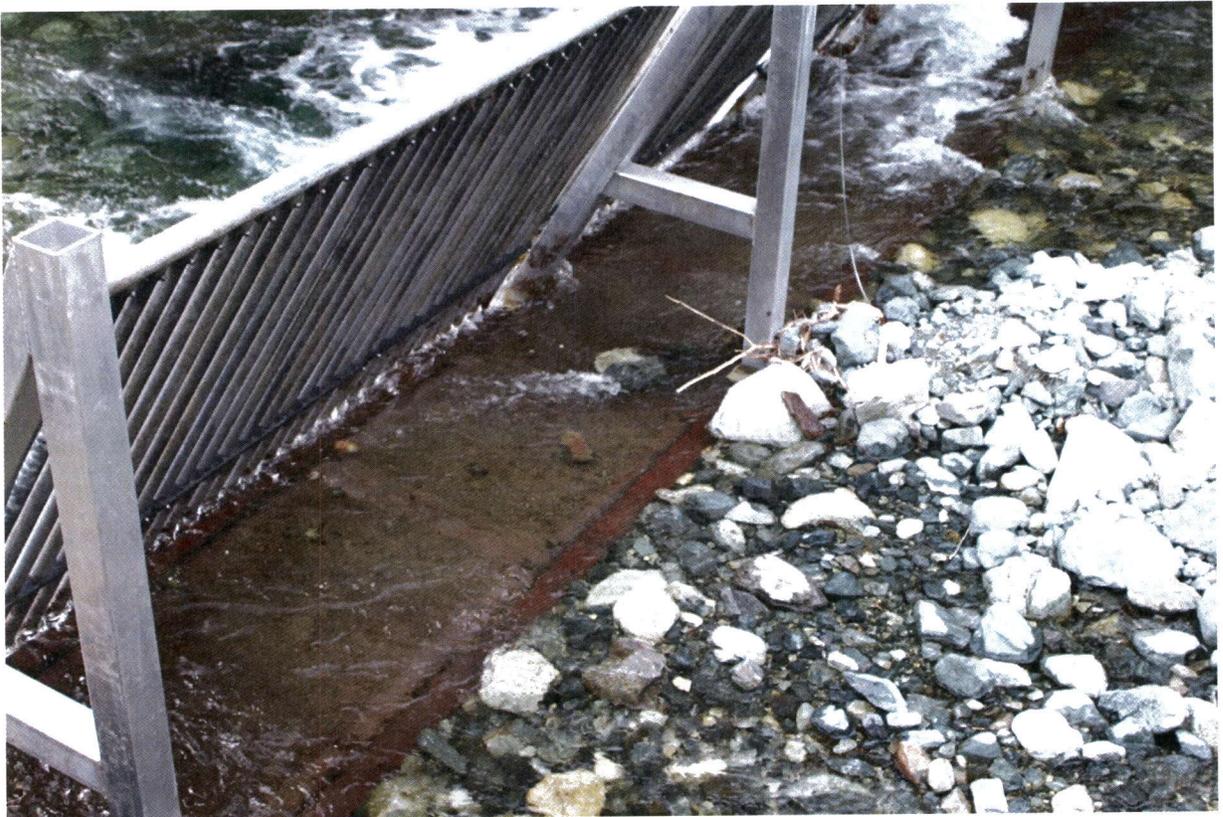
Figure 7.—Screened water intake behind weir.

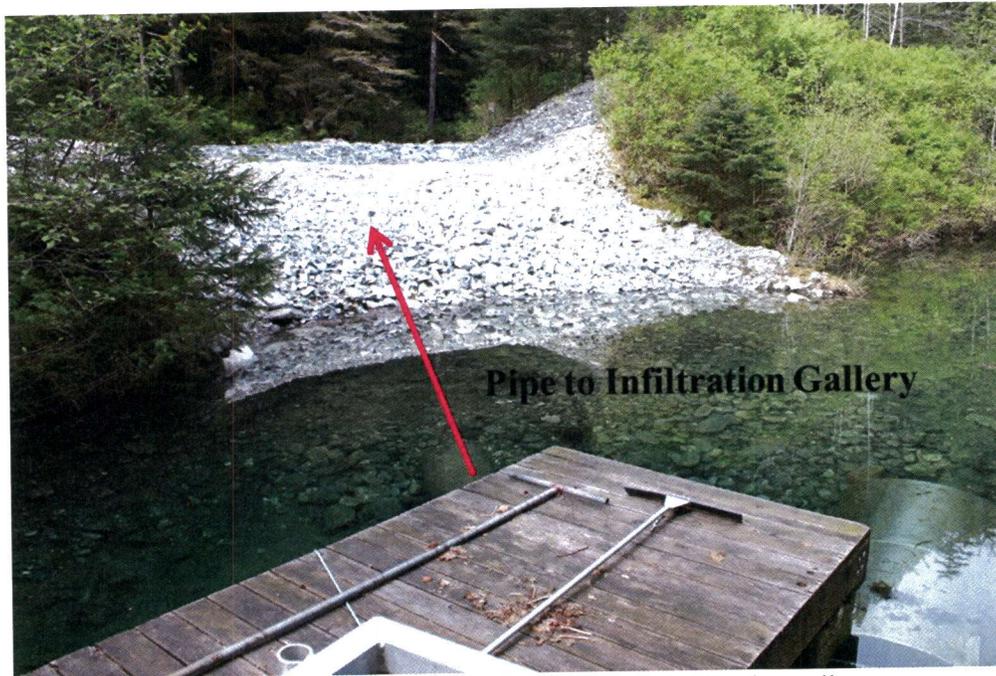
The newly constructed pond water intake is on river left of the North Fork (Figure 8). The south bank of the creek was reinforced with riprap to maintain stability (Figure 9), with the existing pond located behind. NSRAA ran a pipe through the riprap to an infiltration gallery, buried about 1 m deep, immediately downstream of a large boulder in the creek (Figure 9). Tess e-fished the area around the infiltration gallery and did not capture fish. Mr. Wagner said that they

Figure 8.—Intake pond with pipe running to infiltration gallery.

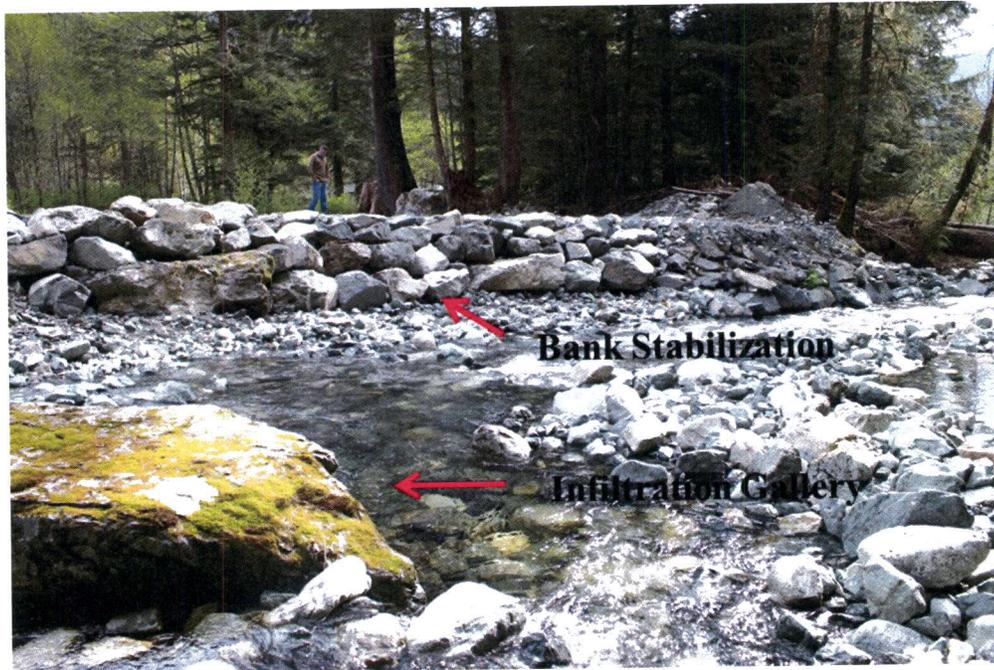
Figure 9.—Riprap on south bank and infiltration gallery below large boulder.

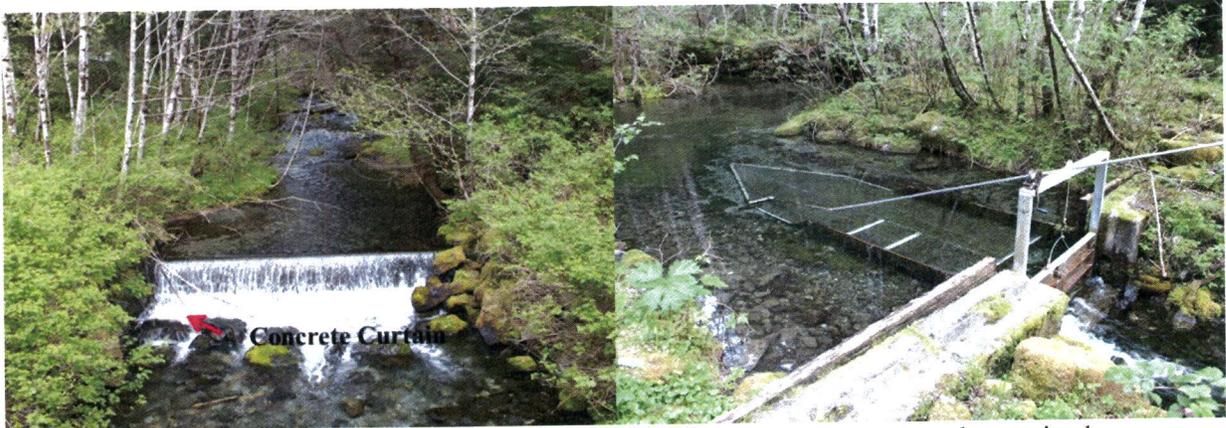
The permanent weir is a concrete structure approximately 1 m tall with a concrete curtain on the bottom so there is no jump pool (Figure 10).

The water intake (Figure 11) on the South Fork is an impoundment with an upstream infiltration gallery that is sufficiently screened to exclude fish.

Figure 10.—Concrete weir and curtain.

Figure 11.—Screened water intake.
