Nomination Form  
Anadromous Waters Catalog

Region Southwest USGS Quad(s) Kodiak A-4  
 Anadromous Waters Catalog Number of Waterway 258-40-10012-2041-0010  
 Name of Waterway Ocean Beach  USGS Name  Local Name  
 Addition  Deletion  Correction  Backup Information

SUBJECT: Old Harbor Ocean Beach Trail

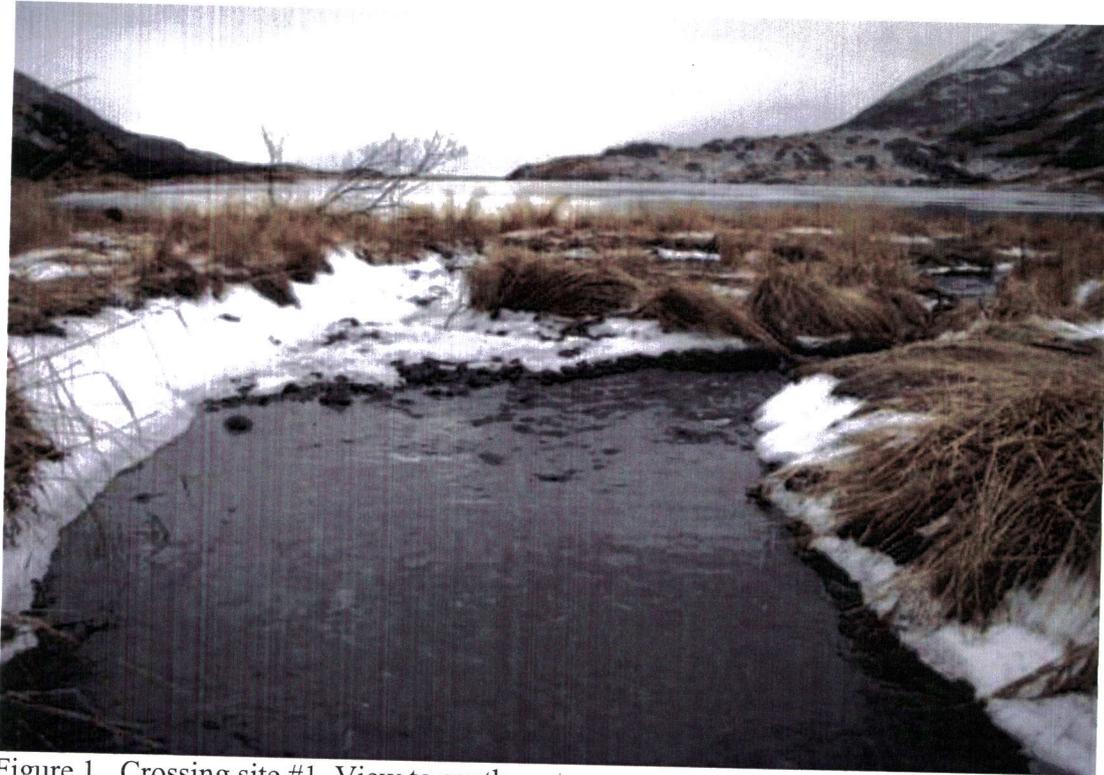
Figure 1. Crossing site #1. View to southwest.

We drove to Stream Crossing #1. The stream crossing is located at Latitude 57.1211, Longitude -153.1993. The crossing is located on a 5.5-foot wide unnamed stream that flows into Lake No. 258-40-10012-0020 (Figures 1 and 2). I stated the condition of the existing crossing is acceptable to cross with ATVs. I recommended using hand tools to create a 2:1 slope on the streambanks at the stream crossing to allow ATVs with a trailer to cross the stream safely. At 1230, I set one baited minnow trap in the stream about 50-feet above the trail crossing and one minnow trap in the lake near the stream outlet. At 1530, I removed the minnow traps. No fish were captured in the trap set in the stream and 10 stickleback were captured in the trap set in the lake. No Fish Habitat Permit will be required to cross the stream.

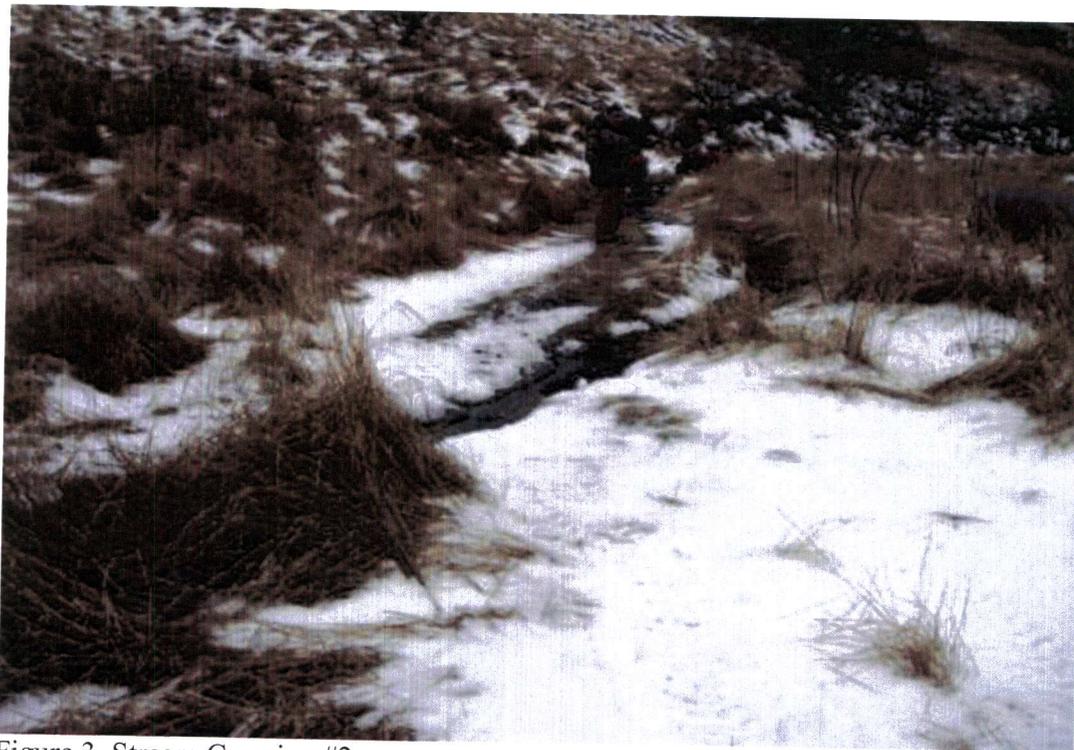
Figure 3. Stream Crossing #2.

We drove to Stream Crossing #2. The stream crossing is located at Latitude 57.1208, Longitude -153.1989. The crossing is located on a 3-foot wide unnamed stream that flows from a spring about 100-feet above the trail. The stream flows into Lake No. 258-40-10012-0020 (Figures 3 and 4). I stated the condition of the existing crossing is acceptable to cross with ATVs. I recommended no action be taken at the stream crossing. No Fish Habitat Permit will be required to cross the stream.

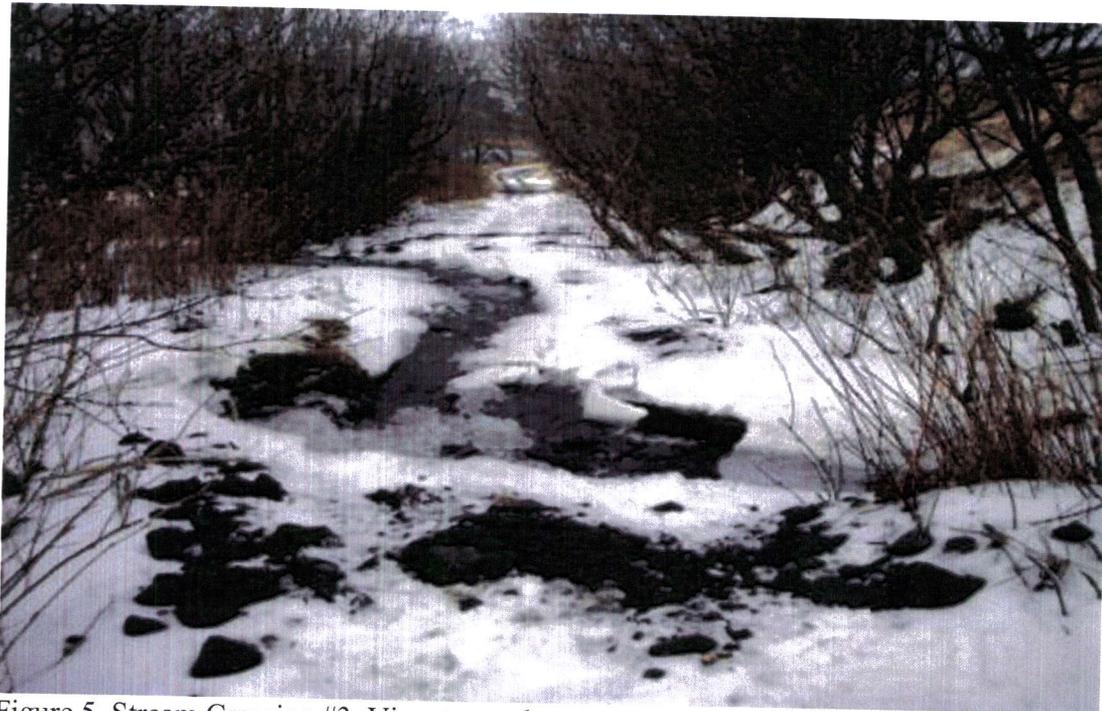
Figure 5. Stream Crossing #3. View to southeast.

We drove to Stream Crossing #3. The stream crossing is located at Latitude 57.1085, Longitude -153.1927. The crossing is located on a 5-foot wide unnamed stream that flows into Lake No. 258-40-10012-0010 (Figure 5). Two failed steel 14-inch diameter pipes are located in the streambed. The stream gradient above the trail is over 20% with minimal fish habitat. I stated the condition of the existing crossing is acceptable to cross with ATVs. I recommended no action be taken at the stream crossing. No Fish Habitat Permit will be required to cross the stream.

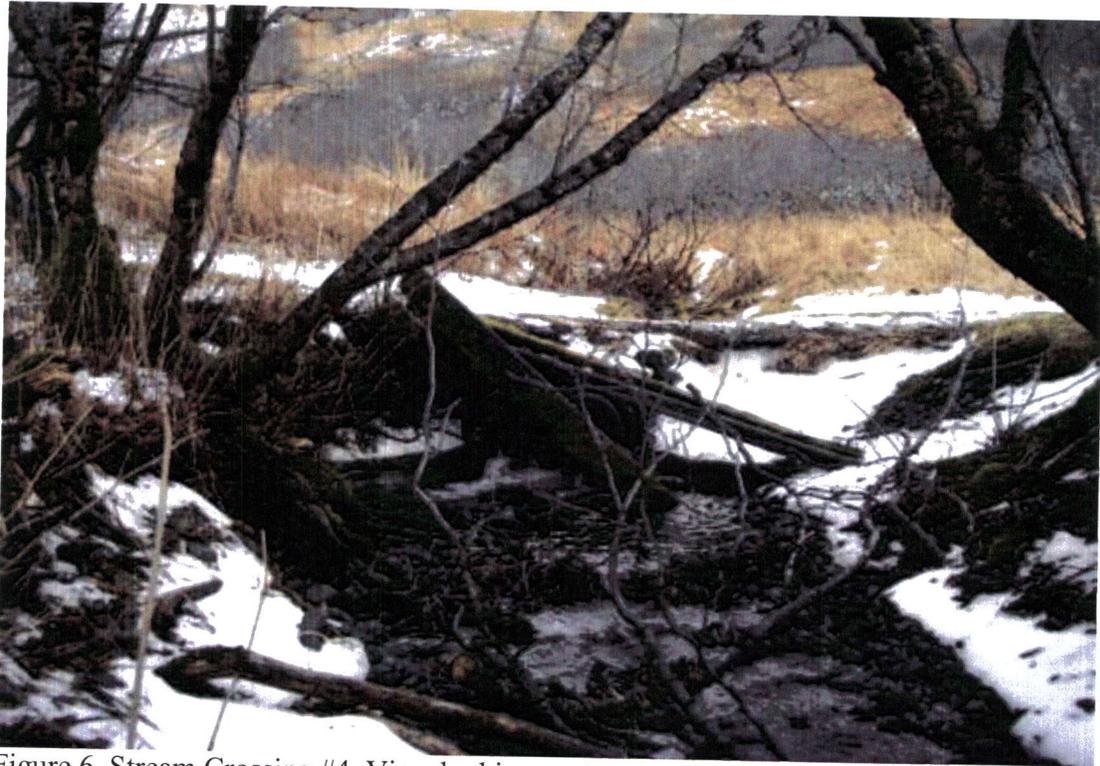
Figure 6. Stream Crossing #4. View looking upstream.

We drove to Stream Crossing #4. The stream crossing is located at Latitude 57.1082, Longitude -153.1924. The crossing is located on a 5-foot wide unnamed stream that flows into Lake No. 258-40-10012-0010 (Figures 6 and 7). Two failed steel 14-inch diameter pipes are located in the streambed. The stream below the trail provided good quality rearing habitat. The stream gradient above the trail is over 20% with minimal fish habitat. I stated the condition of the existing crossing is acceptable to cross with ATVs. I recommended no action be taken at the stream crossing. No Fish Habitat Permit will be required to cross the stream.

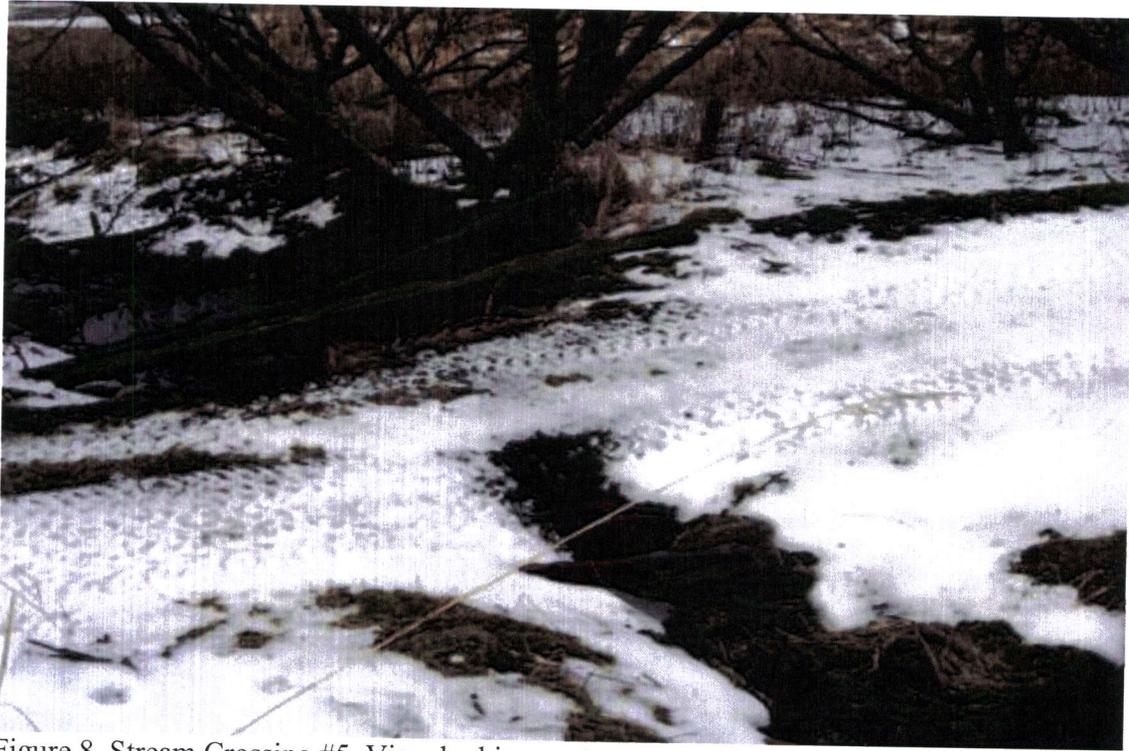
Figure 8. Stream Crossing #5. View looking upstream.

We drove to Stream Crossing #5. The stream crossing is located at Latitude 57.1055, Longitude -153.1907. The crossing is located on a 5-foot wide unnamed stream that flows into Stream No. 258-40-10012 (Figures 8 and 9). Two failed steel 14-inch diameter pipes are located in the streambed. The stream gradient above and below the trail crossing is over 20% with minimal fish habitat. I stated the condition of the existing crossing is acceptable to cross with ATVs. I recommended no action be taken at the stream crossing. No Fish Habitat Permit will be required to cross the stream.

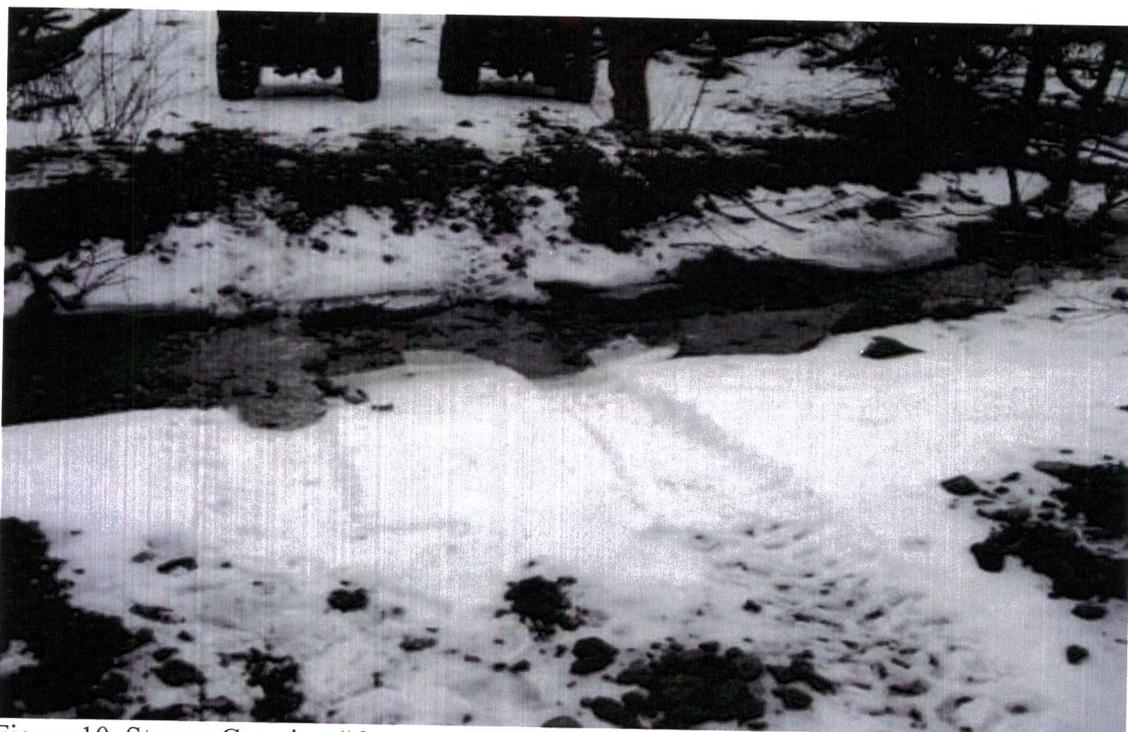
Figure 10. Stream Crossing #6.

We drove to Stream Crossing #6. The stream crossing is located at Latitude 57.1011, Longitude -153.1915. The crossing is located on a 5-foot wide unnamed stream that flows into Stream No. 258-40-10012 (Figures 10 and 11). The stream above and below the trail is over 20% with minimal fish habitat. I stated the condition of the existing crossing is acceptable to cross with ATVs. I recommended no action be taken at the stream crossing. No Fish Habitat Permit will be required to cross the stream.

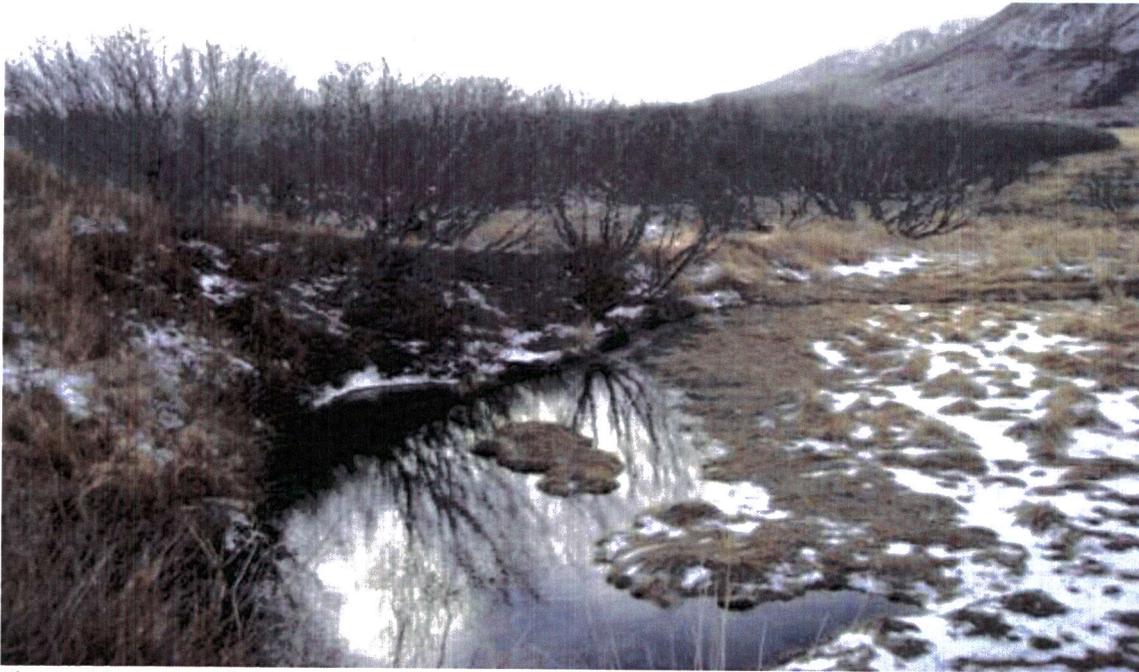
Figure 12. Spring-fed stream adjacent to trail. View to southwest.

We drove to an unnamed spring-fed stream adjacent to the trail (Figure 12). The trail does not cross the stream. The spring is located at Latitude 57.0971, Longitude -153.1824. The stream flows into Stream No. 258-40-10012. I set one minnow trap in the spring. The trap soaked about one hour. The trap captured about 50 juvenile coho salmon. The creek will be nominated to the Anadromous Waters Catalog.

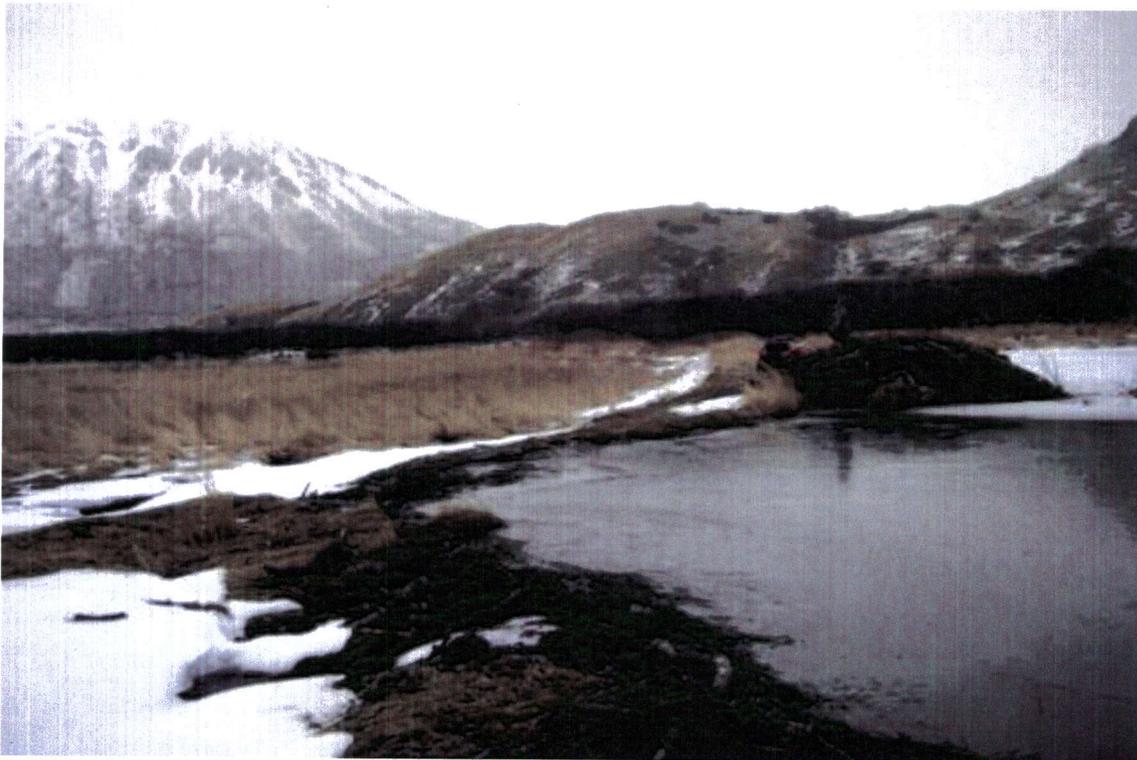
Figure 13. Beaver dam crossing. View to northwest.

We drove to a beaver dam where the trail crosses the outlet stream below the dam. The stream is located at Latitude 57.0959, Longitude -153.1796. The creek flows into Stream No. 258-40-10012. The crossing is located on a 3-foot wide unnamed stream that flows into Stream No. 258-40-10012 (Figure 13). Mr. Shugak proposed to use drift wood from the adjacent beach to build a bridge over the stream and stabilize the soft soil adjacent to the stream. I stated that if the bridge is constructed in a manner that does not block fish passage, no Fish Habitat Permit will be required to install the bridge. I set one minnow trap in the creek below the beaver pond and one trap in the beaver pond. The traps soaked about one hour. The trap below the beaver pond captured five juvenile coho salmon and the trap in the beaver pond captured one juvenile Dolly

Varden and 10 stickleback. The stream will be nominated to the Anadromous Waters Catalog. We drove to the end of the trail at Ocean Beach (Figure 14). At 1500, we returned to McCord bay and were picked up by the landing craft.
