Name of Waterway Packers Creek USGS Name Local Name

State of Alaska
 Department of Fish and Game
 Public Review Nomination for Waters
 Important to Anadromous Species

Packers Creek Fisheries Survey- Fall 2012, Chignik Lagoon, Alaska

**Packers Creek Fisheries Survey- June 2012, Chignik Lagoon,
Alaska**

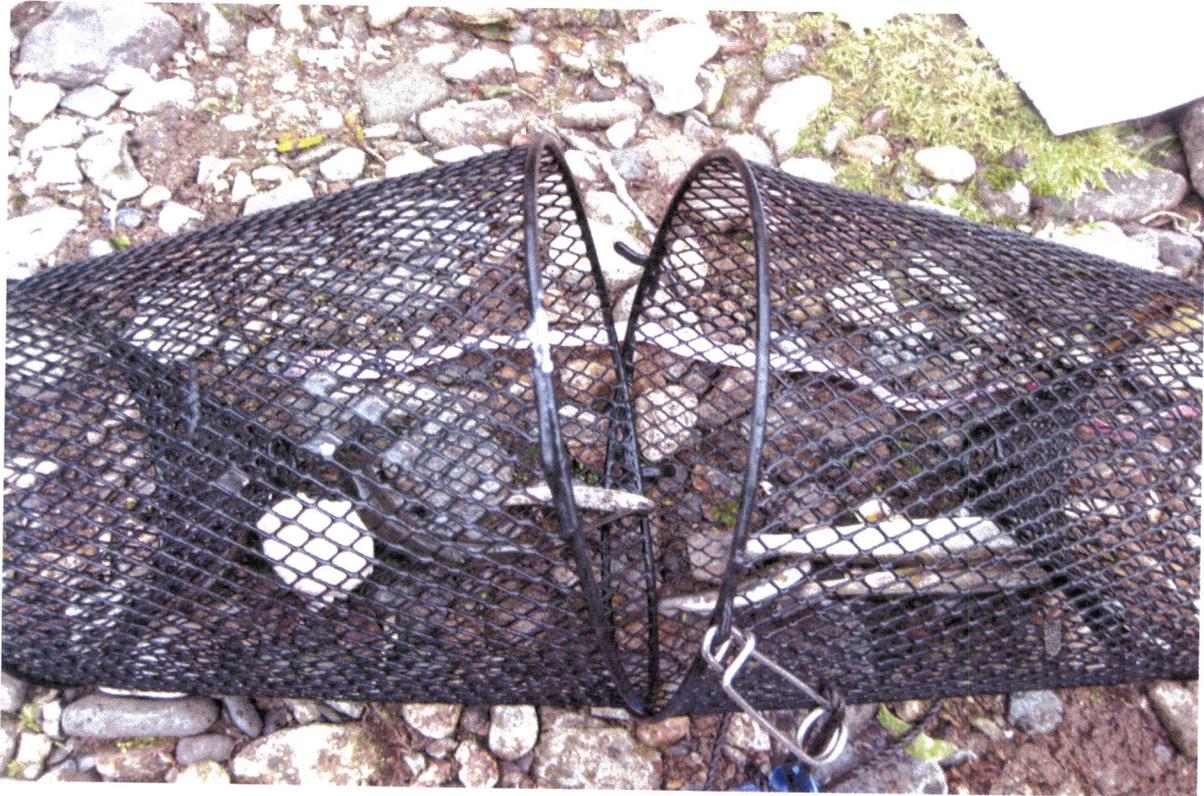
Figure 3. Dolly Varden minnow trap catch from Trap #8 at RM 0.7, Packers Creek, 10/1/12.

A total of eight DV were captured in 170 h of minnow trapping Packers Creek (Tables 1-2). Trap #8 at the gage site (RM 0.7) produced 75% (6-fish) of the catch, while trap # 7 at RM 1.0 provided the remaining 25% or 2-fish (Figures 3-4). No fish were captured in the six traps sited above RM 1.1.

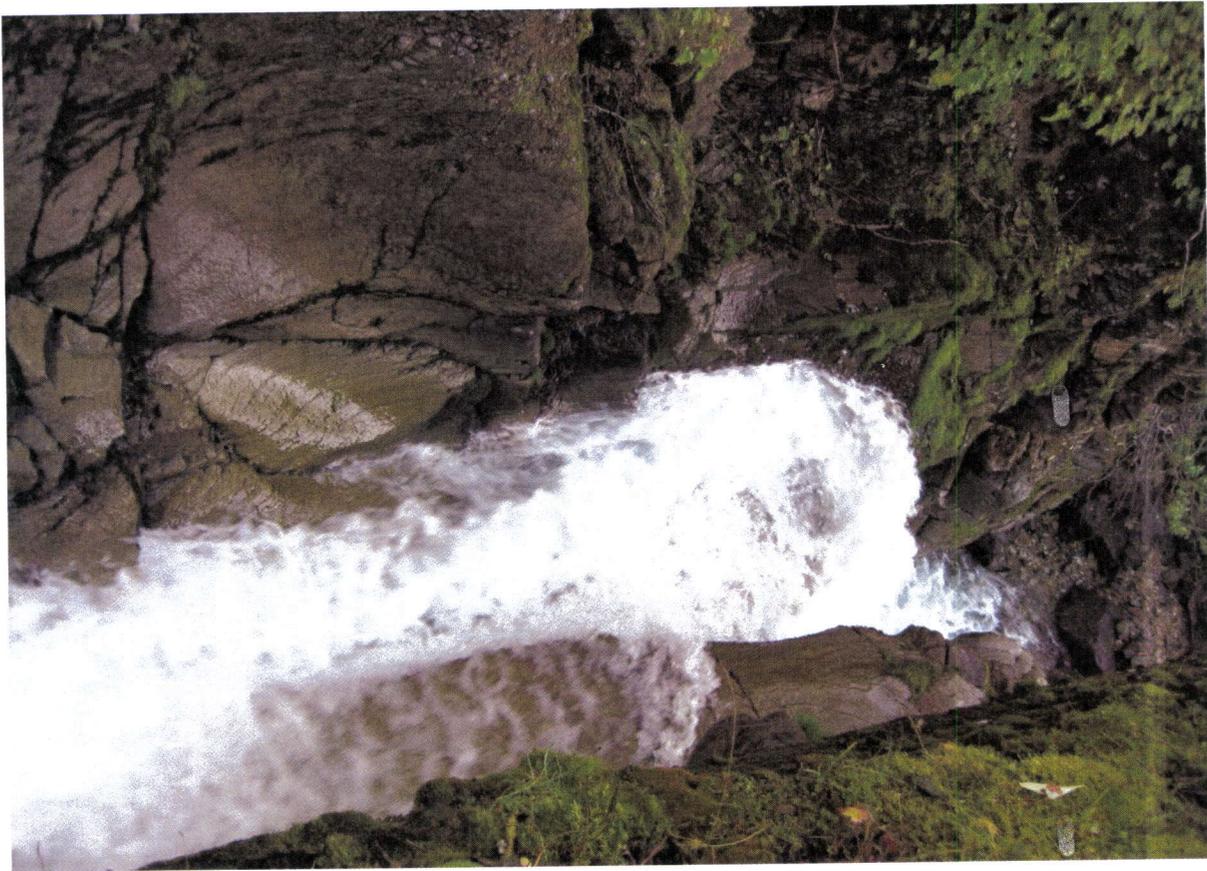
Figure 5. View looking down from the top of the 48ft. waterslide on the east side bank of Packers Creek at RM 1.4, 9/30/2012.

The upper reach of Packers Creek above RM 1.1 is devoid of fish use based on minnow trap catch results (Table 2) and owing to the two migration impediments identified in Figures 5- 6.
