Nomination Form
Anadromous Waters Catalog

Region Southwest USGS Quad(s) Afognak B-1
 Anadromous Waters Catalog Number of Waterway 252-31-10010
 Name of Waterway Unnamed Stream Saposa Bay USGS Name Local Name
 Addition Deletion Correction Backup Information

SUBJECT: AKSSF AWC Survey: Afognak Island
July 2013

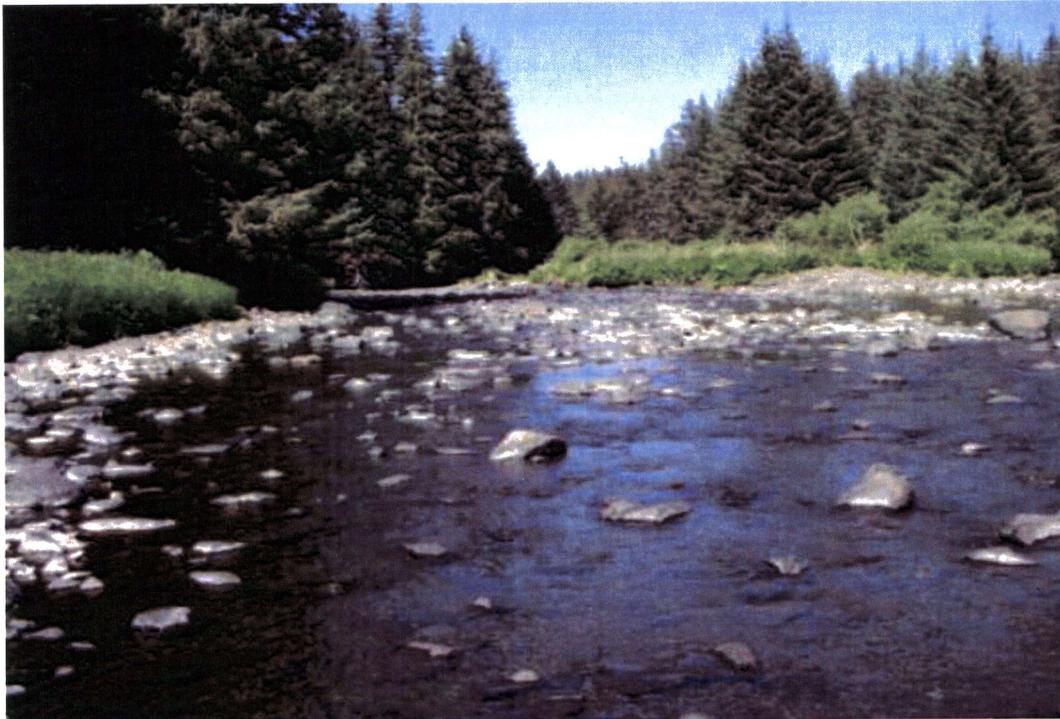
Figure 1. Low stream flow in the Paramanof River. View looking downstream.

On the afternoon of July 24, Mr. Shults and I drove the 1125 Road to an unnamed tributary to Paramanof River (Stream No. 251-40-10030) (Figure 1). About 350 feet below the road we located a 30-foot high barrier about 900 feet above the Paramanof River. Because of the lack of rain, the stream below the barrier contained intermittent flow (Figure 2). We used an electrofisher to sample below the barrier to the Paramanof River. We captured one juvenile coho salmon (55 mm Fork Length (FL)). We captured 10 Dolly Varden (25-115 mm FL). The stream was sampled in April 2013. Because of ice on the stream, no fish were captured or observed during the April sampling trip.

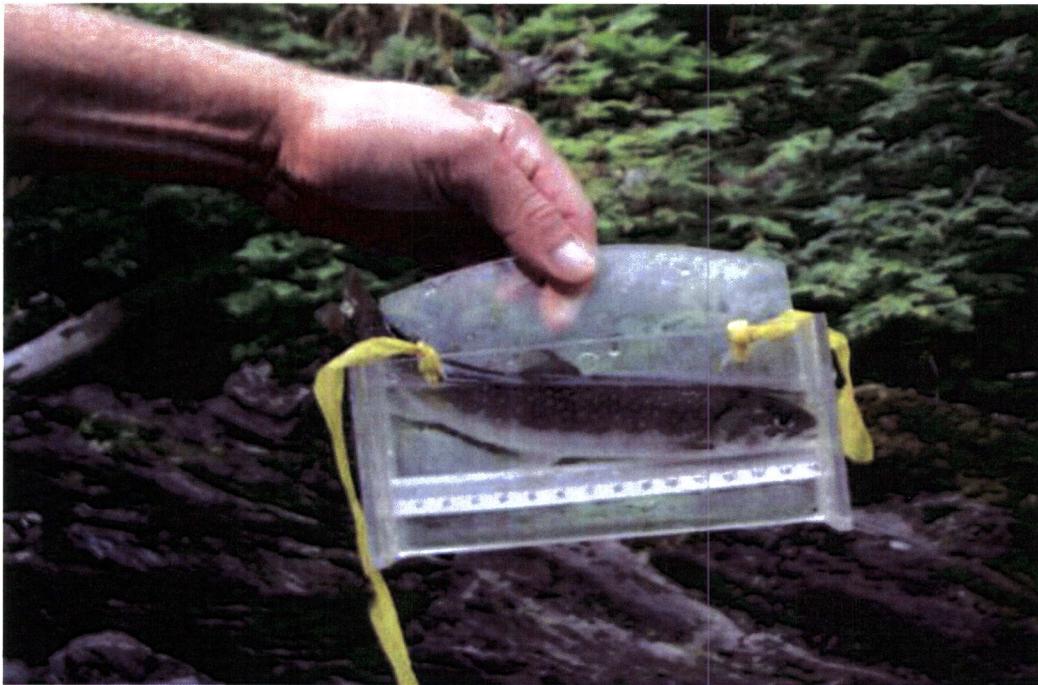
Figure 5. Dolly Varden captured in Stream No. 252-31-10010.

On the morning of July 25, Mr. Harris, Mr. Shults and I drove to the 230 Road and walked down Stream No. 252-31-10010. Timber on lands managed by Koniag Native Corporation will be harvested in the future and Mr. Harris requested the ADF&G confirm the presence of a barrier to fish passage exists below the proposed timber units. We located a barrier about 45-feet high 400 feet above Sapos Bay (Figure 4). We sampled the stream from Sapos Bay to the barrier. We captured 2 Dolly Varden (200-250 mm FL) (Figure 5). The Dolly Varden were captured in the tidally influenced reach and are likely anadromous. I used a hand-held Garmin GPS to correct the specified location of the stream and the location of the barrier. The correct stream location will be nominated for update to the Anadromous Waters Catalog. The Dolly Varden will be nominated to the Anadromous Waters Catalog.

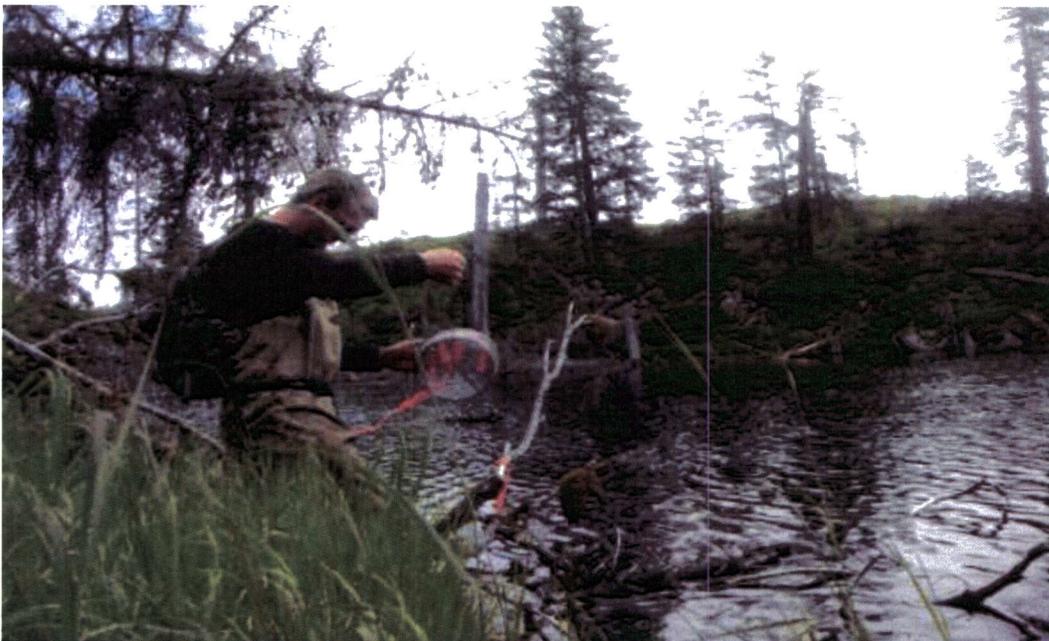
Figure 6. Recovering a minnow trap from the unnamed lake above Stream No. 252-32-10010-2019-3012.

On the morning of July 26, we set two minnow traps in an unnamed lake located above the specified reach of Stream No. 252-32-10010-2019-3012. The traps soaked about 3 hours (Figure 6). The traps captured two Dolly Varden. No length measurement was taken for the Dolly Varden. A 5-foot high beaver dam was located at the lake outlet. We set one minnow trap in Stream No. 252-32-10010-2019-3012. The trap soaked about 3 hours. The trap captured 5 Dolly Varden (55-70 mm FL). I used a hand-held Garmin GPS to correct the specified location of the stream. The correct stream location will be nominated for update to the Anadromous Waters Catalog.

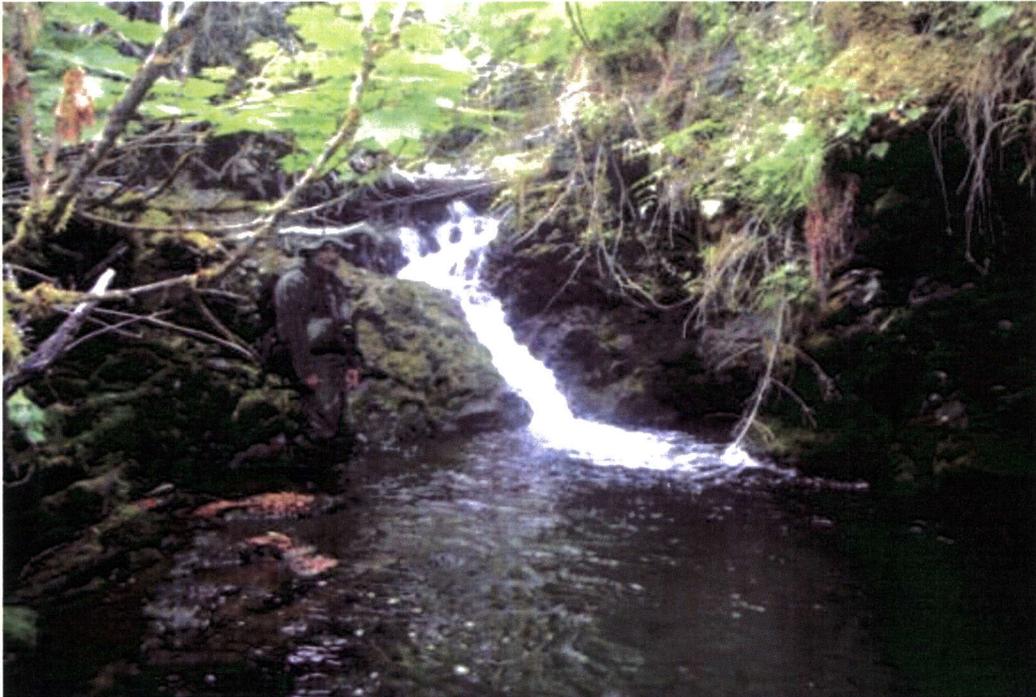
Figure 7. Barrier in Stream No. 252-32-10010-2019. View looking upstream.

We walked to Stream No. 252-32-10010-2019. We set one minnow trap in the stream. The trap soaked about 2 hours. The trap captured 3 juvenile coho salmon (45-70 mm FL). We observed about 1,000 Dolly Varden in the stream. We walked upstream and located a 7-foot high barrier about 0.9 miles above Little Afognak Lake (Figure 7). We walked downstream through heavy blow-down trees to Little Afognak Lake (Figure 8). I used a hand-held Garmin GPS to correct the specified location of the stream and the location of the barrier. The correct stream location and barrier location will be nominated for update to the Anadromous Waters Catalog.

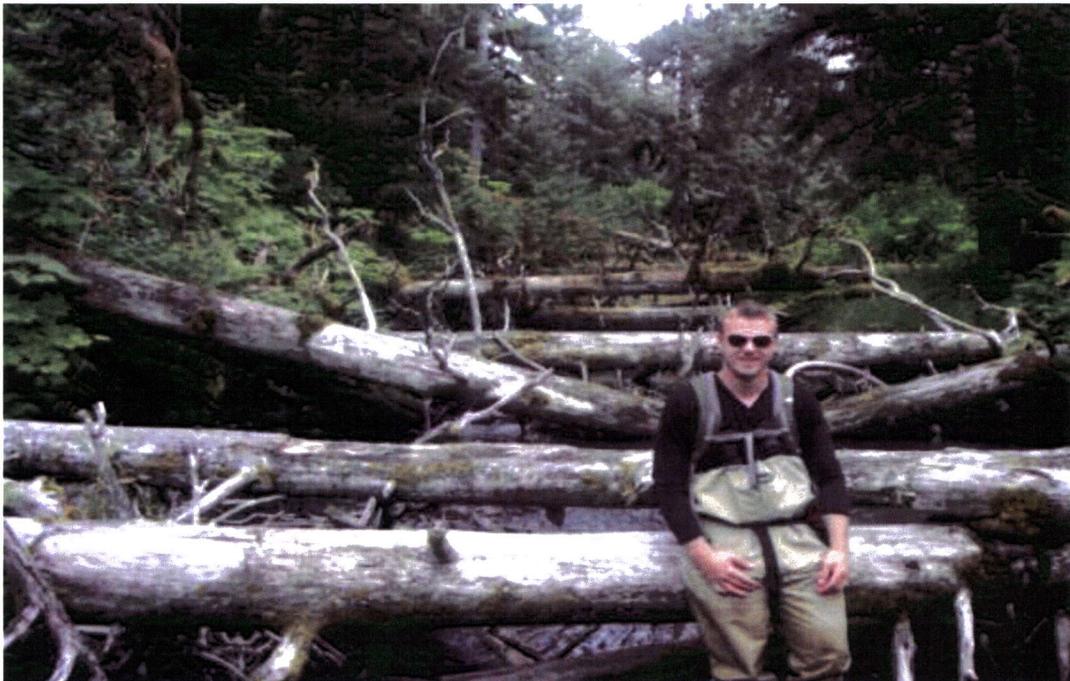
Figure 8. Blow-down trees in Stream No. 252-32-10010-2019. View looking upstream.
