Nomination Form  
Anadromous Waters Catalog

Region Southwest USGS Quad(s) Afognak A-2, A-2 NE  
 Anadromous Waters Catalog Number of Waterway 251-82-10050-2031  
 Name of Waterway Unnamed Tributary Upper Portage Lake  USGS Name  Local Name  
 Addition  Deletion  Correction  Backup Information

SUBJECT: AKSSF AWC Survey: Afognak Island  
September 2015

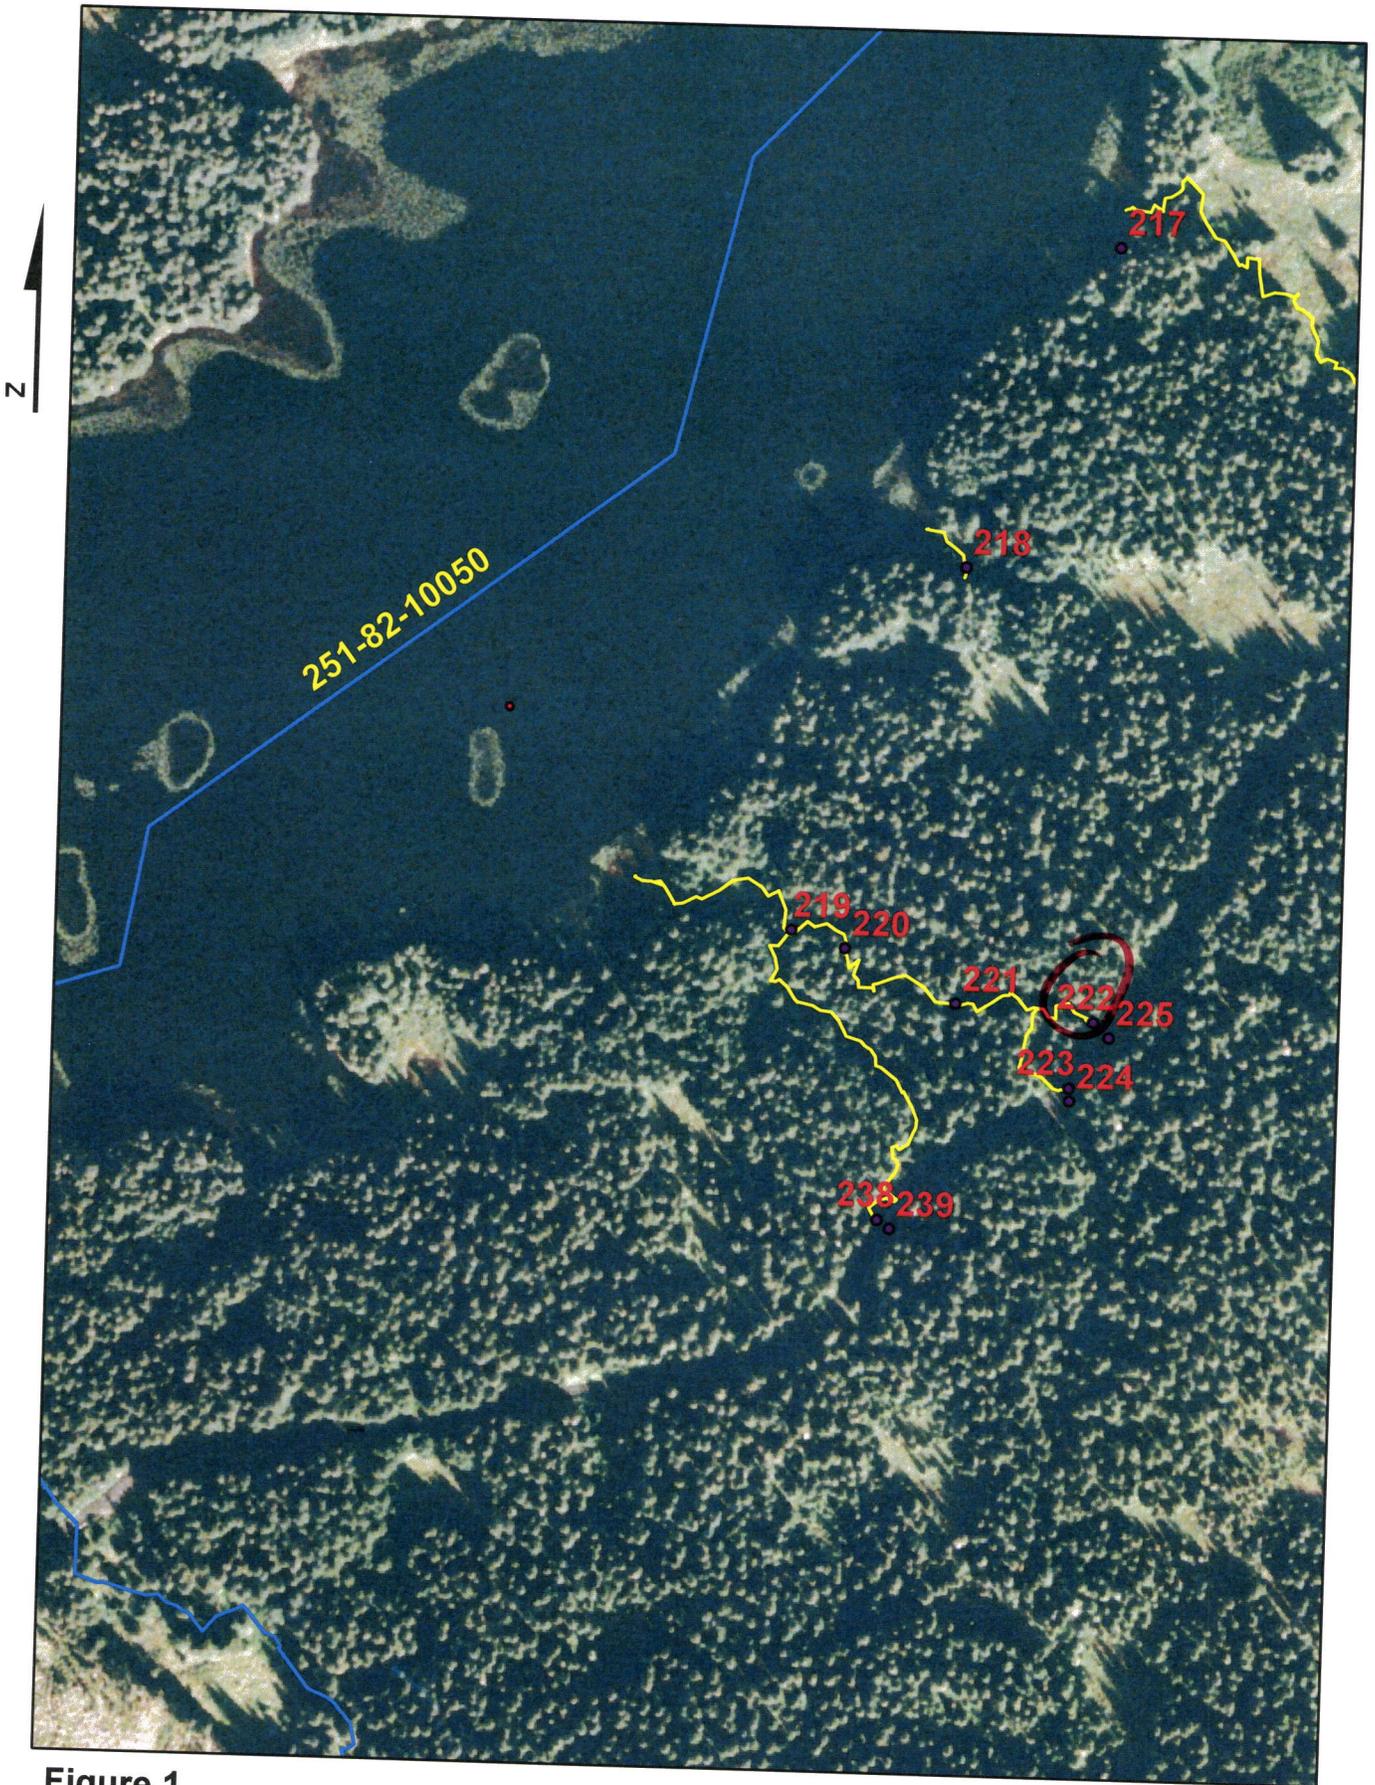
Figure 1

During an joint Koncor and ADF&G AKSSF stream survey, I used an electrofisher to capture juvenile coho salmon in an unnamed tributary to Upper Portage Lake (IDENT 222) (Figure 1). See the September 11-13, 2015 trip report.

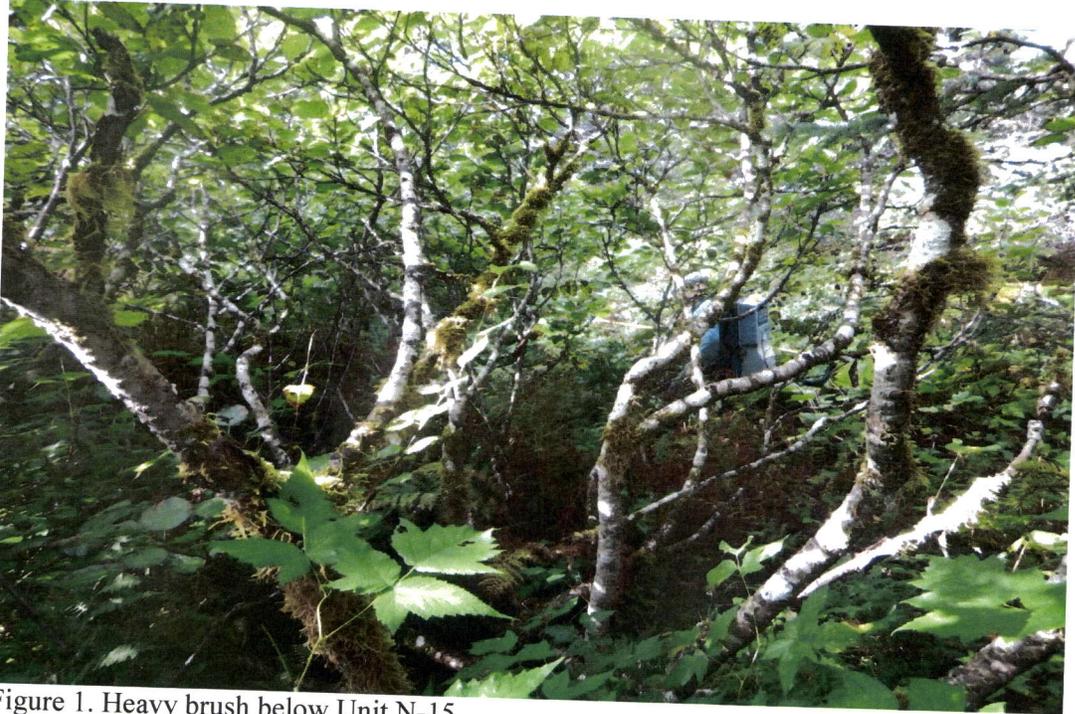
We drove to the 300 Road and walked into Unit N-15. The unit is on land managed by Koncor. We used an electrofisher to sample an unnamed tributary to the upper reach of Stream No. 251-82-10052 located above the 1100 Road. The stream flows through the unit into an old harvest unit that was cut in the 1970s. The brush and regenerated trees made sampling difficult (Figure 1). We located an old spur road that has caused the stream to flow subsurface, blocking fish passage (Figure 2). The ADF&G will work with Koncor to open the road for fish passage. Below the road, we captured 10 Dolly Varden (50-75 mm FL). We plan to re-sample the unnamed tributary in October 2015.

Figure 1. Heavy brush below Unit N-15.

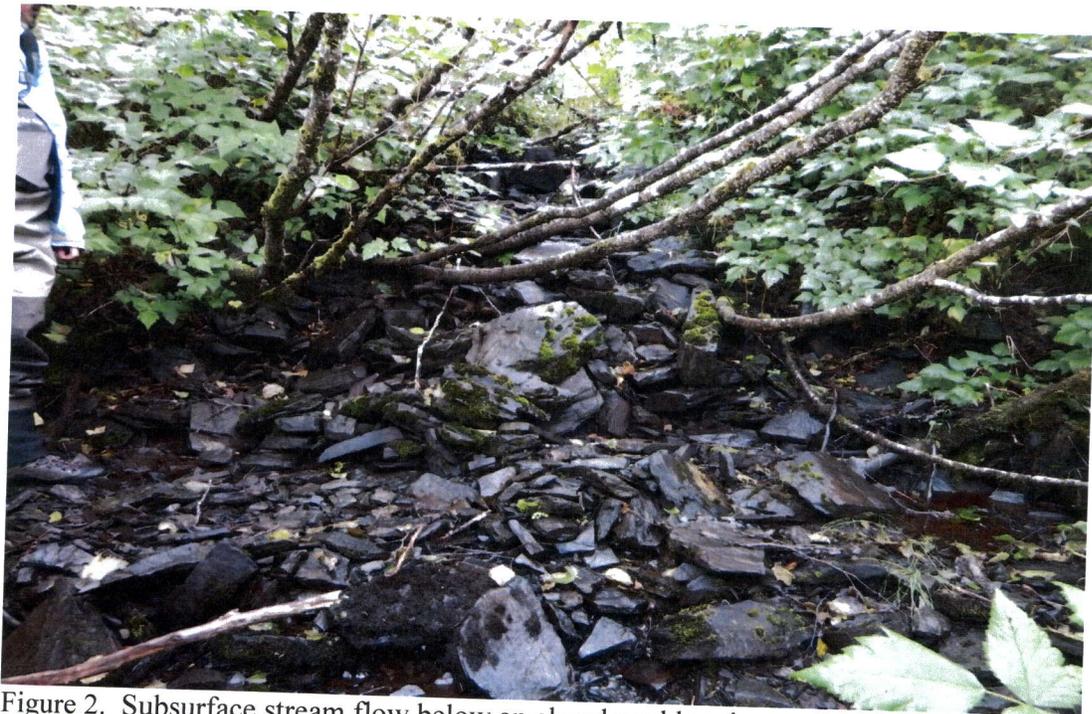
Figure 2. Subsurface stream flow below an abandoned logging road.

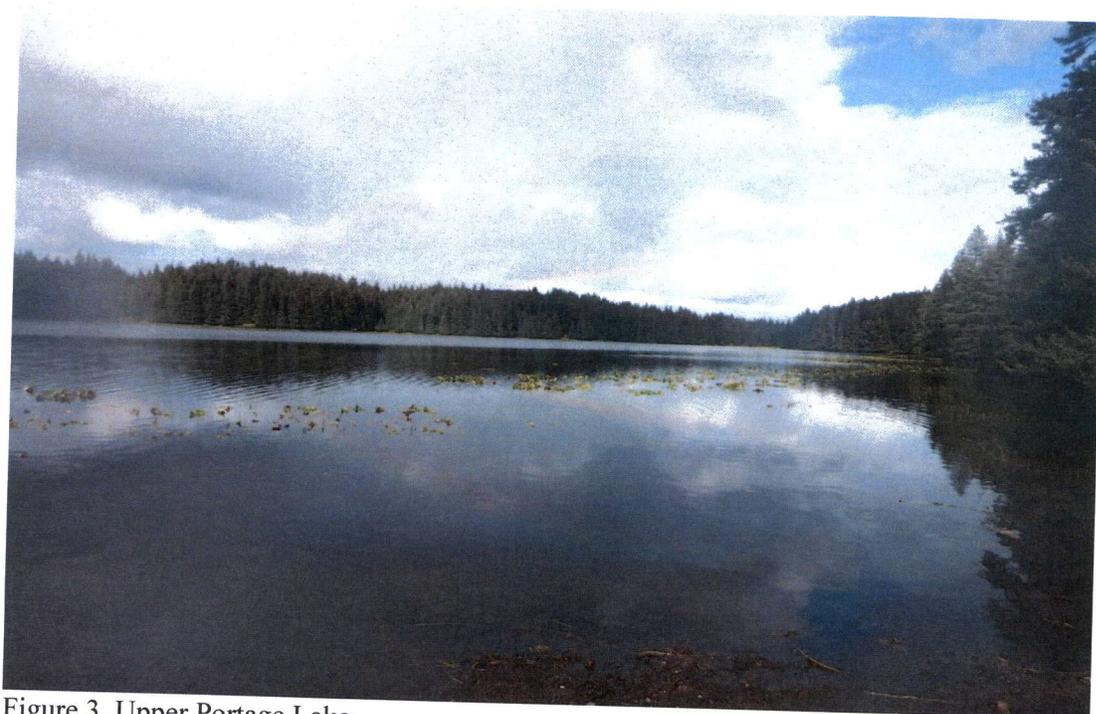
We drove the 1100 Road to MP 10. We sampled about 375 meters of an unnamed stream below the 1100 Road to Upper Portage Lake (Lake No. 251-82-10050-0020) (Figure 3). We captured 15 Dolly Varden (55-100 mm FL).

Figure 3. Upper Portage Lake.

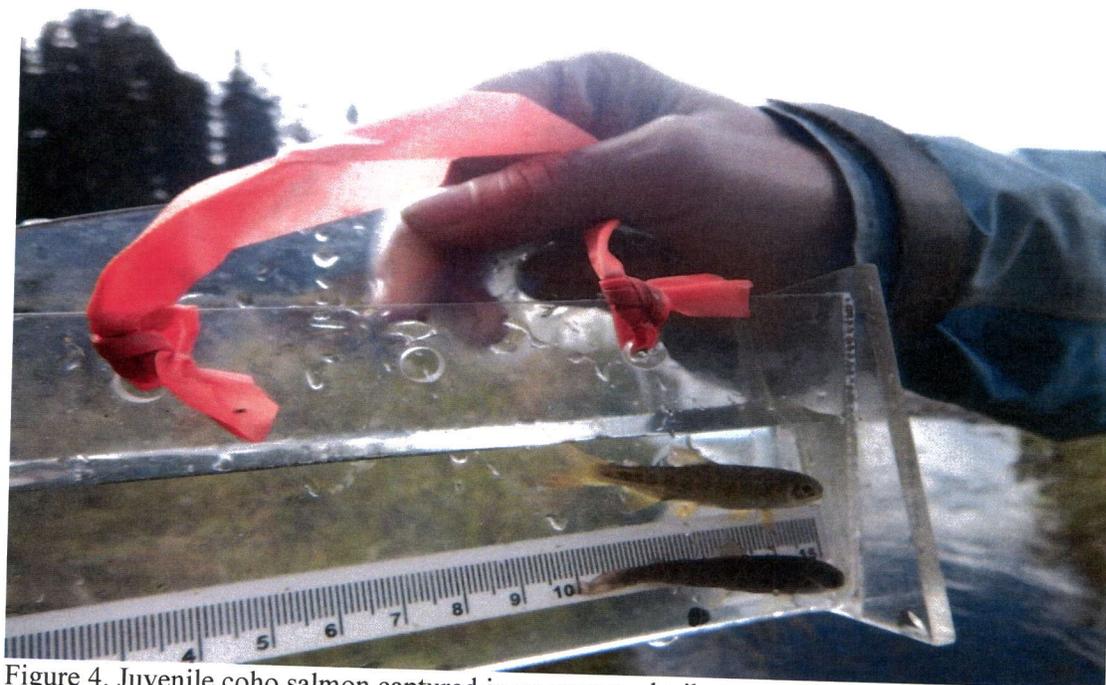
We continued walking south and located an additional unnamed stream. We sampled upstream about 400 meters to the 1100 Road MP 9.9. We captured about 30 juvenile coho salmon and measured 10 fish (50-70 mm FL) (Figure 4). We captured 10 Dolly Varden and measured 5 fish (45-100 mm FL). We ended our sampling at a perched culvert on the 1100 Road (Figure 5). The culvert is a barrier to fish passage and must be removed. The ADF&G will work with Koncor to schedule the removal of the culvert and installation of a log stringer bridge. The unnamed stream will be nominated to the Anadromous Waters Catalog.

Figure 4. Juvenile coho salmon captured in an unnamed tributary to Portage Lake.

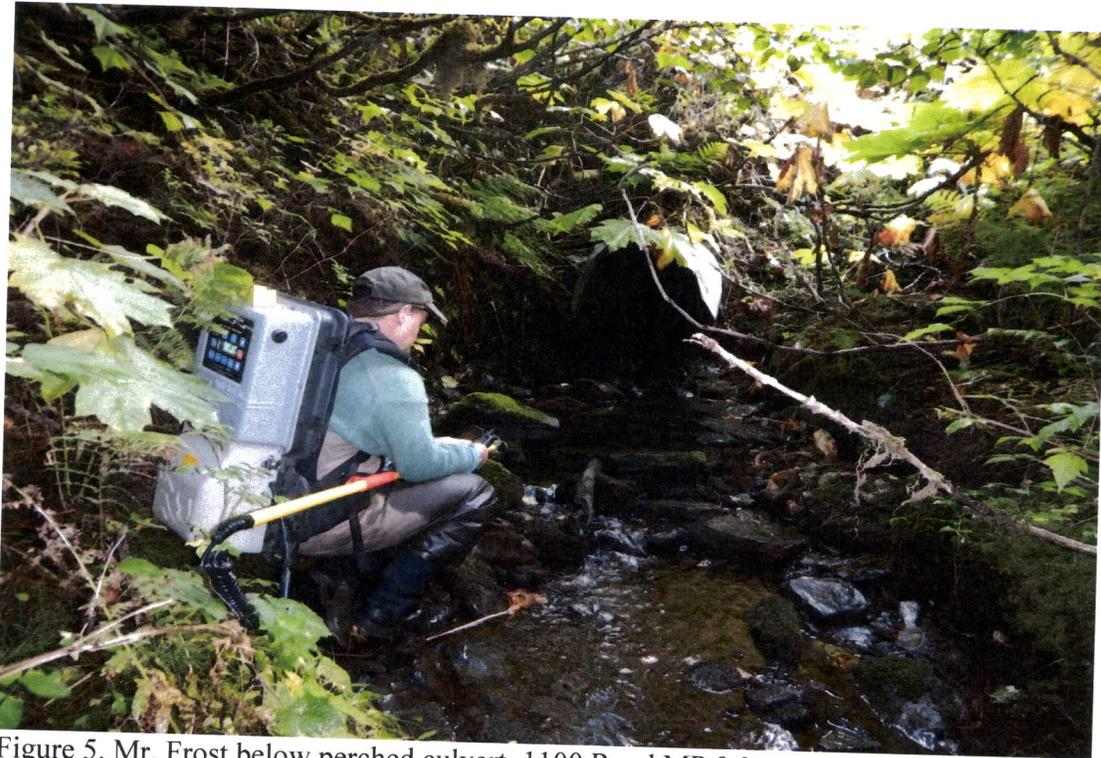
Figure 5. Mr. Frost below perched culvert, 1100 Road MP 9.9.

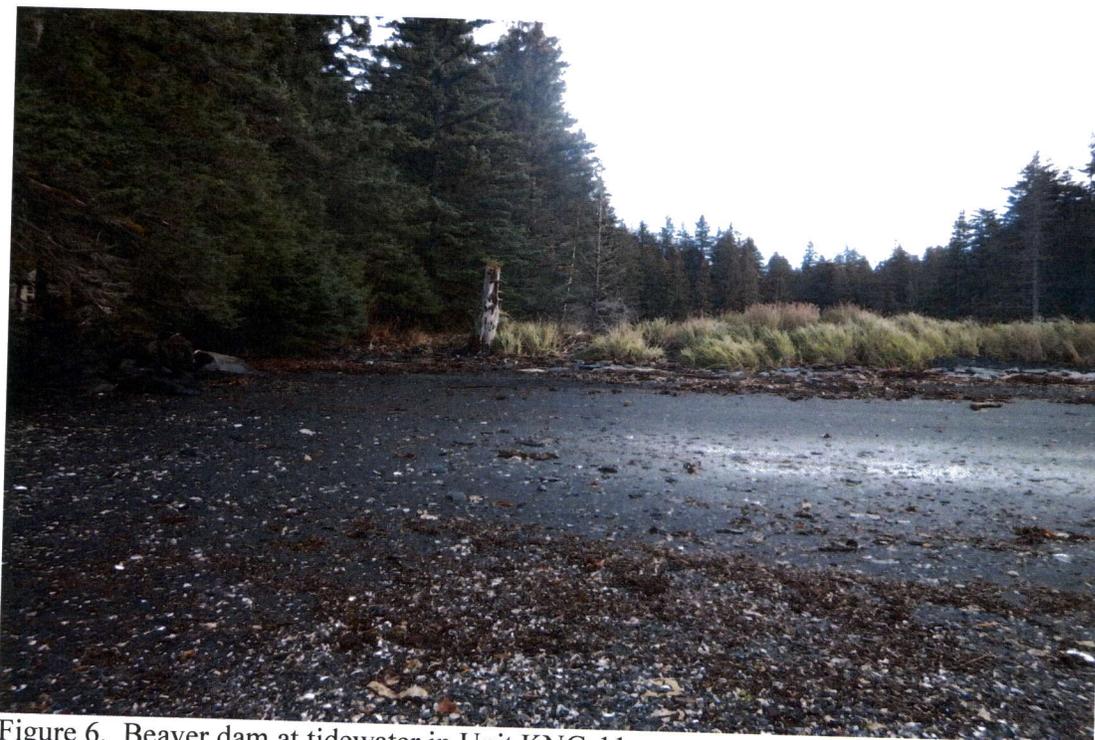
On the morning of September 12, Mr. Harris, Ms. Alas and I drove the 1100 Road to Unit KNG-11 on Discoverer Bay. The land is managed by Koniag. We walked to an unnamed stream and located a barrier to fish passage about 30 meters above a 5 acre beaver pond. A beaver dam is located at about mean high water level to Discoverer Bay (Figure 6). No defined stream channel exists below the beaver dam and no adult fish were observed below the beaver dam or in the lake. No riparian retention area will be required along the lake.

Figure 6. Beaver dam at tidewater in Unit KNG-11.

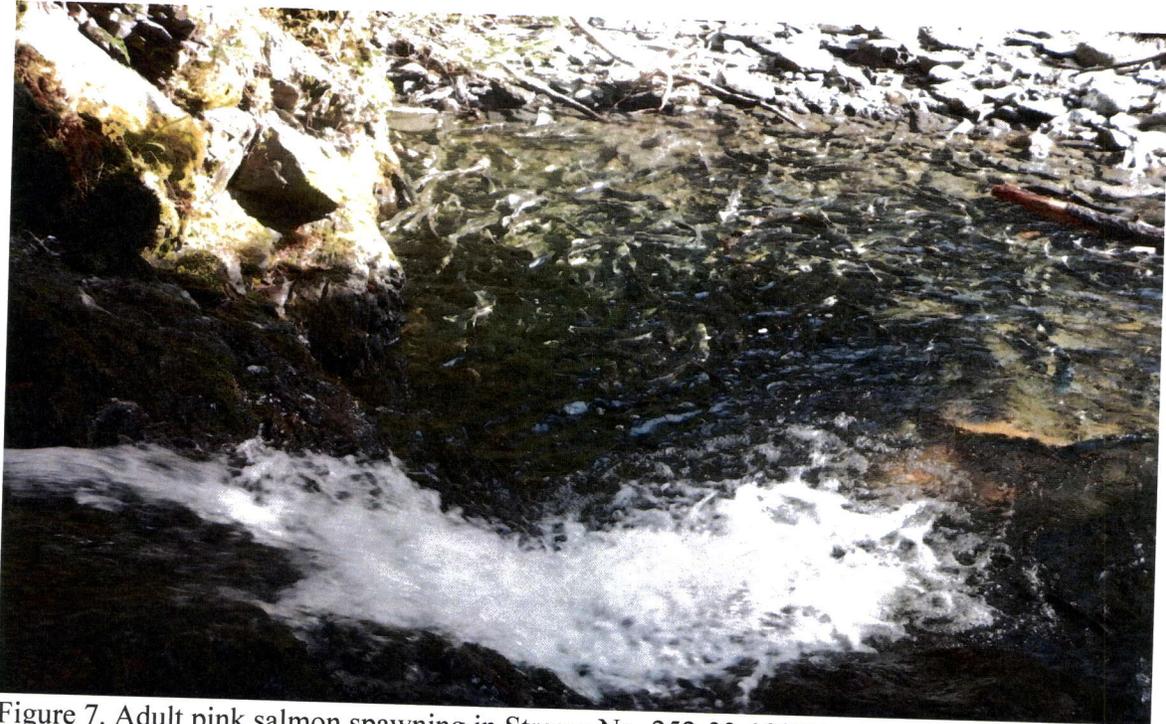
We drove to the 1110 Road to Stream No. 252-33-10025. The stream is on land managed by ANC. We walked about 200 meters below the 1110 Road and observed about 1,000 adult pink salmon spawning below a 4-foot high barrier (Figure 7). Fish were observed spawning in the stream about 120 meters below the barrier. We walked upstream to the 1110 Road and sampled above the road about 200 meters to a 30-foot high falls (Figure 8). I used a Garmin GPS to correct the location of the stream. No adult or juvenile fish were captured or observed above the 1110 Road. The spawning pink salmon, correct stream location, and barrier will be nominated for update to the Anadromous Waters Catalog.

Figure 7. Adult pink salmon spawning in Stream No. 252-33-10025.

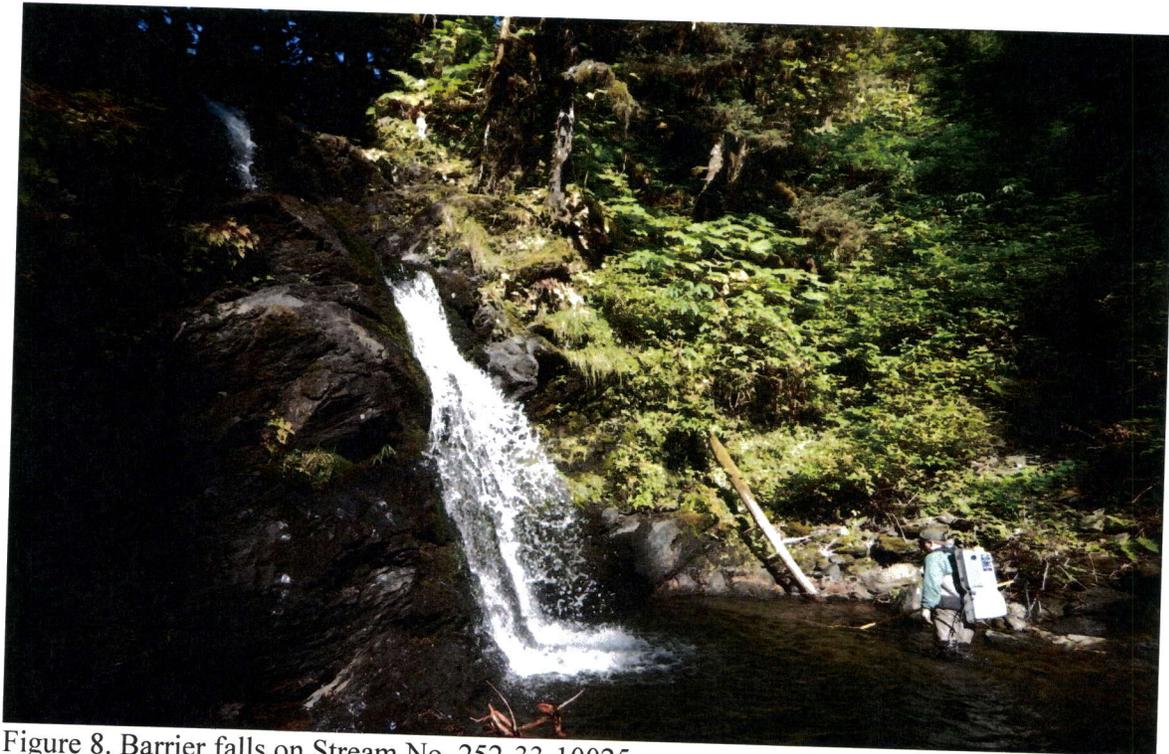
Figure 8. Barrier falls on Stream No. 252-33-10025.

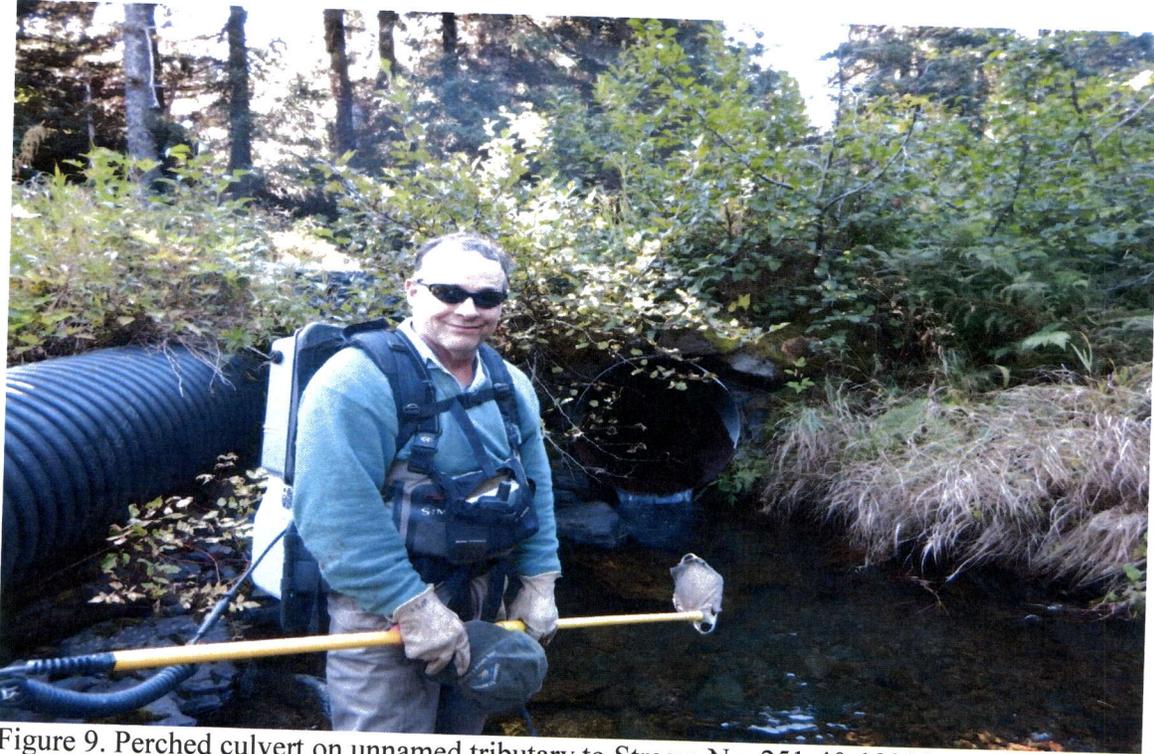
We drove the 1110 Road to MP 10.2. We sampled an unnamed tributary to Stream No. 251-40-10030. The stream is on land managed by ANC. We captured 4 juvenile coho salmon (70-100 mm FL) below a perched culvert (Figure 9). About 250 meters below the 1110 Road we located an abandoned log stringer bridge (Figure 10). The bridge is overgrown with alder. The bridge must be removed. The ADF&G will work with ANC to schedule the removal of the log stringer

Figure 9. Perched culvert on unnamed tributary to Stream No. 251-40-10030.

bridge. We sampled an additional 230 meters of the stream above the 1110 Road. We captured 5 juvenile coho salmon (55-110 mm FL). We captured 10 Dolly Varden (40-110 mm FL). The culvert is a partial barrier to fish passage and must be removed. The ADF&G will work with ANC to schedule the removal of the culvert and installation of a log stringer bridge.

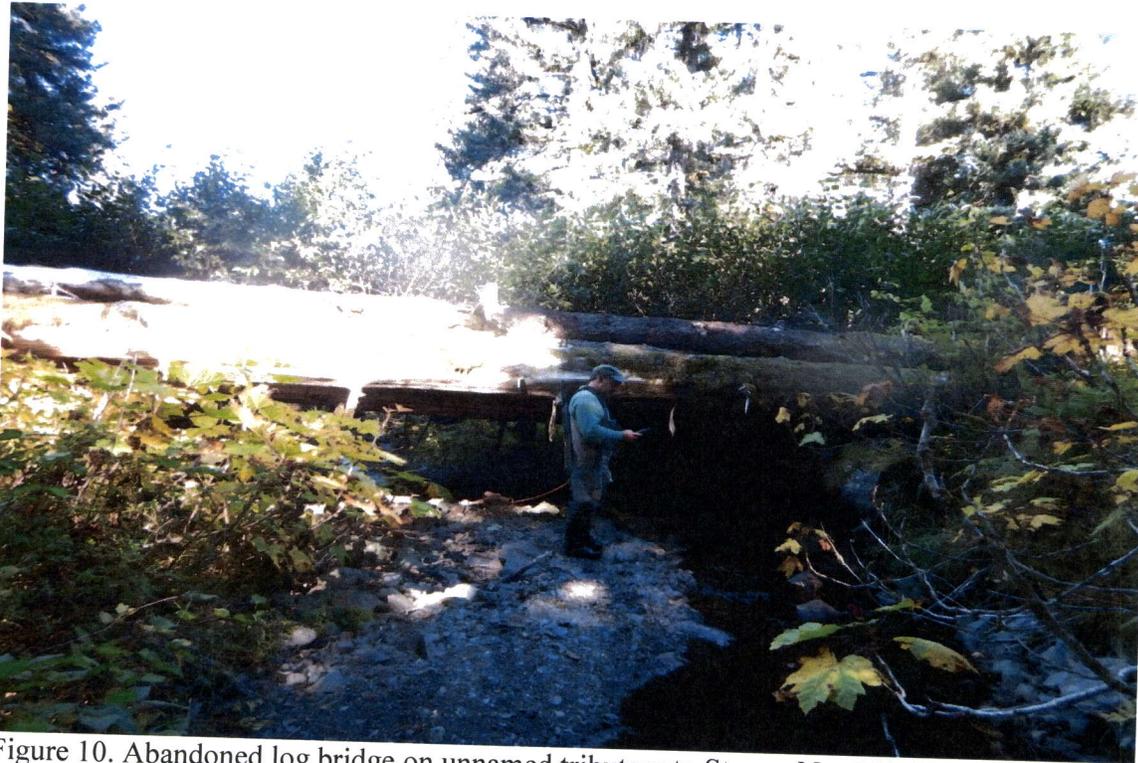
Figure 10. Abandoned log bridge on unnamed tributary to Stream No. 251-40-10030.

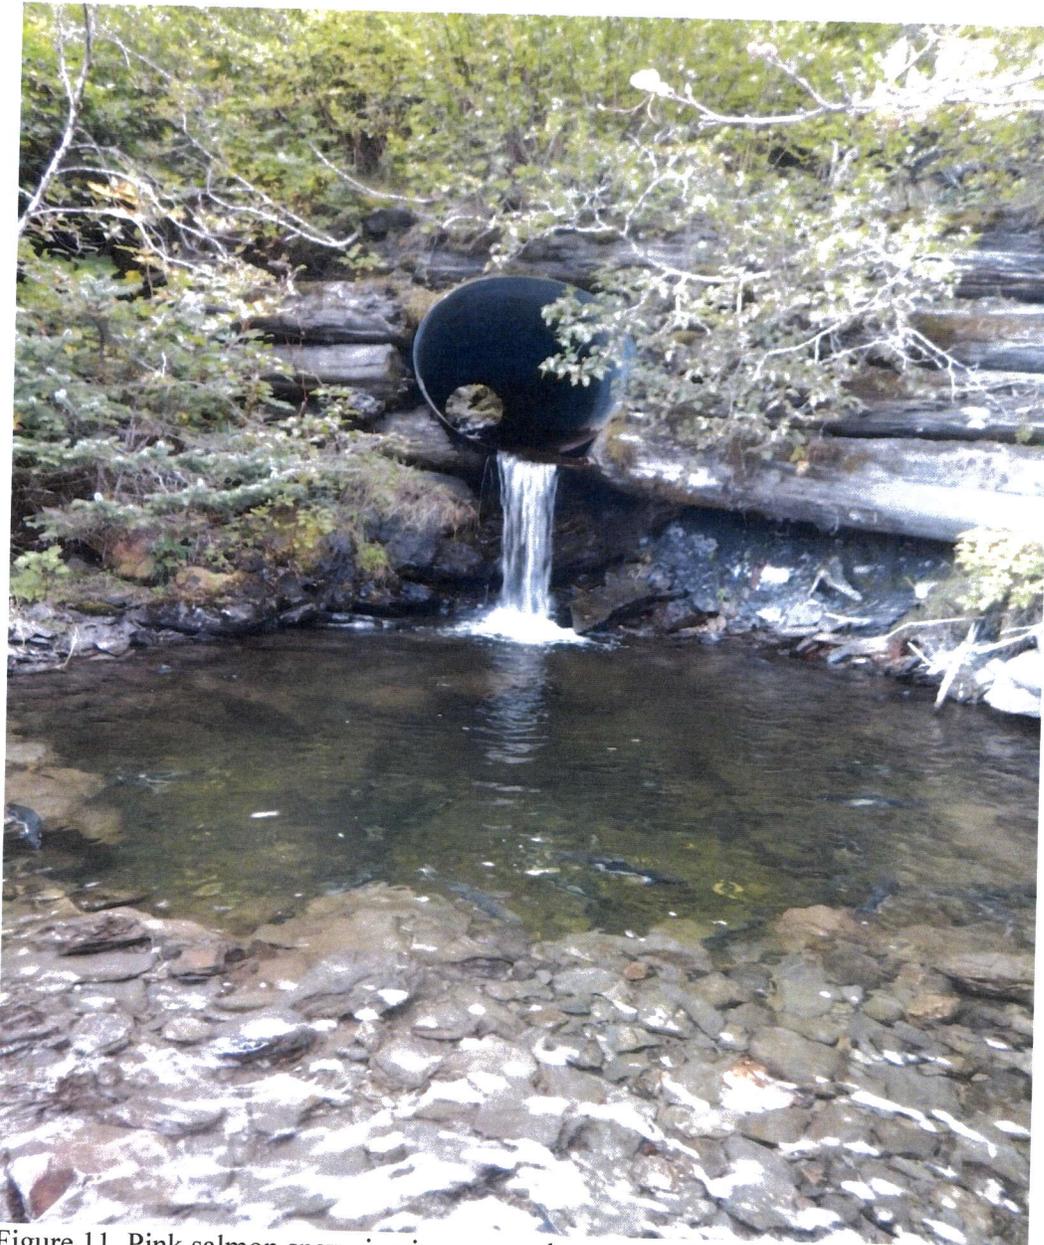
On the morning of September 13, Ms. Alas and I located about 40 adult pink salmon spawning in an unnamed stream located in the ANC camp. The salmon were below a perched culvert located on a camp road (Figure 11). The culvert is directly below a natural barrier. The pink salmon will be nominated to the Anadromous Waters Catalog.

Figure 11. Pink salmon spawning in unnamed stream in ANC camp.

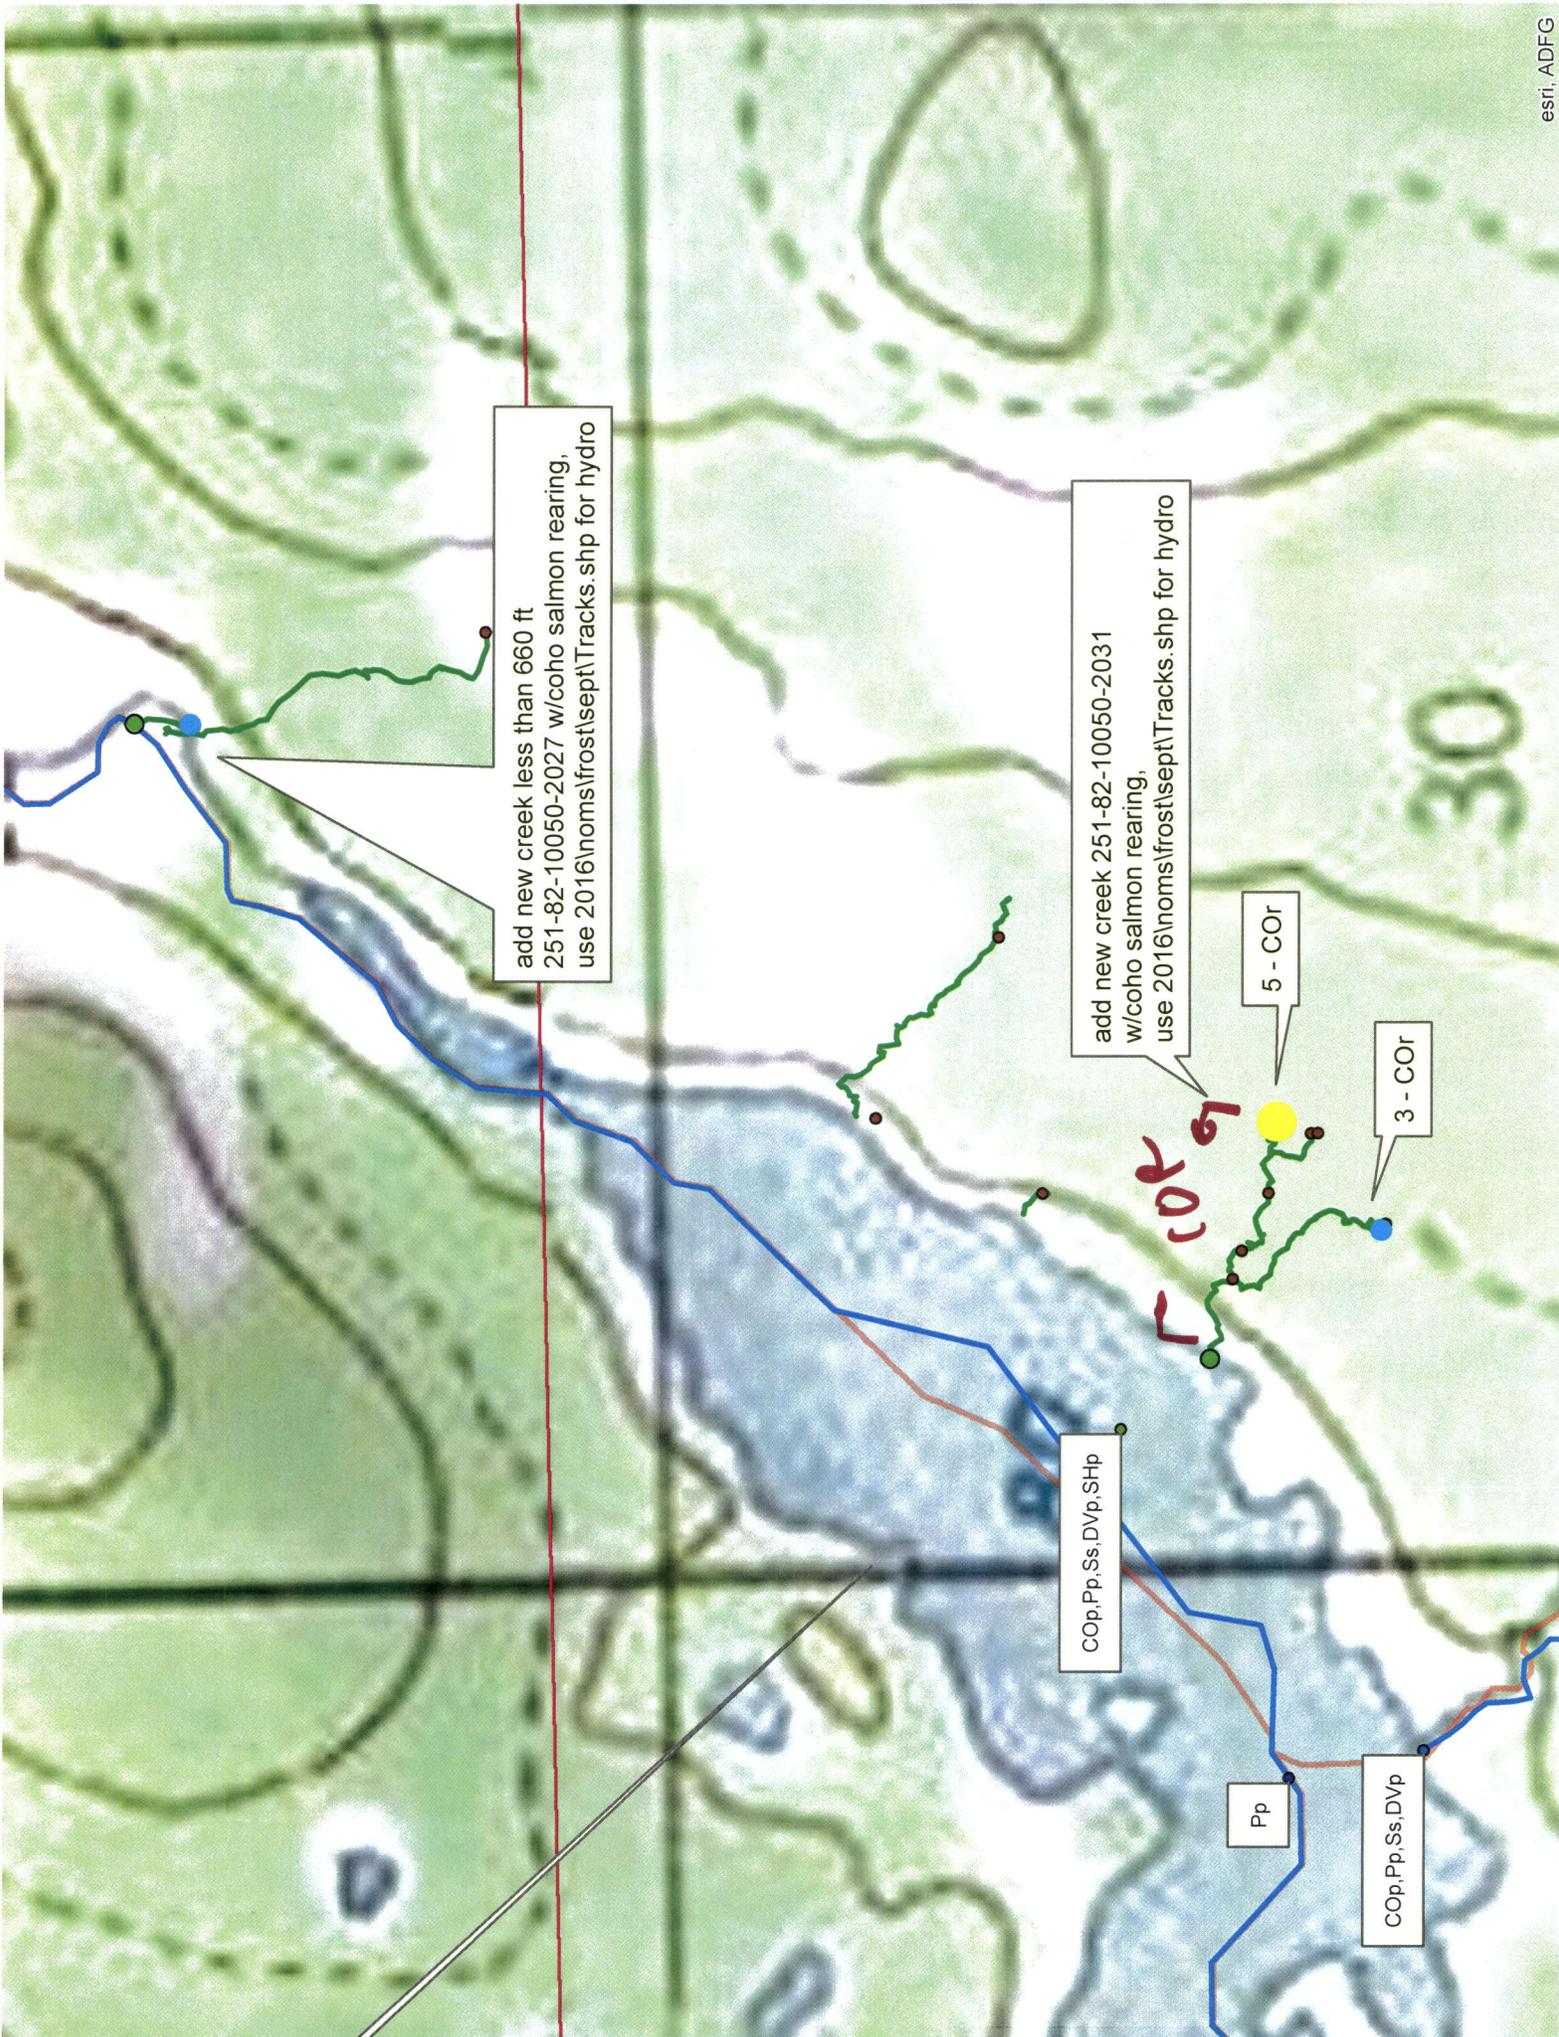
add new creek less than 660 ft  
251-82-10050-2027 w/coho salmon rearing,  
use 2016\noms\frost\sept\Tracks.shp for hydro

add new creek 251-82-10050-2031  
w/coho salmon rearing,  
use 2016\noms\frost\sept\Tracks.shp for hydro
