State of Alaska  
Department of Fish and Game  
Division of Sport Fish

Nomination Form  
Anadromous Waters Catalog

During an joint ANC and ADF&G AKSSF stream survey, we observed adult pink salmon spawning in an unnamed stream in the ANC camp (IDENT 234) (Figure 1). See the September 11-13, 2015 trip report.  
Add new stream ≤ 660ft w/ pink salmon spawning

SUBJECT: AKSSF AWC Survey: Afognak Island  
September 2015

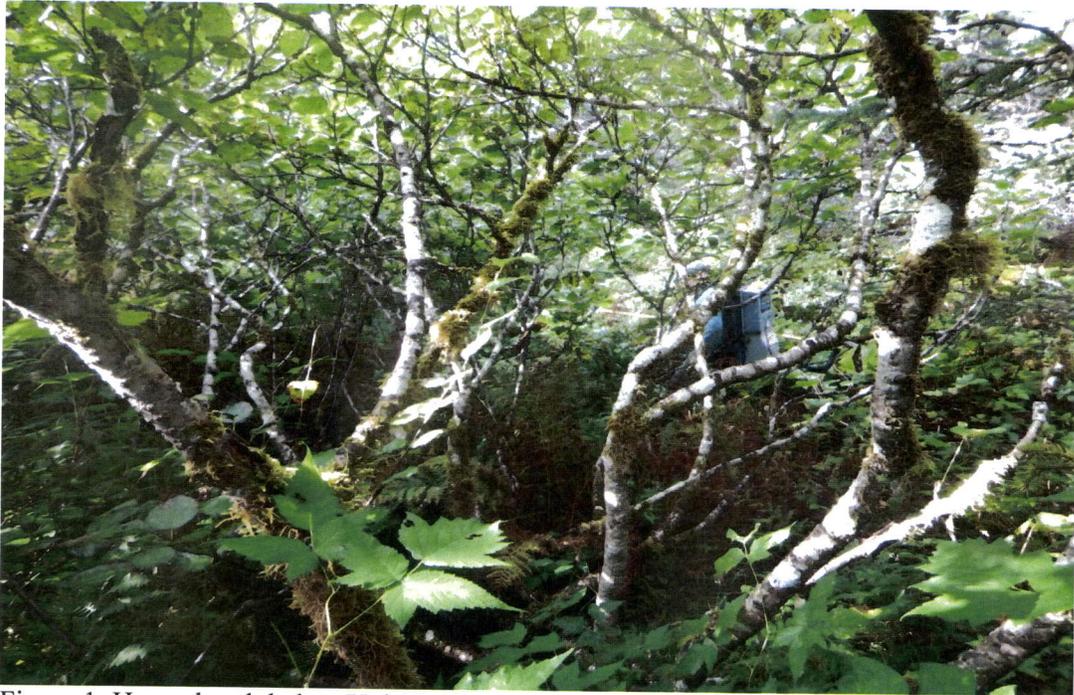
We drove to the 300 Road and walked into Unit N-15. The unit is on land managed by Koncor. We used an electrofisher to sample an unnamed tributary to the upper reach of Stream No. 251-82-10052 located above the 1100 Road. The stream flows through the unit into an old harvest unit that was cut in the 1970s. The brush and regenerated trees made sampling difficult (Figure 1). We located an old spur road that has caused the stream to flow subsurface, blocking fish passage (Figure 2). The ADF&G will work with Koncor to open the road for fish passage. Below the road, we captured 10 Dolly Varden (50-75 mm FL). We plan to re-sample the unnamed tributary in October 2015.

Figure 1. Heavy brush below Unit N-15.

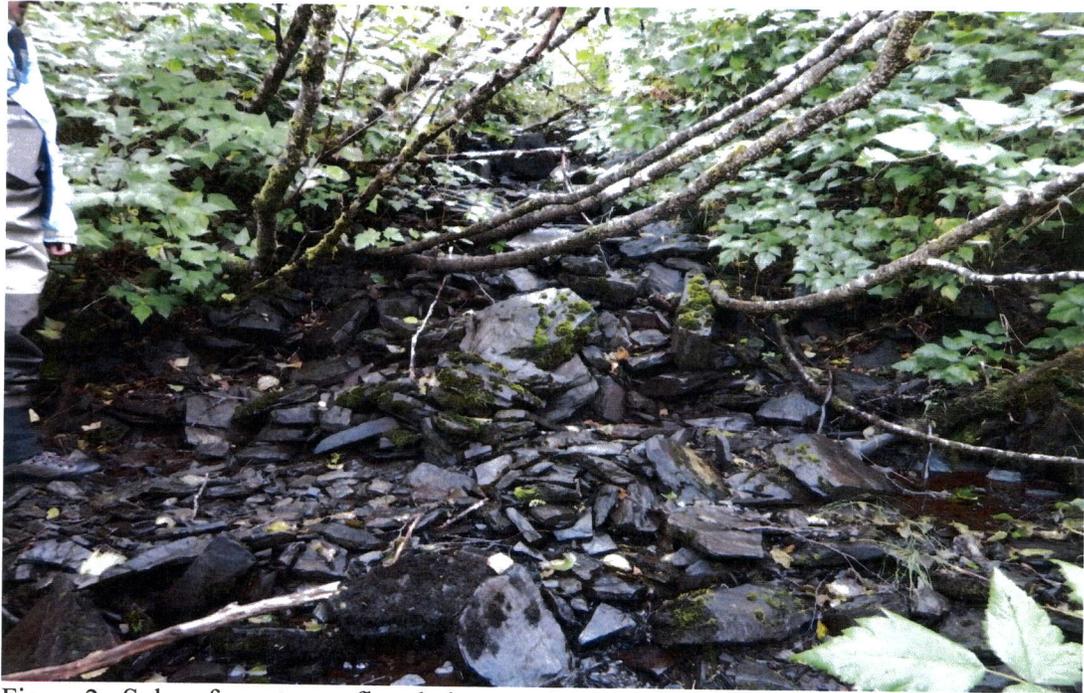
Figure 2. Subsurface stream flow below an abandoned logging road.

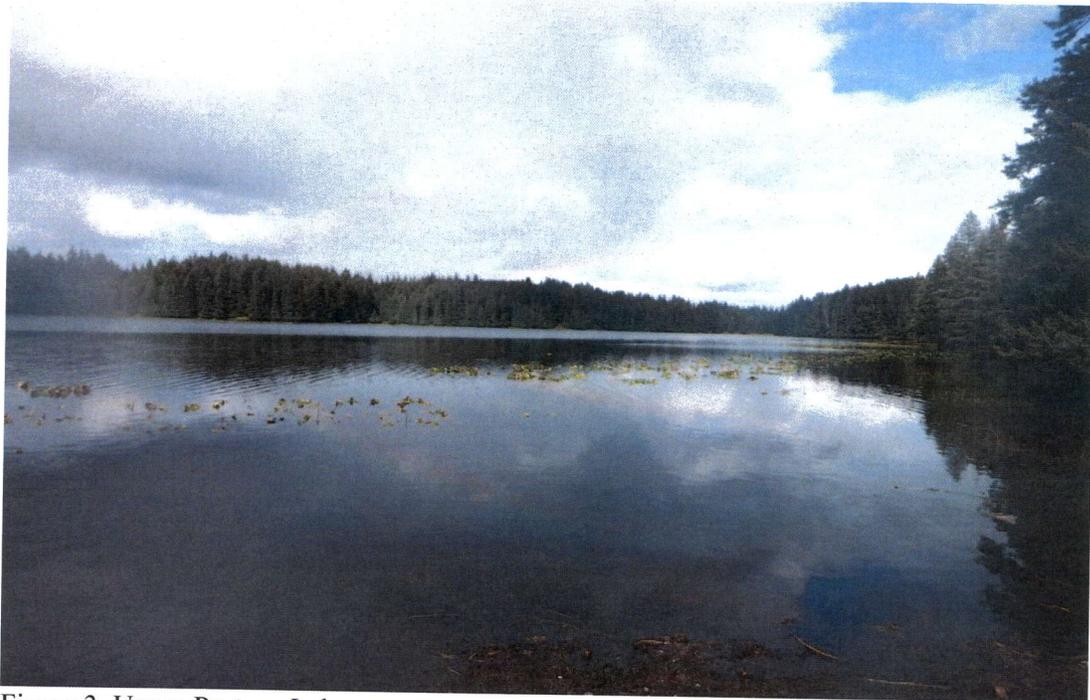
We drove the 1100 Road to MP 10. We sampled about 375 meters of an unnamed stream below the 1100 Road to Upper Portage Lake (Lake No. 251-82-10050-0020) (Figure 3). We captured 15 Dolly Varden (55-100 mm FL).

At Upper Portage Lake, we captured 3 juvenile coho salmon (55-65 mm FL) in the lake. We observed about an additional 100 fish. The rearing coho salmon will be nominated for update to the Anadromous Waters Catalog.

Figure 3. Upper Portage Lake.

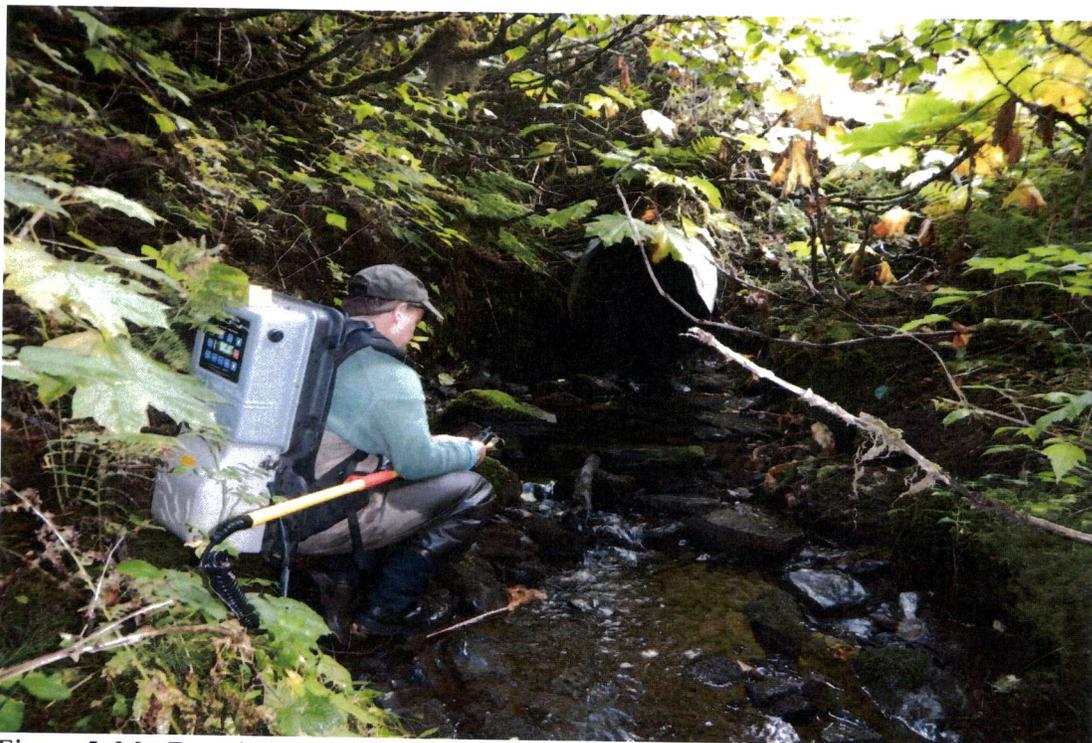
We continued walking south and located an additional unnamed stream. We sampled upstream about 400 meters to the 1100 Road MP 9.9. We captured about 30 juvenile coho salmon and measured 10 fish (50-70 mm FL) (Figure 4). We captured 10 Dolly Varden and measured 5 fish (45-100 mm FL). We ended our sampling at a perched culvert on the 1100 Road (Figure 5). The culvert is a barrier to fish passage and must be removed. The ADF&G will work with Koncor to schedule the removal of the culvert and installation of a log stringer bridge. The unnamed stream will be nominated to the Anadromous Waters Catalog.

Figure 5. Mr. Frost below perched culvert, 1100 Road MP 9.9.

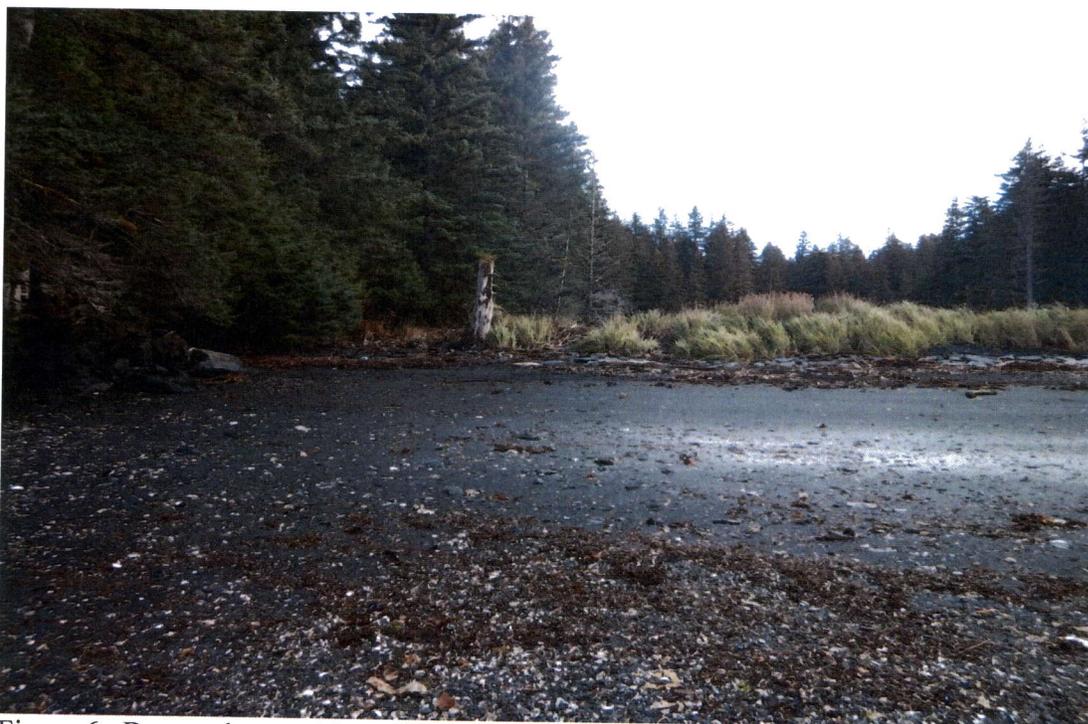
On the morning of September 12, Mr. Harris, Ms. Alas and I drove the 1100 Road to Unit KNG-11 on Discoverer Bay. The land is managed by Koniag. We walked to an unnamed stream and located a barrier to fish passage about 30 meters above a 5 acre beaver pond. A beaver dam is located at about mean high water level to Discoverer Bay (Figure 6). No defined stream channel exists below the beaver dam and no adult fish were observed below the beaver dam or in the lake. No riparian retention area will be required along the lake.

Figure 6. Beaver dam at tidewater in Unit KNG-11.

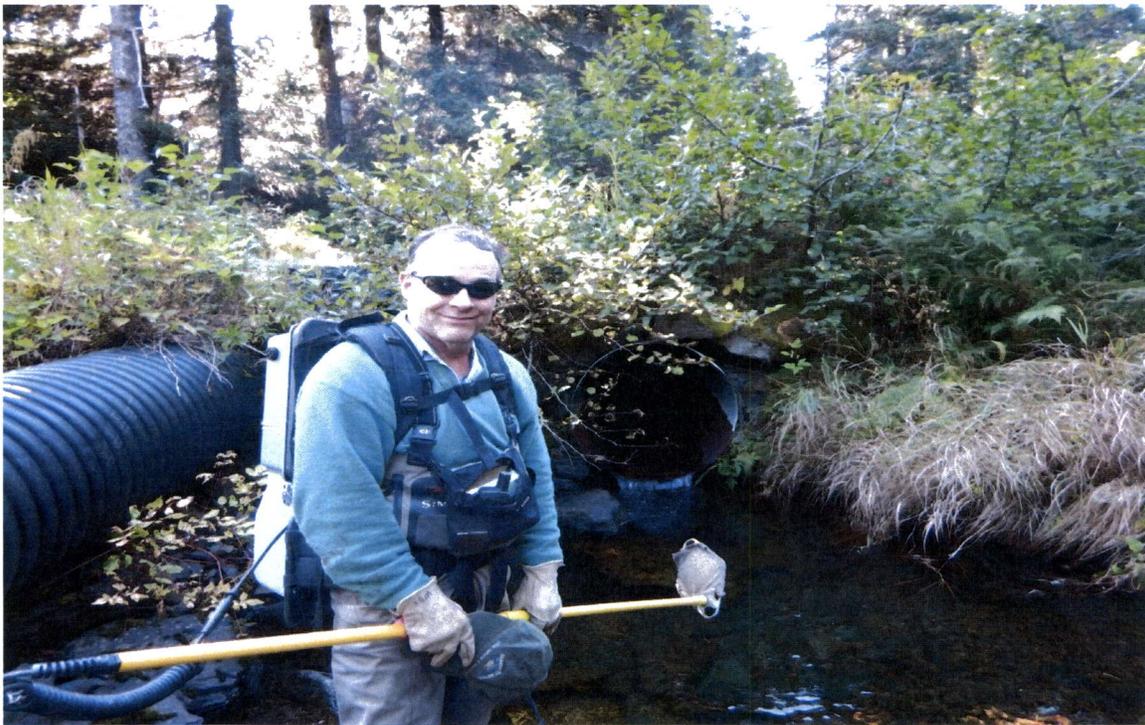
We drove the 1110 Road to MP 10.2. We sampled an unnamed tributary to Stream No. 251-40-10030. The stream is on land managed by ANC. We captured 4 juvenile coho salmon (70-100 mm FL) below a perched culvert (Figure 9). About 250 meters below the 1110 Road we located an abandoned log stringer bridge (Figure 10). The bridge is overgrown with alder. The bridge must be removed. The ADF&G will work with ANC to schedule the removal of the log stringer

Figure 9. Perched culvert on unnamed tributary to Stream No. 251-40-10030.

bridge. We sampled an additional 230 meters of the stream above the 1110 Road. We captured 5 juvenile coho salmon (55-110 mm FL). We captured 10 Dolly Varden (40-110 mm FL). The culvert is a partial barrier to fish passage and must be removed. The ADF&G will work with ANC to schedule the removal of the culvert and installation of a log stringer bridge.

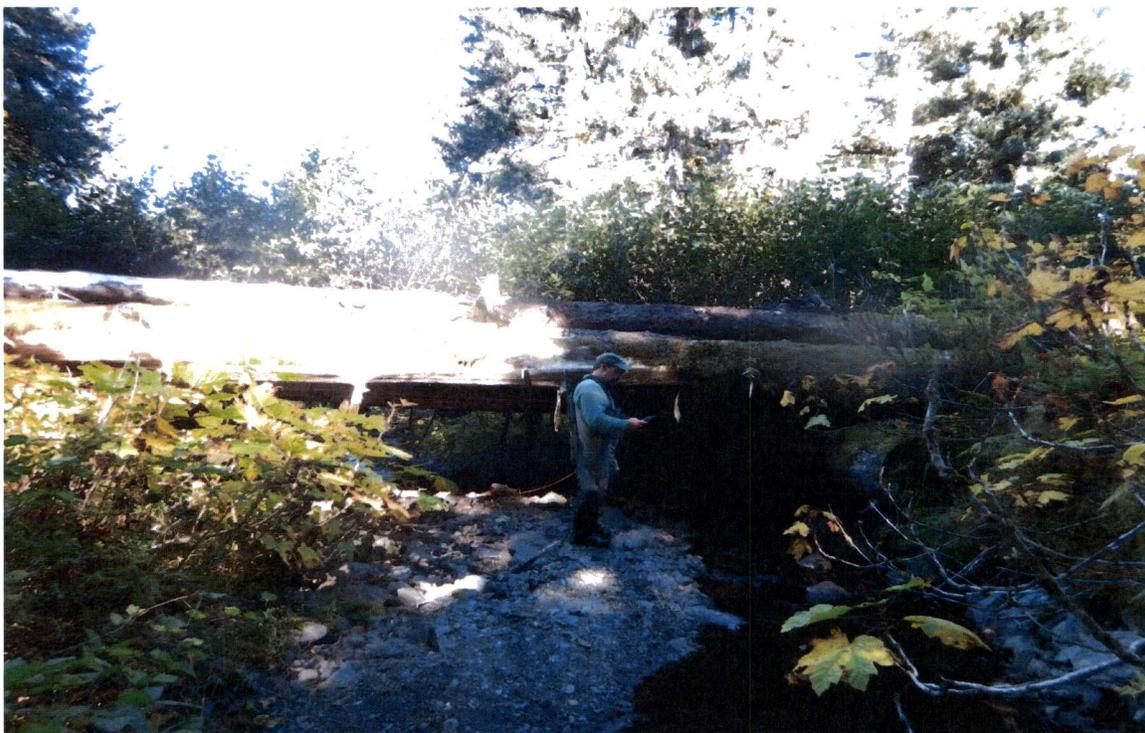
Figure 10. Abandoned log bridge on unnamed tributary to Stream No. 251-40-10030.

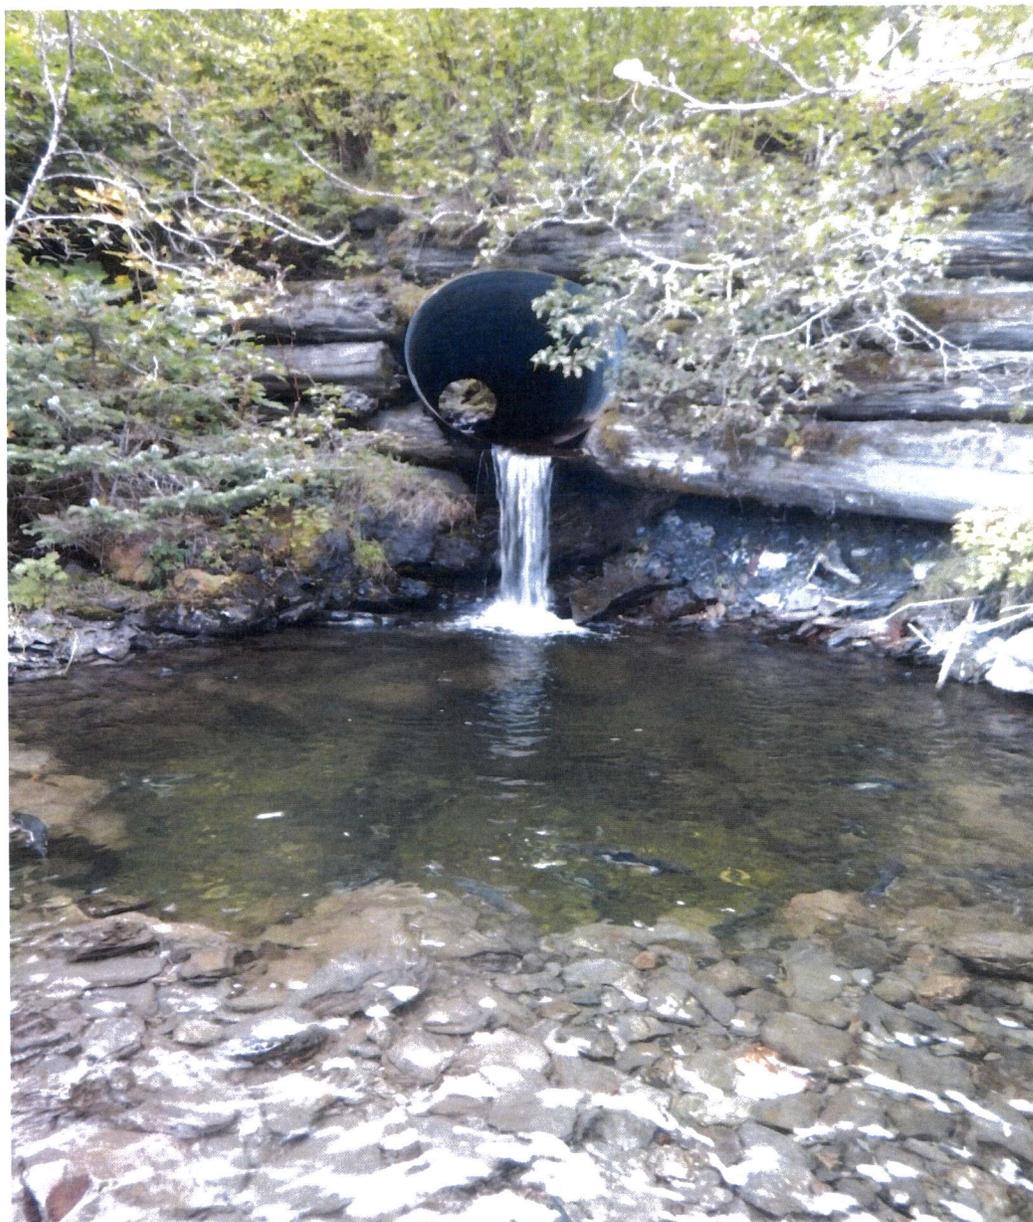
On the morning of September 13, Ms. Alas and I located about 40 adult pink salmon spawning in an unnamed stream located in the ANC camp. The salmon were below a perched culvert located on a camp road (Figure 11). The culvert is directly below a natural barrier. The pink salmon will be nominated to the Anadromous Waters Catalog.

Figure 11. Pink salmon spawning in unnamed stream in ANC camp.
