State of Alaska  
Department of Fish and Game  
Division of Sport Fish

Nomination Form  
Anadromous Waters Catalog

Region Southwest USGS Quad(s) Afognak A-2 A-2NW  
 Anadromous Waters Catalog Number of Waterway 252-33-10043  
 Name of Waterway Unnamed Stream ANC Camp  USGS Name  Local Name  
 Addition  Deletion  Correction  Backup Information

SUBJECT: AKSSF AWC Survey: Afognak Island  
September 2015

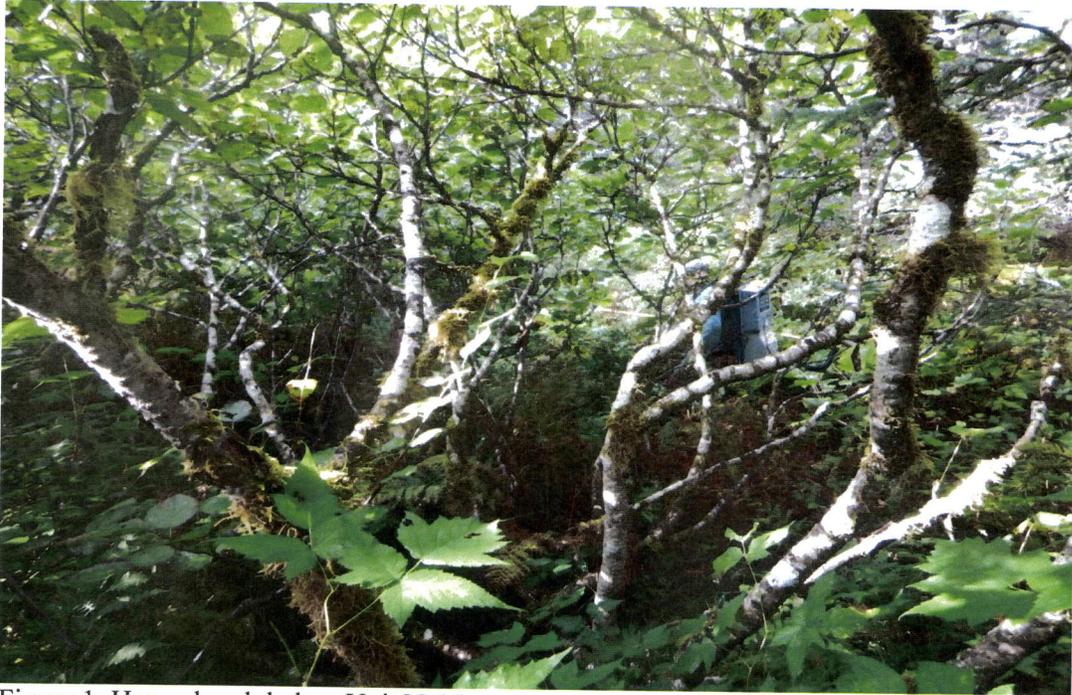
We drove to the 300 Road and walked into Unit N-15. The unit is on land managed by Koncor. We used an electrofisher to sample an unnamed tributary to the upper reach of Stream No. 251-82-10052 located above the 1100 Road. The stream flows through the unit into an old harvest unit that was cut in the 1970s. The brush and regenerated trees made sampling difficult (Figure 1). We located an old spur road that has caused the stream to flow subsurface, blocking fish passage (Figure 2). The ADF&G will work with Koncor to open the road for fish passage. Below the road, we captured 10 Dolly Varden (50-75 mm FL). We plan to re-sample the unnamed tributary in October 2015.

Figure 1. Heavy brush below Unit N-15.

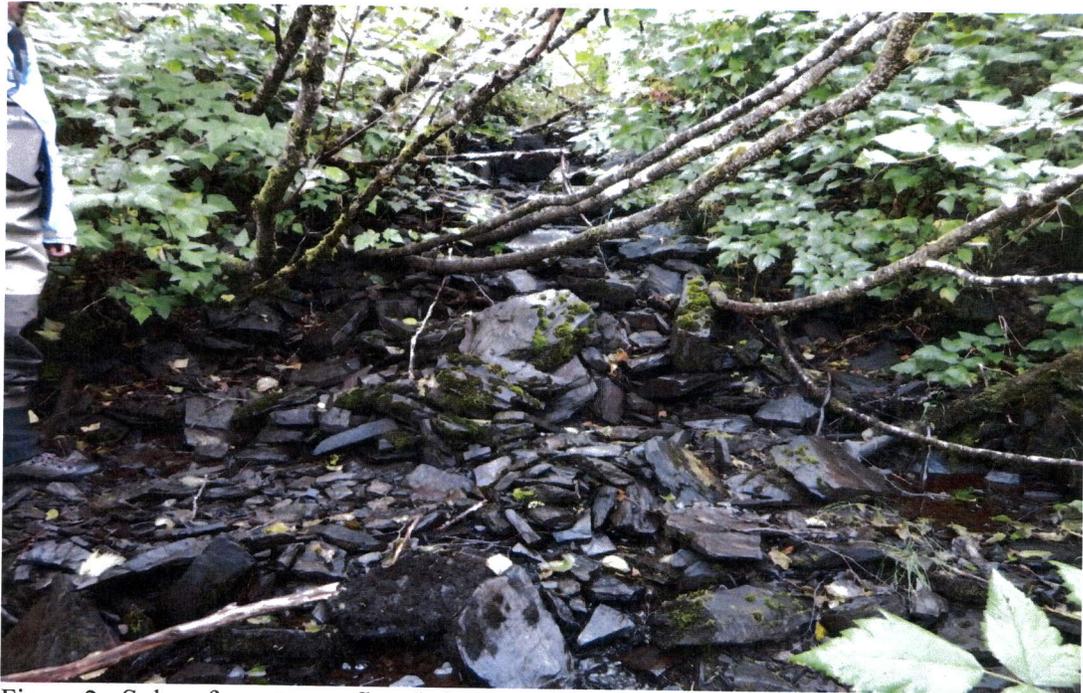
Figure 2. Subsurface stream flow below an abandoned logging road.

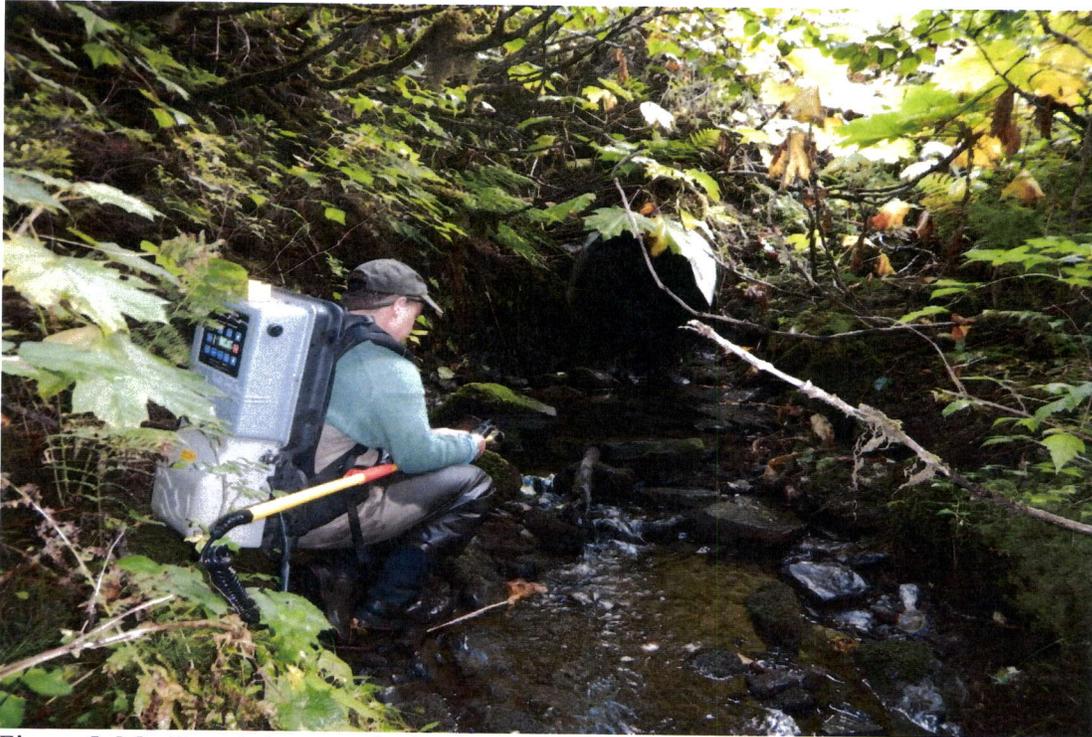
We continued walking south and located an additional unnamed stream. We sampled upstream about 400 meters to the 1100 Road MP 9.9. We captured about 30 juvenile coho salmon and measured 10 fish (50-70 mm FL) (Figure 4). We captured 10 Dolly Varden and measured 5 fish (45-100 mm FL). We ended our sampling at a perched culvert on the 1100 Road (Figure 5). The culvert is a barrier to fish passage and must be removed. The ADF&G will work with Koncor to schedule the removal of the culvert and installation of a log stringer bridge. The unnamed stream will be nominated to the Anadromous Waters Catalog.

Figure 5. Mr. Frost below perched culvert, 1100 Road MP 9.9.

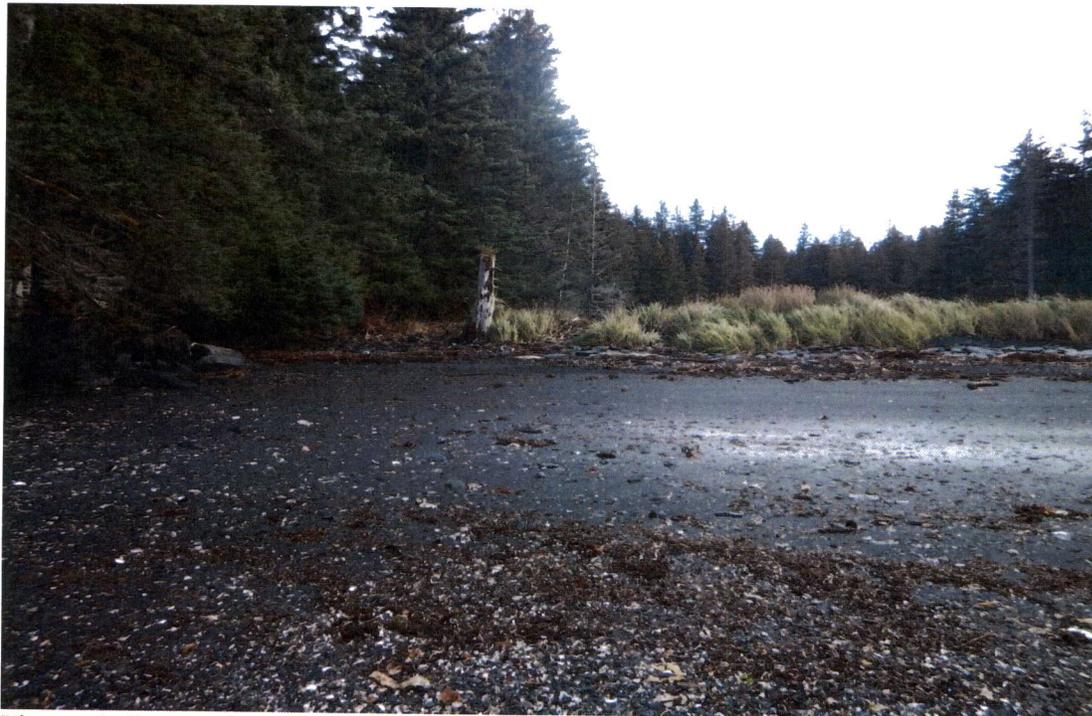
On the morning of September 12, Mr. Harris, Ms. Alas and I drove the 1100 Road to Unit KNG-11 on Discoverer Bay. The land is managed by Koniag. We walked to an unnamed stream and located a barrier to fish passage about 30 meters above a 5 acre beaver pond. A beaver dam is located at about mean high water level to Discoverer Bay (Figure 6). No defined stream channel exists below the beaver dam and no adult fish were observed below the beaver dam or in the lake. No riparian retention area will be required along the lake.

Figure 6. Beaver dam at tidewater in Unit KNG-11.

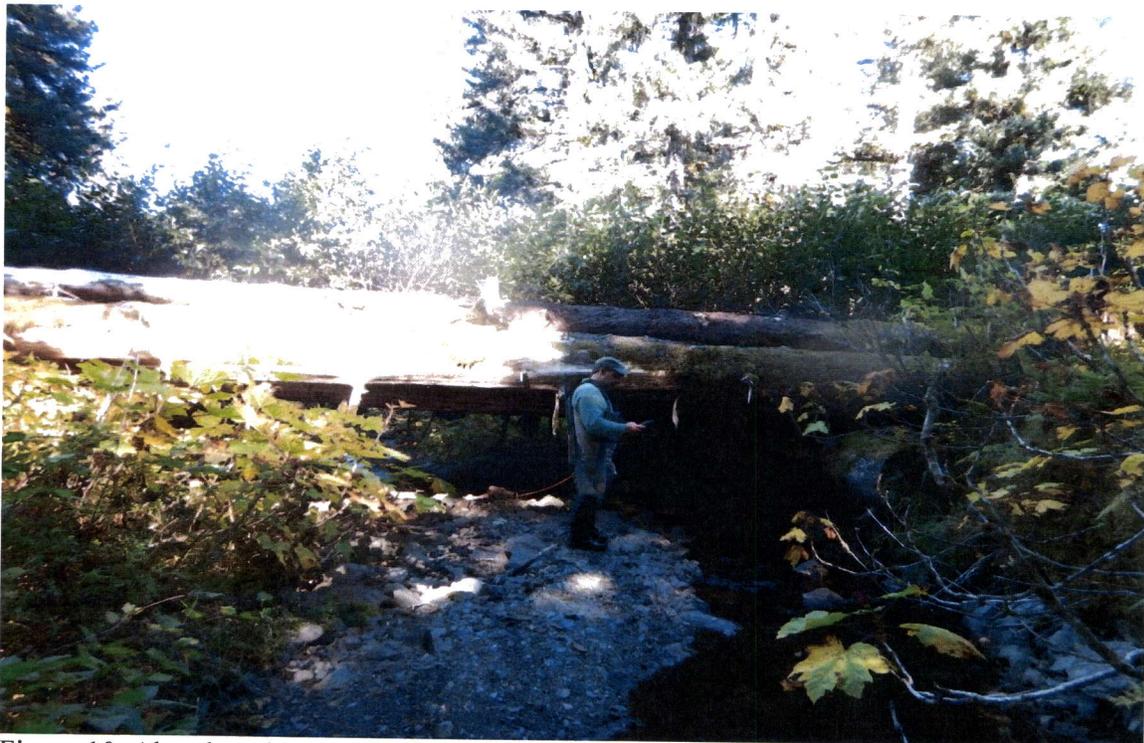
Figure 10. Abandoned log bridge on unnamed tributary to Stream No. 251-40-10030.

We drove the 1110 Road to MP 10.2. We sampled an unnamed tributary to Stream No. 251-40-10030. The stream is on land managed by ANC. We captured 4 juvenile coho salmon (70-100 mm FL) below a perched culvert (Figure 9). About 250 meters below the 1110 Road we located an abandoned log stringer bridge (Figure 10). The bridge is overgrown with alder. The bridge must be removed. The ADF&G will work with ANC to schedule the removal of the log stringer

bridge.

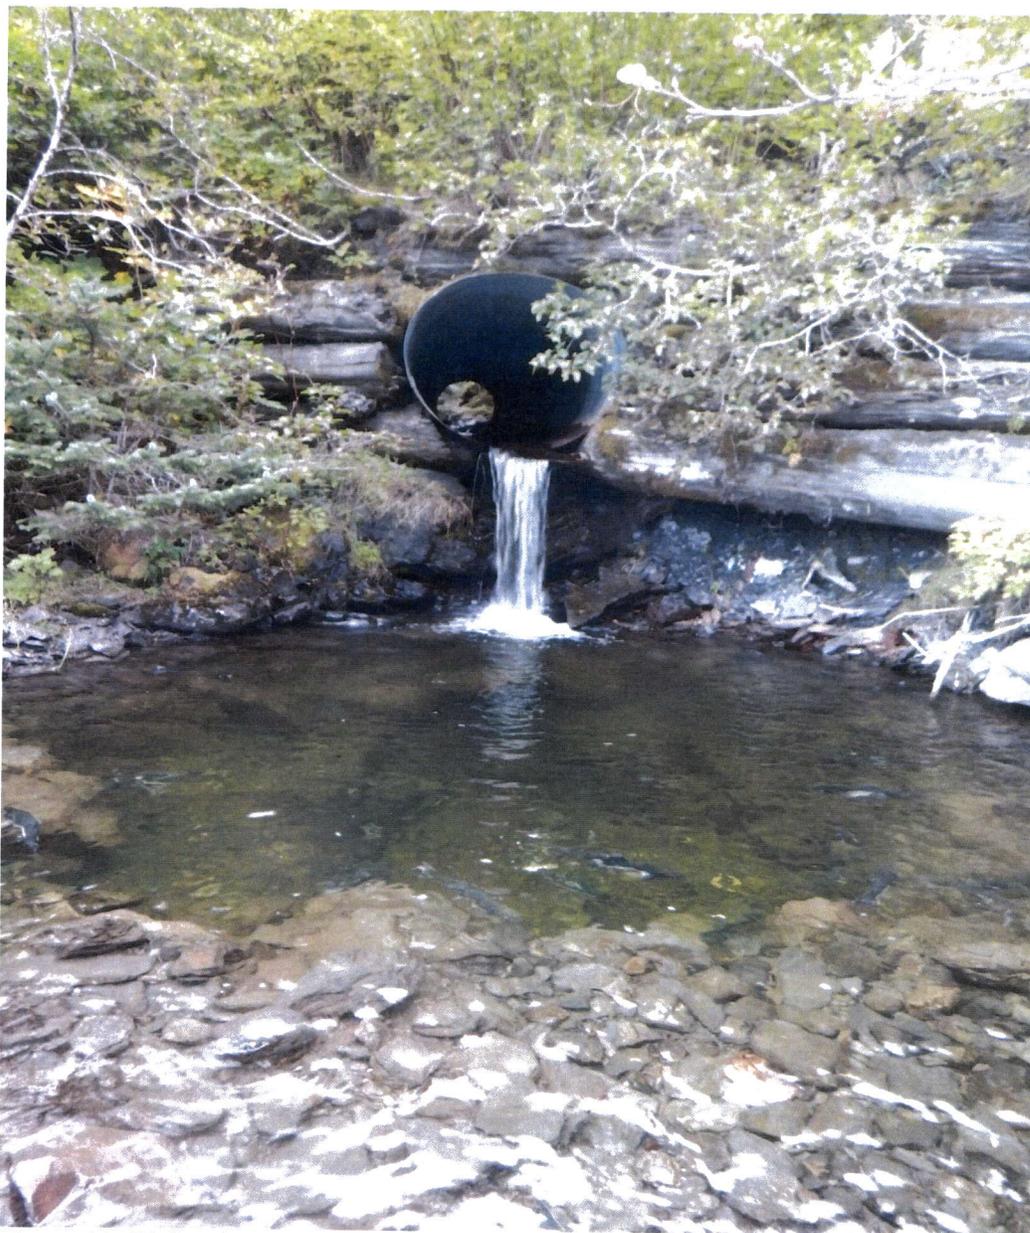
On the morning of September 13, Ms. Alas and I located about 40 adult pink salmon spawning in an unnamed stream located in the ANC camp. The salmon were below a perched culvert located on a camp road (Figure 11). The culvert is directly below a natural barrier. The pink salmon will be nominated to the Anadromous Waters Catalog.

Figure 11. Pink salmon spawning in unnamed stream in ANC camp.
