Summary of Coho Spawning Observations in Upper Pederson Hill Creek

Stream Name: Pederson Hill Creek (aka Casa Del Sol Creek (Bethers et al. 1995))

Anadromous Stream Catalog Number: 111-50-10490

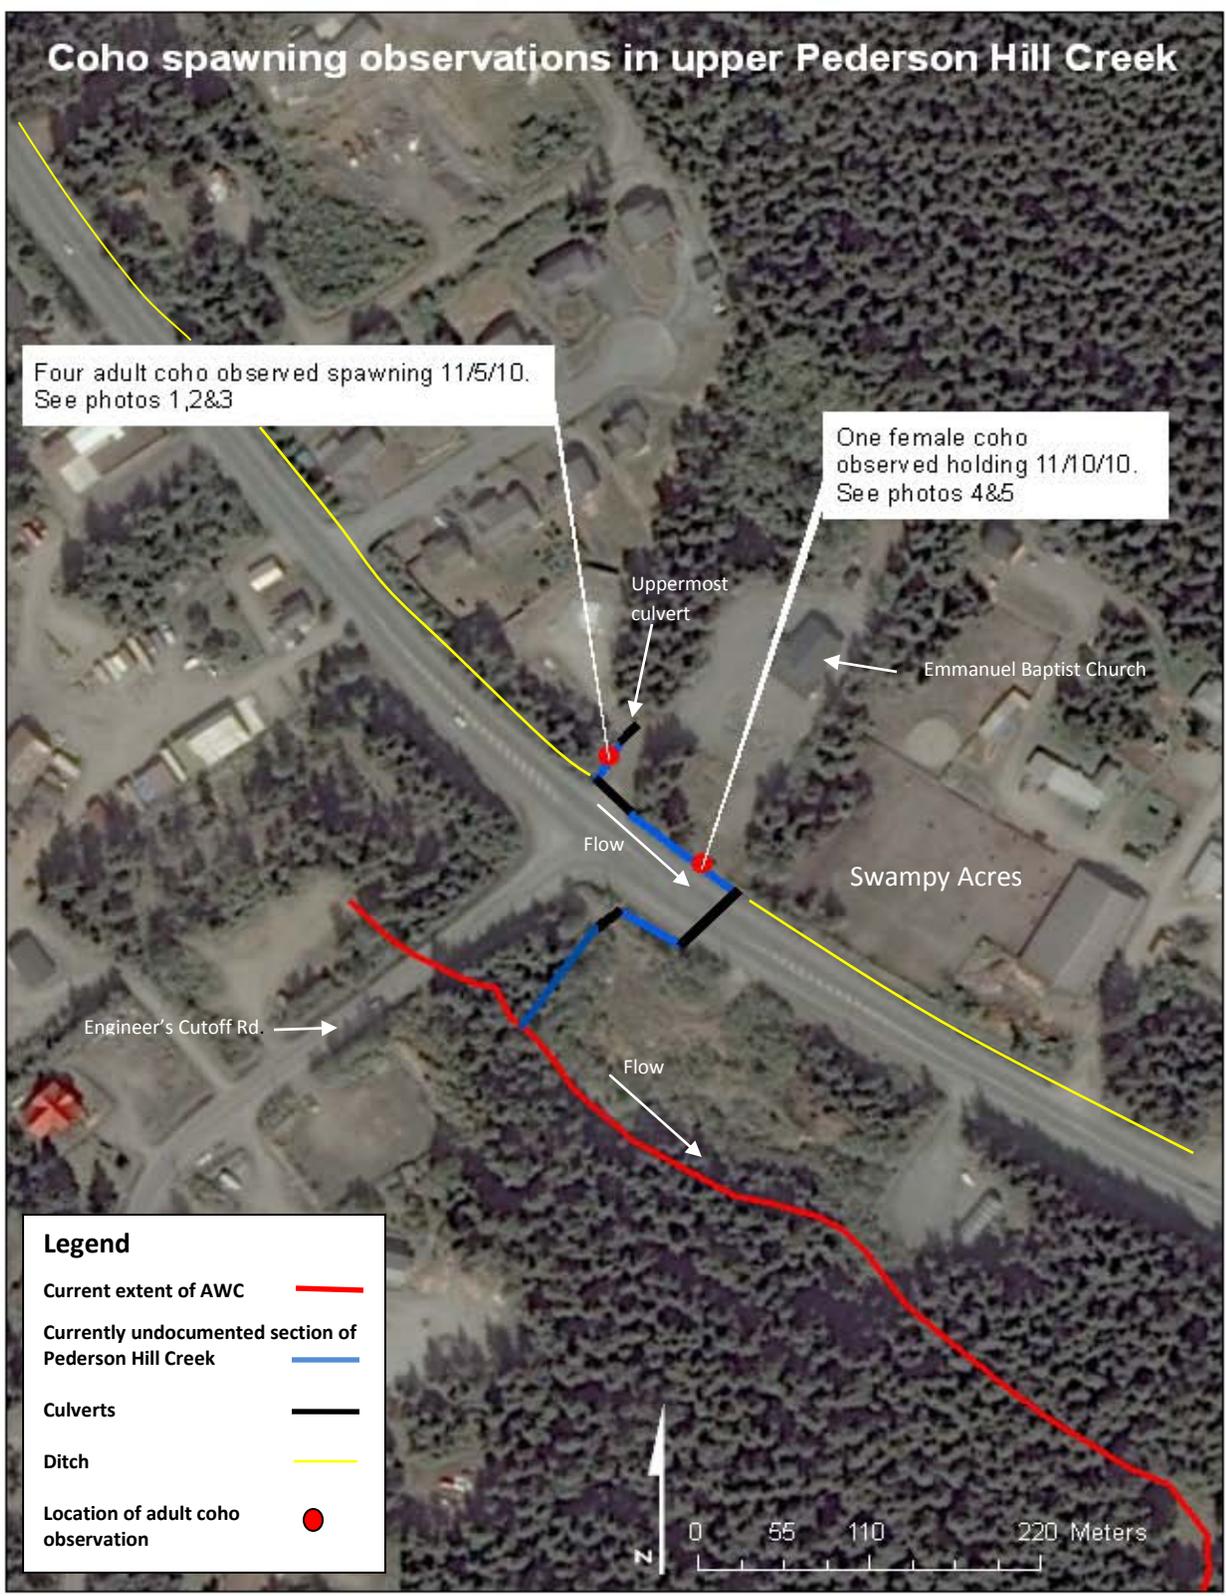
Coho spawning observations in upper Pederson Hill Creek

From the map above it can be seen that Pederson Hill Creek has been routed into the ditch on the north side of Glacier Highway. The Creek is then routed under Glacier Highway into the ditch on the south side of the highway before it passes through a culvert under a private driveway then back into its 'natural' channel. Large amounts of sediment are directly transported into Pederson Hill Creek via the roadside ditch. It is surprising the coho made it to the location they did as the culverts are only designed for water conveyance in the ditch and do not appear adequate to pass adult fish. The uppermost culvert pipe is a blockage to adult fish passage; however, I was unable to determine if there is any additional spawning habitat upstream of this location, as the land is privately owned.

Four adult coho observed spawning 11/5/10.
See photos 1,2&3

One female coho observed holding 11/10/10.
See photos 4&5

Uppermost culvert

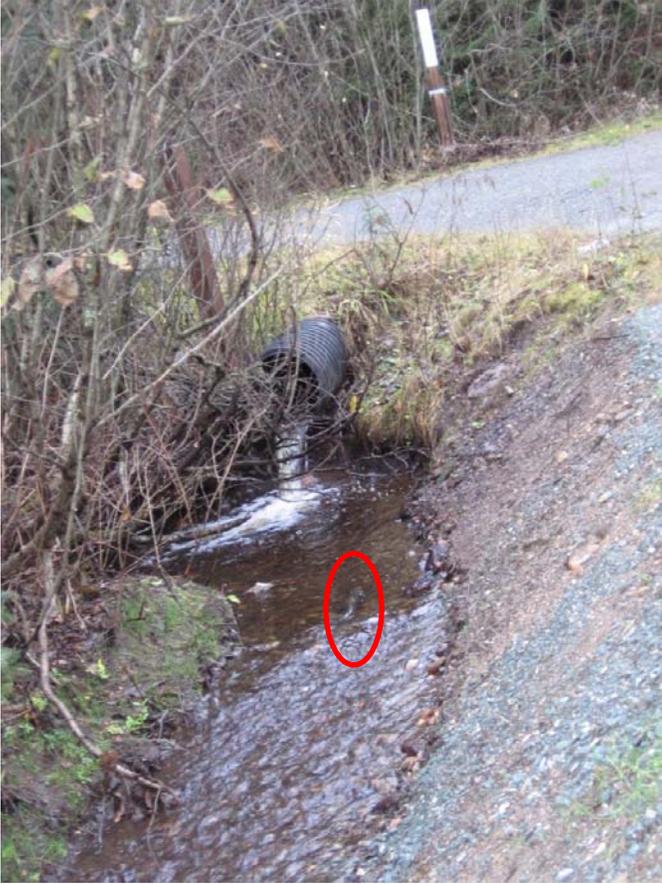
Picture 1: Uppermost plastic pipe culvert on Pederson Hill Creek. Red circle highlights adult coho spawning in the gravel immediately downstream from pipe.

On 11/5/10 Brian Jones of the City Borough of Juneau (CBJ) Water Utility Department observed four coho actively spawning in the gravel immediately below the uppermost culvert on Pederson Hill Creek as indicated on the map below. Pictures 1 – 3 were taken by Mr. Jones and a colleague and show two of the four fish. A female coho on a freshly excavated redd can clearly be seen.

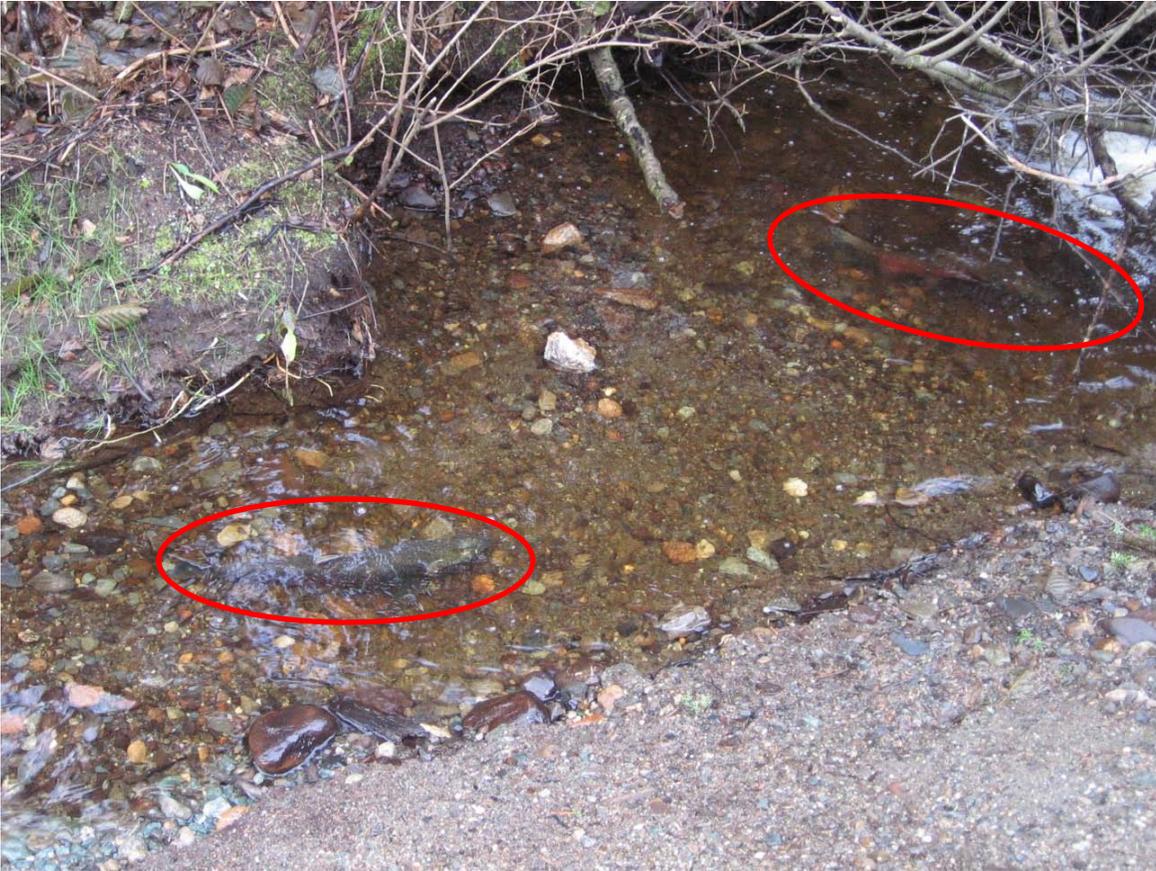
Picture 2: Red circles highlight a male and female coho spawning in the tail-out of the pool immediately below the uppermost pipe culvert. Female coho is situated on a freshly excavated redd.

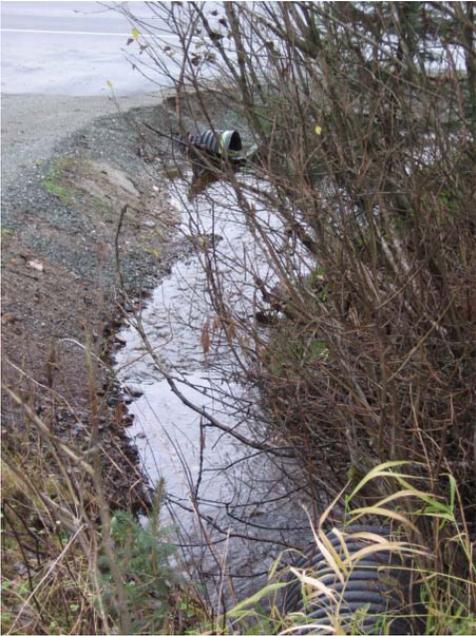
Picture 3: Facing south showing stream reach between uppermost culvert on Pederson Hill Creek and Glacier Hwy.

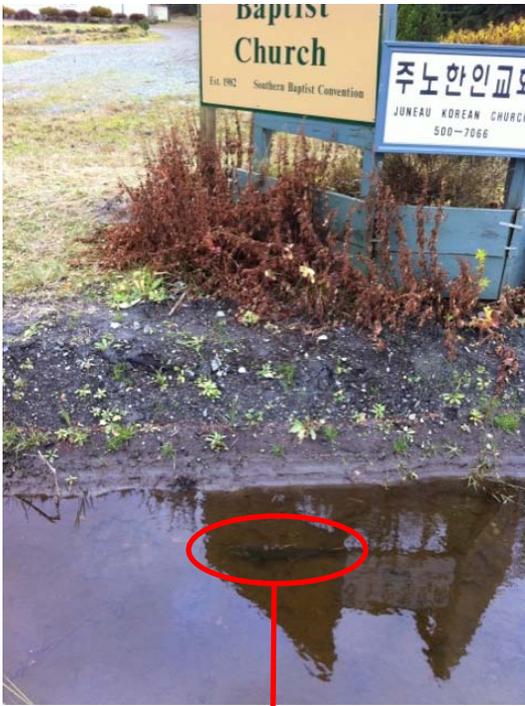
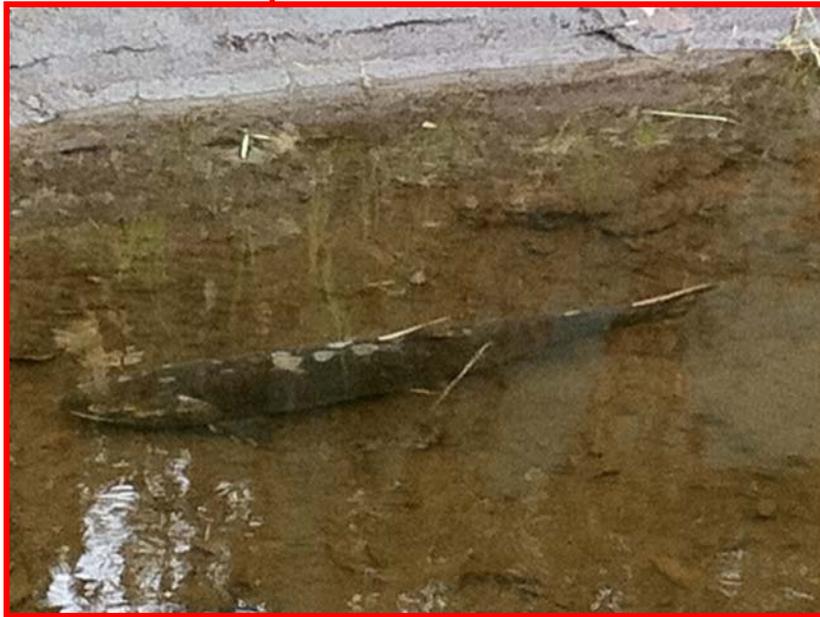
Pictures 4&5: Female coho holding in section of Pederson Hill Creek routed through the ditch on north side of Glacier Hwy adjacent to Emmanuel Baptist Church

On 11/10/10 I (James Ray, U.S. Fish and Wildlife Service) observed a single female coho holding in a section of Pederson Hill Creek that is currently routed through the ditch line on the north side of Glacier Highway adjacent to the Emmanuel Baptist Church, as indicated on the map below (also see pictures 4&5). It is likely the fish observed on 11/10/10 was one of the four coho observed on 11/5/10 that had fallen back. Although none of the other fish were present, the redd was still clearly visible upstream.
