### **13 Mile Creek**

*Stream:* 115-32-10250-2040

*Date Surveyed:* July, 2011

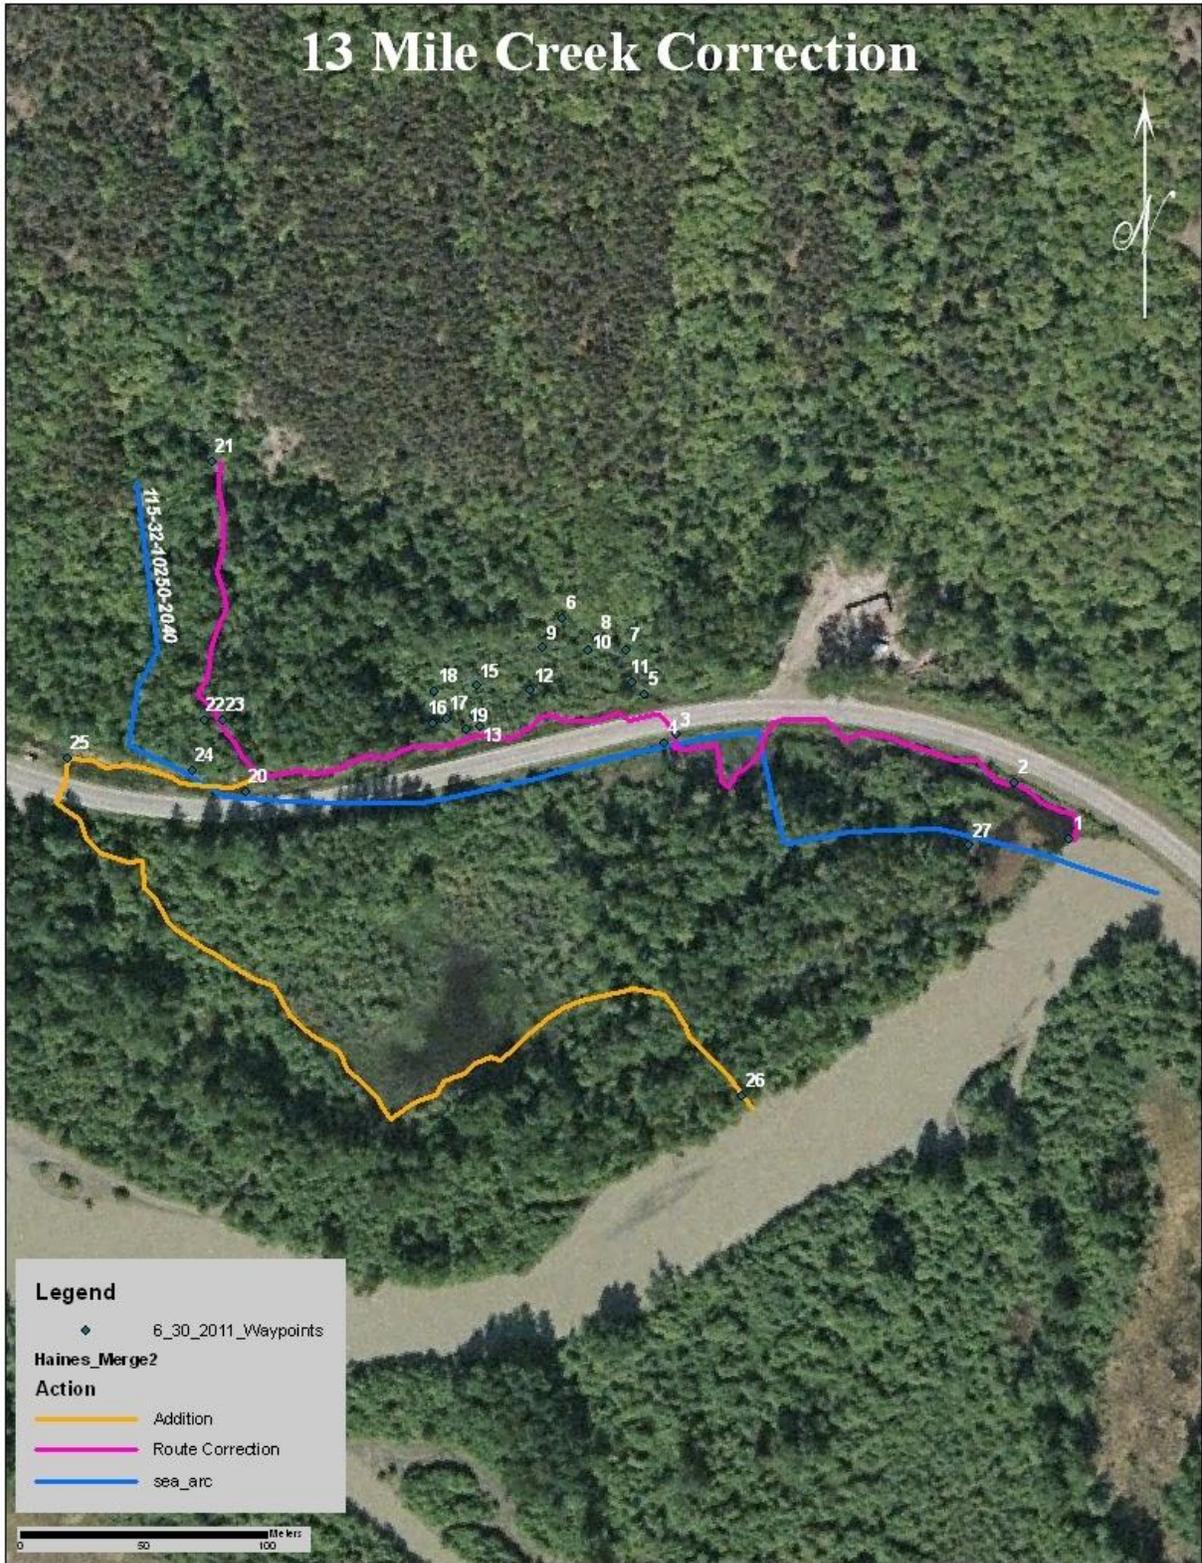
Figure 1: 13 Mile Creek Correction Map

*Findings:* The upper and lower limits of this stream were found to differ from that in the AWC. The stream also takes a more sinuous path before emptying into the Chilkat.

*Notes:* This stream's anadromous extent ends at a waterfall flowing from the mountainside. If flows to the highway where it splits, creating two anadromous streams, one flowing along the highway for a distance before passing through a culvert and into a sidechannel of the Chilkat River. The second branch flows through a culvert and widens into a marsh before channelizing again and entering the Chilkat sidechannel.

*Recommendations:* Update this stream's route, upper, and lower limits in the AWC
