DelMar Creek Addition

Watershed: Frontal Wrangell Narrows

Date Surveyed: July 2013

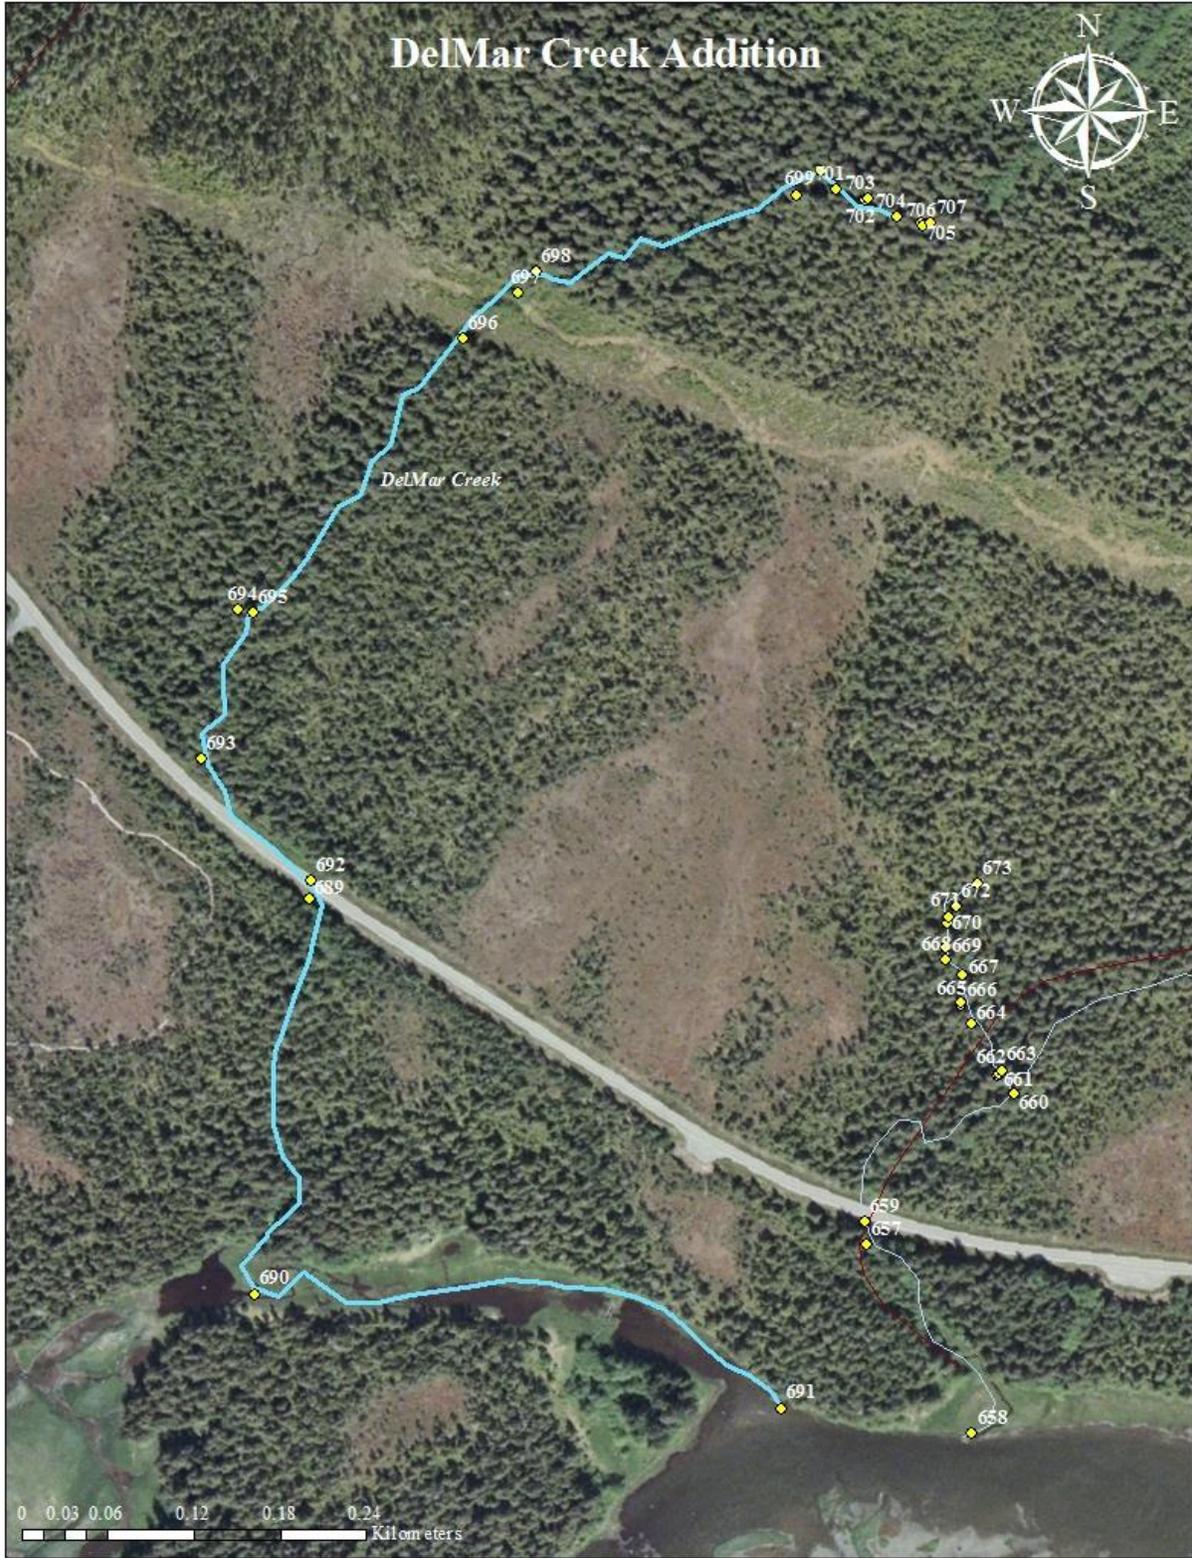
Figure 1. DelMar Creek Addition Map

Findings: This stream has juvenile Coho present up to waypoint 704. The stream provided excellent salmonid rearing habitat.

Recommendations: Add this stream to the AWC.
