108-60-10049 Route Correction**Stream:** City Creek (108-60-10049, cataloged for COs, Pp, CTp, DVp)**Watershed:** Big Creek-Frontal Frederick Sound**MTRS:** C058S079E, Petersburg D-3**Date Surveyed:** June 1 and 2, 2013

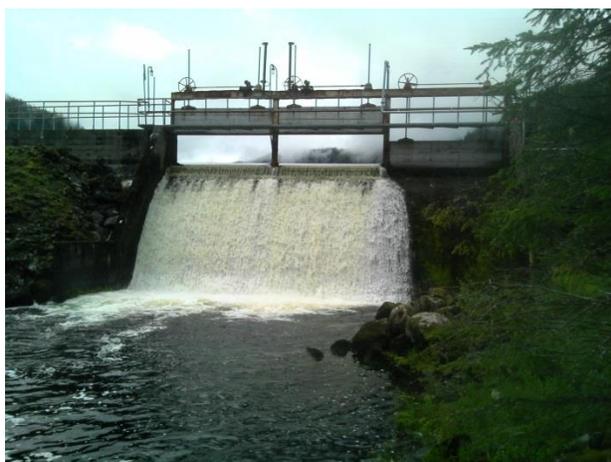
Figure 1: Below Petersburg Reservoir Dam.

Findings: We tracked City Creek (108-60-10049) and sampled the tributaries up to the Petersburg Reservoir dam just below the lake (Figure 1, Table 1). We encountered an old wooden dam below the lake that did not appear to restrict fish passage (Figure 2). We found the current route for this stream differs from the AWC (Figure 3).
