LAUNCH CREEK ADDITION

Stream: Launch Creek

Date Surveyed: May 22, 2013

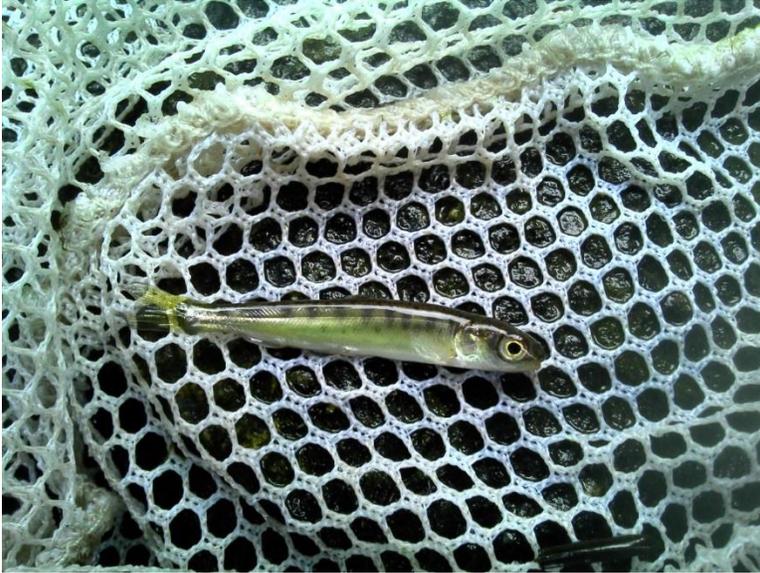
Figure 1: Chum salmon caught in Launch Creek.

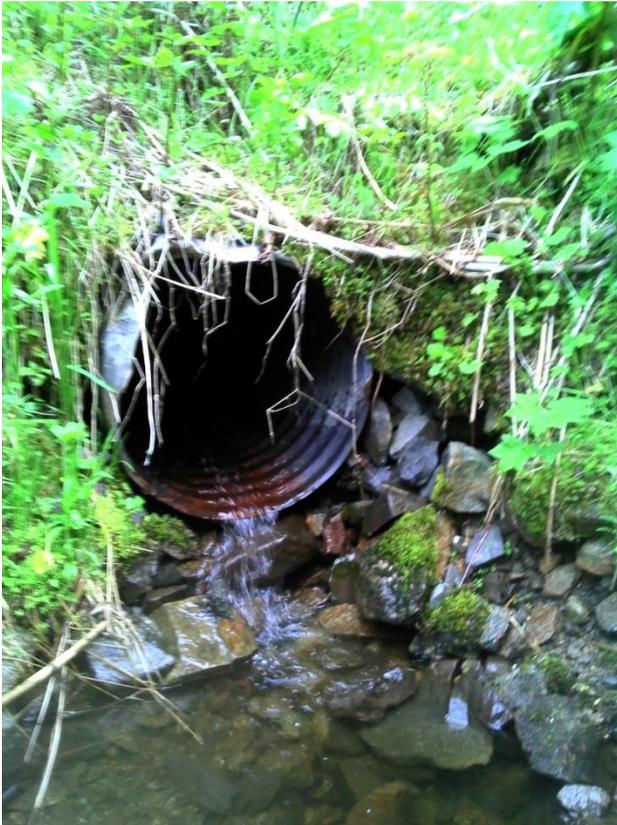
Figure 2: Downstream side of slightly perched culvert under the boat launch road.

Waypoint	Latitude	Longitude	Notes	Sample Effort	Sample Results
179	56.5543	-132.6306	Above intertidal zone of creek. Tracking up.		
180	56.5546	-132.6304	Caught several YOY salmon below road. Stream fed by roadside ditch.	EF	9 CO, 2 CH, 1 P
181	56.5547	-132.6301		EF	6 CO YOY
182	56.5547	-132.6300	Small tributary entering river right. Tracking up.		
183	56.5548	-132.6301		EF	2 DV, 2 sculpin
184	56.5548	-132.6301	Downstream side of culvert. Water pulses through culvert in an inconsistent flow.	EF	1 DV
185	56.5550	-132.6303	Upstream side of culvert. Consistent flow in this side. Stream runs along ditch.		
186	56.5552	-132.6296	Electrofished along roadside. Ends at a ~ 20 ft. bedrock wall barrier.	EF	No Fish
187	56.5548	-132.6298	Pool at base of downstream culvert. Culvert runs beneath access road to boat launch. Culvert is perched ~ 6".	EF	3 CO, 1 DV, 2 CT, 2 sculpin
188	56.5547	-132.6297	Upstream side of culvert.
