## SHOEMAKER BAY CREEK ADDITION

**Stream:** Shoemaker Bay Creek

**Date Surveyed:** August 14, 2013

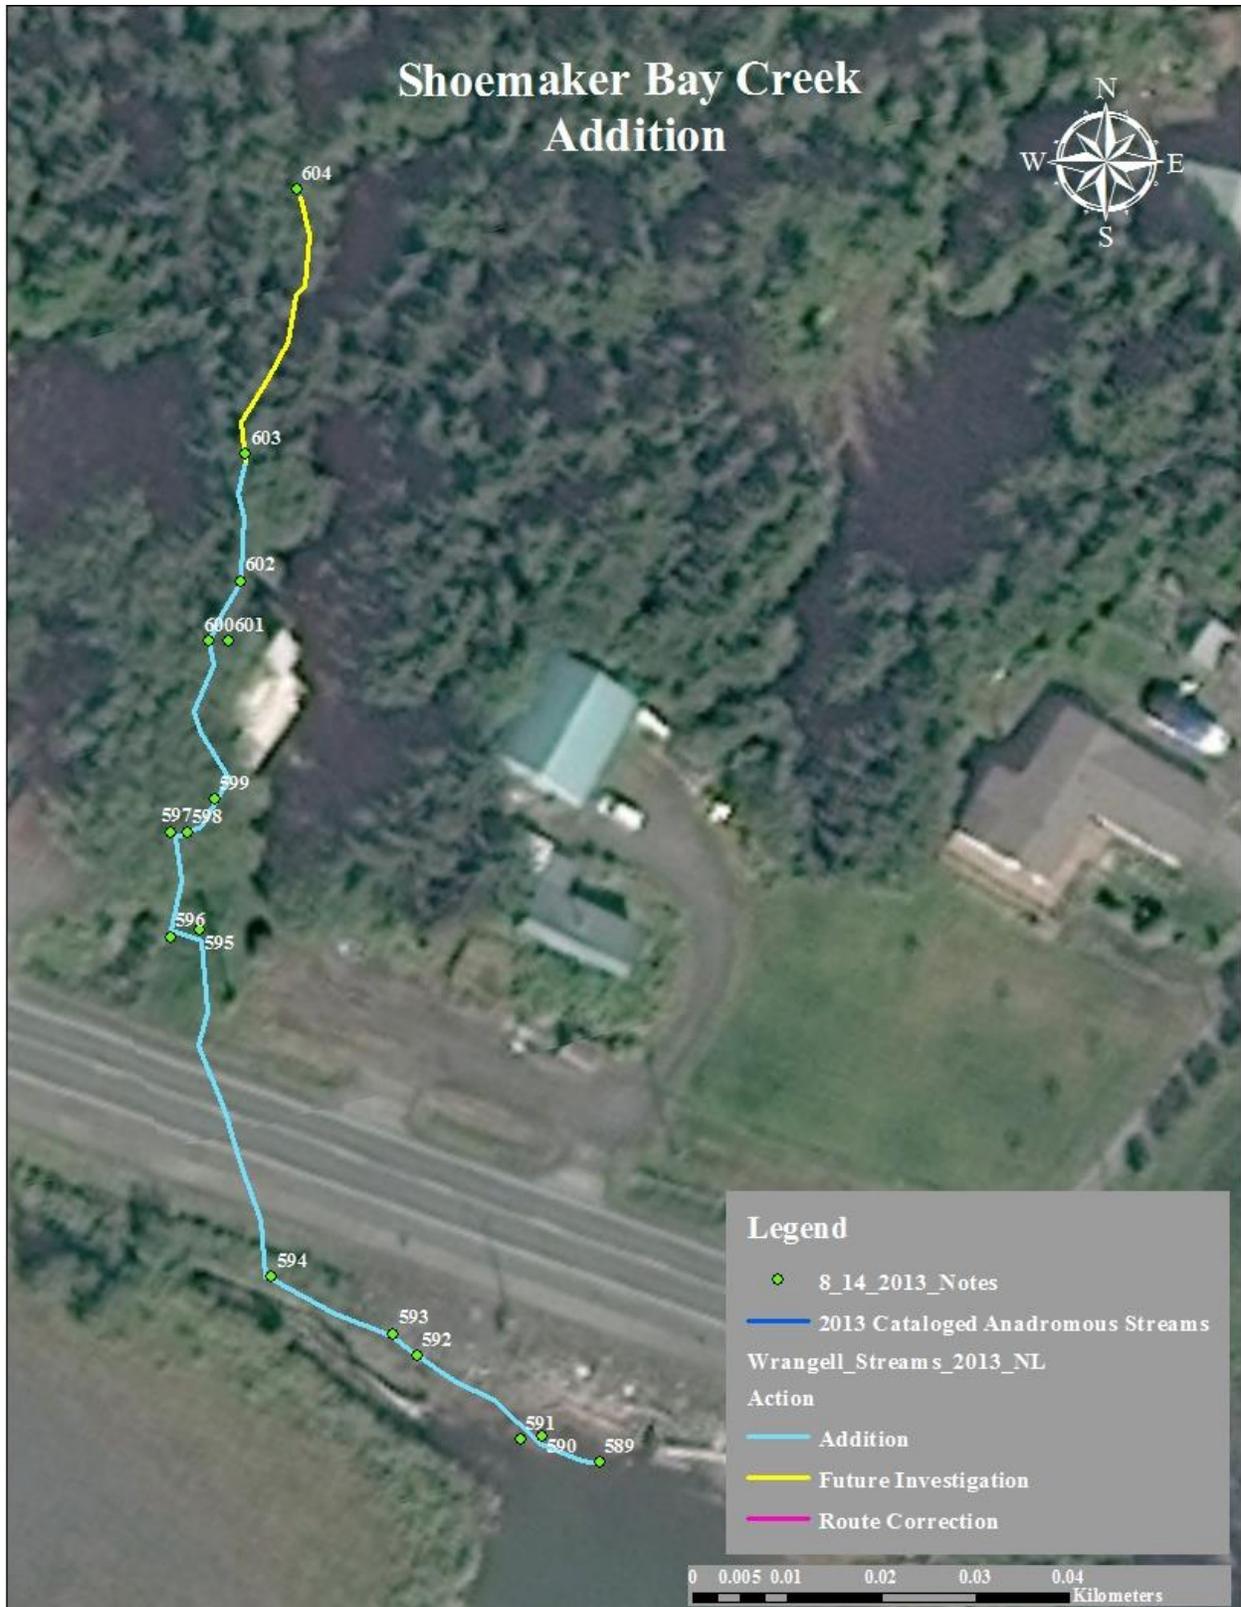
Figure 1.– Shoemaker Bay Creek addition map.

**Findings:** We surveyed this uncataloged creek along the Zimovia Highway and caught coho salmon using an electrofishing unit (Table 1). This stream flows through a homeowner's property and abuts the house foundation (Figure 1). There is a small bridge over the creek allowing access to another building on the other side of the creek. The survey was ended when the gradient became steeper and the substrate was cobble and boulders.

**Recommendations:** Add this stream to the AWC.
