**111-50-10750-2027-3008****CORRECTION****Water body name:****Survey date:** 10/11/2013**Water body number:** 111-50-10750-2027-3008**Species & Lifestage:** CO<sub>r</sub>, DV<sub>r</sub>, CT<sub>r</sub>**Watershed:** Admiralty Island-Frontal Lynn Canal**MTR:** C041S066E **Quad:** Juneau B-2

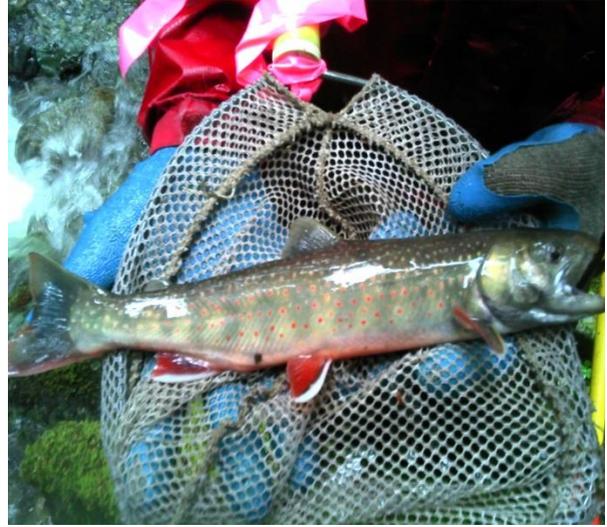
1016	58.2856	-134.6573	Pair of adult coho salmon making a redd.	VI	2 CO
1017	58.2863	-134.6557	Possible side channel on river left.		
1018	58.2860	-134.6539	Captured a very big resident Dolly Varden char in spawning colors at the base of small cascade.	EF	1 DV, 1 CT

Figure 2.—Captured Dolly Varden char in spawning colors.

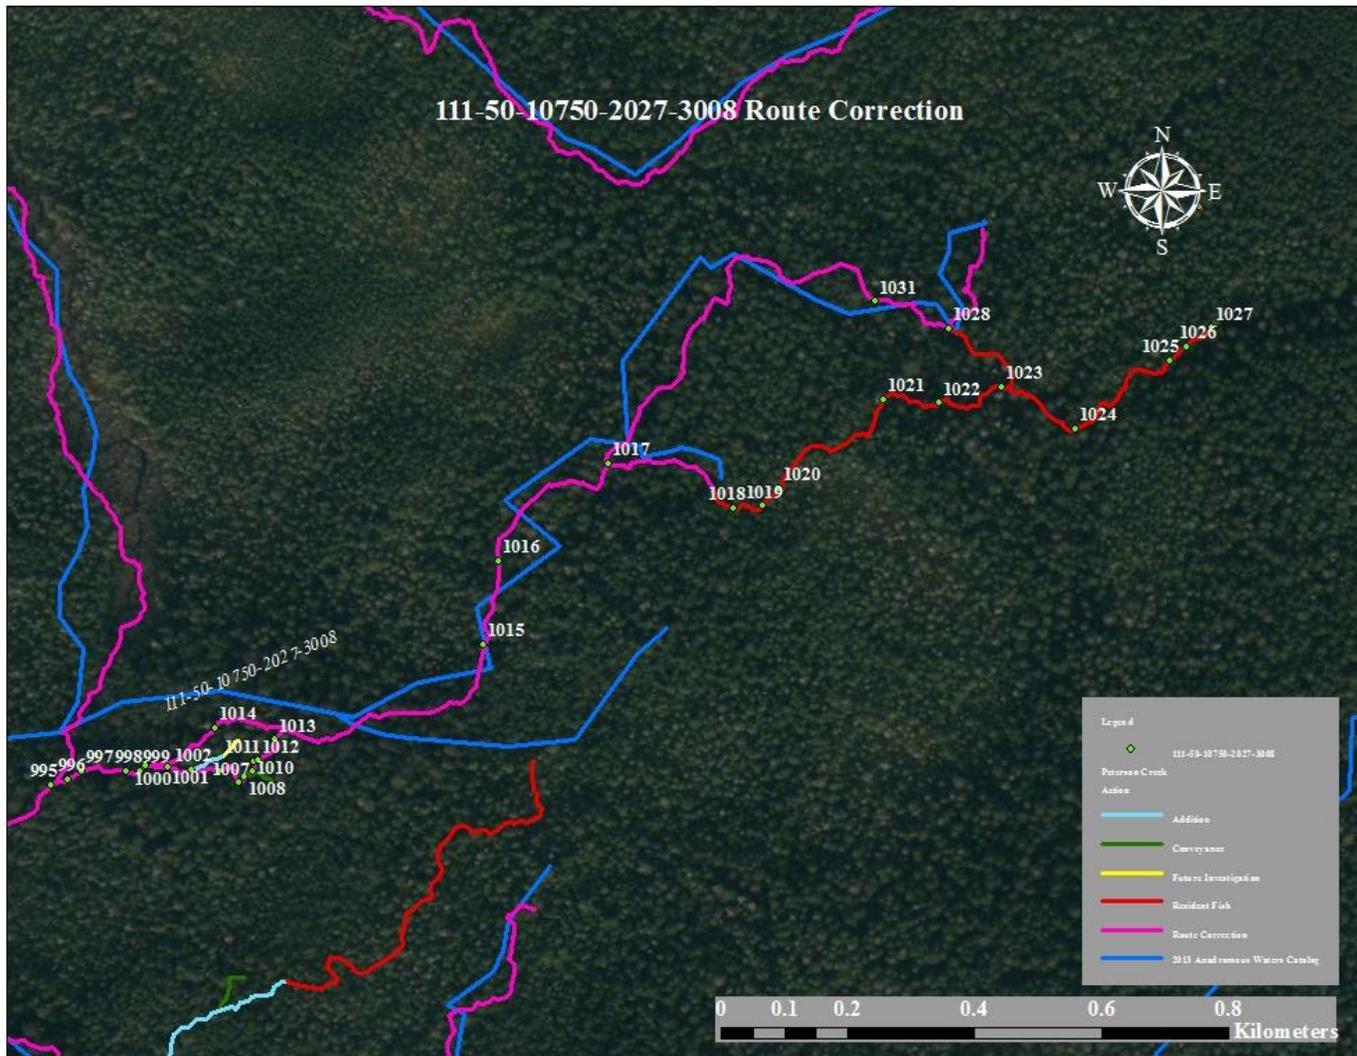
Figure 3.–111-50-10750-2027-3008 route correction map.

**Recommendations:** Correct the current course in AWC.
