THAYER CREEK

Water body name: Thayer Creek

Water body number: 112-17-10500

CORRECTION

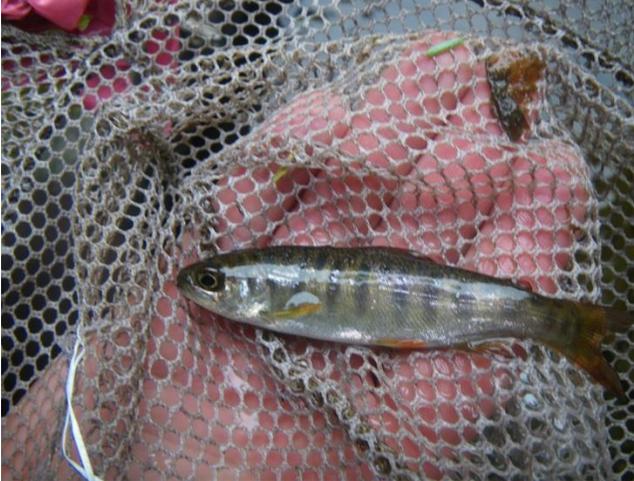
Figure 1.—Coho salmon caught below waterfall in Thayer Creek.

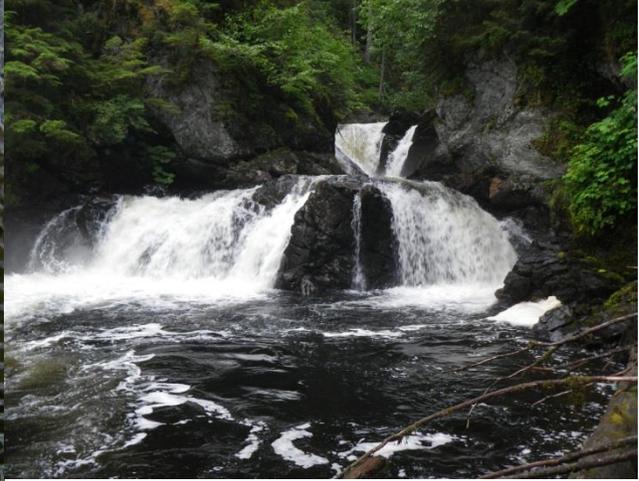
Figure 2.—First 12' waterfall with 20' deep plunge pool.

Findings: The lower section of Thayer Creek is gravel and cobble substrate. We had visual observations of several adult pink and one chum salmon in the stream. There is a series of water falls approximately 1250' upstream from the mouth of the creek that we determined are anadromous fish passage barriers. We caught four rearing coho salmon downstream of the waterfalls and saw several pink and one pair of sockeye salmon swimming in the plunge pool below the falls. Upstream of the waterfall the creek flows through a bedrock gorge for approximately one mile then opens up to a low gradient stream with gravel and cobble substrate. We surveyed a tributary in this area and caught resident cutthroat trout and Dolly Varden char.

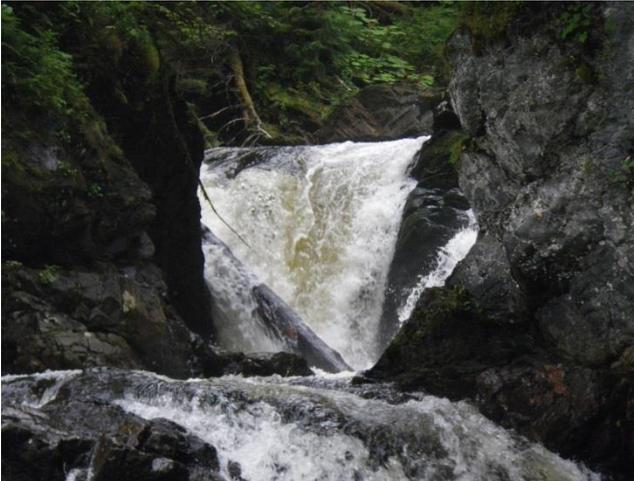
Figure 3.—Second 14' waterfall with no plunge pool.

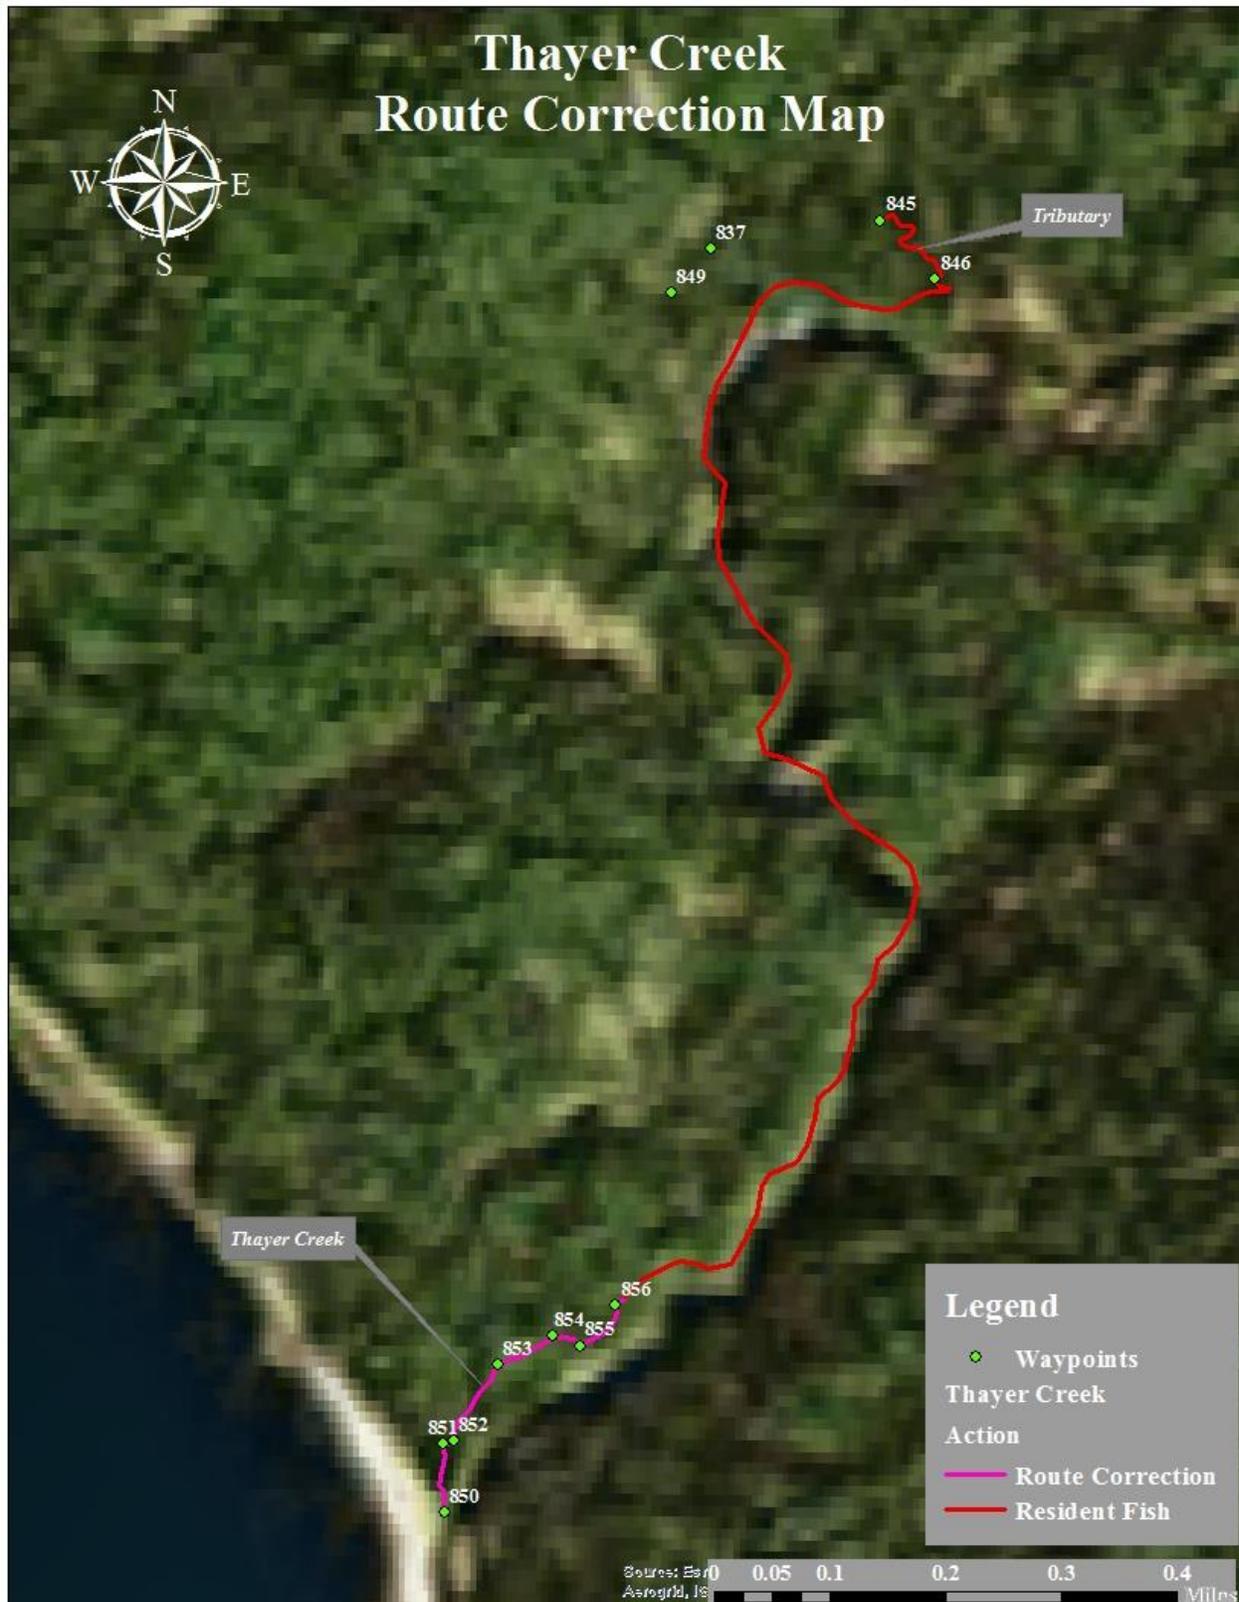
Figure 5.– Thayer Creek route correction map.

Recommendations: Correct the anadromous section of Thayer Creek in the AWC to represent the actual extent of anadromy. Add rearing coho salmon and sockeye salmon presence to the AWC.
