## 1<sup>ST</sup> WATERFALL CREEK

**Water body name:** 1<sup>st</sup> Waterfall Creek

**Water body number:** 101-90-10700

## ROUTE CORRECTION

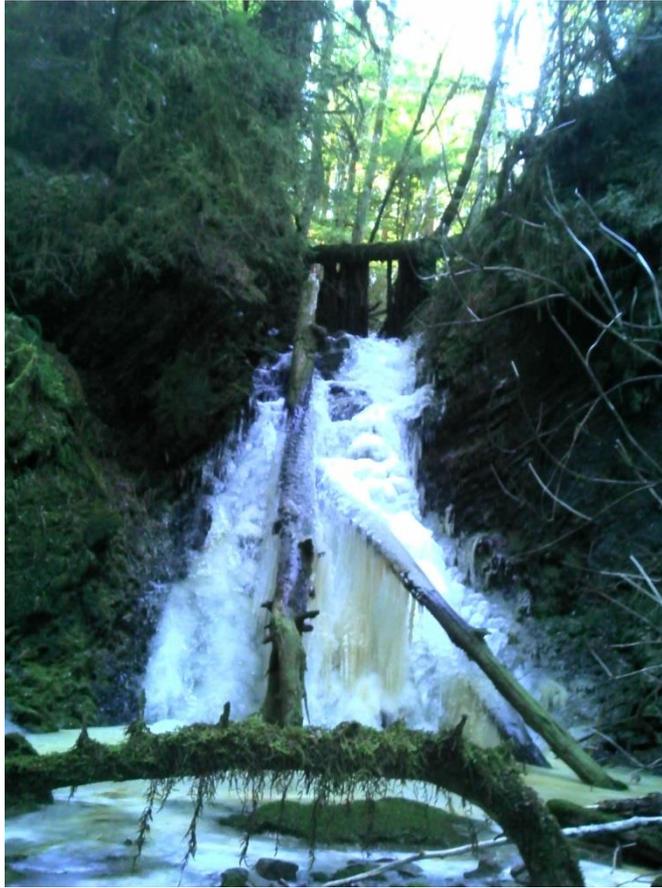
Waypoint	Latitude	Longitude	Notes	Sample Effort	Sample Results
38	55.4735	-131.7889	Where tidewater influence ends		
39	55.4732	-131.7892	stream forks, tracking main flow.		
40	55.4724	-131.7882	Culvert outlet that goes under tongass ave, has good pool at base but is perched 2' and there are several pipes in and around this area.		
41	55.4723	-131.7880	Culvert inlets, pipes enter RL of culvert.		
42	55.4709	-131.7855	20' barrier falls here. Looks like there is an old dam at the top where the channel narrows. Wood culvert also at the base of the falls.

Figure 1.-Barrier falls on 1<sup>st</sup> Waterfall Creek.

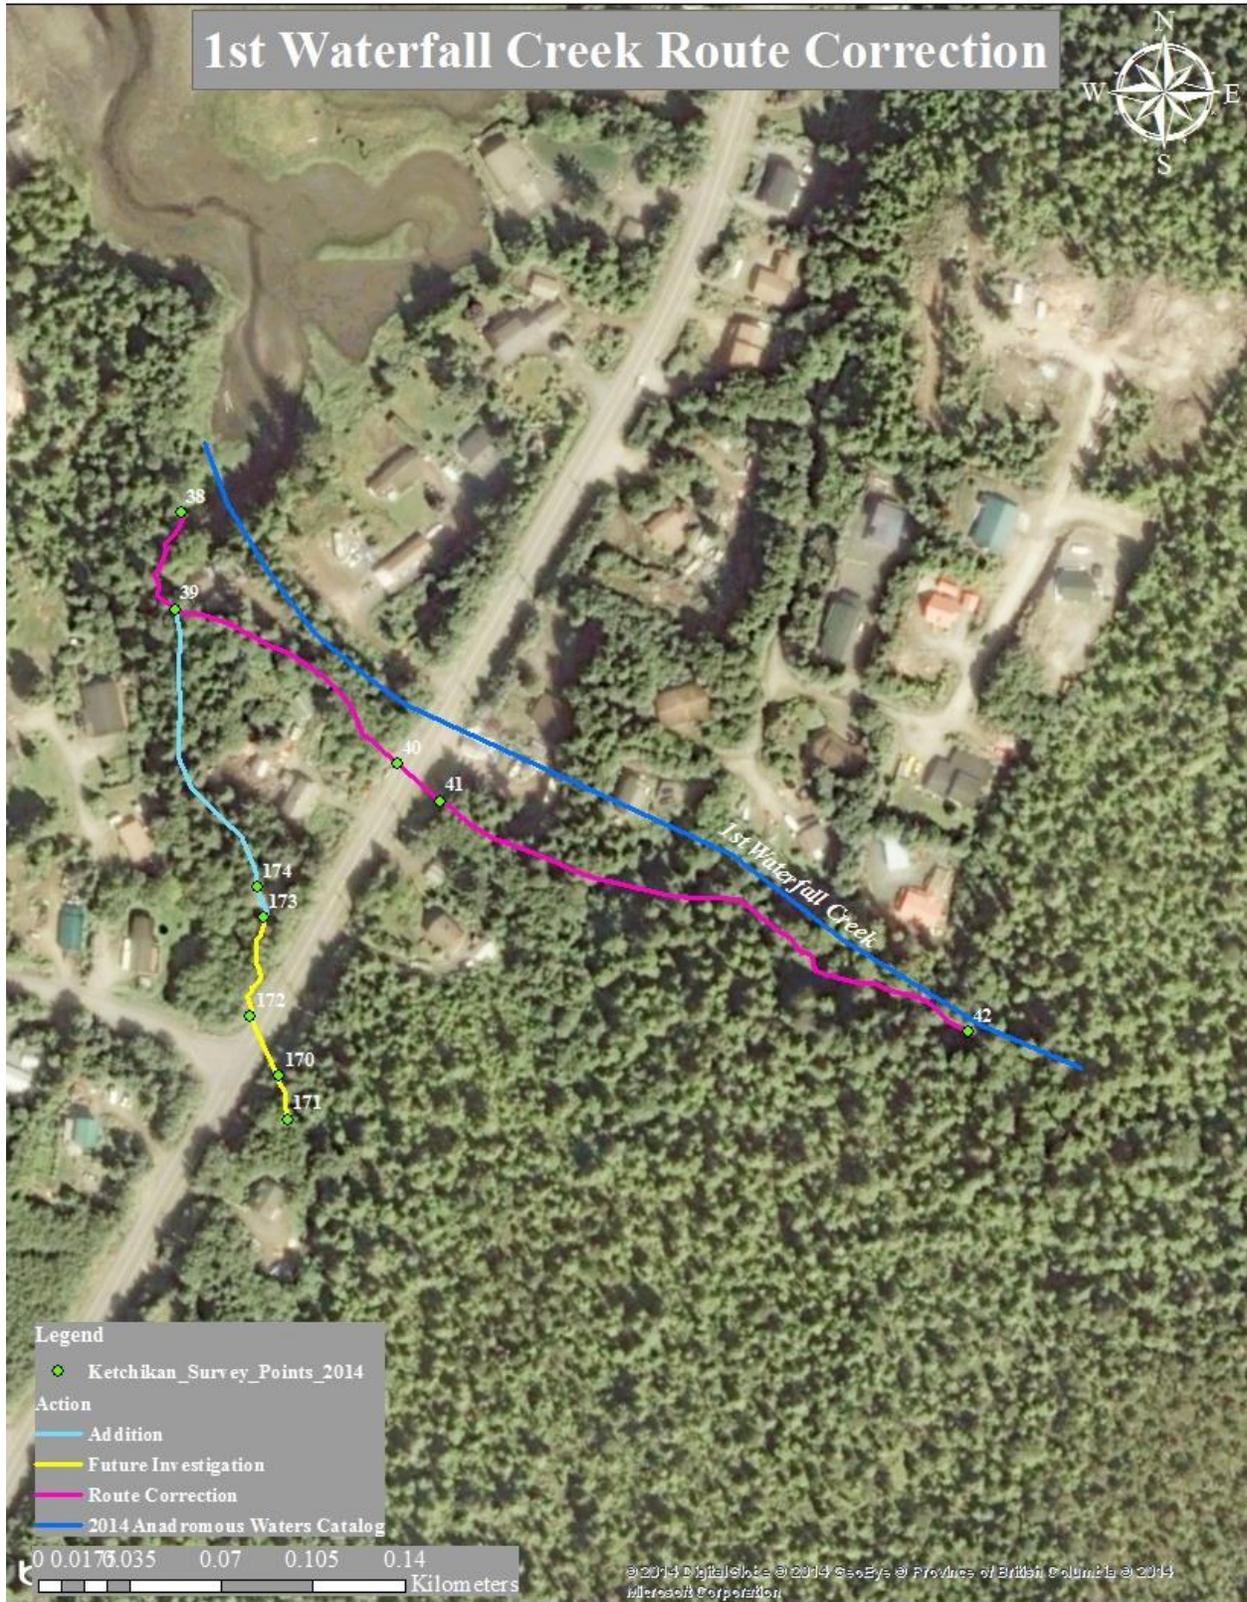
**Findings:** This stream's currently cataloged route is inconsistent with the actual field-verified route. Additionally, coho juvenile salmon were captured in a tributary to this stream, so coho rearing needs to be added to the AWC database.

Figure 2.– 1<sup>st</sup> Waterfall Creek Route Correction map.

**Recommendations:** Please update this stream's route to reflect the field-verified route, and add COr to the AWC database.
