HERRING COVE CREEK**ROUTE CORRECTION****Water body name:** Herring Cove Creek**Survey date:** 5/8/2014**Water body number:** 101-45-10070**Species & Lifestage:** CHp,COp,Pp**Watershed:** Carroll Inlet-Frontal Revillagigedo Channel **MTR:** C075S090E **Quad:** Ketchikan B-5**Findings:** This stream's cataloged route differs from the field-verified route.**Recommendations:** Please update this stream's course to reflect the field-verified route and maintain species currently cataloged.

Table 1.-Herring Cove Creek Survey Data.

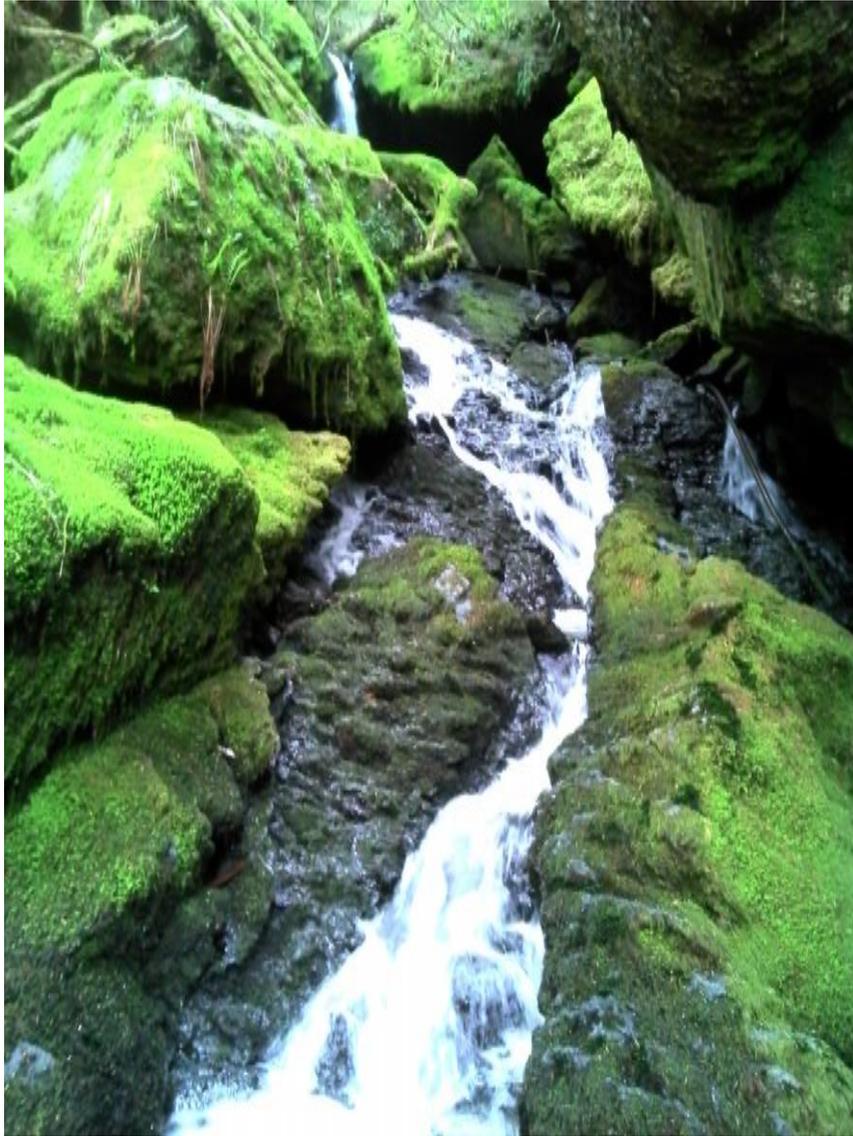
| Waypoint | Latitude | Longitude | Notes | Sample Effort | Sample Results |
|---|---|---|---|---|---|
| 184 | 55.3283 | -131.5342 | Cataloged upper limit is correct. Long bedrock cascade before a tall falls. | | |

Figure1.-Lower portion of the bedrock cascade barrier on Herring Cove Creek.

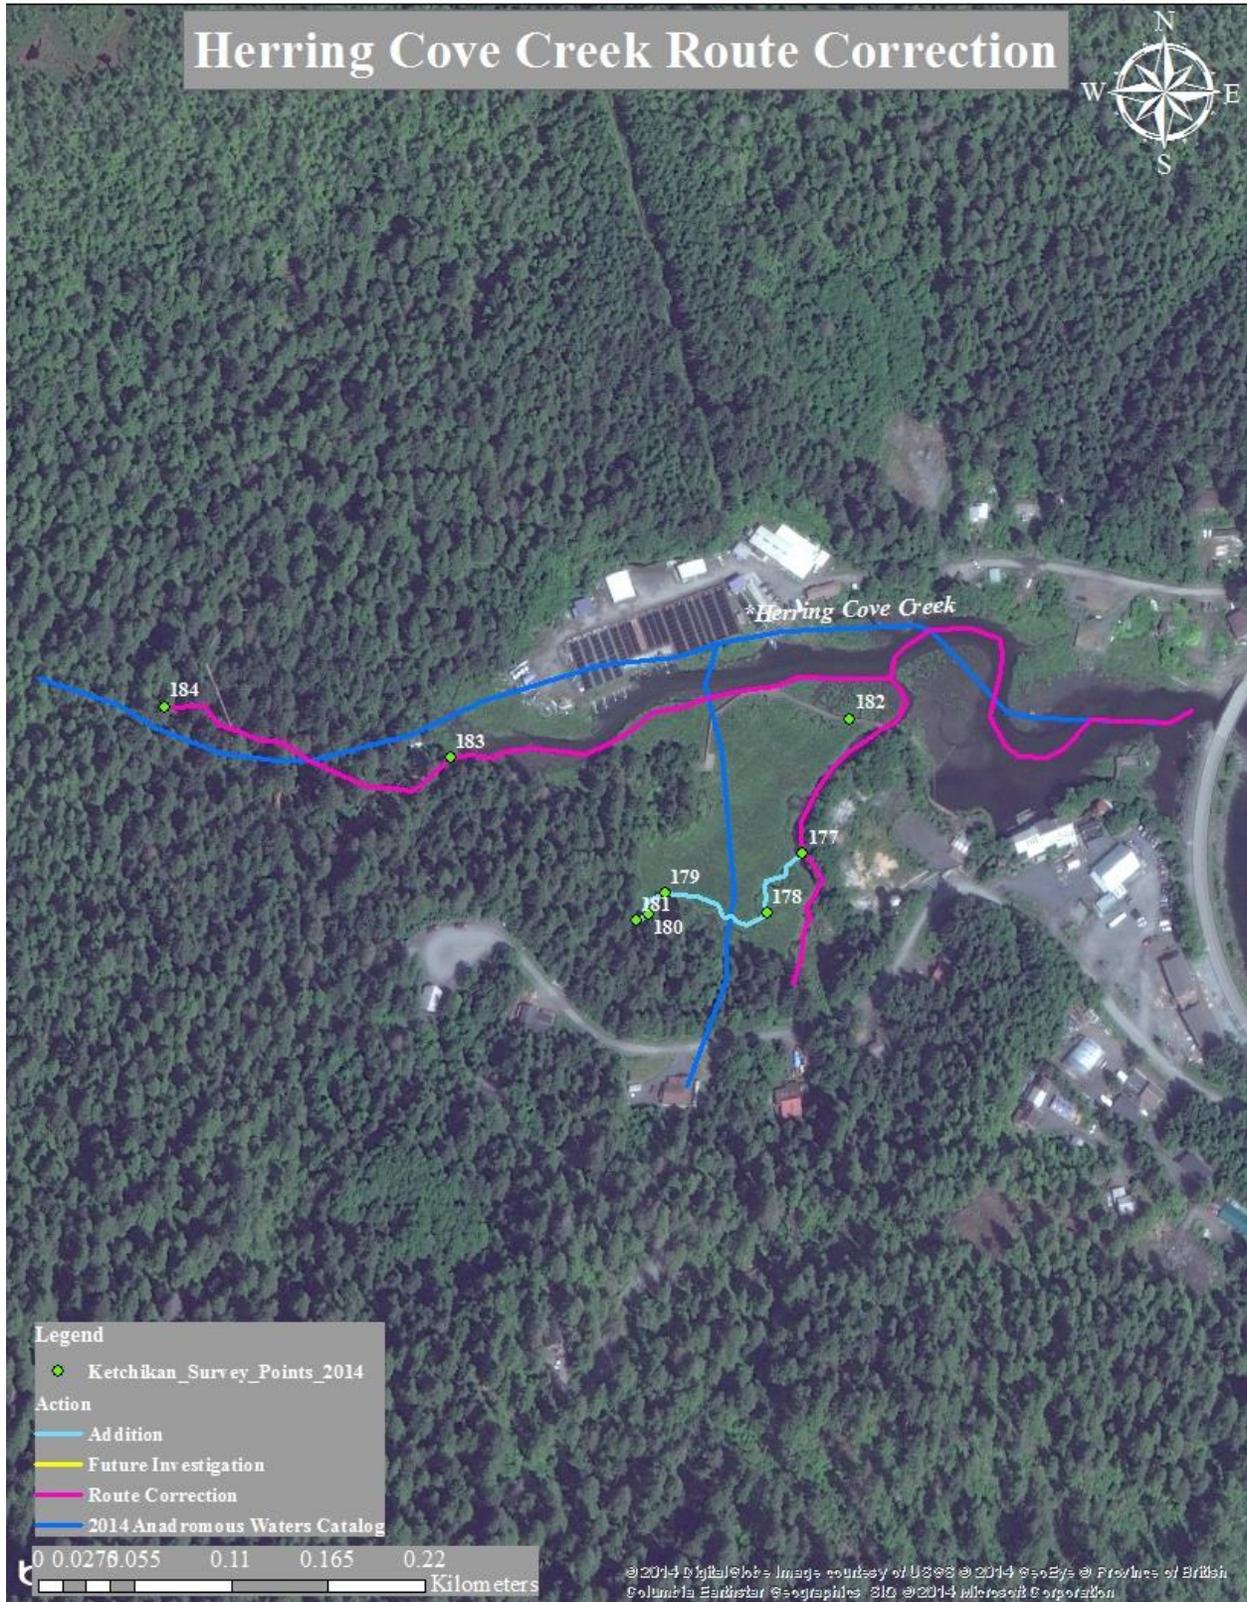
Figure 2.– Herring Cove Creek Route Correction map.
