CRYSTAL CREEK**CORRECTION****Water body name:** Crystal Creek**Survey date:** 6/9/2014**Water body number:** 191-20-13800-2023**Species & Lifestage:** COs, DVp**Watershed:** White River-Frontal Gulf of Alaska**MTR:** C022S022E **Quad:** Icy Bay D-2**Findings:** We surveyed stream 191-20-13800-2023 using a GPS and handnet. We were able to catch rearing coho salmon. We did not come across any fish barrier, but we were above area that was being considered for logging.**Recommendations:** Correct the current route in the AWC and add rearing coho salmon.

Table 1.–191-20-13800-2023 survey data.

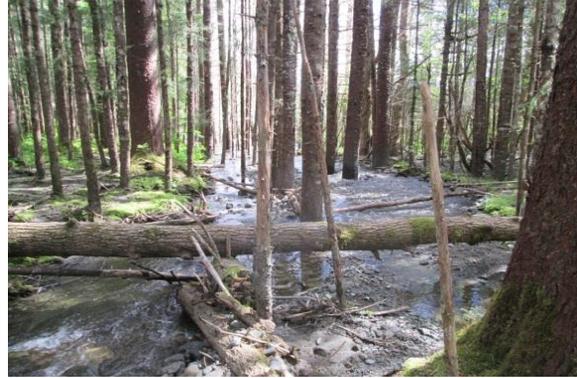
Figure 2.—There is no defined channel once stream leaves mountain side.

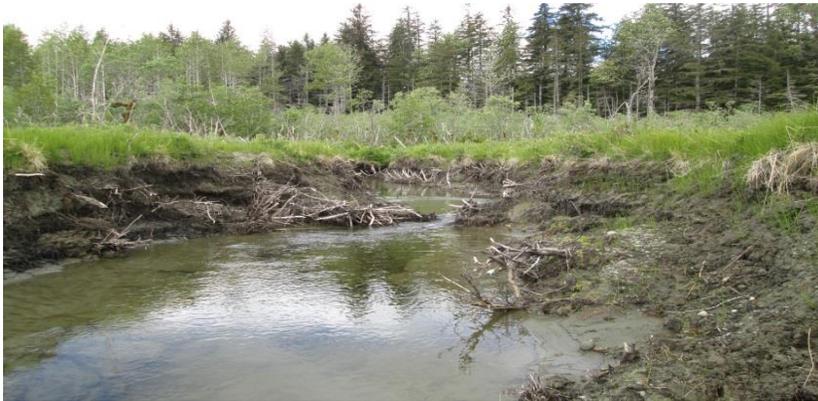
Figure 3.—The stream is cutting back through the sediment layer that had been deposited here when beavers were active in area.
