Department of Fish and Game  
Division of Habitat

SUBJECT: Glacier Creek Investigation  
Trip Report

On May 27-30, 2014, Habitat Biologists Nicole Legere, Gordon Willson-Naranjo, and I surveyed Glacier Creek and tributaries to determine fish presence along a proposed road alignment. Constantine Metals proposes to reconstruct an existing access road on the east side of Glacier Creek that has overgrown and is no longer usable (Figure 1). The road was constructed in 1977 to access mineral resources. The reconstructed road will be 4 km long with a road prism of 4.25 m top width and a 4.8-5.5 m bottom width. Five bridges between 5.4-12 m long and 18 culverts will be installed for hydraulic conveyance.

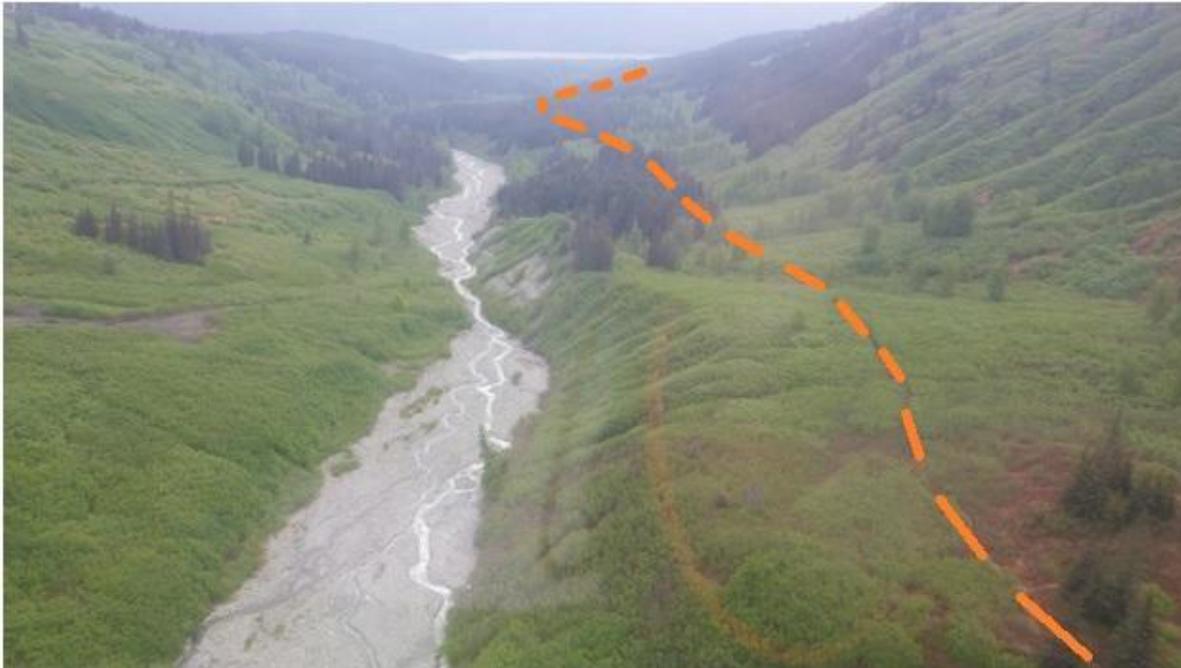
Figure 1.—Looking north, down Glacier Creek with approximate road alignment in orange (May 28, 2014).

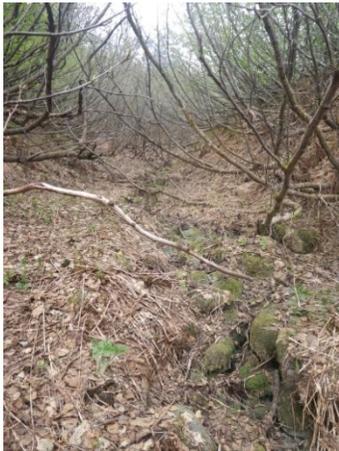
Streams A through D, and F through G are ephemeral channels that did not contain flowing water during our site visit (Figures 2, 3). Stream E has a deeply incised channel with cobble and boulder substrate and high bed load movement. The channel gradient is 22% upstream and downstream of the road crossing. We electrofished from the Stream E confluence with Glacier Creek to upstream of the proposed road crossing and did not capture fish (Figures 4, 5).

Figure 2.—Stream A (May 28, 2014).

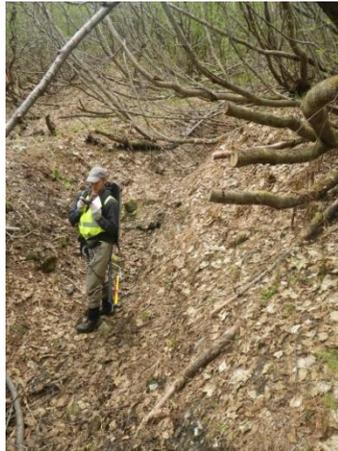
Figure 3.—Stream D (May 28, 2014).

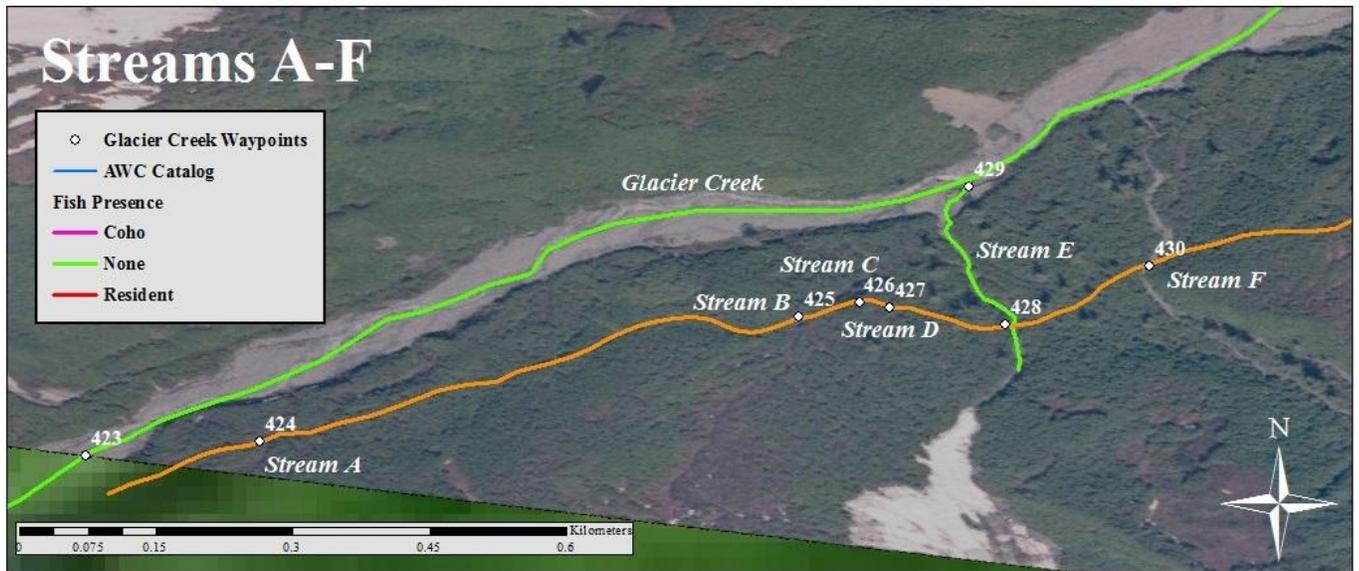
Figure 5.—Map of proposed road alignment and stream crossings A-F.

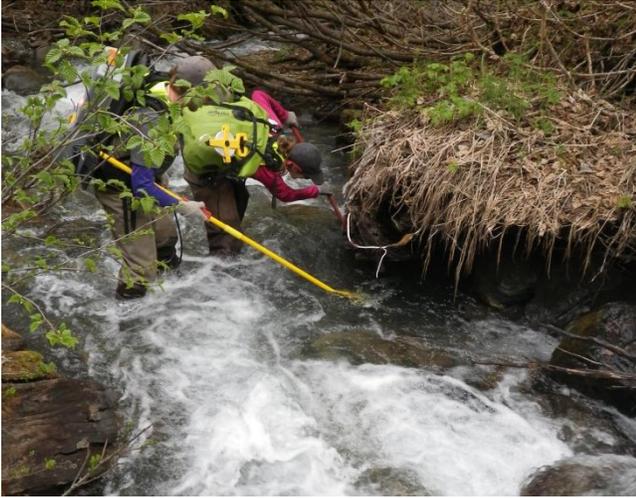
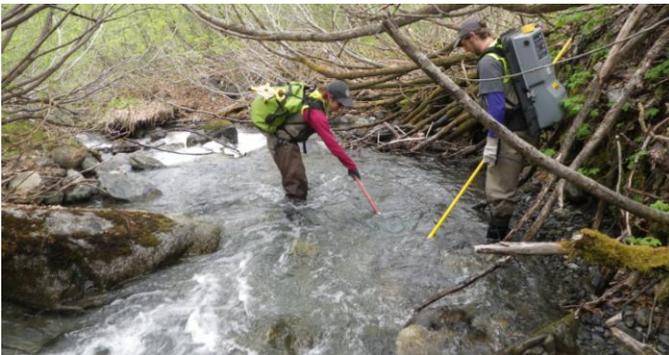
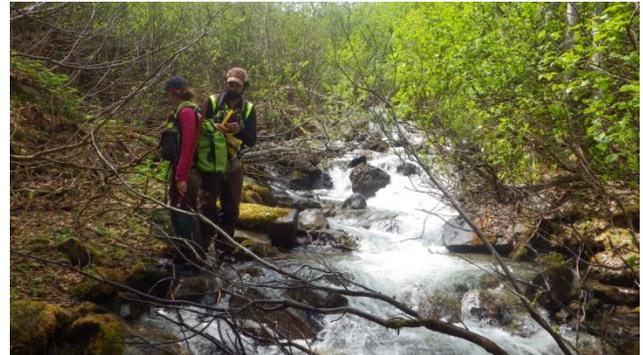
Stream H, locally known as Christmas Creek, was the largest tributary of Glacier Creek we surveyed. The stream has gravel to boulder substrate. We electrofished above and below the proposed road alignment (Figures 6, 7, 8, 9) and captured two Dolly Varden char, 95-150 mm, and visually observed

one below the alignment. Channel bed width (CBW) at the proposed road crossing averages 3.8 m<sup>1</sup>, and the stream gradient is 10% 17 m upstream and 13% 18 m downstream of the road. The crossing was flagged for a 9 m log stringer bridge.

Figure 6.—Nicole Legere and Matthew Kern electrofishing an undercut bank in Stream H (Photo by GWN: May 28, 2014).

Figure 8.—Nicole Legere and Matthew Kern electrofishing Stream H (Photo by GWN: May 28, 2014)

Figure 9.—Gordon Willson-Naranjo and Nicole Legere upstream of the road crossing (May 28, 2014).

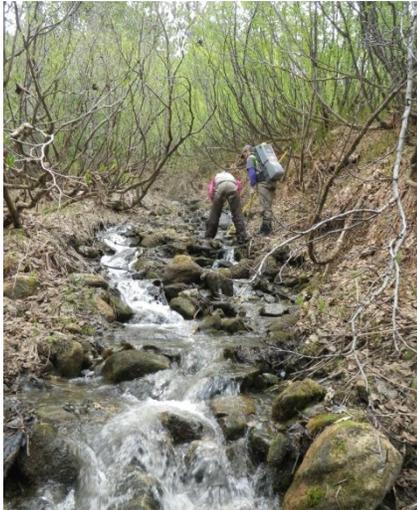
Figure 10.—Electrofishing Stream K (Photo by GWN: May 28, 2014).

Streams I, J, and K are tributaries to Christmas Creek (Stream H). We electrofished these drainages and did not capture fish (Figure 10). Stream J is a small drainage that had flow above and below the road alignment, and flowed subsurface for about 15 m at the road alignment. Stream L has an average channel bed width of 2 m, and has 16% gradient 18 m upstream and 12% 20 m downstream of the crossing (Figure 11). The Stream L crossing was flagged as a 48 in corrugated metal pipe (CMP) culvert. Stream M (Figure 12) has an average channel bed width of 1.5 m and a gradient of 26% 18 m upstream and 26% 18 m downstream of the crossing. The Stream M crossing was flagged as a 7.6 m log stringer bridge. We electrofished Streams L and M above and below the road alignment and caught no fish.

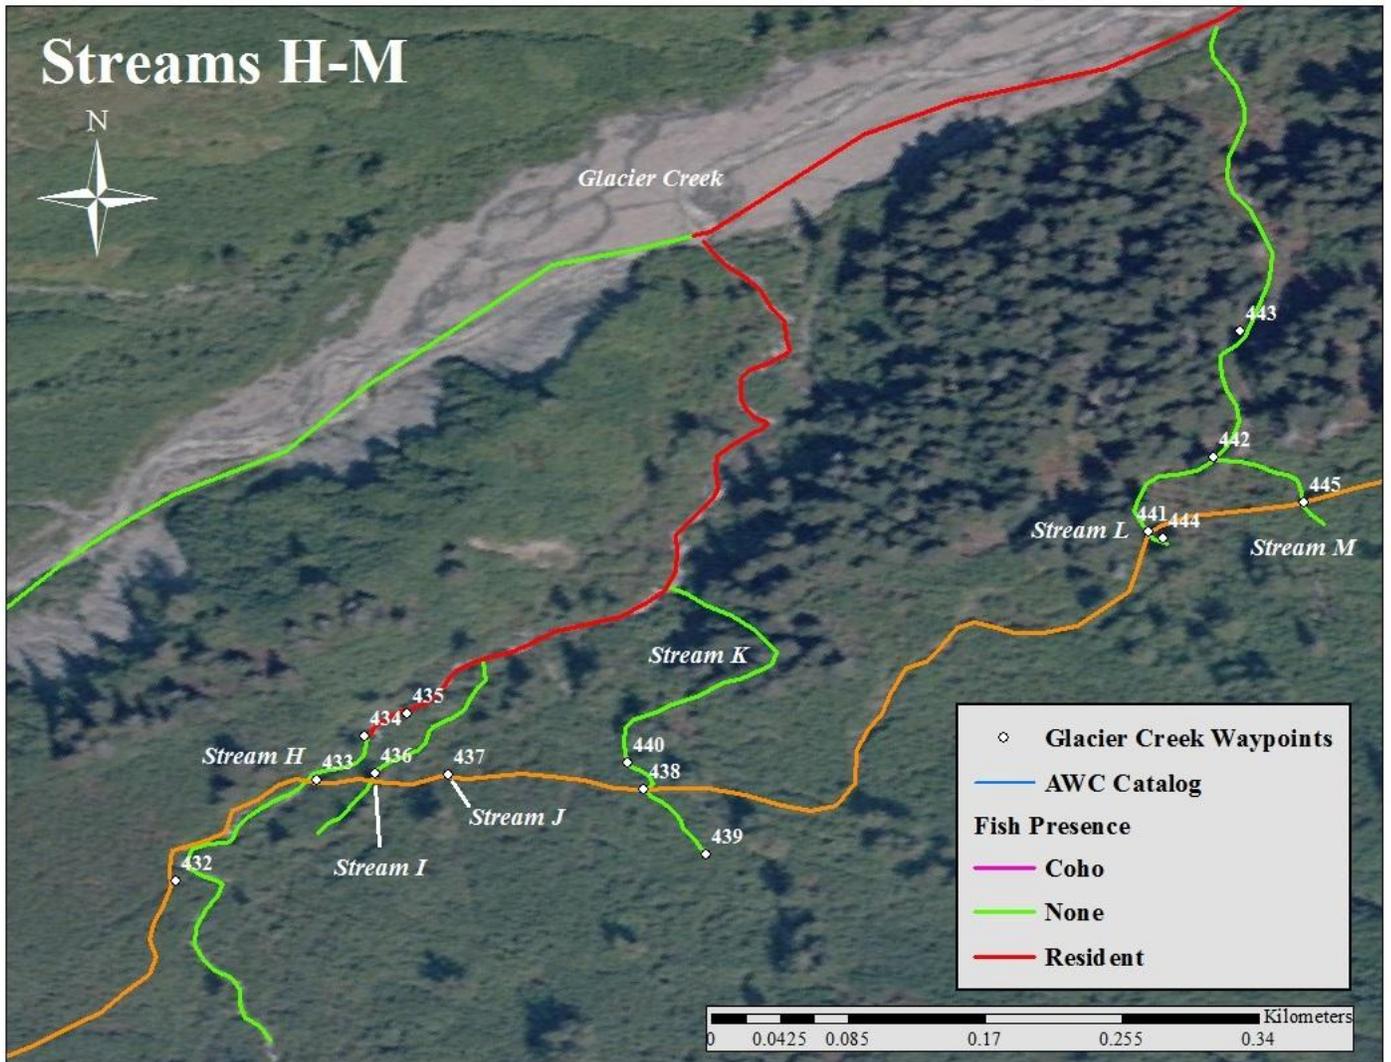
Figure 12.—Map of proposed road alignment and stream crossings H-M.

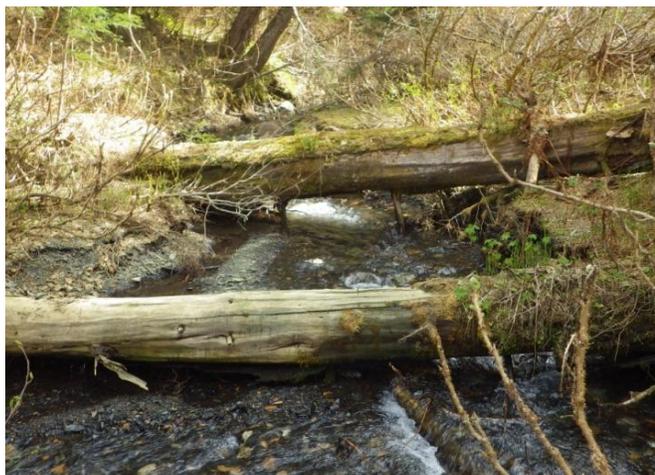
Stream P has gravel substrate and an average channel bed width of 2.3 m near the road alignment (Figure 13). Gradient is 4% 18 m upstream, and 5% 18 m downstream of the road. We captured one 180 mm Dolly Varden char (Figure 14), and visually observed another downstream of the road alignment.

Figure 13.—Stream P just downstream of the road crossing (May 28, 2014).

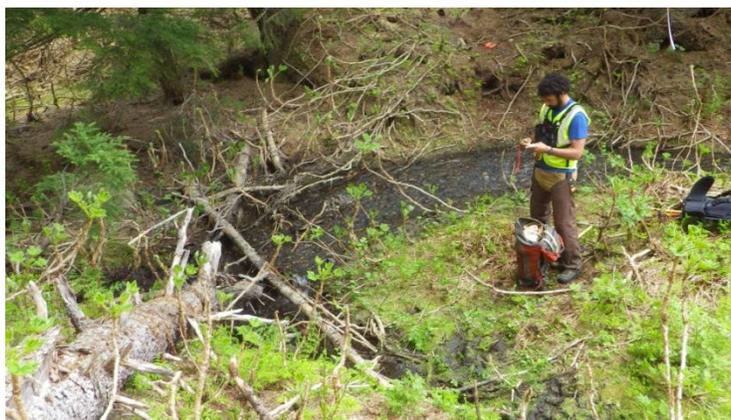
Figure 15.—Gordon Willson-Naranjo on the bank of Stream Q at the crossing (May 29, 2014).

Stream Q has gravel substrate and an average channel bed width of 1.4 m near the road crossing. The stream was flagged for a 24 in CMP culvert. Stream Q has a gradient of 10% 17 m upstream, and 14% 18 m downstream of the road alignment (Figure 15). We electrofished from the confluence of Glacier Creek to above the road alignment and did not find fish. There is a 1.5 m falls between the Glacier Creek floodplain and Stream Q that may impede upstream resident fish passage (Figure 16).

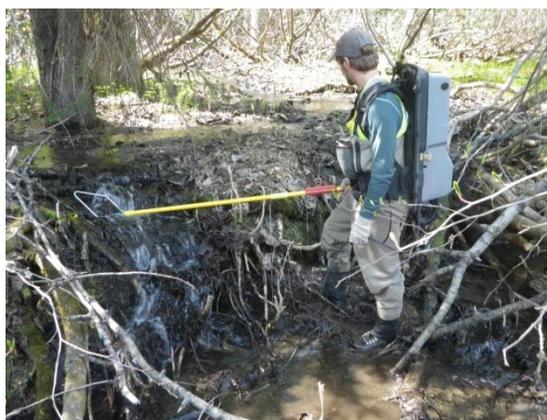
Figure 16.—Matthew Kern at the falls near the confluence of Stream Q and Glacier Creek (Photo by GWN: May 29, 2014).

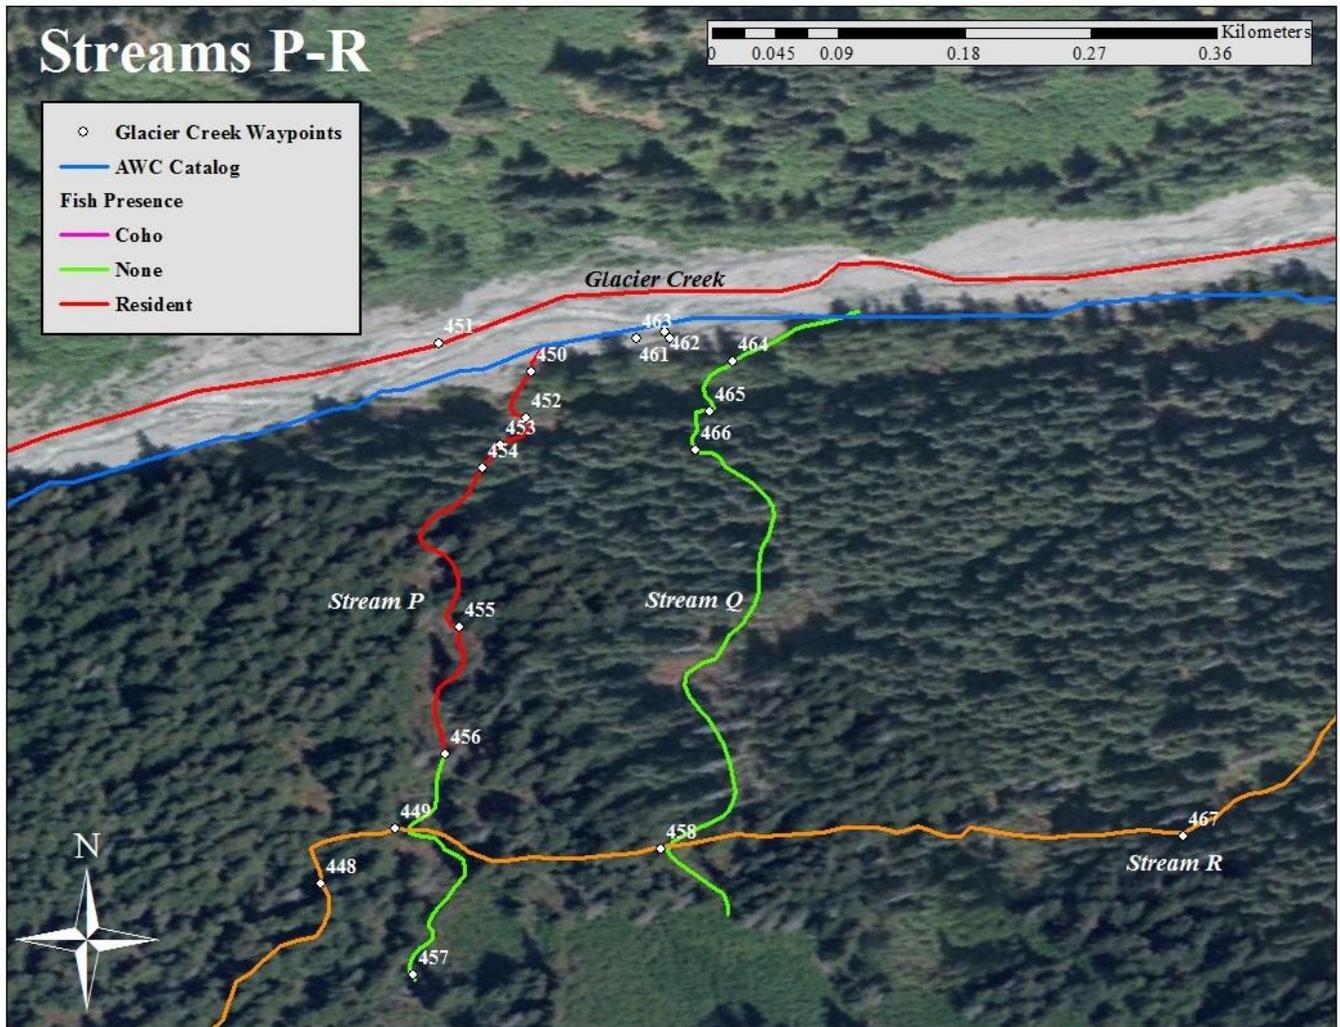
Stream R may be ephemeral and was flagged as an 18 in CMP (Figure 17). Stream gradient above the road alignment is 18% 15 m upstream and 19% 15 m downstream of the road. Substrate consists of sand and organics.

Figure 17.–Map of proposed road alignment and stream crossings P-R.

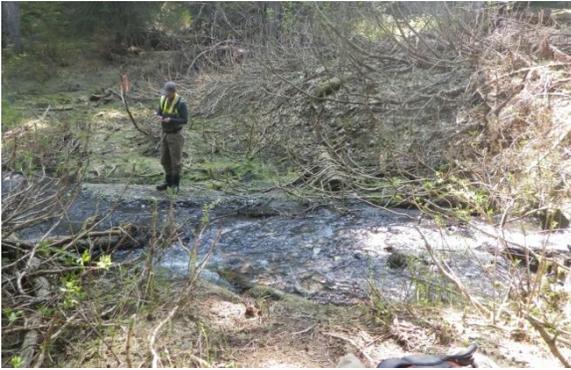
Stream S has 18% gradient 20 m downstream, and 10% gradient 29 m upstream of the road. The average channel bed width near the road crossing is about 2.1 m and the stream was flagged for a 9 m log stringer bridge (Figure 18). We electrofished above and below the road alignment and caught several Ephemeroptera (mayfly) larvae and no fish (Figure 19).

Figure 18.—Stream S near the road crossing (Photo by GWN: May 29, 2014).

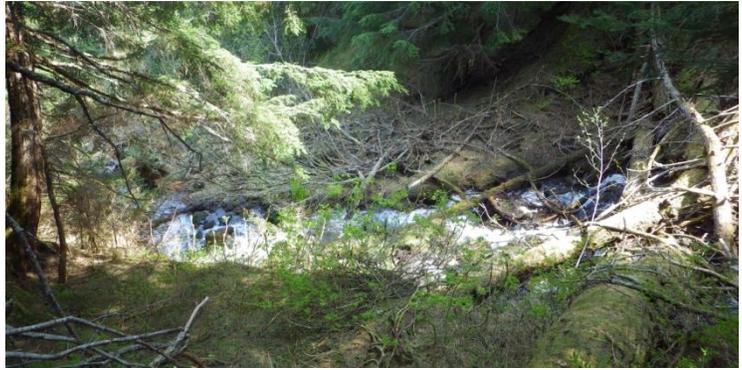
Figure 19.—Stream S downstream of the road crossing in a step pool cascade section (May 29, 2014).

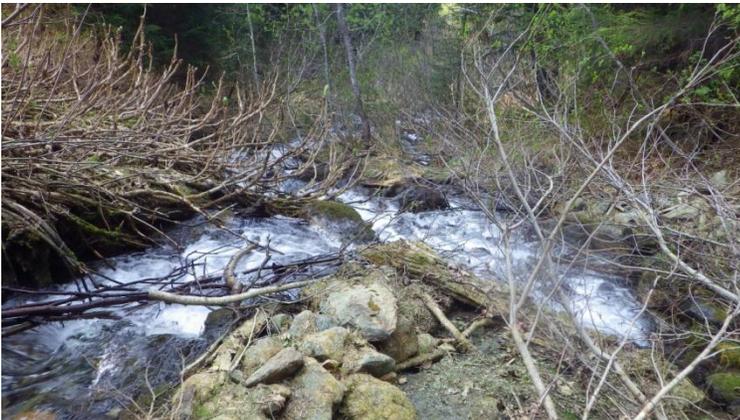
Stream T has several step pools and an average channel bed width of 2.6 m near the road alignment (Figure 20). The stream is flagged for a 6 m log stringer bridge. Channel gradient is 23% 15 m upstream and 23% 21 m downstream of the road. We encountered a series of waterfalls and cascades just above the confluence with Glacier Creek that are barriers to fish passage (Figures 21, 22). We electrofished above the barrier and road alignment and did not capture fish. On May 27 we set 4 minnow traps and did not capture fish after an overnight soak.

Figure 20.—Stream T looking downstream from the road alignment (May 29, 2014).

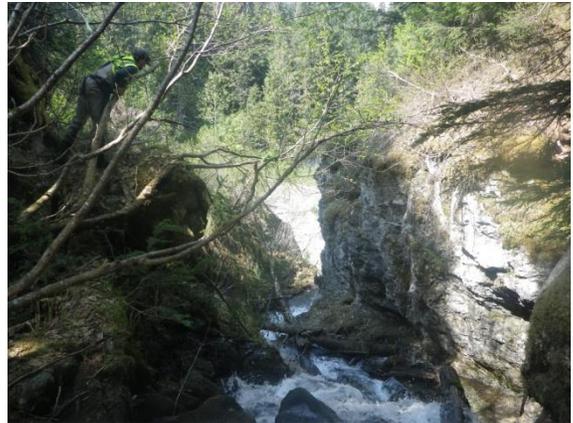
Figure 21.—Series of waterfalls on Stream T just before confluence with Glacier Creek (Photo by GWN: May 29, 2014).

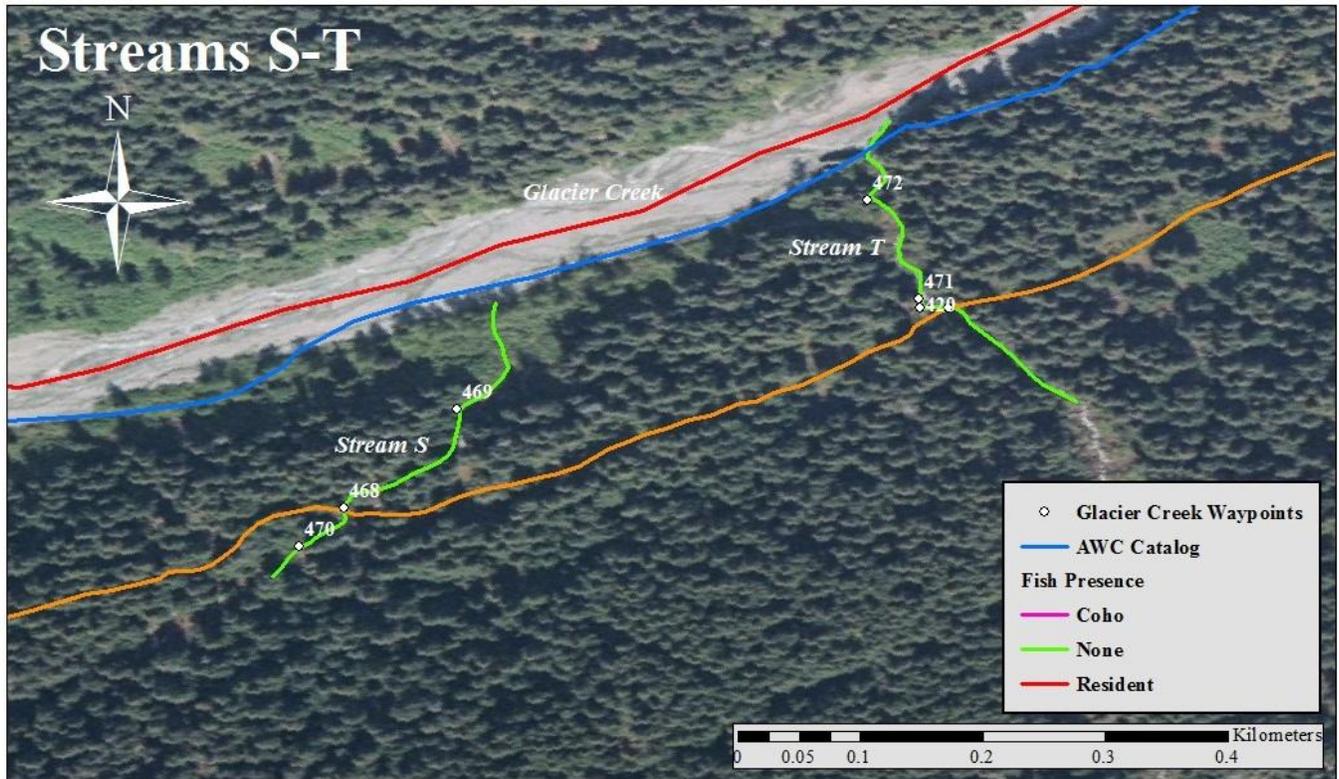
Figure 22.–Map of proposed road alignment and stream crossings S-T.

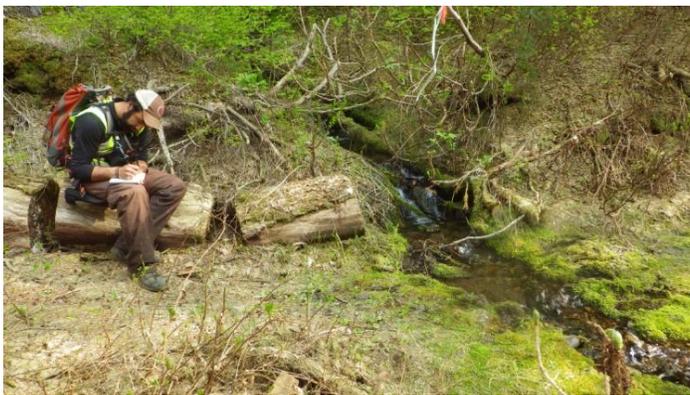
Figure 23.–Gordon Willson-Naranjo near Stream U at the road crossing (May 29, 2014).

Stream U has an average channel bed width of 0.45 m near the road alignment (Figure 23). The stream flows about 200 m downstream of the crossing before reaching a small pond (Figure 24). On May 27 we set one baited minnow trap in the pond and after an overnight soak captured four 60-80 mm Dolly Varden char. On May 28, we electrofished upstream of the pond and captured two 50-70 mm Dolly Varden char (Figures 25, 26, 27). At the road alignment the stream steepens to 18% 20 m upstream and 16 % 20 m downstream of the road crossing.

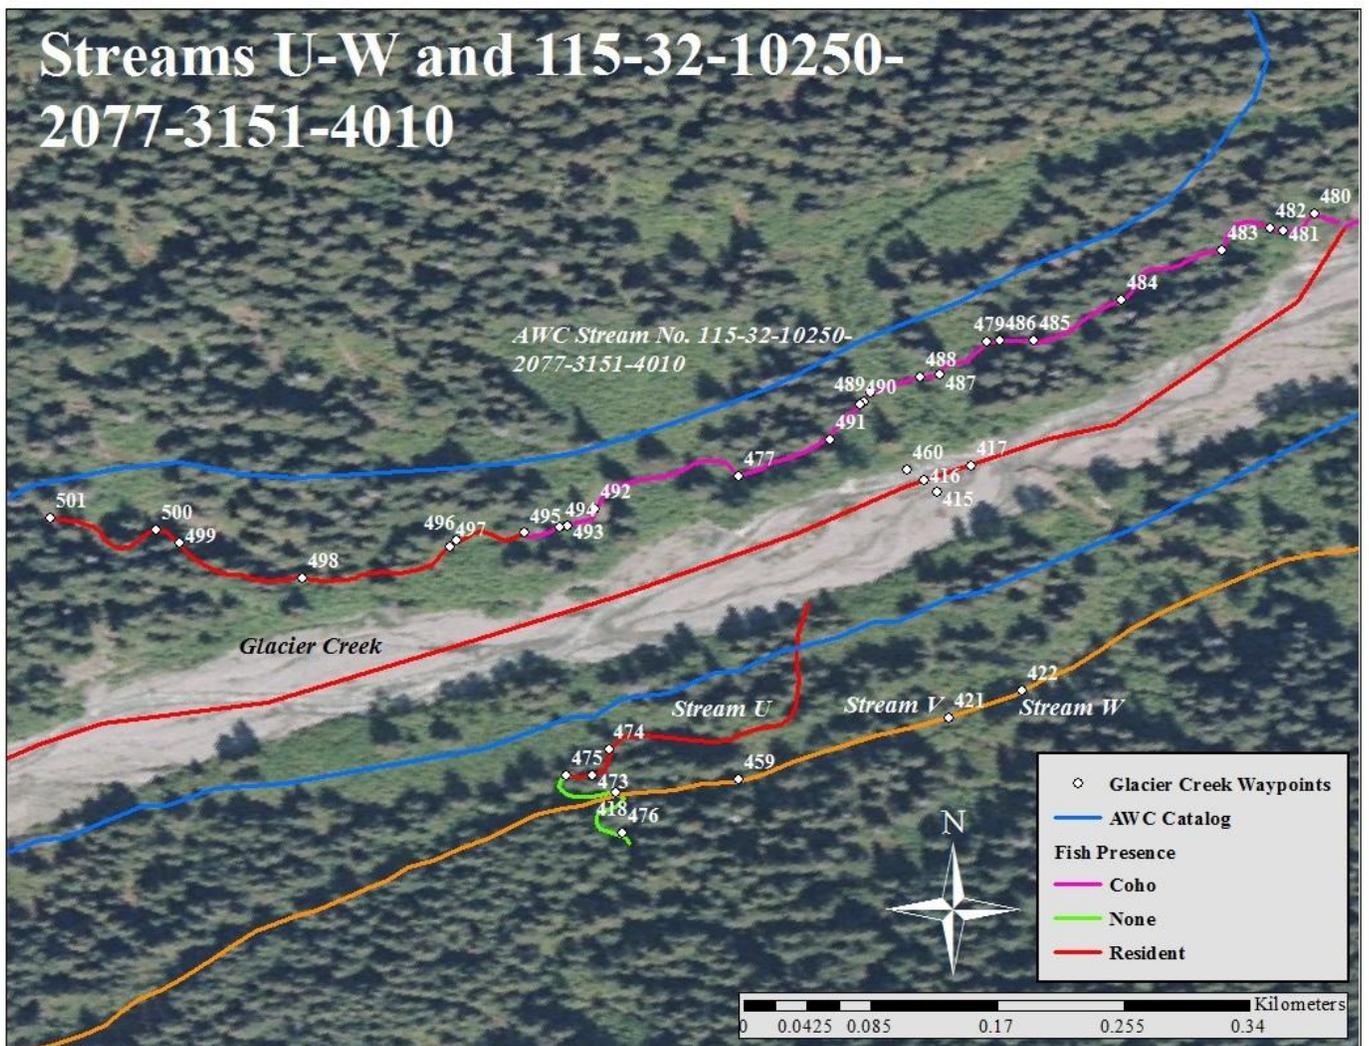
Figure 27.—Map of proposed road alignment, stream crossings U-W and Stream No. 115-32-10250-3151-4010.

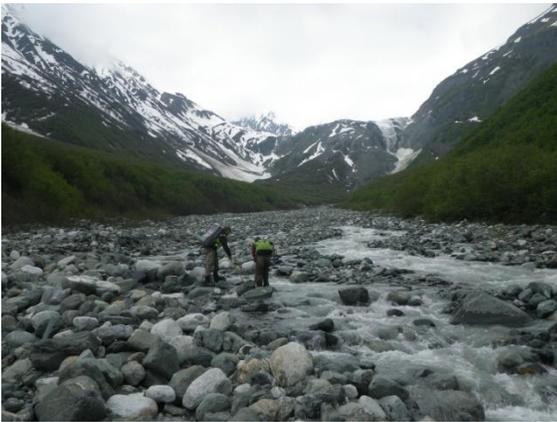
Figure 28.—Electrofishing in Glacier Creek (May 28, 2014).

Glacier Creek, Stream No. 115-32-10250-2077-3151, is cataloged for Dolly Varden char, cutthroat trout, and coho salmon. In Glacier Creek we opportunistically set traps, electrofished, and measured channel gradient, temperature, and conductivity (Figures 28, 29, 30). Channel gradient ranged from 4% to 15%. Water temperature ranged from 35.7° F near the headwaters to 45.8°F at the former bridge crossing<sup>2</sup>. During our site visit the Glacier Creek floodplain was wider than the wetted channel width suggesting that higher summer flows and high bed load movement prevent vegetation from establishing.

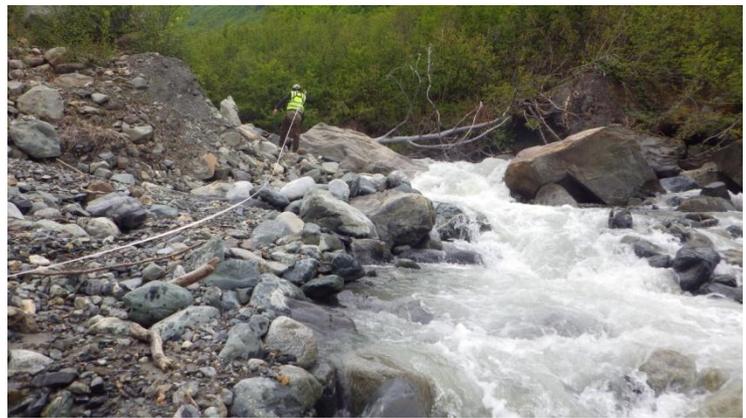
Figure 29.—Measuring channel gradient in a steep section of Glacier Creek (May 28, 2014).

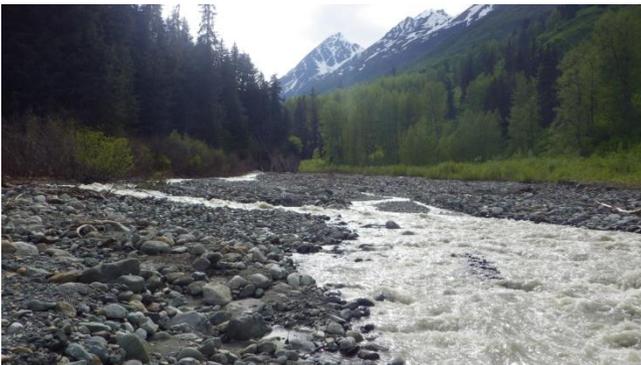
Figure 30.—Low gradient section of Glacier Creek (May 28, 2014).

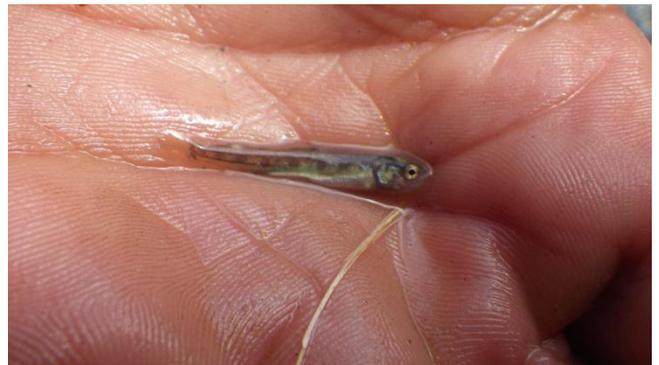
Figure 31.—Dolly Varden char, about 20 mm, captured in Glacier Creek (May 29, 2014).

We captured several 20 mm Dolly Varden char (Figure 31) that appeared to be emerging from fine gravel substrate while electrofishing. We also captured Ephemeroptera (mayfly) and Plecoptera (stonefly) larvae while electrofishing (Figure 32). On May 27, we set five baited minnow traps near the former bridge crossing (WPT 415: Appendix A) and captured 17 Dolly Varden char, 55-85 mm, after an overnight soak (Figure 33). Coho salmon have not been documented in Glacier Creek. I will submit a

correction to change the upper extent of anadromy to the confluence of 115-32-10250-2077-3151 and 115-32-10250-2077-3151-4010 (Glacier Creek Correction: Appendix).

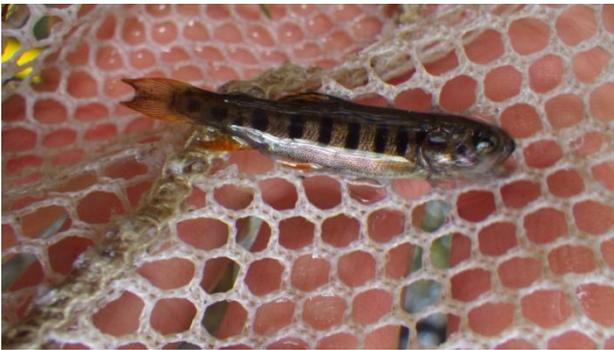
Figure 34.—Juvenile coho salmon captured while electrofishing (May 30, 2014).

On May 30, 2014, we surveyed a cataloged tributary to Glacier Creek, Stream No. 115-32-10250-2077-3151-4010, listed for Dolly Varden char, cutthroat trout, and coho salmon. We electrofished the cataloged reach and captured all three species (Figures 34, 35, Table 1). I will submit a route correction to update the stream route in the Anadromous Waters Catalog (Glacier Creek Tributary Correction: Appendix). The stream channel is low gradient and contains sand, gravel, and cobble substrates (Figures 36, 37), and I will return in the fall to conduct spawning surveys.

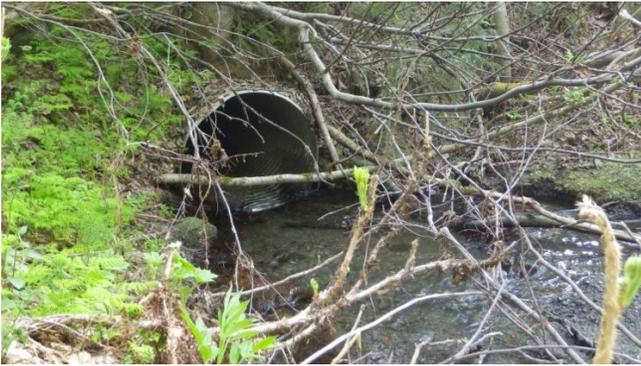
We observed a 1.0 m diameter culvert that conveys the stream under an overgrown road that was formerly accessed via the Porcupine Road across the Glacier Creek bridge. Though not bedded, the culvert does not impede fish passage (Figure 38). The stream has several large pools and abundant woody debris (Figure 39).

Figure 38.—Culvert under overgrown road (May 30, 2014).

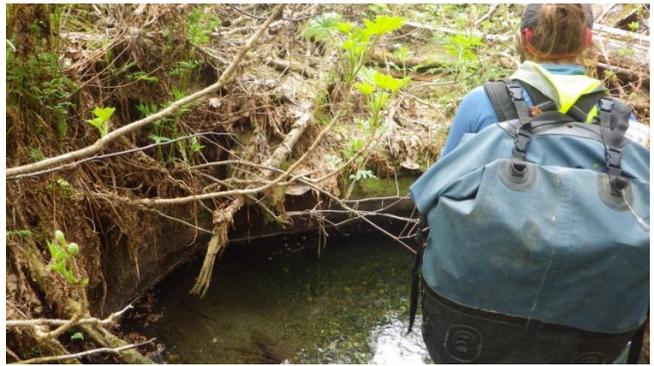
Figure 39.—Deep scour pool (May 30, 2014).

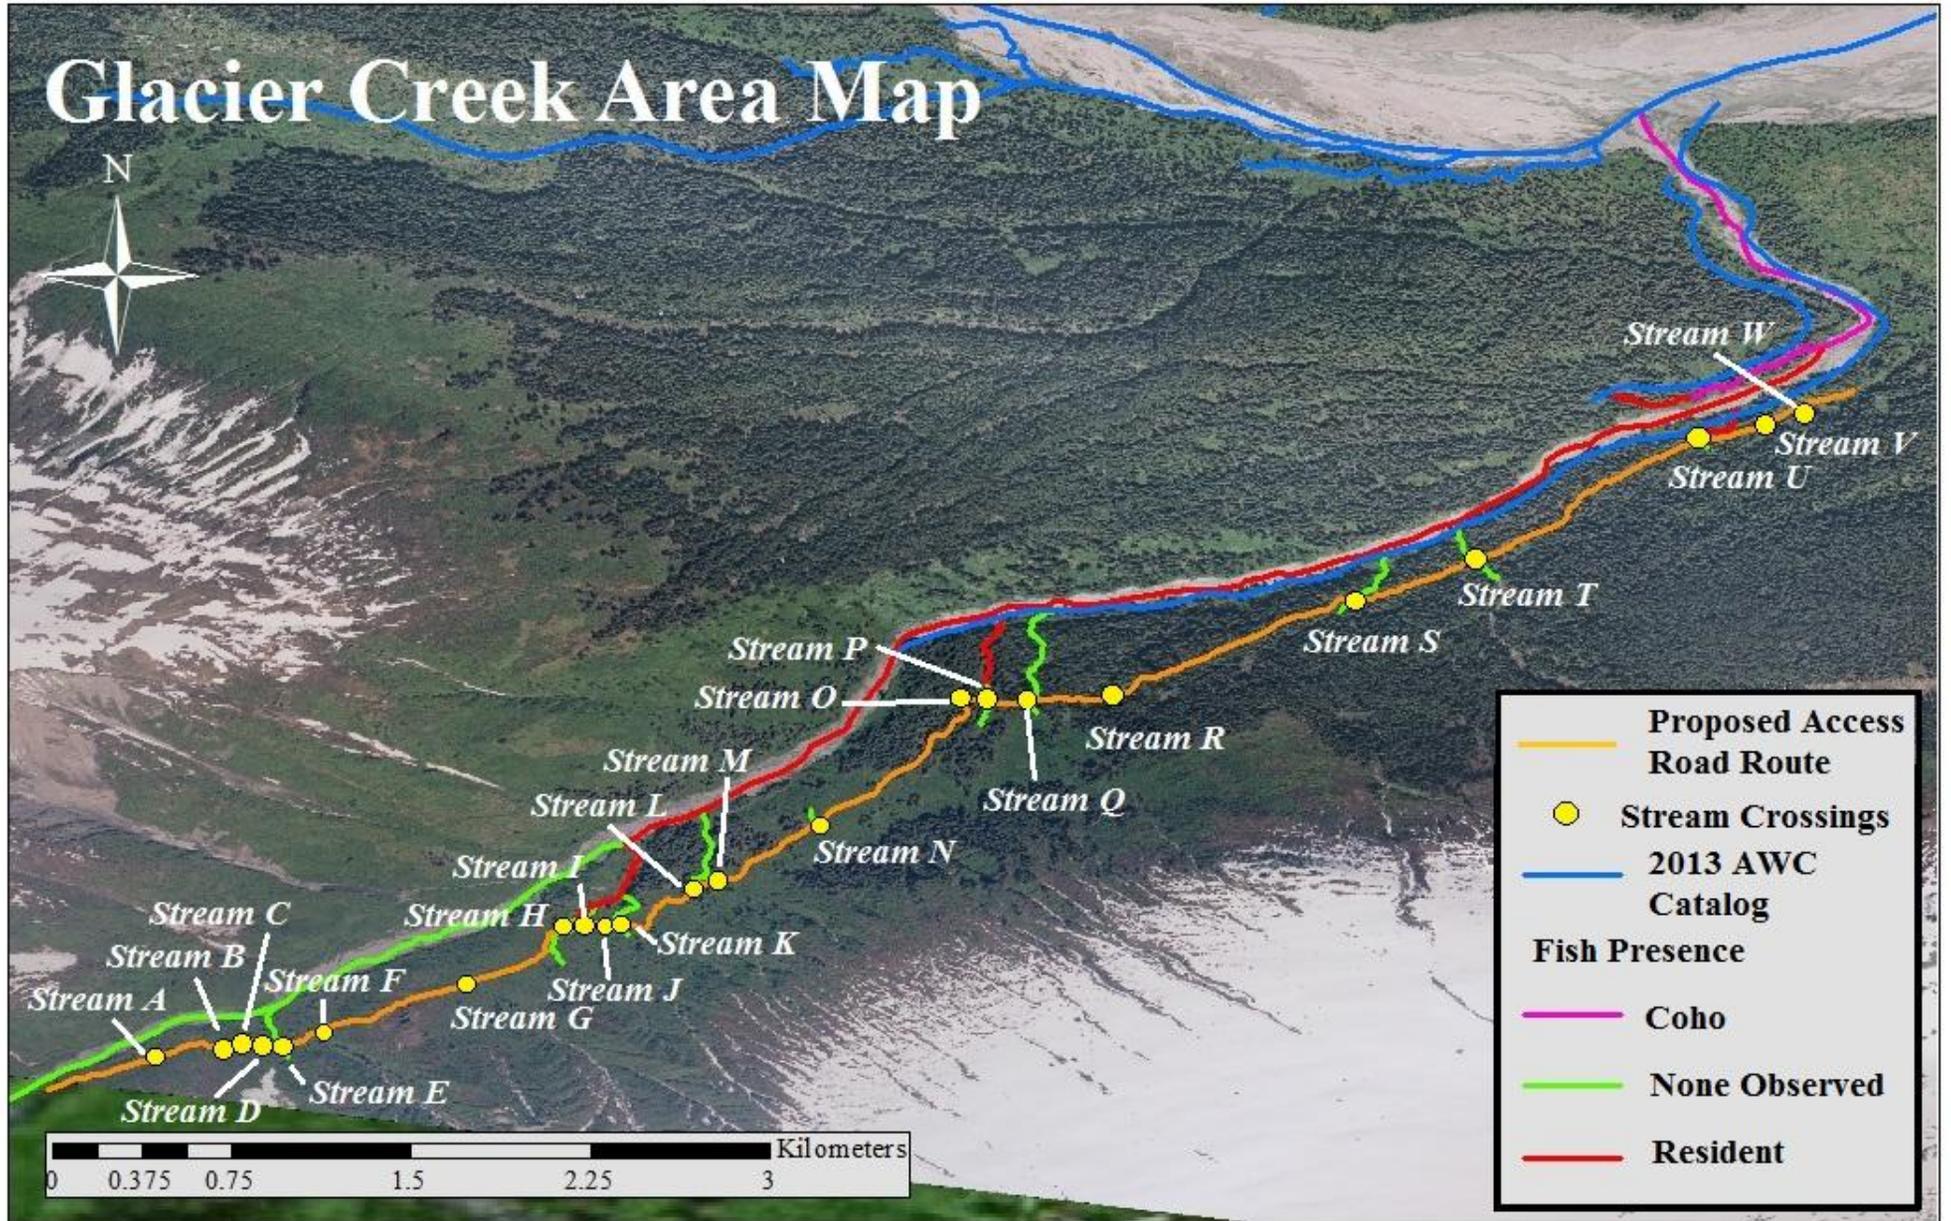
Appendix A.-Map of all stream crossings surveyed and proposed access road.

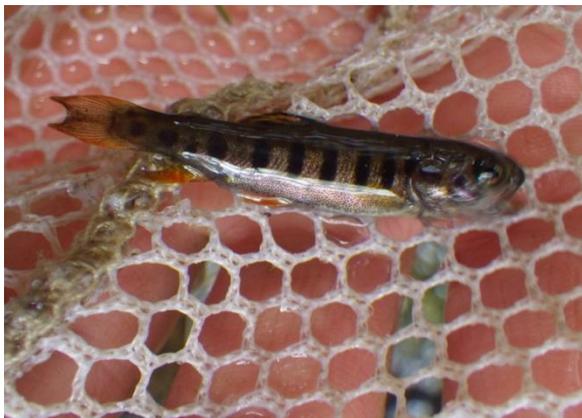
Figure 1.–Coho salmon captured while electrofishing ( May 30, 2014).

**Findings:** We surveyed this Glacier Creek tributary and electrofished from the confluence with Glacier Creek upstream. We captured Dolly Varden char, cutthroat trout, and coho salmon (Figure 1, Table 1). We observed an old culvert beneath an overgrown road that did not block fish passage (Figure 2). The stream contains deep pools, and gravel substrates (Figure 3).

**Recommendations:** We recommend updating the stream arc and upstream coho presence extent of this stream (Figure 4).

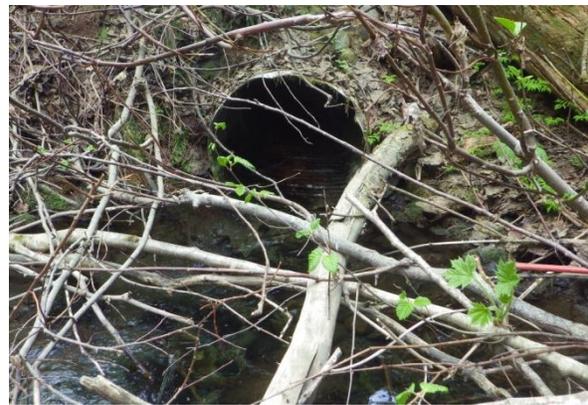
Figure 2.–Culvert under overgrown road (May 30, 2014).

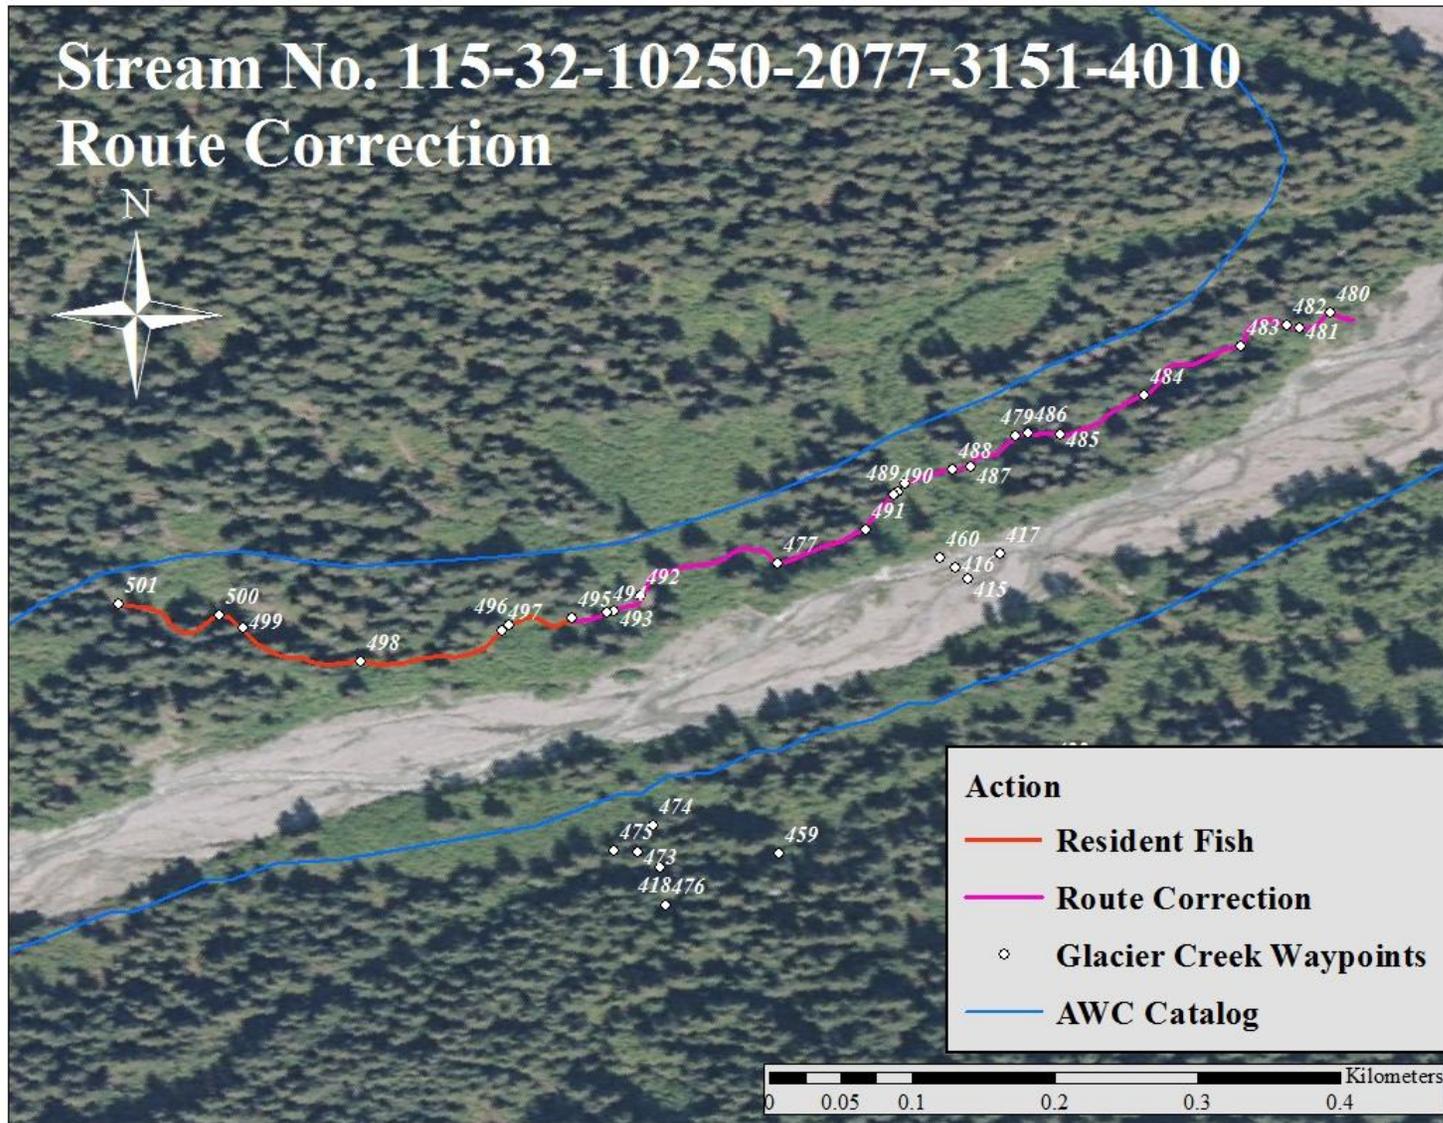
Figure 4.—Map of Glacier Creek tributary with waypoints labeled.

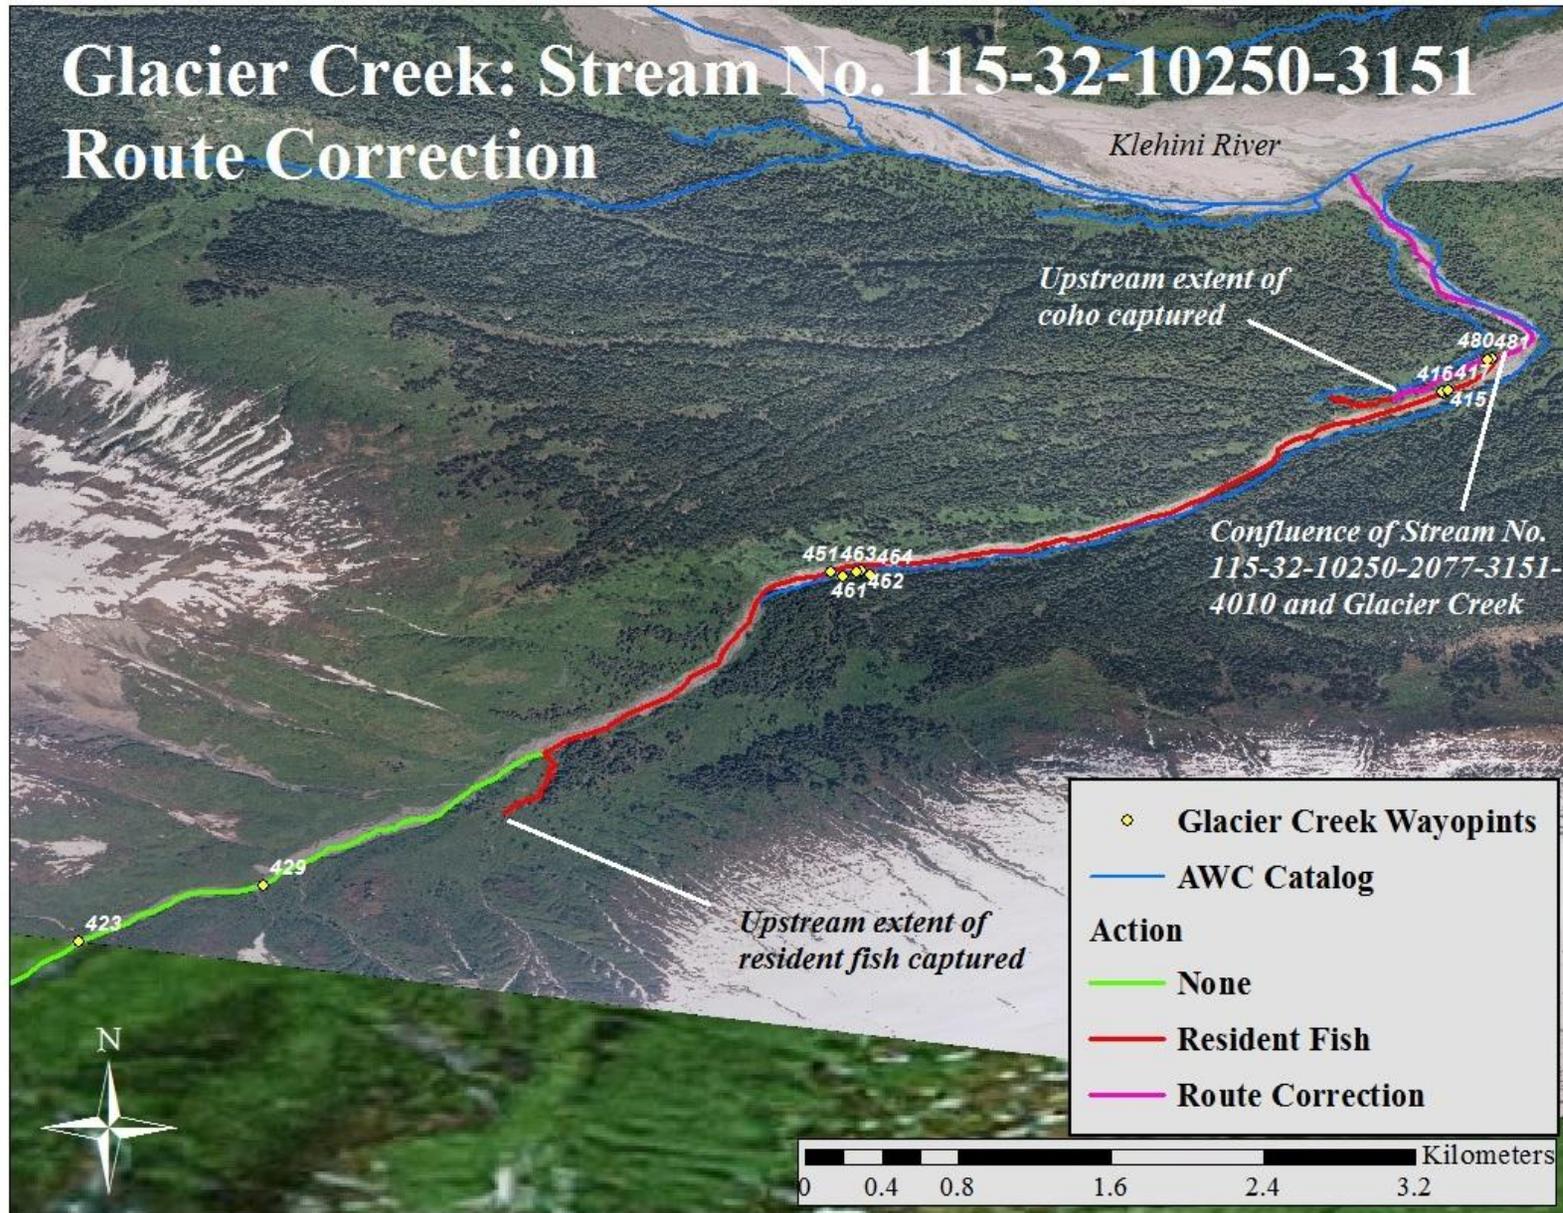
Figure 8.—Area map of Glacier Creek with waypoints labeled.

**Recommendations:** After a review of all existing nomination documents for Glacier Creek, there is no documentation of anadromous fish, therefore we recommend moving the upstream extent of coho presence to the confluence with Stream No 115-32-10250-2077-3151-4010.
