107-40-10790**CORRECTION****Water body name:****Survey date:** 9/25/2014**Water body number:** 107-40-10790**Species & Lifestage:** DVp**Watershed:** Salamander Creek-Frontal Eastern Passage**MTR:** C064S085E **Quad:** Petersburg B-1**Findings:** We surveyed stream no. 107-40-10790 using a backpack electrofisher and GPS (Table 1). We caught juvenile coho salmon, Dolly Varden char, and cutthroat trout (Figure 1-3).**Recommendations:** Update the stream route in the AWC. Add coho rearing and cutthroat trout presence (Figure 4).**Nomination:** Pending

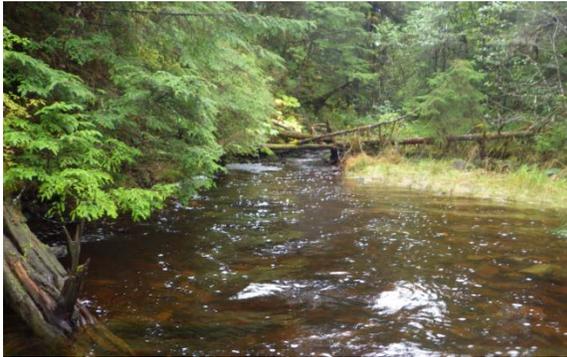
Figure 1.–View upstream from the mouth.

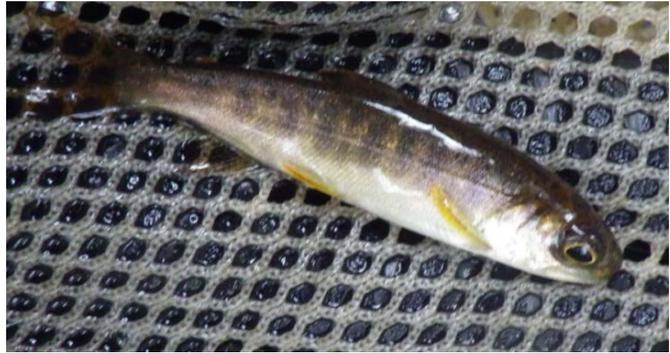
Figure 2.–Coho salmon captured at WP 219.

Waypoint	Latitude	Longitude	Notes	Sample Effort	Sample Results
118	56.3429	-132.1495	Stream 10790. Cannot E-fish mouth due to high tide.		
119	56.3426	-132.1499	Standing at mouth center.		
219	56.3423	-132.1499	Returned to Stream No. 107-40-10790 to E-fish. Problems with the electrofisher on previous survey.	EF	1 CO
220	56.3422	-132.1499	1 CO about 40mm.	EF	1 CO
120	56.3421	-132.1505	E-fisher giving us some trouble.	EF	No Fish
122	56.3410	-132.1511	Tributary on river right.		
123	56.3408	-132.1511	Tributary on river left.		
124	56.3399	-132.1523		EF	1 CT
125	56.3397	-132.1525	Tributary on river right, backwatered with a lots of skunk cabbage.		
126	56.3394	-132.1529	Tributary on river left.	EF	1 DV
127	56.3385	-132.1538	Powerline.		
128	56.3373	-132.1547	Gradient 10% over 25 yds.		
129	56.3367	-132.1546	Gradient 10% over 12 yds.		
130	56.3366	-132.1542	Top of Cascade falls. Looking downstream, 12 % over 14 yds down, then 13 % over next 10 yds.

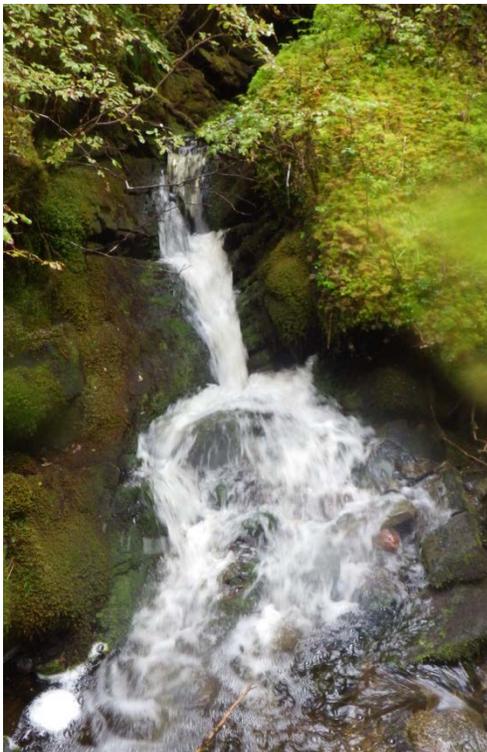
Figure 3.–Base of falls at WP 134.

Waypoint	Latitude	Longitude	Notes	Sample Effort	Sample Results
134	56.3329	-132.1572	Incised falls barrier.		
135	56.3328	-132.1573	Top of falls in this reach. Back to road and then 3.5 mile hike to truck.

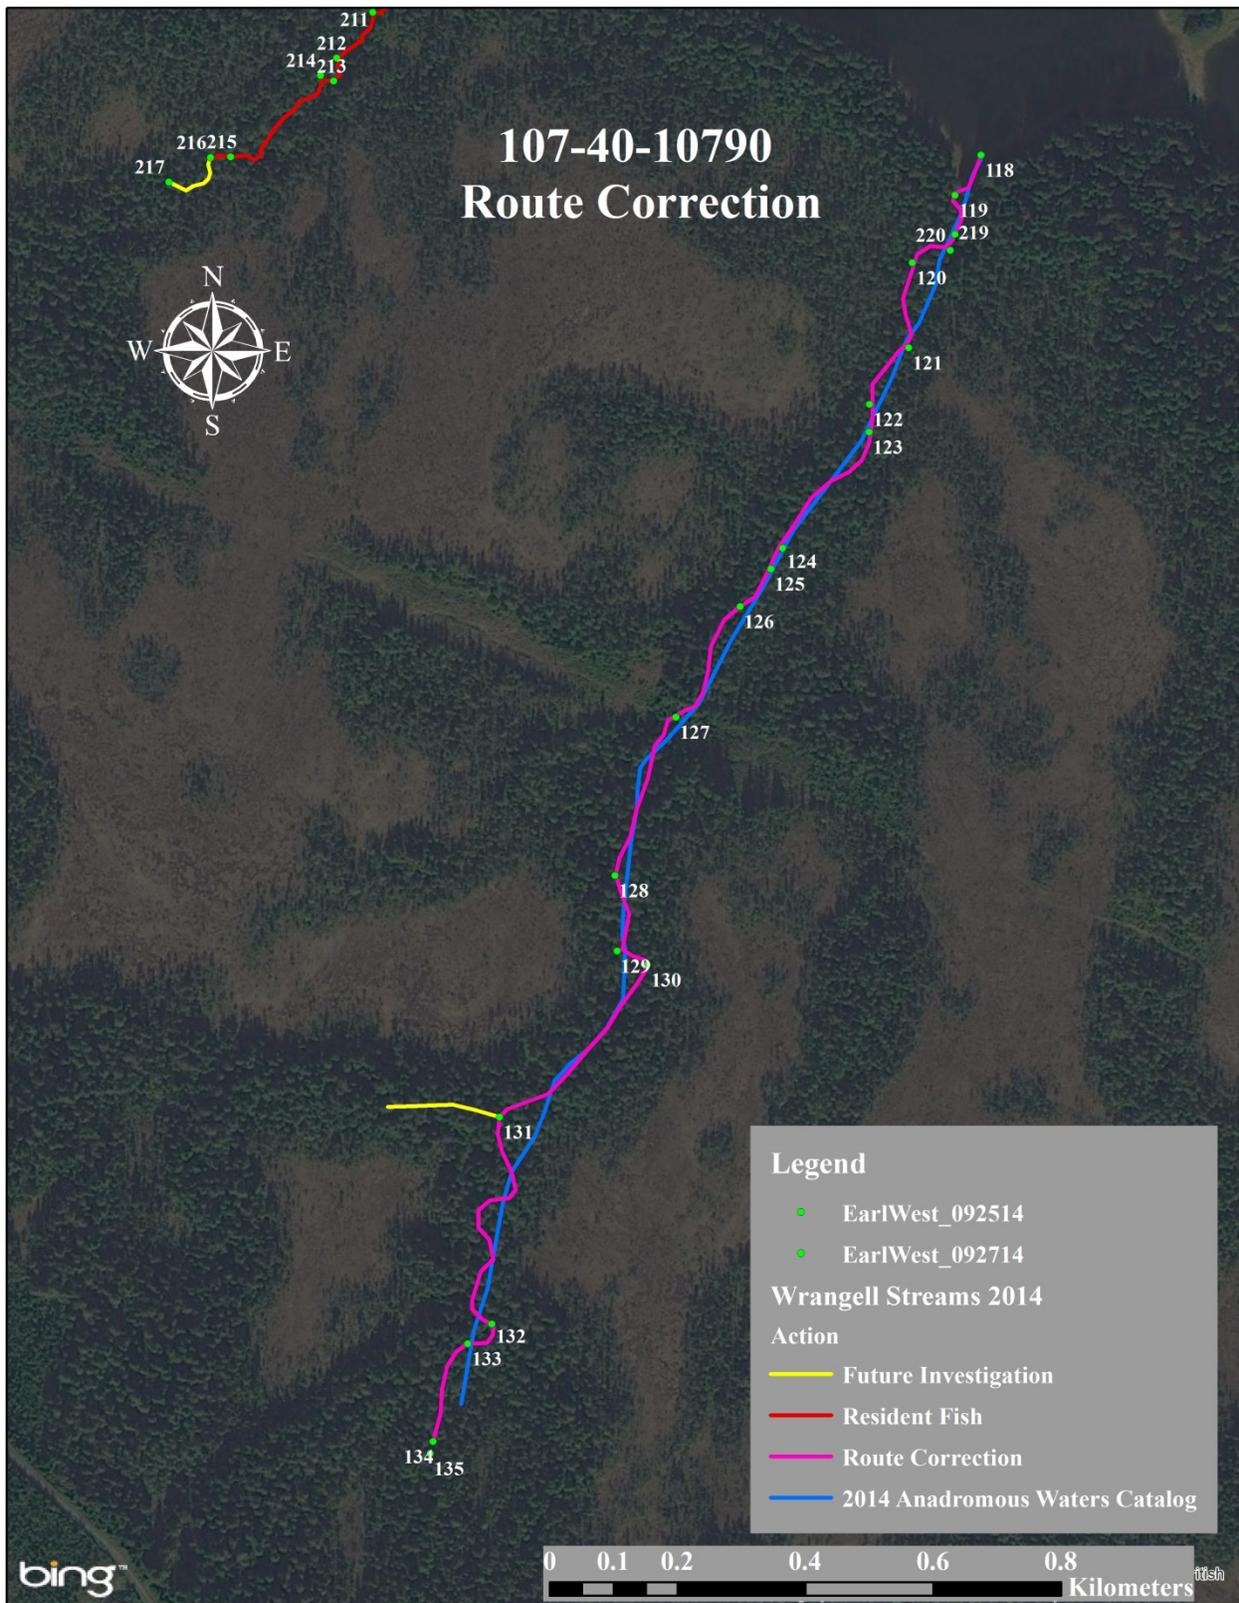
Figure 4.—107-40-10790 route correction map.
