MEMORANDUM

STATE OF ALASKA

SUBJECT: Dry Bay ORV Trails
Trip Report

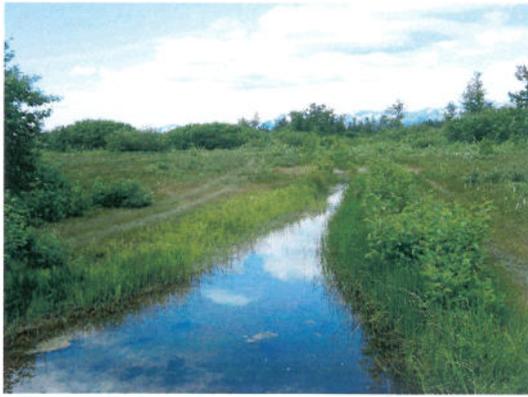
Photo 1. Doame River wetland drainage.

We located an un-cataloged, low-flow drainage about 600' west of the Doame River that flooded an abandoned ORV trail (see Photo 1). Several salmonids were observed swimming in the tire-track channel, we captured coho and stickleback in five traps. This ephemeral channel probably connects to the Doame River or neighboring streams during high flows or floods, and is created by channeling water from nearby wetlands. If the deeply incised abandoned ORV trail was not present, I doubt this channel would exist. New ORV trails that bypass the drainage are established on both sides of the channel and do not cross the drainage.

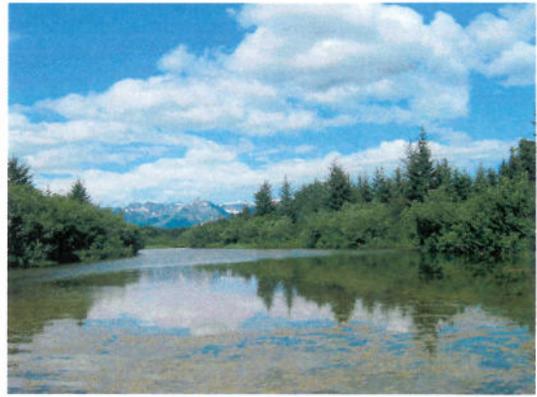
Photo 2. Lake southeast of the EAR.

About 300' southeast of the EAR crossing, we located an un-cataloged lake that drains adjacent wetlands and may provide overflow relief to the EAR during flood events (see Photo 2). Three traps set in the lake captured coho and sockeye salmon and stickleback. Aerial photographs suggest that the lake's two stream outlets drain directly to the EAR. The adjacent ORV trail probably does not impact this lake system, except if trail erosion runoff drains to the lake during wet conditions. I will nominate this lake and outlet stream for inclusion in the Catalog.

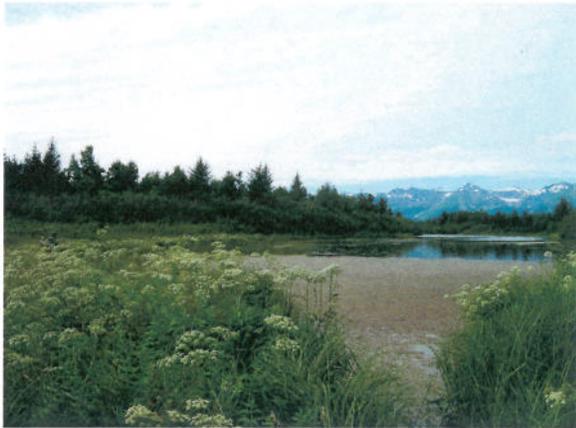
Photo 3. Lake southwest of the EAR.

Along the ORV trail about ¼ mile southwest from the EAR crossing, the trail crosses a 10' wide, un-cataloged lake and outlet drainage (see Photo 3). Aerial photographs indicate that the outlet drains directly to the EAR a few hundred feet downstream, although we did not verify this. Seven traps set in the lake and outlet captured coho and sockeye salmon and stickleback. Some bank undercutting near the narrow crossing entrances are evident, and small rock appears to have been placed in the streambed to strengthen the crossing. If this crossing remains open, it should be clearly marked and the banks sculpted for entry and hardened. Additional hardening of the streambed may also be beneficial. I will nominate this lake and outlet drainage for inclusion in the Catalog.

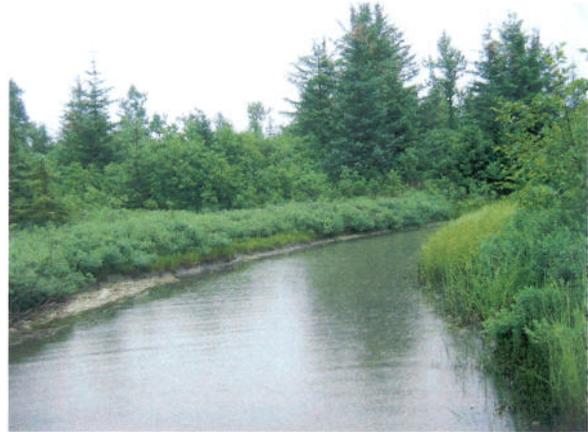
Photo 4. Small pool in the ORV trail.

About 1 mile west of EAR along the trail, we observed several dead coho and stickleback in a small isolated pool in the trail (see Photo 4). A 2-minute seine tow of about ½ the pool captured coho and sockeye salmon and stickleback. Most of the fish appeared unhealthy, having large heads and skinny bodies, which is probably due to competition within the small pool. We could not identify a nearby

anadromous water body where the fish might have originated, and speculate that the pool would probably not exist if the trail was not deeply incised. The connection might be more obvious during higher flows and could warrant further investigation before making trail maintenance recommendations at this location.

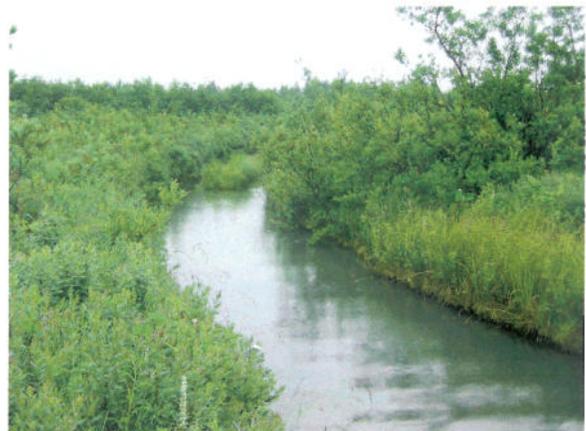
Photo 5. Lower EAR wetland drainage (trail).

This drainage has experienced significant bank erosion from ORV crossings, from wave action undercutting the banks and a deeply incised track, causing the drainage to backwater along the perpendicular trail (see Photo 5). Two seine tows captured hundreds coho and sockeye salmon and stickleback. Due to the erosion situation and because the western portion of this loop trail provides access to the area, this crossing should be closed. I will nominate this drainage for inclusion in the Catalog.

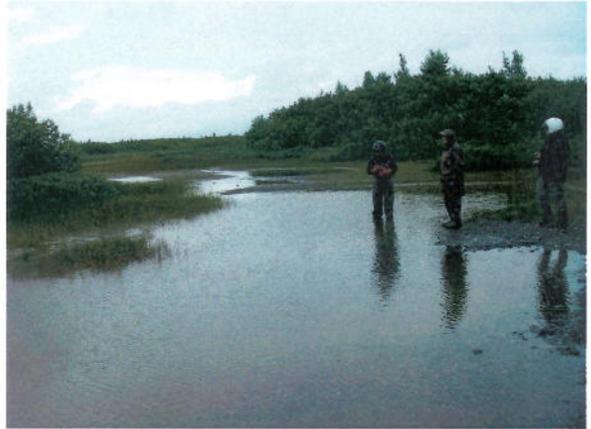
Photo 6. Lower Dog Salmon Creek drainage.

Although we did not sample for fish, this drainage probably does not connect to Dog Salmon Creek (see Photo 6). Stickleback were observed several hundred feet up and downstream of the crossing. Primary streambed substrate is small rock. Because a safer, more defined crossing is available in the upper reach of Dog Salmon Creek, this crossing should also be closed.

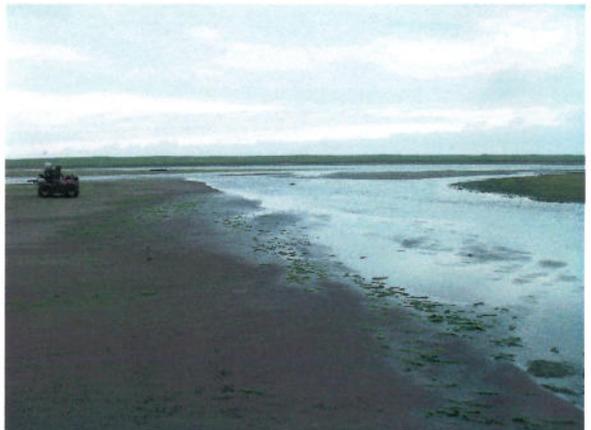
Photo 7. Dog Salmon Creek estuary.

The estuarine crossing of Dog Salmon is heavily tidally influenced (see Photo 7), and only accessible during low tide and low flows. Evidence of any ORV crossing is washed away with each tidal cycle. Due to the limited access, ORV crossings probably only occur when few fish are present, thereby causing minimal impacts to salmonids. Stream substrate at the crossing consisted of sand with some natural gravel, and may cause temporary increased sedimentation during ORV crossings. Efforts to stabilize or clearly mark the crossing would probably be washed away in the next tide or flood. We did not sample for fish.

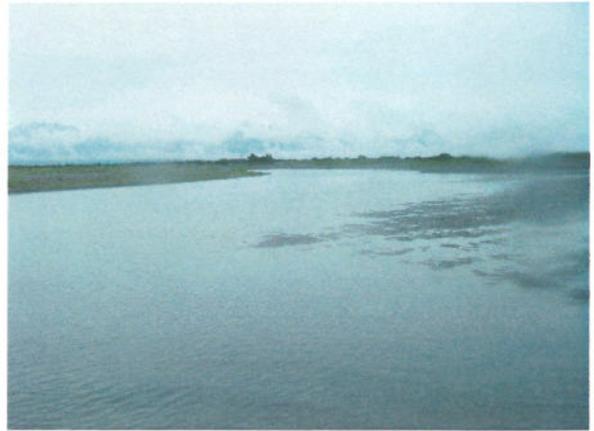
Photo 8. East slough of Alsek River.

Two seine tows captured starry flounders and staghorn sculpin, no salmonids were observed. This backwatered slough is cataloged as part of Alsek River (see Photo 8). Stream crossing access is only available during low tides and low flows, as this reach is heavily tidally influenced. The substrate of this crossing site and of the greater tidal flats area is loose sand and silt. Thus, other than increased sedimentation, ORV crossings at this slough probably have few long-term impacts to fish. Efforts to stabilize or clearly mark the crossing site would probably be washed away during the next tide or flood.

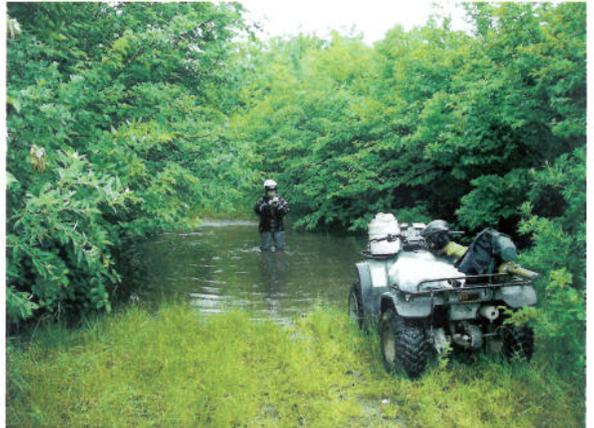
Photo 9. Isolated pools on abandoned trail.

We located several small pools flooding an abandoned trail, the largest pool was about knee-deep and 20' x 20' (see Photo 9). The pools probably result from lack of trail maintenance; trail access is now obtained along the tidal flats. Although we did not sample for fish, we did not observe any salmonids and doubt any connection to anadromous waters occurs. However, during high water the pools may connect to one another and flood the trail.
