**Re: ADF&G Fish Resource Permit (#SF2009-142); Collections Report**

**Salmon Fry Cage Study 2009; Palmer Wastewater Treatment Plant Outfall Stream (preliminary results)**

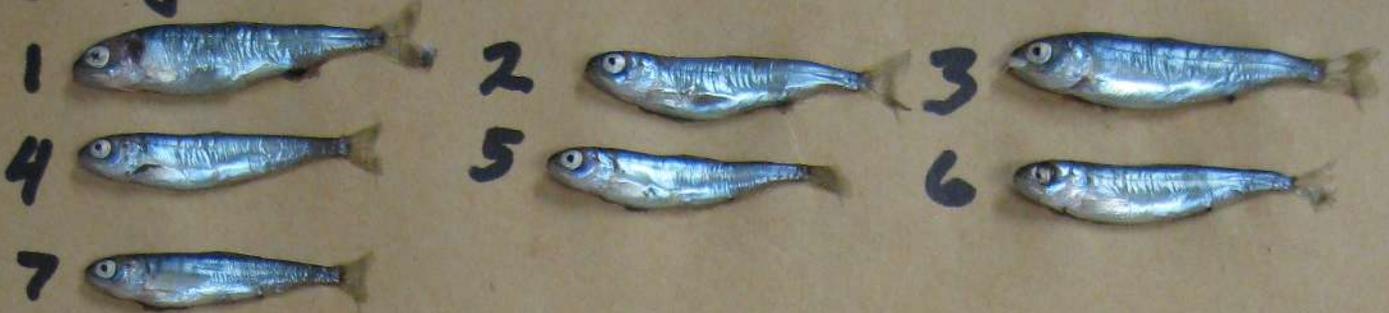
**Cage 1**

**Cage 1 averages: 4.5 cm, 32% increase; 0.77 g, 71% increase**

Cage 1 was above the outfall, outside the mixing zone (~0.4% of outfall ammonia concentration) and contained 7 fry, all live sockeye. Two netting tears were observed near the cage top, and the flood had overtopped the cage.

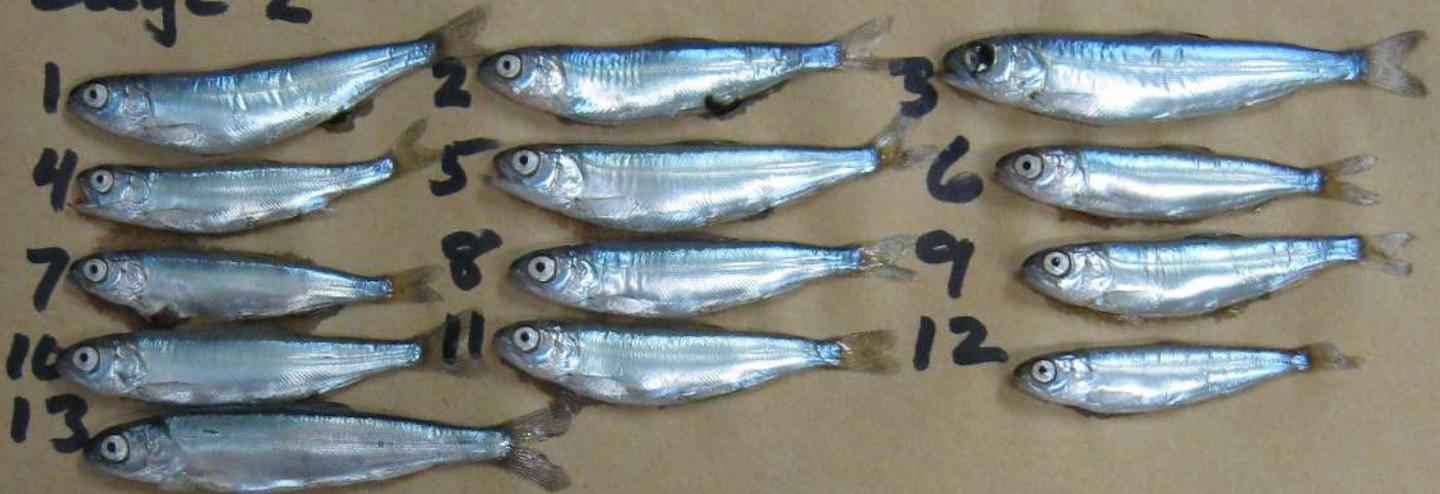
**Cage 2**

**Cage 2 averages: 5.3 cm, 56% increase; 1.5 g, 233% increase**

Cage 2 was just below the outfall, inside the mixing zone (up to ~29% of outfall ammonia concentration) and contained all live fry; 10 sockeye, 3 chum. Netting tears were observed near the top and in the cage floor.

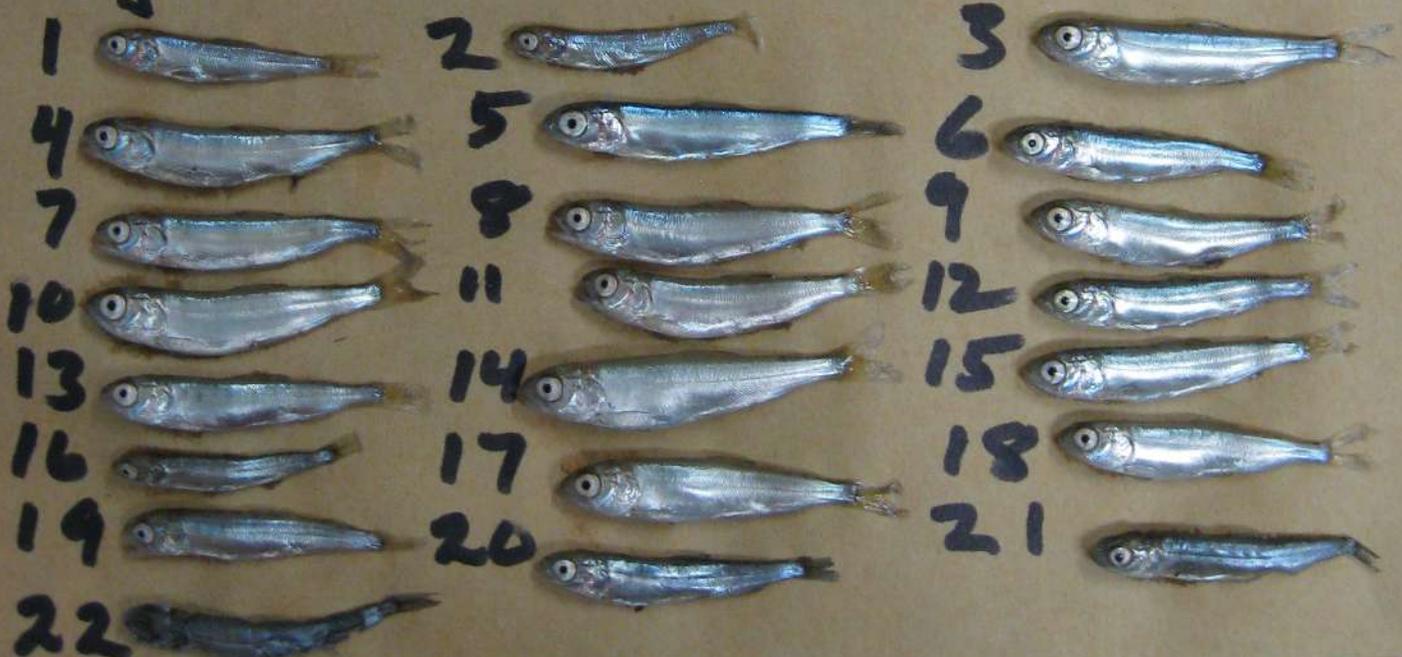
**Cage 3**

**Cage 3 averages: 4 cm, 18% increase; 0.58 g, 29% increase**

Cage 3 was below the outfall, but outside the mixing zone (~0.7% of outfall ammonia concentration) and contained 19 live and 4 dead fry (plus an additional fry found in the mud, not in the photo), estimated 95% sockeye (some were too small or decomposed for confident identification). The cage was intact but the lid had been overtopped and loosened.
