Short Creek
101-11-91
7-9-75
Novak

Name Regina Cove Catalog No. 101-11-88
 Latitude N 54° 48' 49" WR No. _____
 Longitude W 130° 34' 02" K No. _____
 Geodetic Map No. Pr. Rupert D-2 Work Area Ketchikan
 Location Head Regina Cove, Fillmore Is. Watershed Length Approx. 1/2 mile
 Drainage Area of Watershed _____
 Water Supply Type Precipitation, runoff and possibly springs.

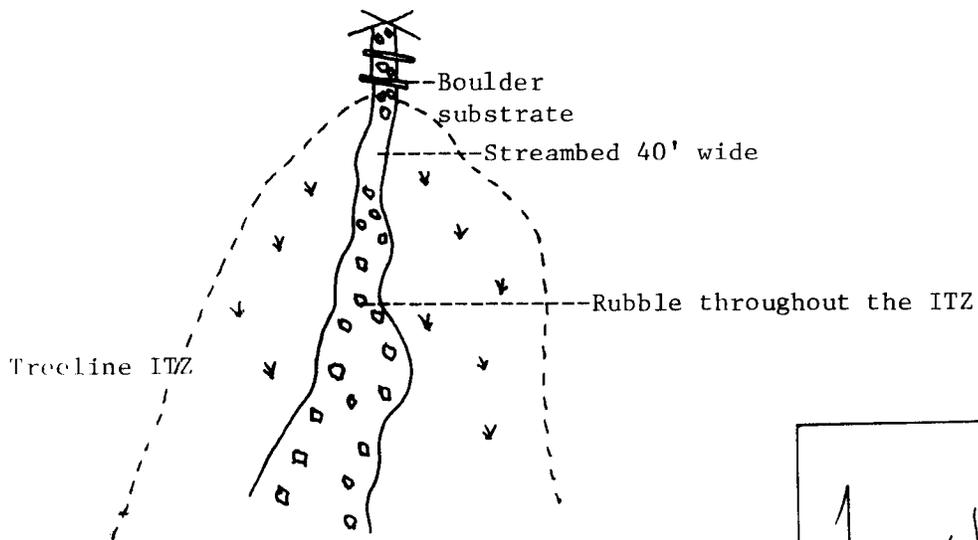
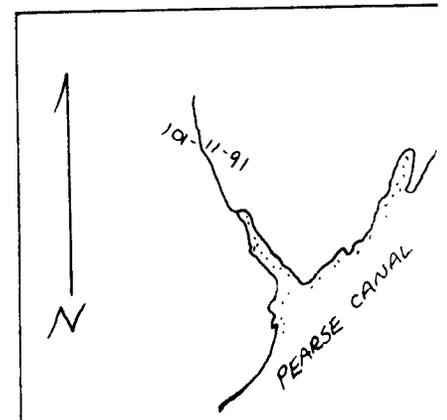
An intermittent stream with very little or no fishery value. At the time of this survey, the streambed was dry except for small pool drainage and inter-gravel flow. The ITZ is composed mainly of rubble and boulders. Near the treeline, logs and debris criss-cross the streambed. Cedar, hemlock forest surrounds the stream with a large grass-flats off the upper ITZ.

0% ASA

LOCATION: Head of Inlet 1.3 miles NE Akeku Point
LATITUDE: 54° 51' 11"
LONGITUDE: 132° 28' 51"
WATERSHED: Length 1/2 mile, area 1 sq. mile, runoff
