101-43-15
5-5-73

Name _____ Catalog No. 101-43-15
 Latitude N 55° 20' 32" WR No. _____
 Longitude W.131° 15' 49" K No. _____
 Geodetic Map No. Ketchikan - B-4 Work Area Ketchikan
 Location So. of Snipe Islands Watershed Length 1-1/4 miles
 Drainage Area of Watershed _____
 Water Supply Type Runoff, springs.

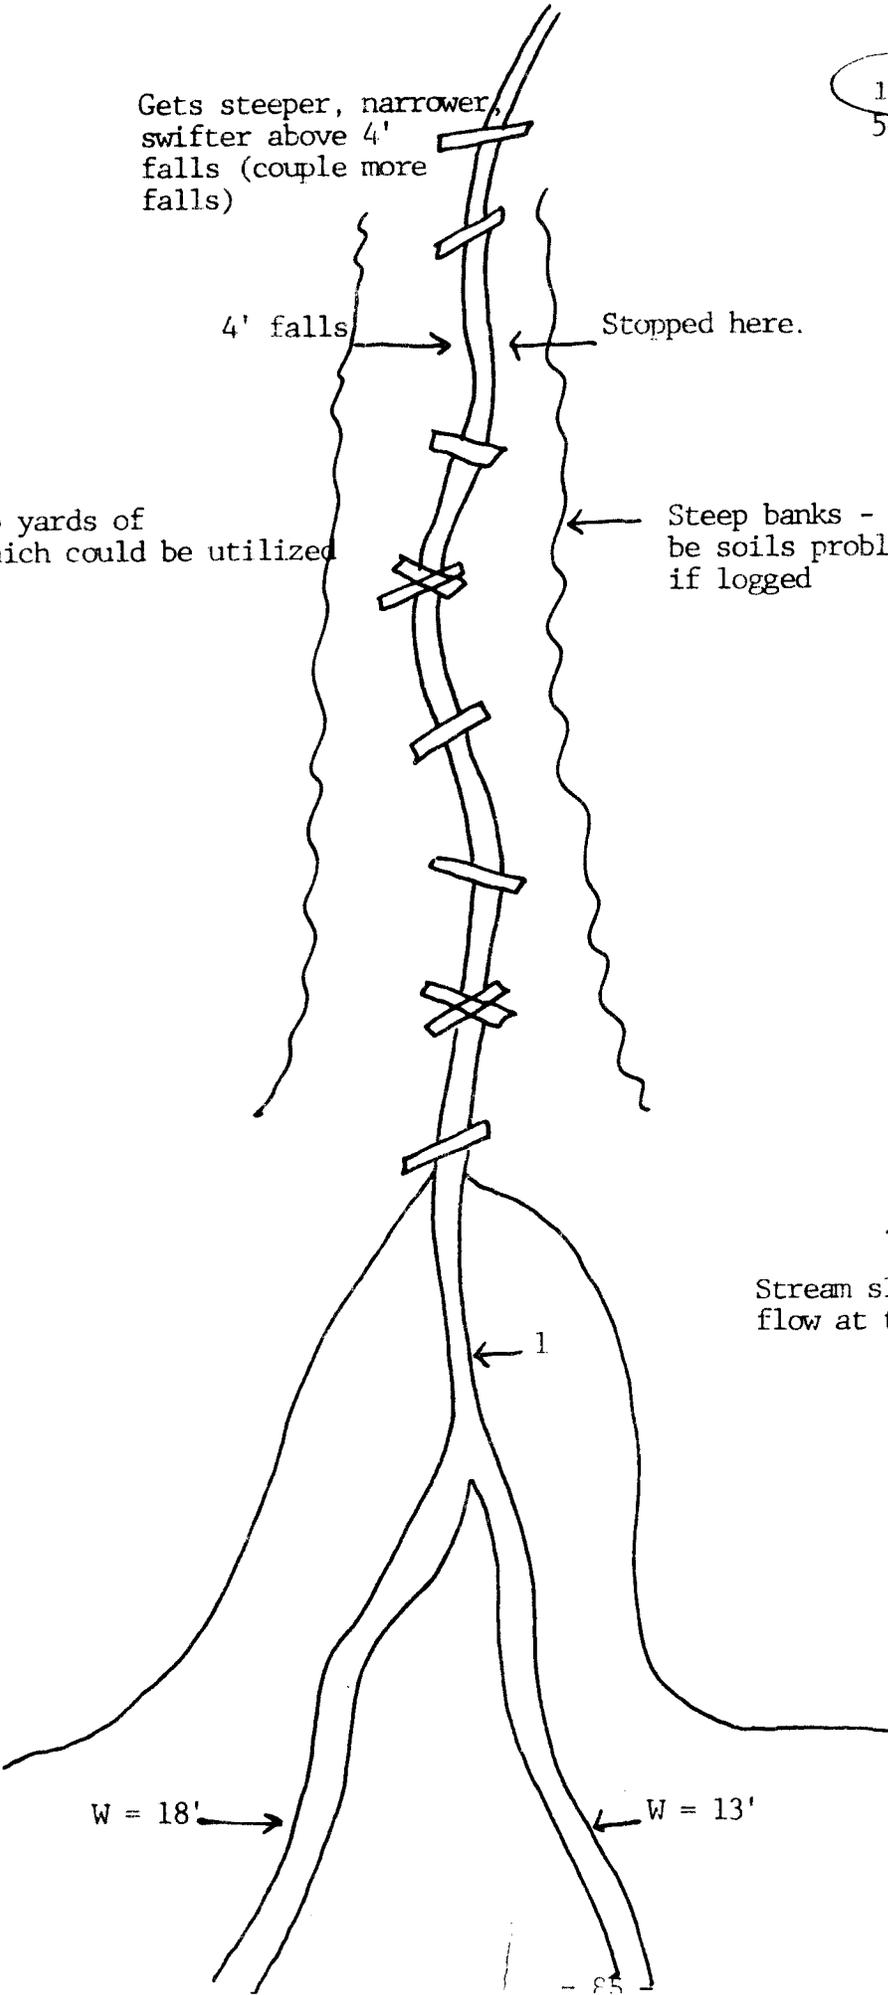
Gets steeper, narrower,
swifter above 4'
falls (couple more
falls)

4' falls

Stopped here.

100 - 125 yards of
stream which could be utilized
by fish.

Steep banks - could
be soils problem
if logged

Several trees in and
across stream but no
blocks and good looking
gravel.

Stream slightly above normal
flow at time of survey

Rehabilitation Potential A few logs in stream but not worth the time to remove.
