PEAK ESCAPEMENT RECORD

Blossom River
101-55-40

Name: Blossom River Catalog No.: 101-55-40
 Latitude: 55 23' 43" WR No.: _____
 Longitude: 130 26' 18" K No.: K34-1
 Geodetic Map No.: Ketchikan C-2 Work Area: Ketchikan
 Location: Smeaton Bay, Wilson Arm, large tributary of Wilson River. Watershed Length: 23 miles
 Water Supply Type: Snowfields, glaciers, small lakes, runoff. Drainage Area: 110 sq. miles.

Blossom River
 Smeaton Bay
 Stream #8
 6-22-76
 Larson, Wood, Downey

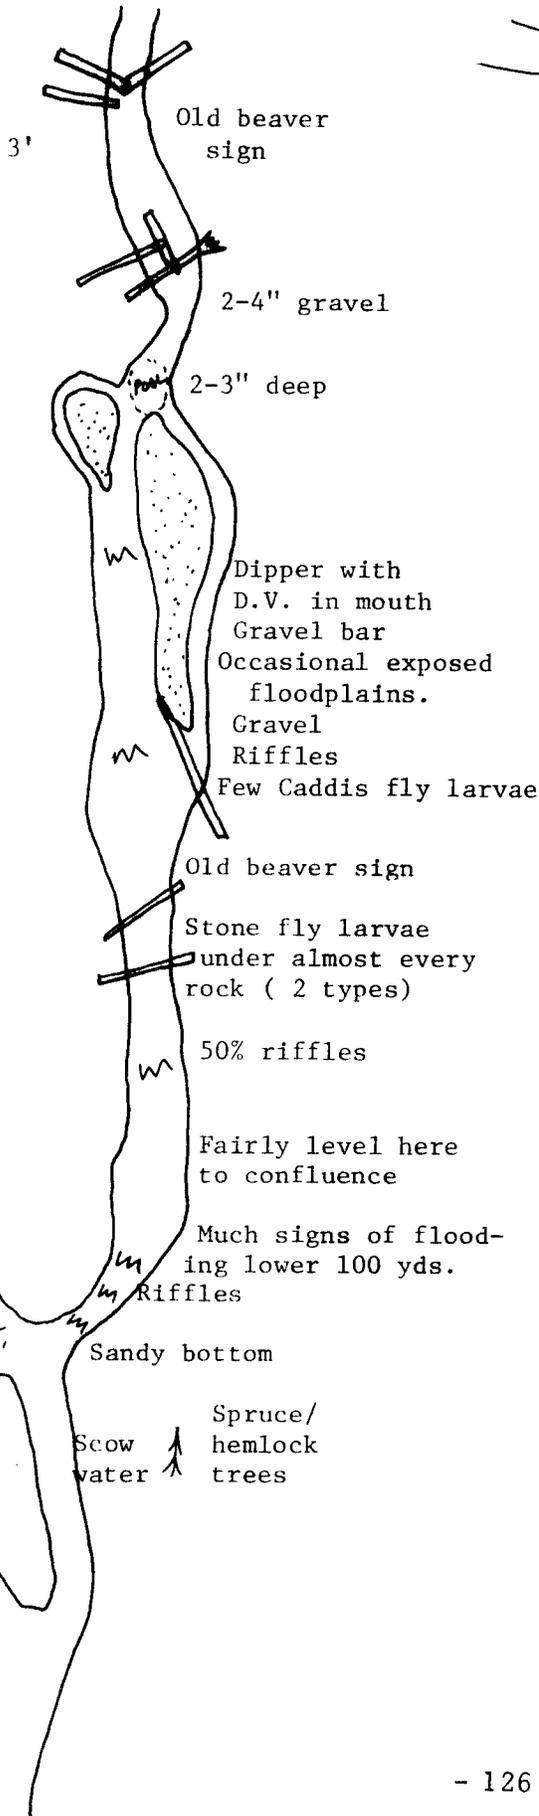
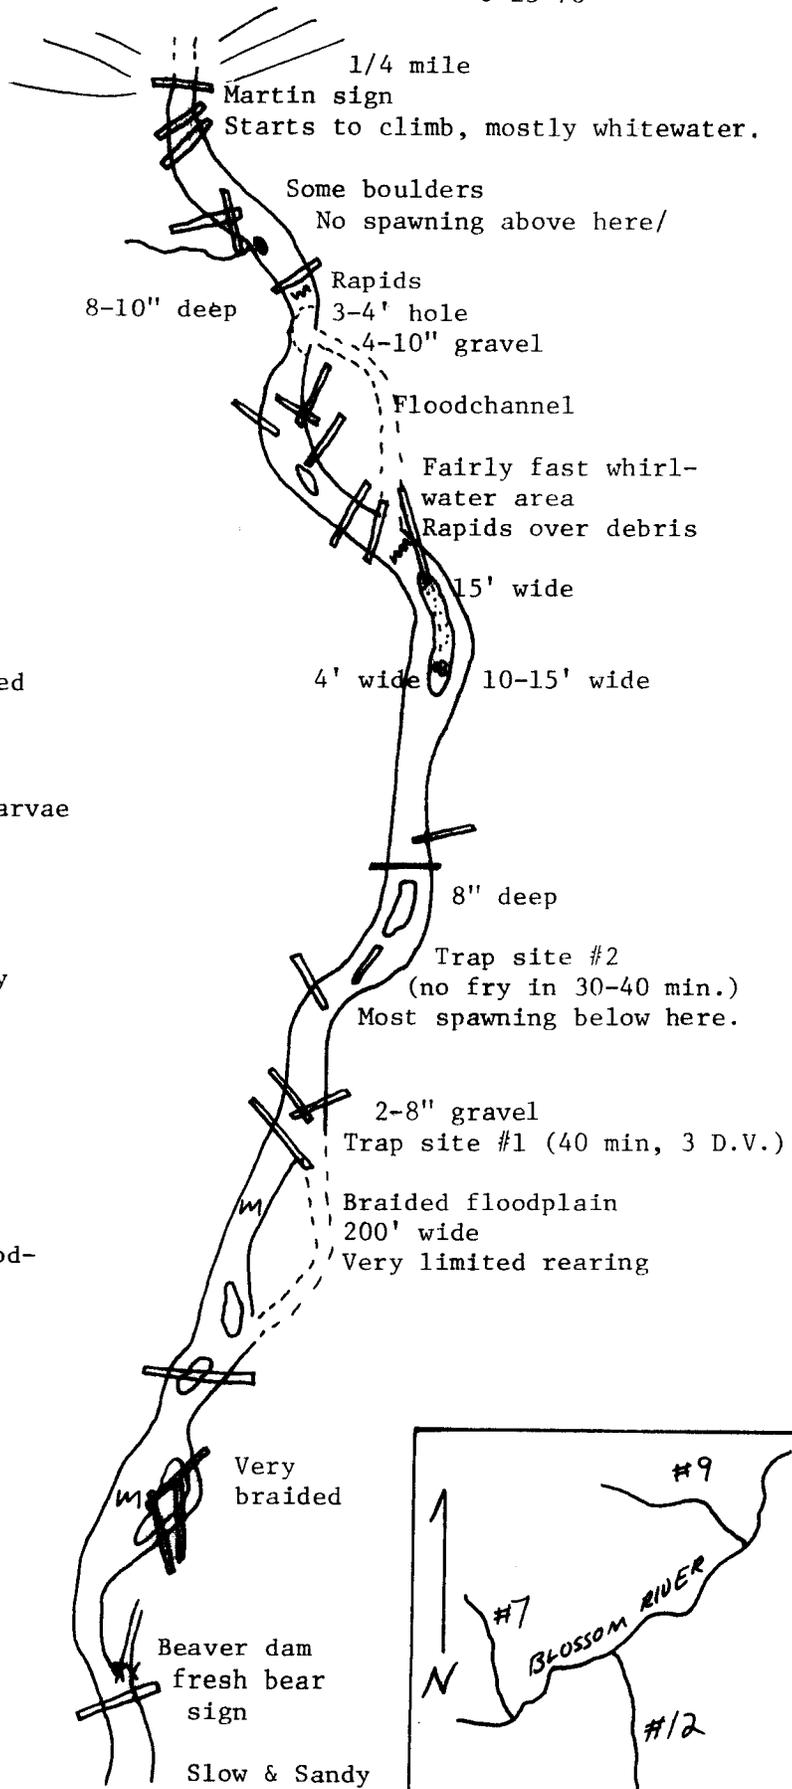
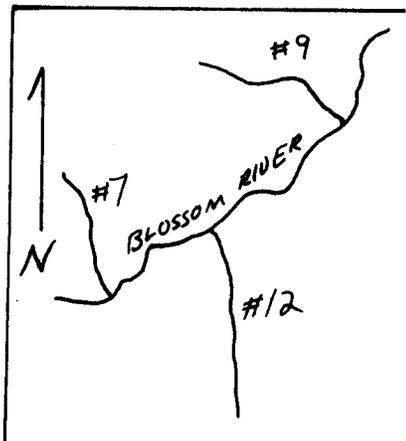
|| } Stream comes back to one channel here but has steepened considerably and is the end of any fish utilization.

1-3" gravel throughout with a little clean looking sand mixed in. Looks like good spawning gravel.

Not much pool and rearing area - probably average for this size stream, pools 2' deep.

Banks are flat and stable, gray current bushes predominates the smaller vegetation.

Bluff which sits back from the stream 50 yds. This is a steep area with some slumpage - unstable.

Slough and beaver dam area - slow moving water - most coho fry observed were here.

One of the most productive small streams examined in this system. Spawning area at head should be given complete protection.

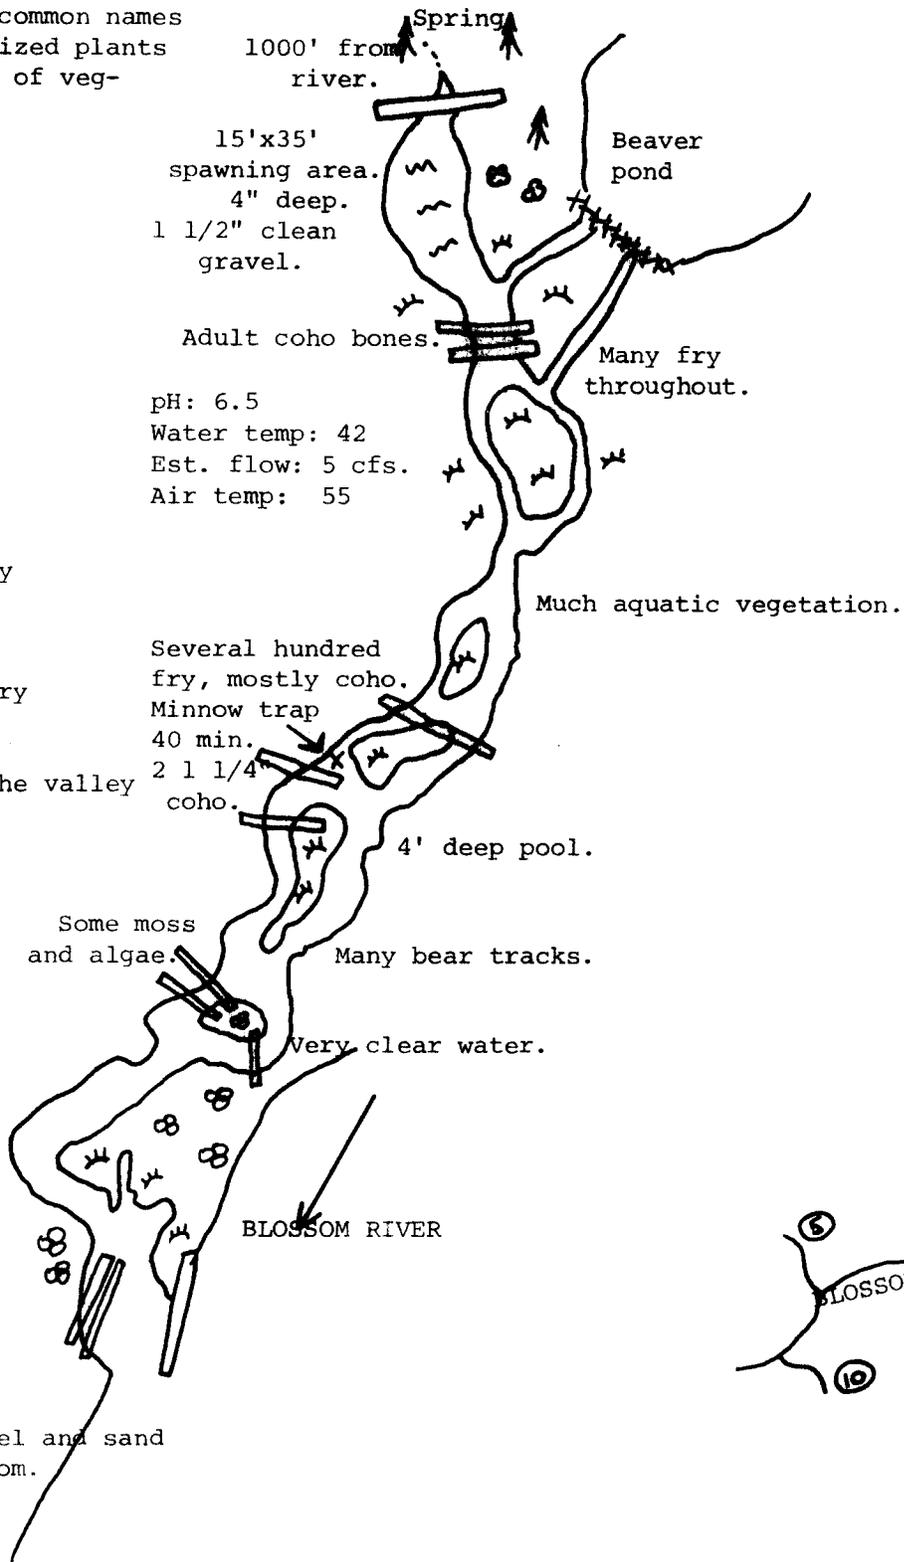
Blossom River
 Tributary #5
 6-23-76
 R.Larson, Jackinsky

Gradient increases.

- 20'W.
- 1st 50 feet:
- 2 king fry
 - 6 Dolly Varden
 - 20 coho
 - 50 unidentified.

Gravel and sand bottom.

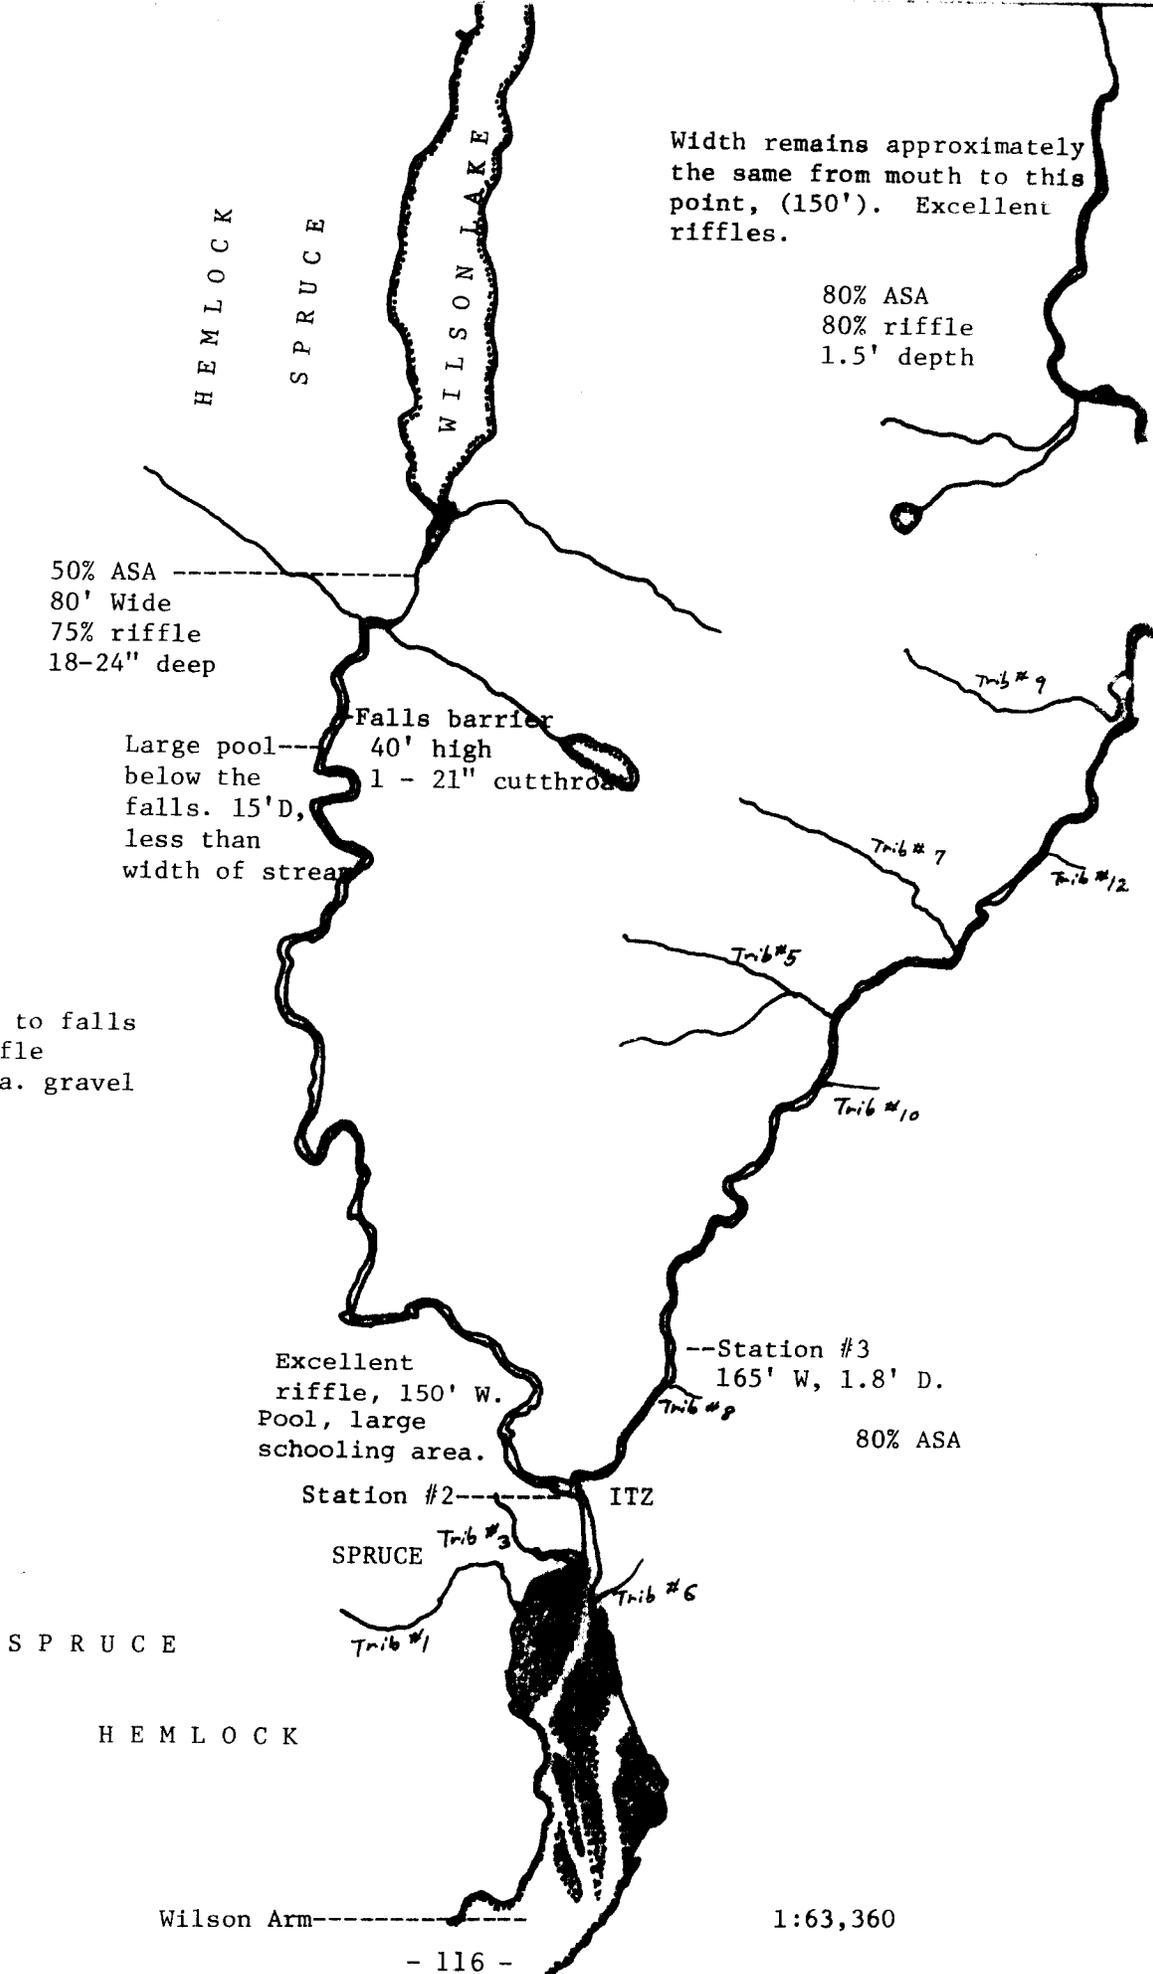
Width remains approximately the same from mouth to this point, (150'). Excellent riffles.

80% ASA
80% riffle
1.5' depth

50% ASA
80' Wide
75% riffle
18-24" deep

Falls barrier
40' high
1 - 21" cutthroat
Large pool---
below the falls. 15'D,
less than width of stream

80% ASA to falls
75% riffle
2-4" dia. gravel

Excellent riffle, 150' W.
Pool, large schooling area.
--Station #3
165' W, 1.8' D.
80% ASA

Station #2--- ITZ
