Bakewell Arm - Right Head

101-55-70

9-19-74

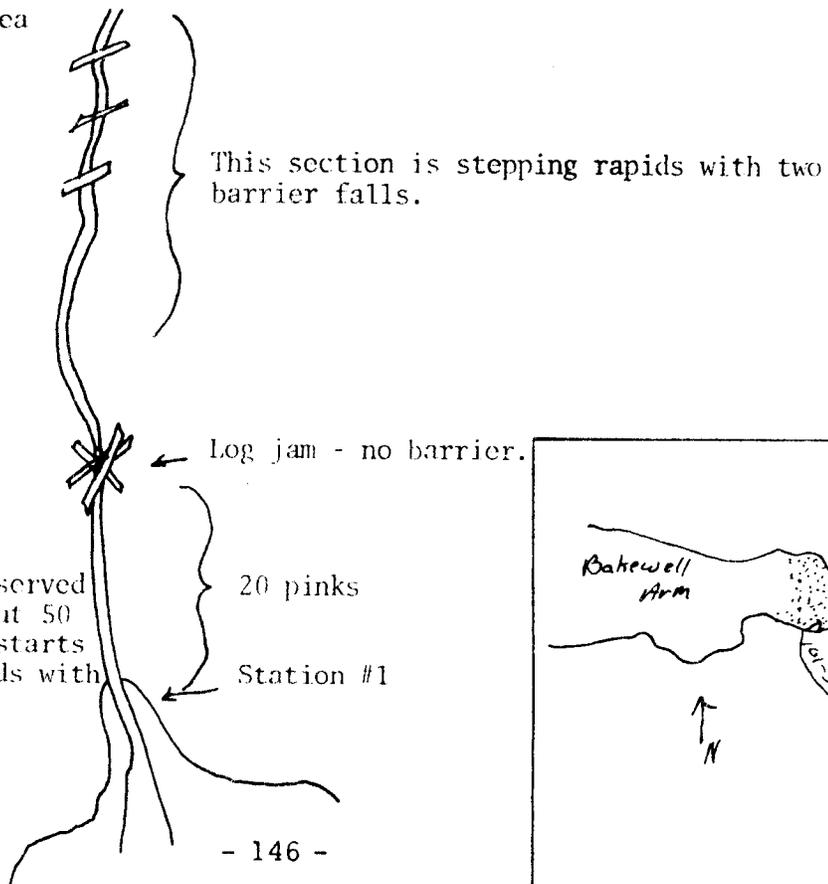
Station #1

5% available spawning area

This section is stepping rapids with two barrier falls.

Log jam - no barrier.

20 pinks

Just above the I.T. is a massive log jam. Walked above the log jam and observed two pinks. However, about 50 yards above the log jam starts a series of stepped rapids with two barrier falls.
