BAKEWELL LAKE  
Upper End

101-55-073

BAKEWELL LAKE LADDER

Name Bakewell River Catalog No. 101-55-73  
 Latitude N 55° 17' 54" 51" WR No. 28  
 Longitude W 130° 38' 53" K No. 32 101-55-10730  
 Geodetic Map No. Ketchikan B-2, B-3, A-3 Work Area Ketchikan  
 Location Smeaton Bay - Bakewell Arm Watershed Length 8 miles  
 Drainage Area of Watershed 32 Sq. miles (Polar Planimeter)  
 Water Supply Type Large lakes (2) with precipitation and ground water supplements.

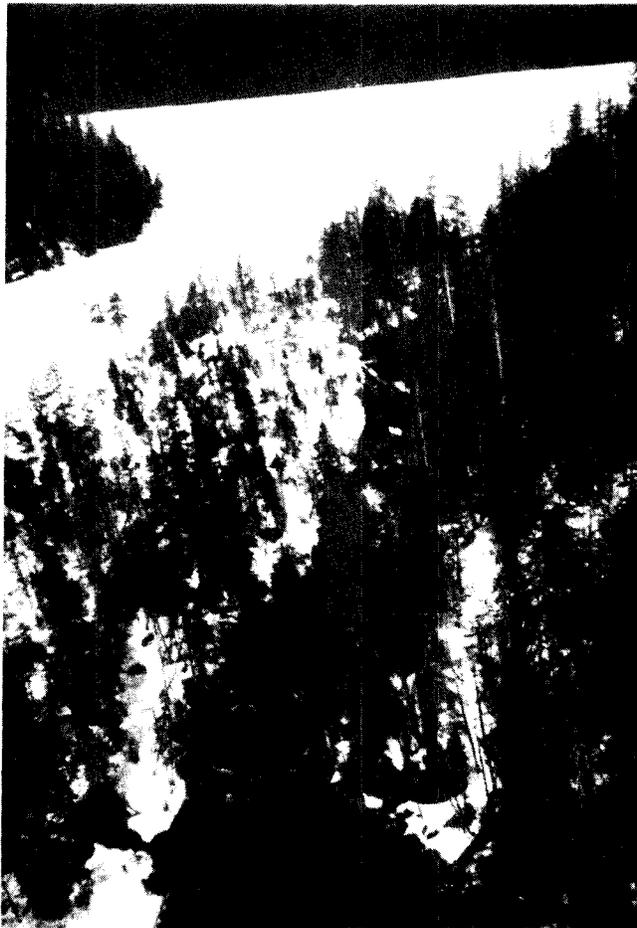
Stream between Badger and Bakewell  
Lakes.

Badger Lake in background.

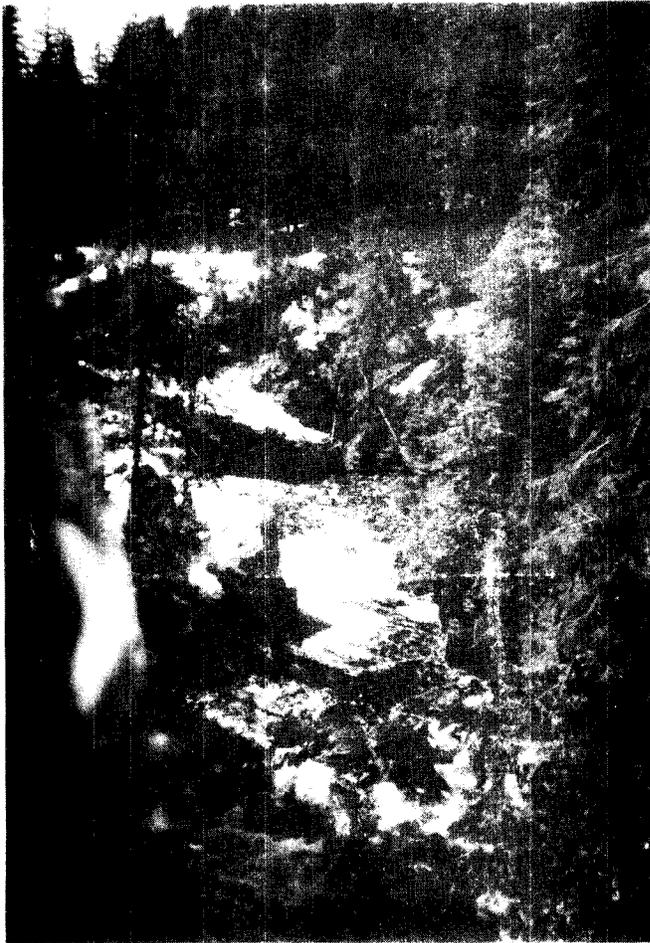
History of Land Use Fish ladder construction began in 1958 with operation until 1972. Unsuccessful due to design of construction.

Rehabilitation Potential Relocate or re-design steep pass in area of old ladder. Excellent rearing system above falls.
