**Technical Report No. 02-05**

## **Wasilla Creek Stream Condition Evaluation**

**Jeffrey C. Davis and Gay A. Muhlberg**

**August 2002**

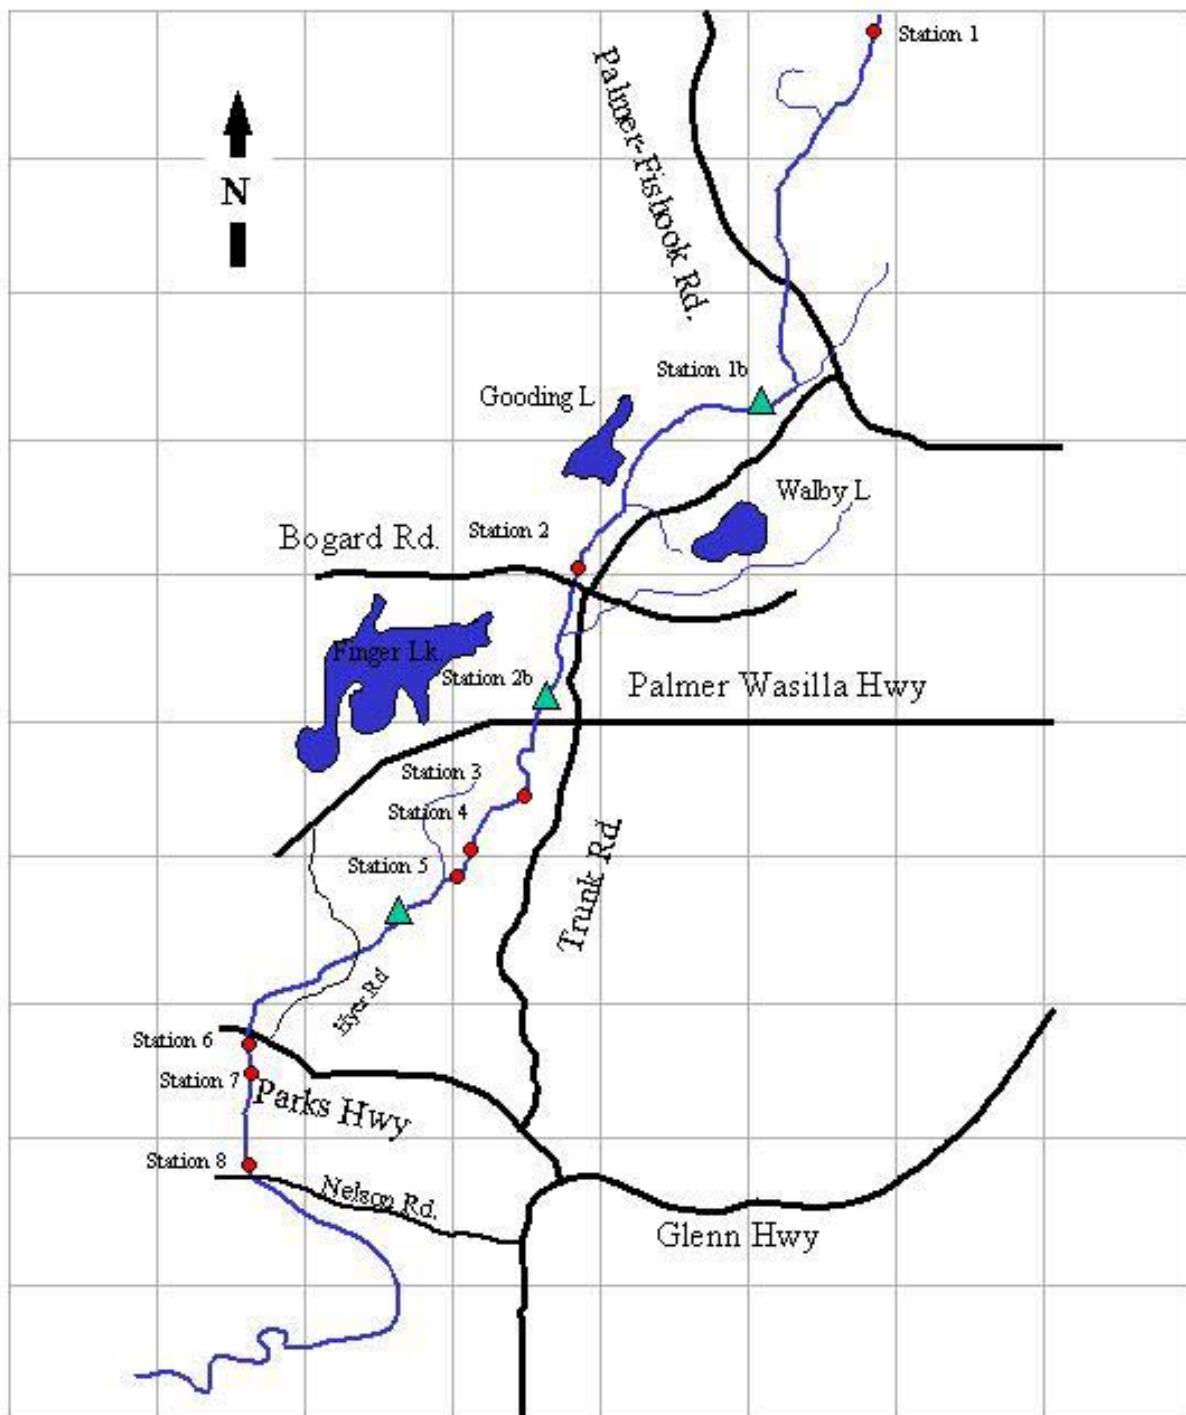
**Figure 1. Wasilla Creek showing sampling stations (●). Triangles are located at additional water sampling locations.**

Eight sampling stations were established on Wasilla Creek near Wasilla, Alaska. Four stations were located at sites where little or no immediate impacts were evident (Stations 1, 5, 7, and 8) and four stations where riparian or channel modifications were obvious (Figure 1). Each sampling station was 100-m long. Additional water sampling sites were established to distribute water collection locations evenly from station 1 to station 8.

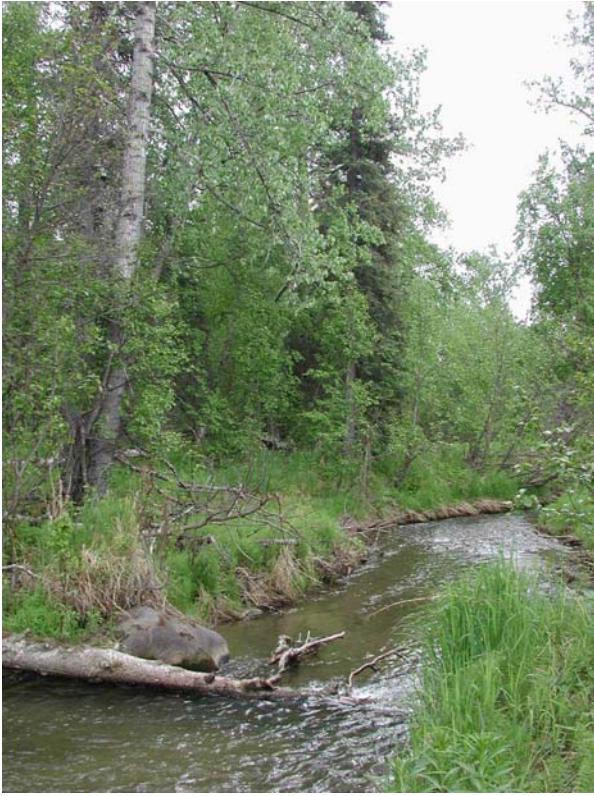
Station 1 was the farthest upstream sampling site and was located above most agricultural and housing development (Figure 1). Station 1 was accessed from the Glenn Highway to Soapstone Road to Norman Road to a dirt road under the powerline. Based upon the lack of any obvious riparian or channel alterations, Station 1 was selected as a reference site. The riparian vegetation was classified as open mixed birch spruce forest. The understory of this forest type is composed of *Calamagrostis*, *Spirea*, *Vaccinium* and *Ledum* (Figure 2). There were some cottonwoods within the floodplain. Willow and alder were present in small patches adjacent to the stream channel.

**Figure 2. Photograph of station 1 riparian vegetation.**

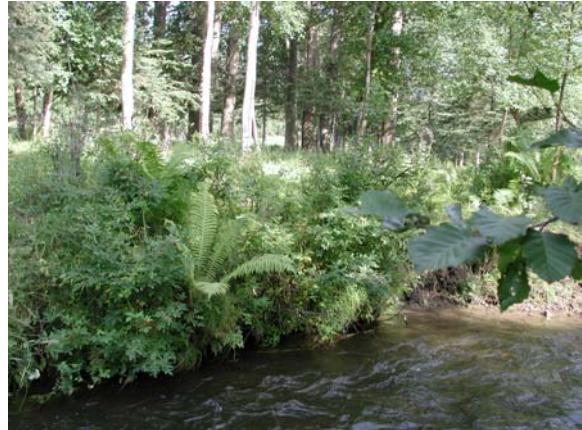
Station 2 was located just upstream of Bogard Road. At this location Wasilla Creek flows through a pasture that supports a small herd of cattle. Cattle use of the stream and riparian area is not restricted. The lower portion of the sampling reach appears to have been channelized, perhaps to accommodate road construction. The riparian vegetation has been modified considerably by grazing. The riparian vegetation was classified as Open Balsam Poplar Forest (Figure 3). Alder and browsed cottonwoods and willows were common in the understory (Figure 4). Although grazed, the riparian zone was well vegetated (Figure 5 and Figure 6).

**Figure 3. Open Balsam Poplar forest adjacent to station 2.**

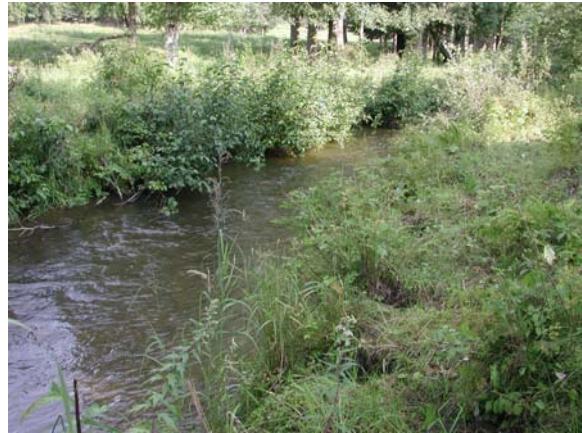
**Figure 4. Zone of alder and willow along the stream margin of station 2.**

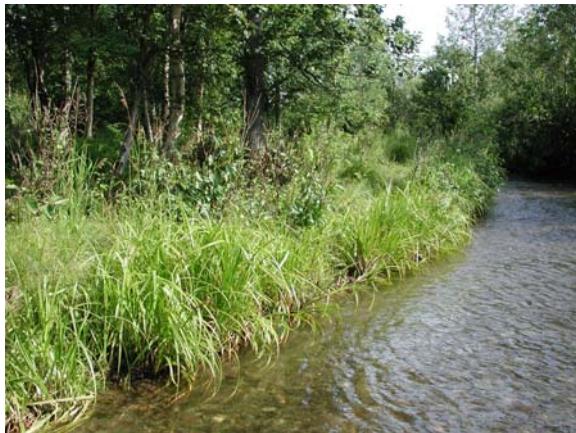
**Figure 5.** Zone of sedges along stream margin of station 2.

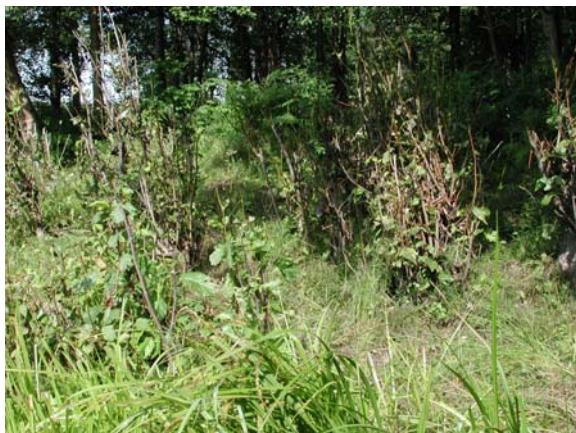
**Figure 6.** Browsed cottonwoods within station 2.

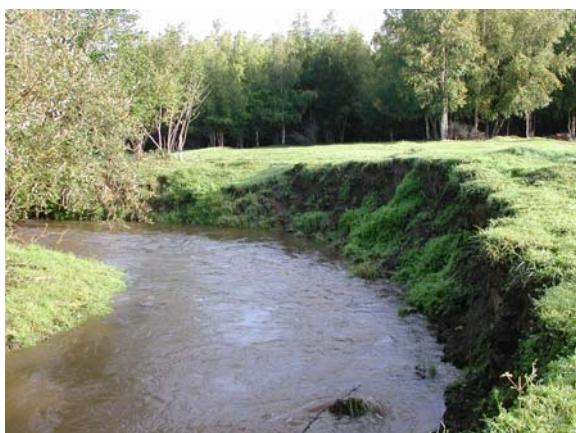
Station 3 was located downstream of the Palmer-Wasilla Highway. Heavy grazing and land clearing adjacent to station 3 resulted in modifications to the riparian vegetation (Figure 7). Most of the riparian area along this station was grazed to a low grass cover. This livestock-modified vegetative community is not addressed in the classification methodology. The vegetation had been completely removed at some locations due to trampling by livestock (Figure 8). The remnant riparian vegetation was classified as closed and open tall alder shrub (Figure 9). The understory was dominated by *Equisetum*.

**Figure 7.** Heavily grazed riparian area of station 3.

At stations 2 and 4 it appeared that grazing had resulted in some aggradation and channel widening. At station 3 previous grazing and land clearing had caused a change in the riparian vegetation to a closed alder shrub community. Subsequent bank erosion resulted in large increases in fine sediment, near 40% of the substrate at the time of this study. This deposition of fine material caused the channel to meander. The increase in sinuosity explains the low slope at this station relative to other sites. The meandering channel has undercut the banks causing the remaining riparian alders to enter the stream resulting in the high amount of debris dams seen at this site. These debris dams further reduce stream energy and the ability of the stream to transport the sediment load. Woody debris can also redirect flow, causing additional bank scouring (Thorne 1990). This process of erosion, followed by deposition leading to more erosion has been observed by others (Beeson and Doyle 1995).

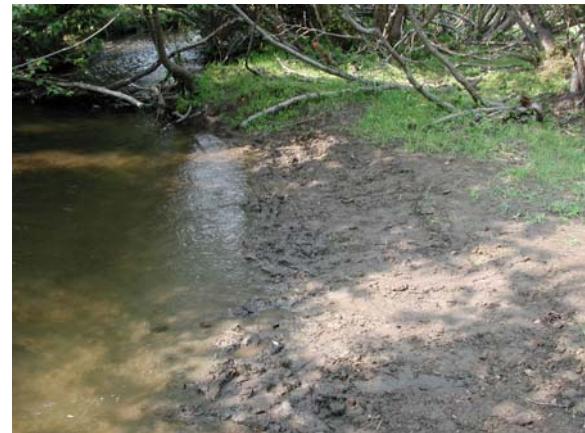
**Figure 8.** Denuded portions of station 3.

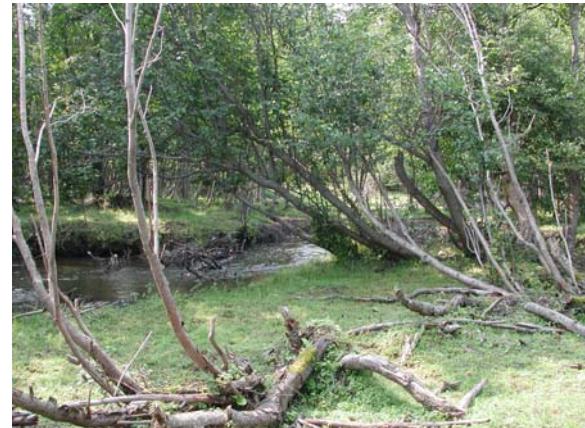
**Figure 9.** Open alder shrub community of station 3.

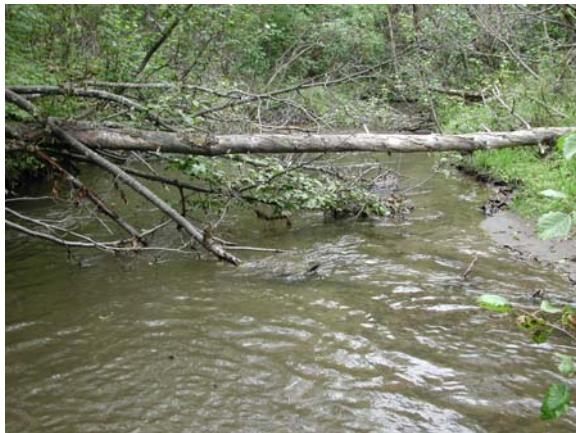
**Figure 10.** Closed alder shrub riparian community of station 4.

Station 4 also was considered an impacted site to livestock grazing. The riparian plant community was classified as closed alder shrub (Figure 10). Some older birch and cottonwood were present. The stream banks were trampled in many locations (Figure 11).

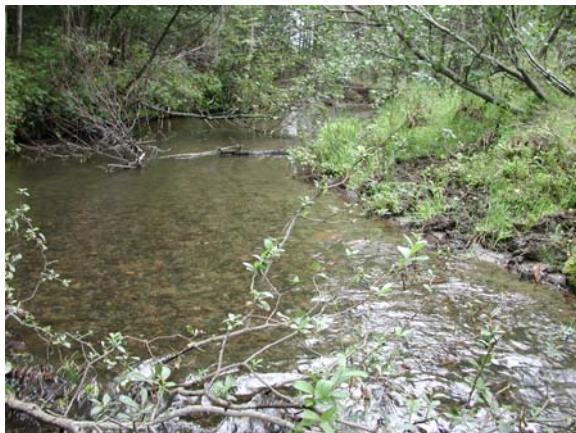
**Figure 11.** Riparian vegetation of station 4 showing bank trampling.

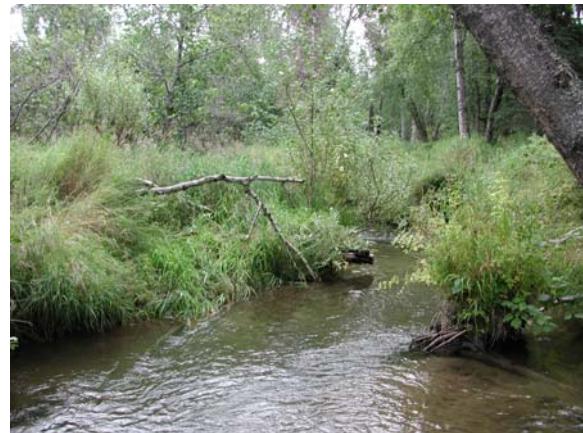
Station 5 was located 1 km downstream of the impacted stations 3 and 4; however, the riparian zone and stream channel appeared to be unmodified. The riparian vegetation was classified as open spruce birch forest (Figure 12). Willows and alders were common along the stream margins with

**Figure 12.** Open mixed forest of station 5.

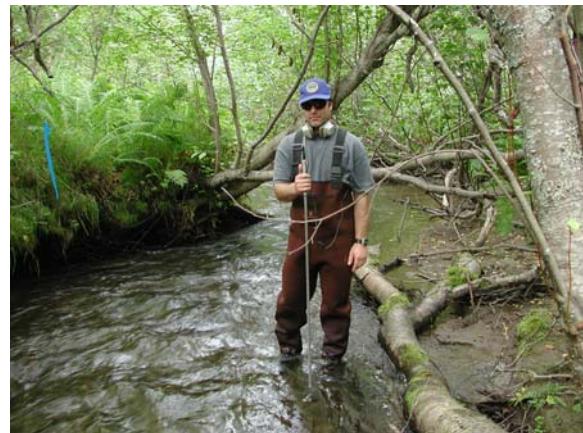
**Figure 13.** Closed alder shrub of station 5.

occasional closed alder shrub communities dominating the first five meters lateral to the stream (Figure 13). The stream banks were composed primarily of *Calamagrostis* as seen at station 1 (Figure 14).

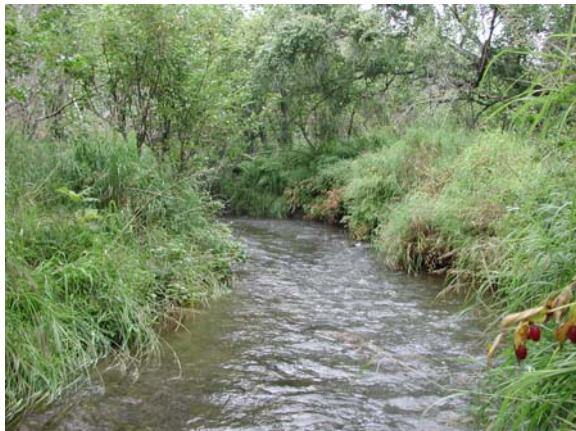
**Figure 14.** Steam banks of station 5.

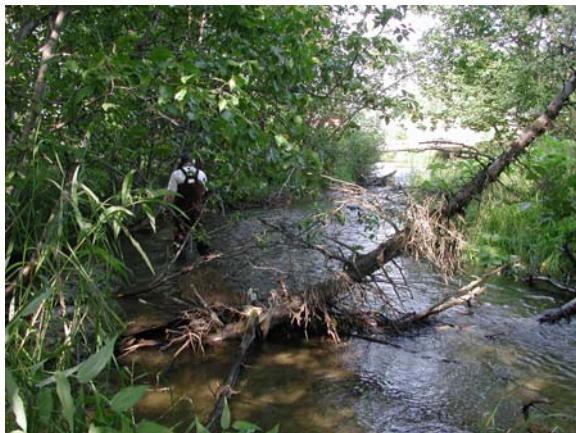
**Figure 15.** Closed alder community of station 6.

The riparian vegetation was limited to a one to two meter zone of *Calamagrostis* and alders followed by gravel parking or a closed alder shrub (Figure 15 and Figure 16).

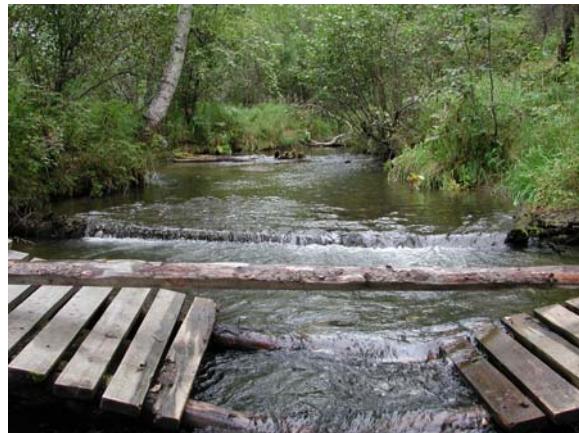
The riparian vegetation and channel geometry of stations 7 and 8 were considered unimpacted. The riparian vegetation was open to closed mixed spruce birch forest (Figure 17 and Figure 18). However, at both stations there were zones of closed alder shrub adjacent to the stream extending up to five meters laterally.

**Figure 17.** Station 7 riparian community.

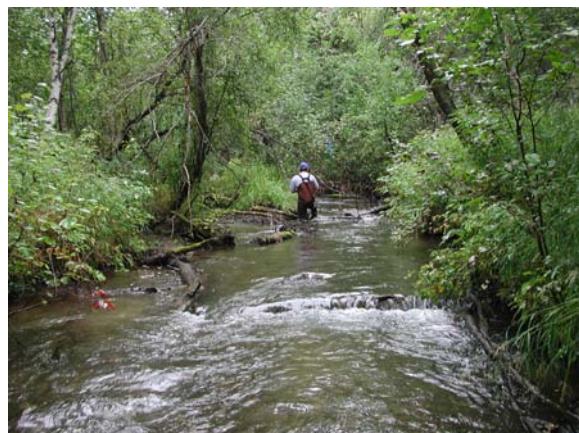
**Figure 18.** Station 8 riparian community of closed spruce birch forest.

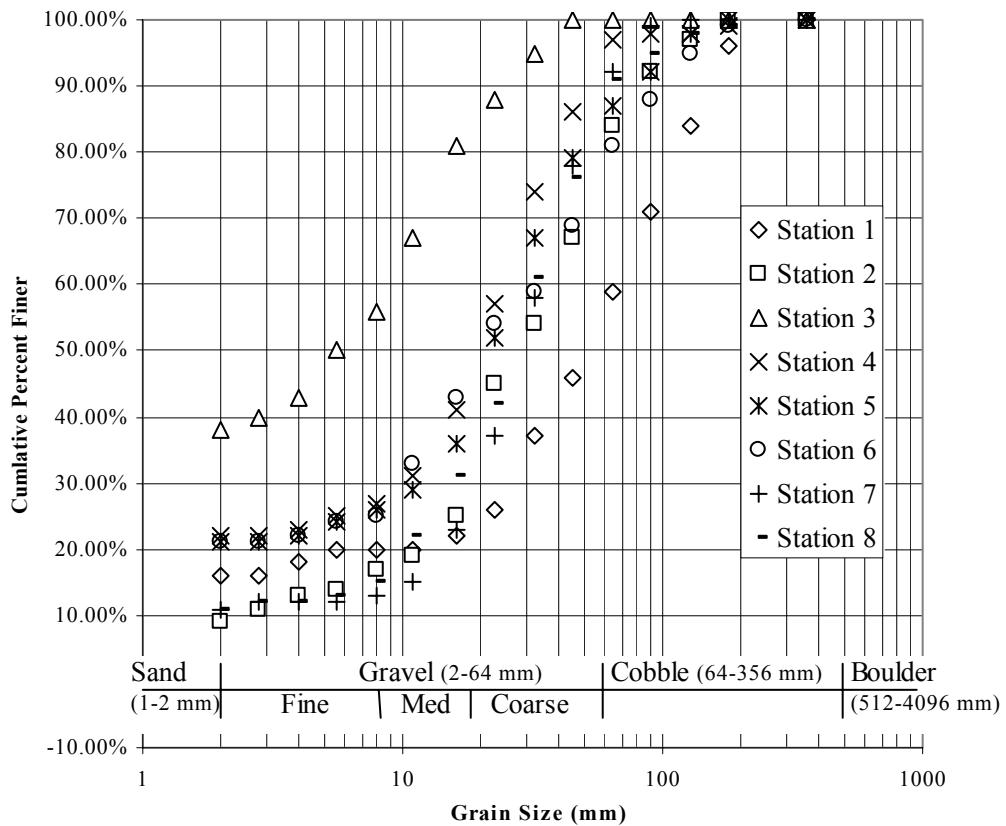
**Figure 19. Substratum size distribution.**

The substratum size distribution for all sites is shown in Figure 19 and Table 1. The size distribution at station 1 was larger and at station 3 smaller than most other stations.

Station 1 substratum was primarily cobble and gravel. The estimated maximum particle size in motion during bankfull flows, referred to as the critical grain size (mm), was determined using the tractive force equation of Kappesser (1993). The critical grain size was 20.3 mm. Comparison with the substratum size distribution graph shows that slightly more than 20% of the substrate is in motion during bankfull flows; therefore, the

The substratum at the impacted station 3 was considerably smaller than all other stations, with nearly 40% of the substrate less than two mm. Based upon the critical grain size, the substrate is much smaller than expected due to channel shape and slope with an estimated 70% of the substrate in motion during bankfull flows. The three stations downstream of station 3 all had greater than 20% of the substrate composed of fine sediment (< 2 mm).

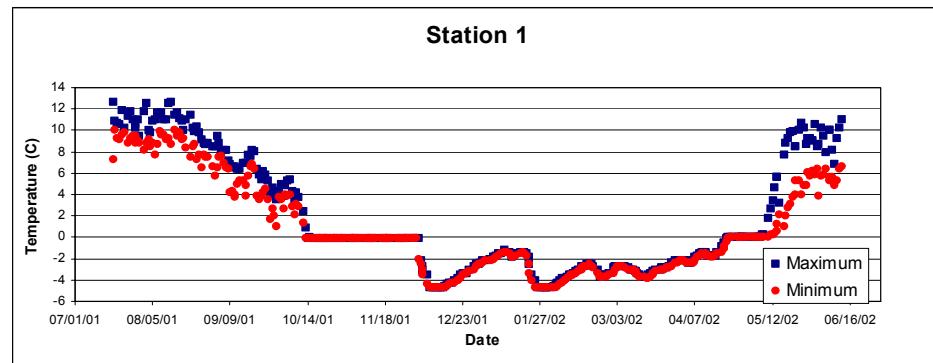
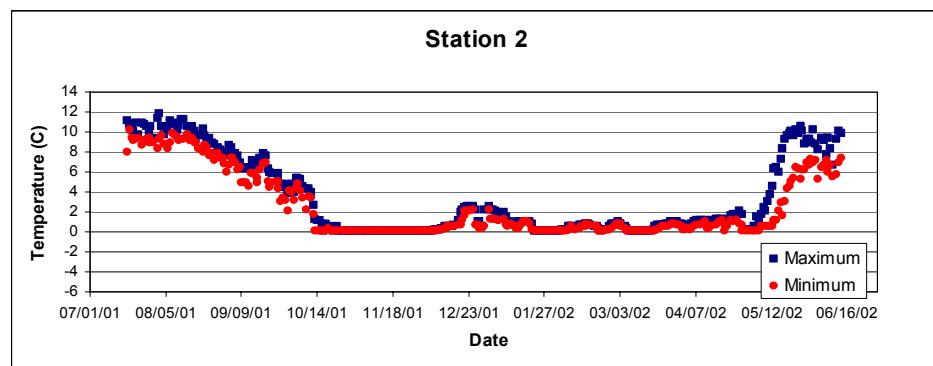
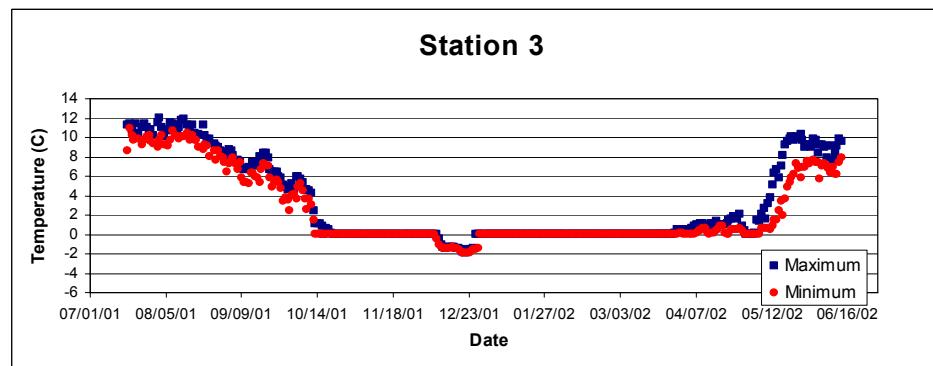
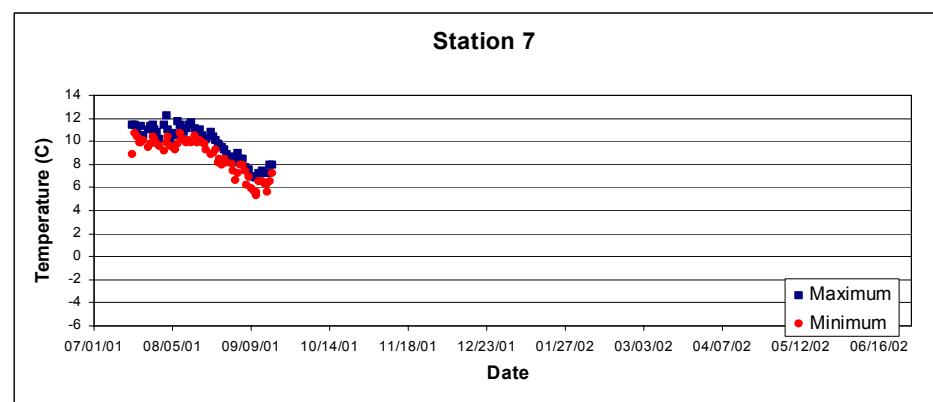
Water temperature data are shown in Figure 20. Station 1 had the daily and seasonal maximum and minimum temperatures with maximum mid-summer values of near 13 degrees C and minimum of -4.7 during the winter. Temperature data for station 7 are not available because the logger was destroyed by ice.

**Figure 20.** Wasilla Creek stream water temperatures from July 18, 2001, through June 13, 2002.

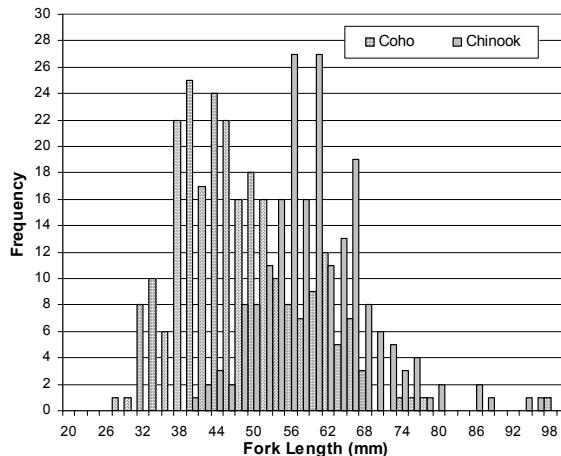
The size frequency distribution of coho and chinook salmon is shown in Figure 21. At the sample time (September) there appeared to be two age classes of coho, with a median fork length of 40 to 44 mm for age 0, and near 60 mm for age 1 fish. Only one age class of chinook was observed with a median fork length of 58 to 60 mm for age 0.

**Figure 21. Size-frequency distribution of juvenile coho and chinook salmon in Wasilla Creek.**

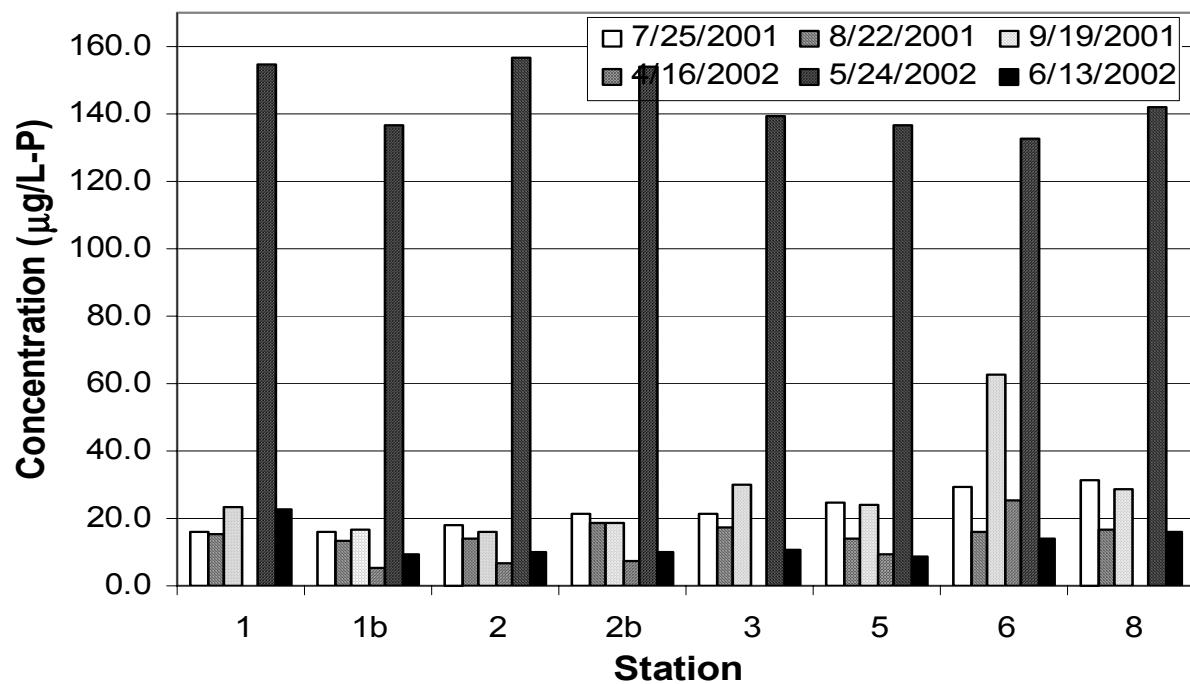
**Figure 22.** Total phosphorus concentrations for all sampling stations showing high concentration during breakup in May.

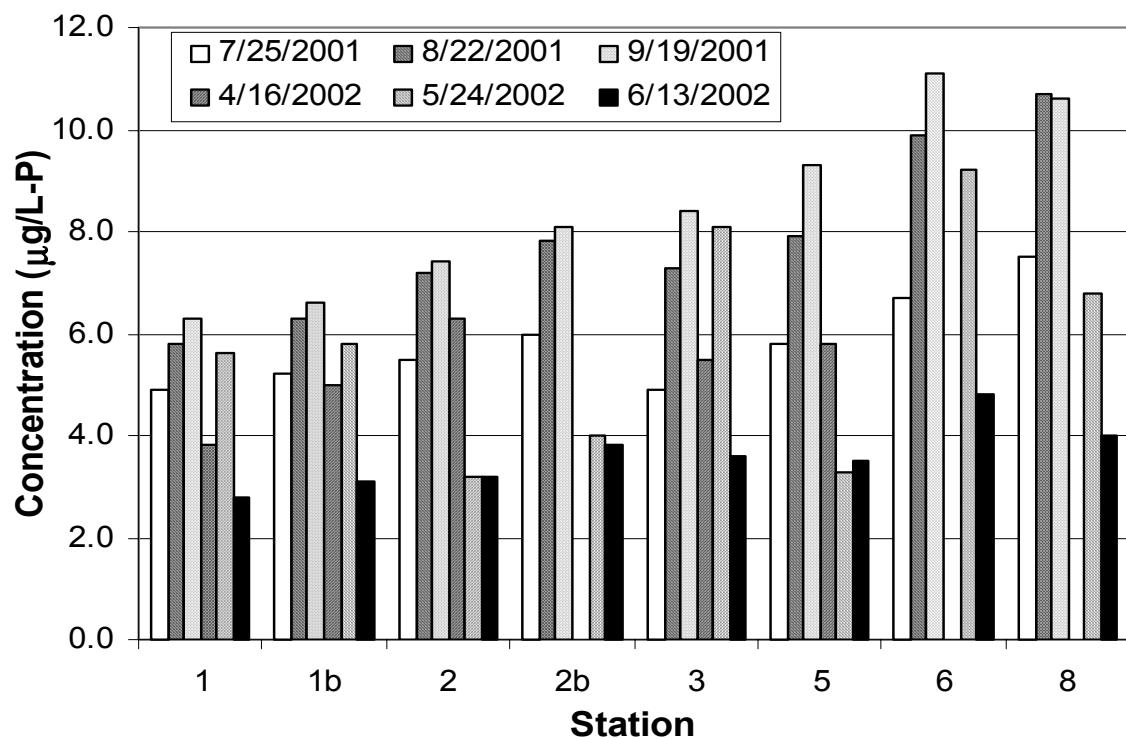
**Figure 23.** Dissolved reactive phosphorus concentrations for all stations showing downstream increases.

The downstream increase in conductivity and nutrients reported here also was observed in previous studies conducted on Chester Creek within the Municipality of Anchorage, Alaska (Davis and Muhlberg 2001). Reference data are required to determine if this is related to development.

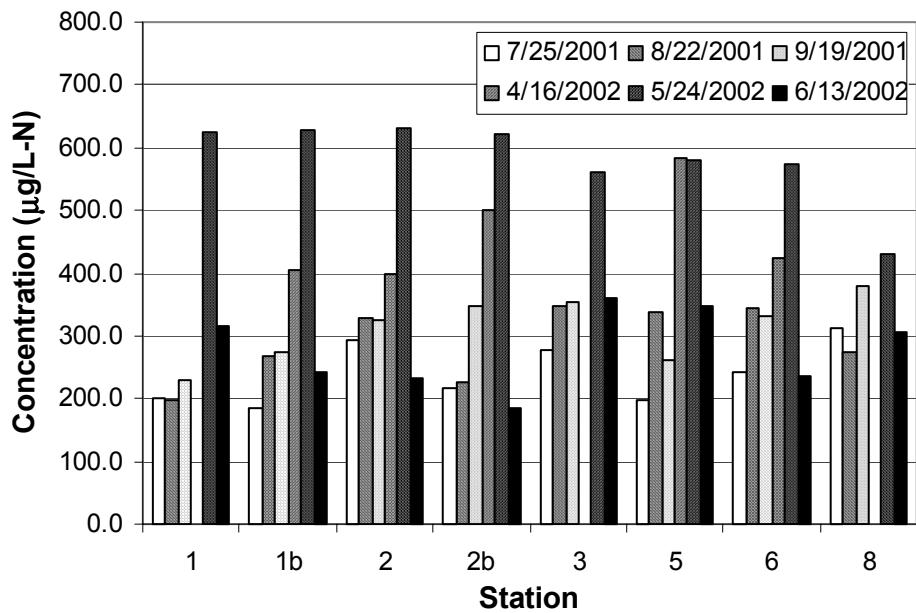
**Figure 24.** Wasilla Creek nitrate-nitrogen concentrations for all stations and sampling dates.

In addition to riparian and physical habitat changes at livestock-grazed sites, there were peaks in  $\text{NO}_3\text{-N}$  at stations 2 and 3. These increases may be due to runoff from pastures. Additional work should be conducted to address this hypothesis. Ratios of nitrate to dissolved phosphate-P indicate phosphorus limitation. Phosphate-P has been found to limit primary production at concentrations below 6  $\mu\text{g/L}$  (Mulholland et al. 1990; Bothwell 1989) and concentrations in Wasilla Creek are near this value. However, chlorophyll-a and dissolved phosphate-P concentrations are not correlated. Light also may become limiting at some times and some locations.

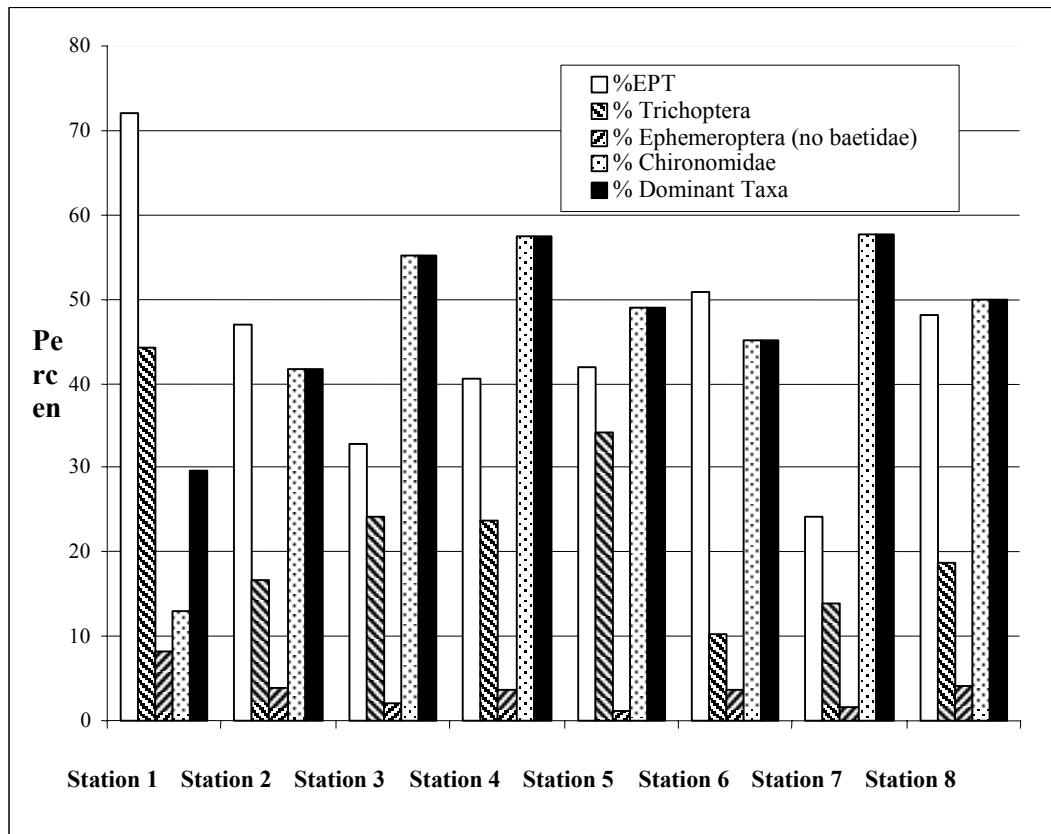
Differences in the invertebrate community occurred between the upstream station 1 and the remainder of the sites. The portion of the community that were in the Ephemeroptera (mayfly), Plecoptera (stonefly), and Trichoptera (caddisfly) (EPT) orders decreased from over 70% of the community at station 1 to less than 50% at and downstream of station 2 (Figure 25). Large differences also were seen in the percent mayflies and caddisflies.

At station 1 the chironomidae (midges) were only a small portion of the community (13%), while at the remaining stations the chironomidae were near 50% and dominated the community. The invertebrate community was more diverse at station 1 (lower Simpson's Diversity Idex) than other stations and the single most dominant organism made up 30% of the community. The dominant organism at station 1 was the sediment intolerant caddisfly, *Ecclisomyi* sp., which never exceeded 10% of the community at any other station.

**Figure 25. Comparison among stations for select metrics showing the change in the invertebrate community downstream from station 1.**
