**EVALUATION OF STREAM CROSSING STRUCTURES FOR PROVIDING FISH PASSAGE IN A TUNDRA STREAM; FISH SAMPLING OF FAWN CREEK, PRUDHOE BAY, ALASKA, 2004.**

**Evaluation of Stream Crossing Structures for Providing Fish  
Passage in a Tundra Stream;  
Fish Sampling of Fawn Creek, Prudhoe Bay, Alaska, 2004.**

**Technical Report No. 04-05**

**Office of Habitat Management  
and Permitting  
Alaska Department of Natural Resources**

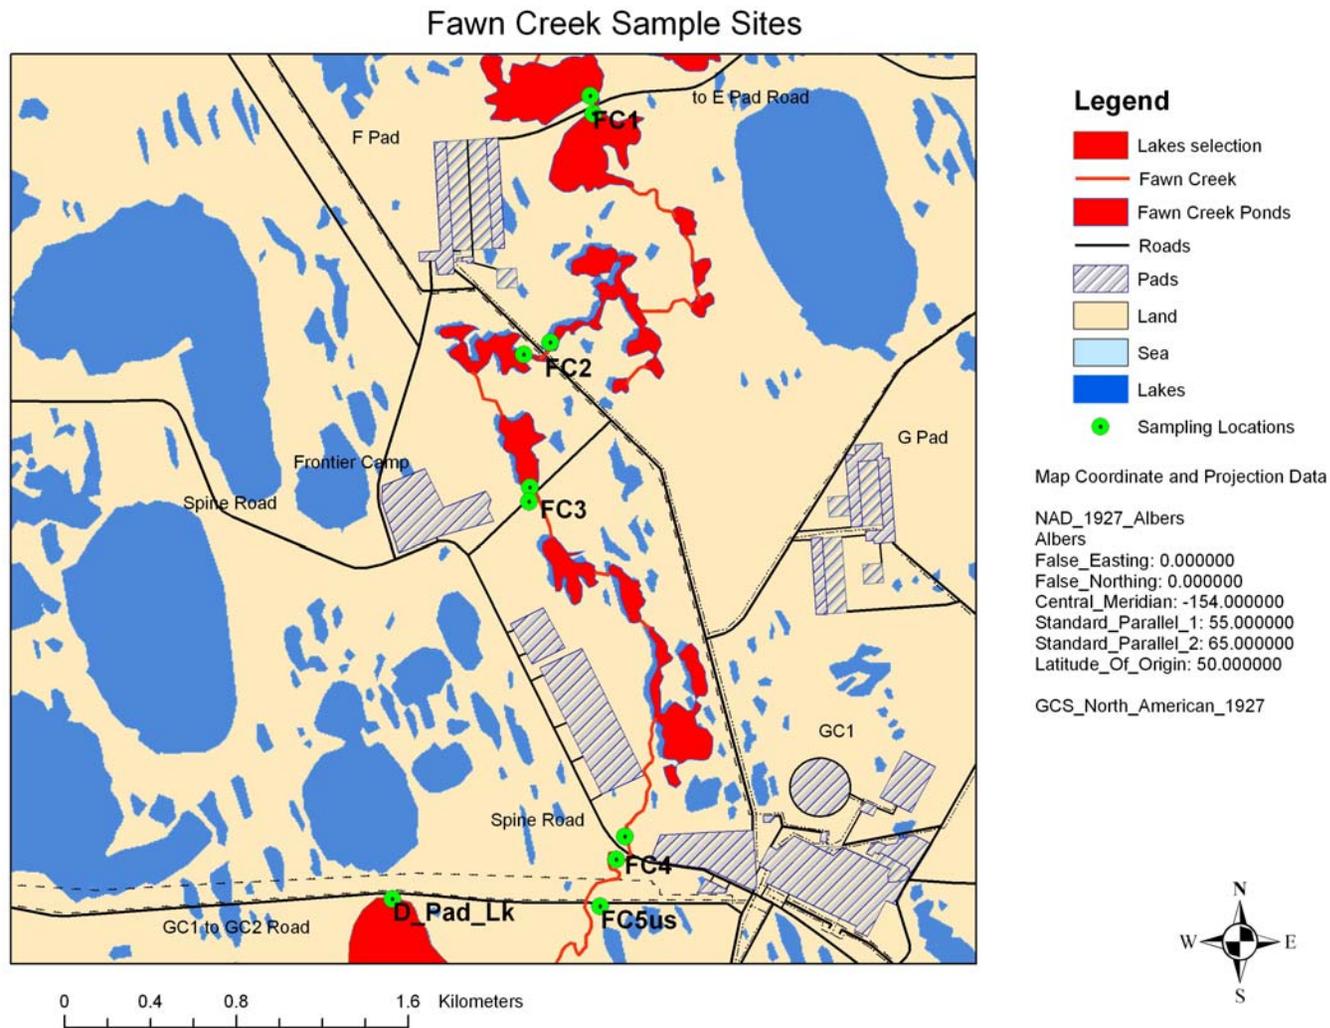
**Figure 2.** Fyke nets were set above and below each road crossing of Fawn Creek (green bull's-eyes); with the exception of the upstream most crossing where one net was fished upstream from the GC1 to GC2 road and one net was set in D-Pad Lake. From north to south (downstream to upstream) road crossings are Fawn Creek 1 (FC1) through Fawn Creek 5 (FC5); D Pad Lake was the upstream most net site.

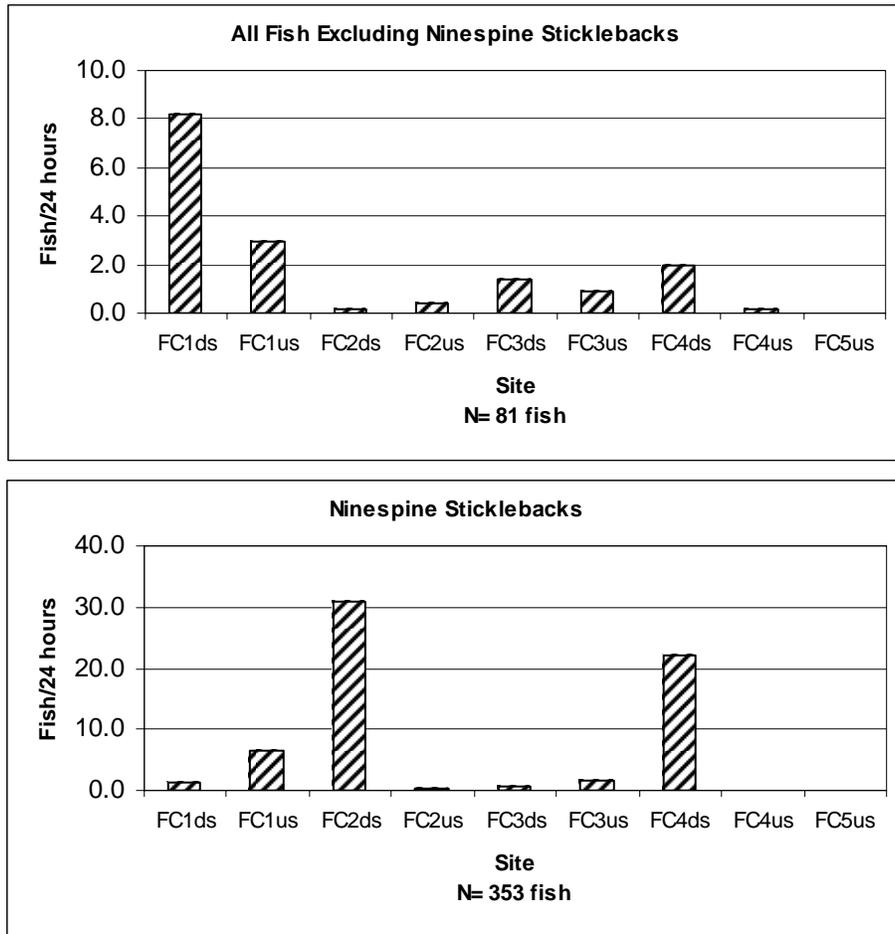
**Figure 3. Fyke net catch summary in fish per 24 hour period for all net sites, Fawn Creek, July 2004.**

Standardized catches from July sampling (fish per 24 hour period) generally were highest downstream from the first road crossing and lowest at the upstream-most locations (Figure 3). Non-parametric analysis of variance between the ranked catch rates at all sites sampled in July indicate that non-stickleback species were not distributed equally throughout the sample area and that capture rates were highest downstream in the system (KW=16.3434,  $p = 0.0377$ , Appendix III). Highest catch rates for all species tended to be higher downstream from culverts than upstream (Figure 3); however, statistical analysis suggests that catch rates were not significantly different up or downstream from individual stream crossings when considering the entire sampling area and only non-stickleback species (Wilcoxin Rank Sum, U downstream = 354, U upstream = 221,  $p = 0.1375$ , Appendix III). Only one, exceptionally large broad whitefish was captured above the Spine Road at net site FC4us in roughly 137 hours of effort; no fish were captured above FC4us. Analysis of stickleback catch rates strongly indicates that the species is unevenly distributed throughout the drainage, and that sticklebacks were concentrated downstream from road crossings (KW = 29.2088,  $p = 0.0003$ ; Wilcoxin Rank Sum, U downstream = 415, U upstream = 160,  $p = 0.0055$ , Appendix III). No sticklebacks were captured upstream from the Spine Road.

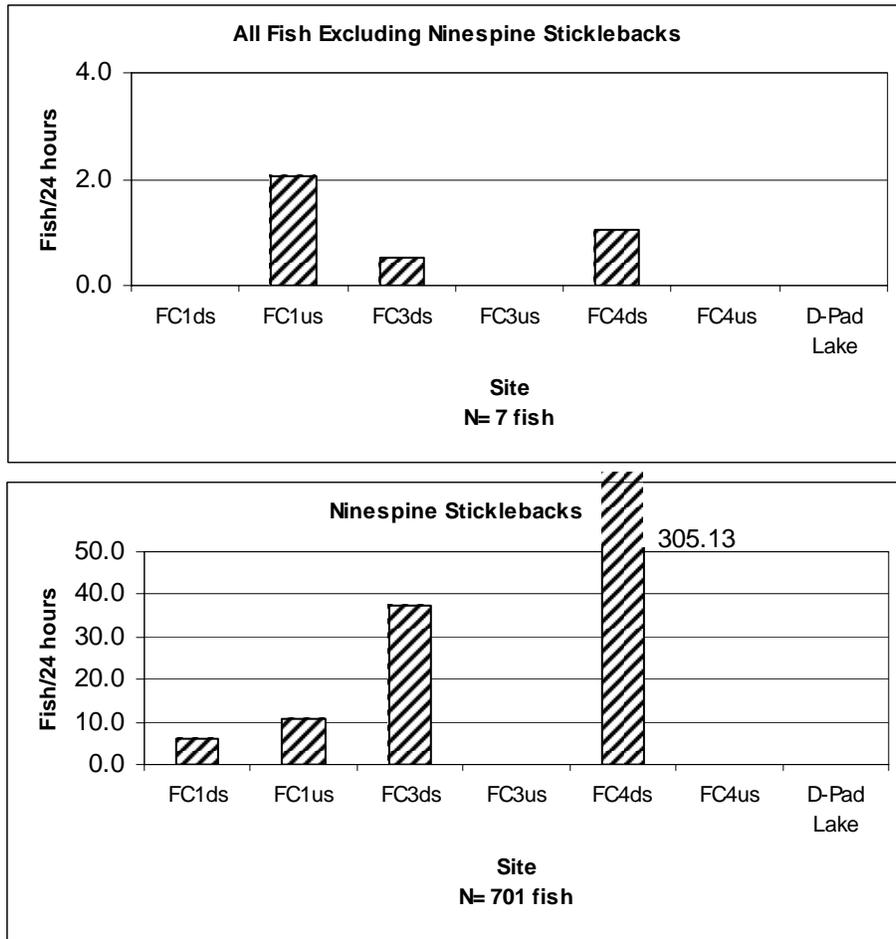
**Figure 4. Fyke net catch summary in fish per 24 hour period for all sites, August 2004.**

Ninespine stickleback numbers were relatively high in August, with highest catch rates downstream from culvert batteries (Figure 4). Highest catch rates occurred below the Spine Road at FC4ds which appears to be the upper limit of fish use in the system. High catch rates of sticklebacks in August are common in drainages on the arctic coastal plain as fish begin to congregate and move to wintering areas. In this case, it appears that sticklebacks were

concentrating near pools associated with culvert scour for wintering or attempting to move towards upstream water bodies for wintering.

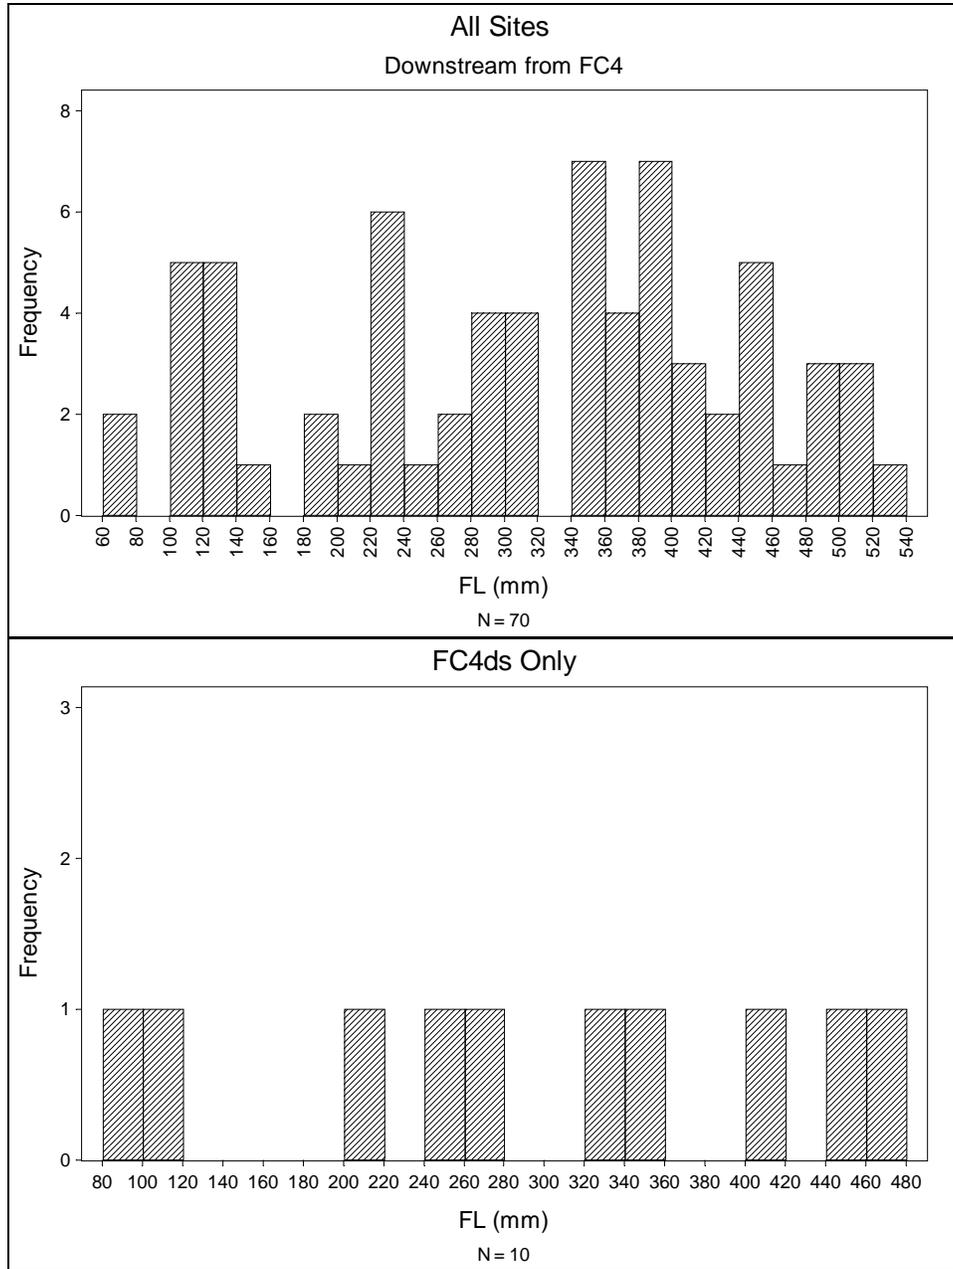
**Figure 5. Length frequency distributions of the catch at FC4ds and all downstream sites (excluding FC4ds) suggests that all age/size classes of non-stickleback fish present in the system are reaching as far as upstream as just below the Spine Road.**

While catch rates appear to be influenced by the stream crossings, fish passage is occurring through the lower three stream crossings (FC1 through FC3). Fish size distribution in the pool below the Spine Road crossing is similar to the size distribution observed in the lower drainage, indicating that crossings are not differentially excluding any particular size class of fish (Wilcoxin Rank Sum, U all downstream fish = 426.50, U FC4ds fish = 401.50,  $p = 0.8732$ ) (Figure 5, Appendix III). It is likely that at particular flow levels in the system, different culvert

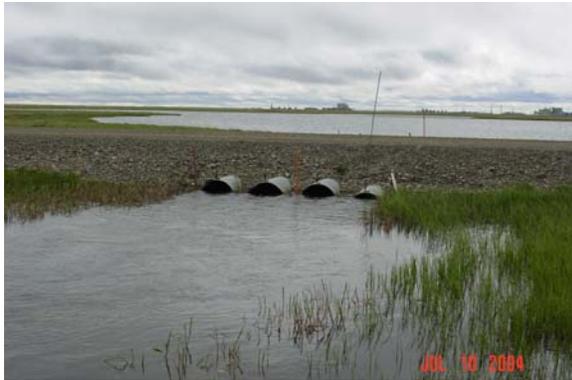
**FC1 Crossing**– View of downstream side of culvert battery, all culverts are more than 50% submerged.

Water surface elevation difference between upstream and downstream sides can be observed.

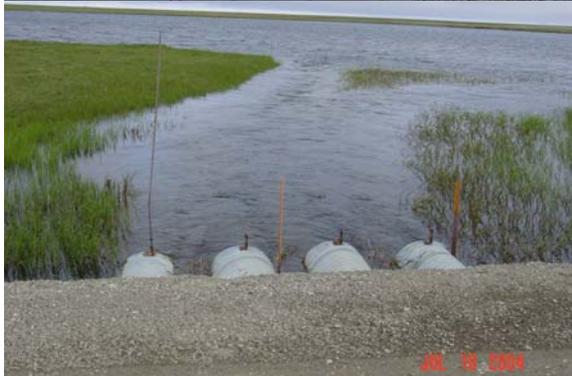
**FC1 Crossing**- View of culvert battery looking downstream from F Pad to E Pad Road.

FC1ds net is located off of the point at top center of the photograph.

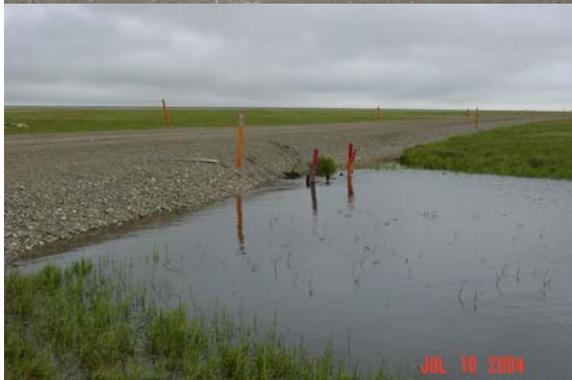
**FC1 Crossing**- View of upstream side of culvert battery, culvert inlets are completely submerged.

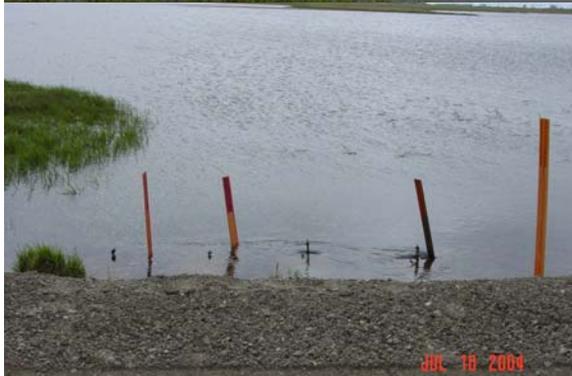
**FC1 Crossing**- View of culvert battery looking upstream from F Pad to E Pad Road.

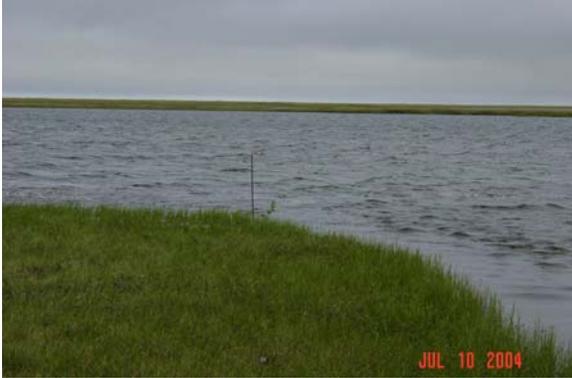
**FC1ds Net Set**– traditional set, full extension of lead from shore  
Set on 7/6/2004 and pulled on 7/11/2004  
Reset on 8/3/2004 and pulled on 8/5/2004

July Effort – 114.7 hours  
August Effort – 46.5 hours

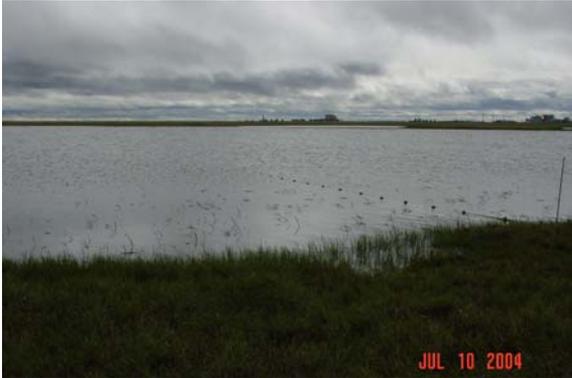
**FC1us Net Set**– traditional set, full extension of lead from shore  
Set on 7/6/2004 and pulled on 7/11/2004  
Reset on 8/3/2004 and pulled on 8/5/2004

July Effort – 114.8 hours  
August Effort – 46.6 hours

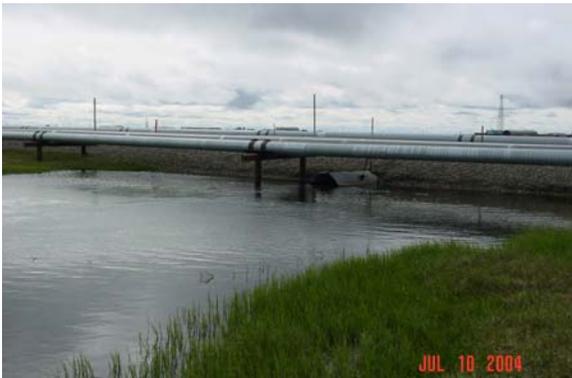
**FC2 Crossing**– View of downstream side of culvert.

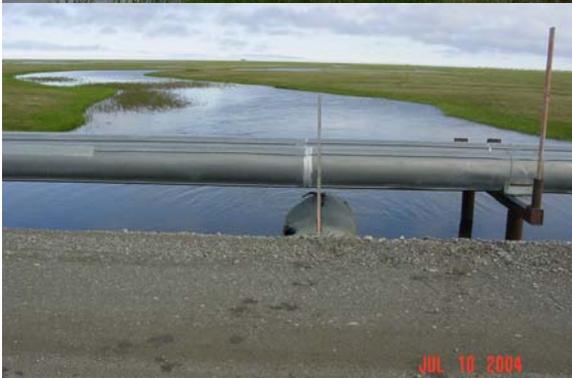
**FC2 Crossing**– View of culvert looking downstream from F-Pad to GC-1 Road.

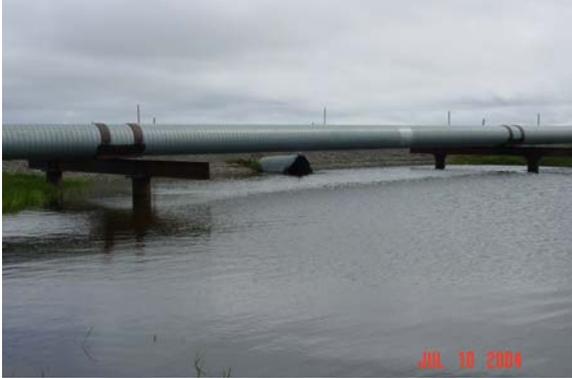
**FC2 Crossing**– View of upstream side of culvert.

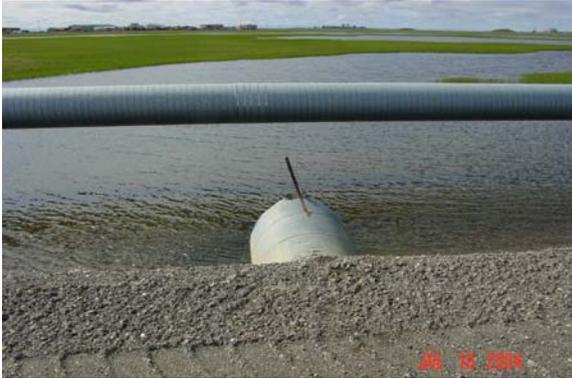
**FC2 Crossing**- View of culvert looking upstream from F-Pad to GC-1 Road.

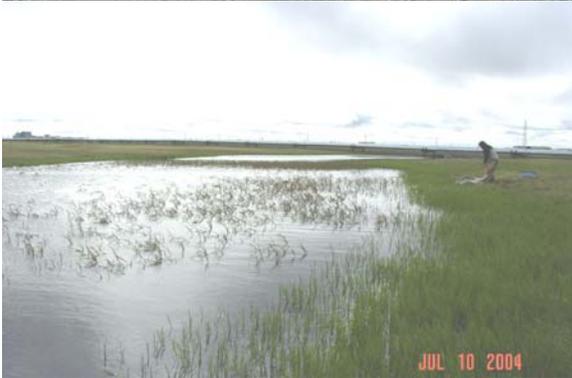
**FC2ds Net Set**– bi-directional set, creek blocked, fishing up and down stream  
Set on – 7/5/2004 and pulled on 7/11/2004

July Effort – 136.6 hours

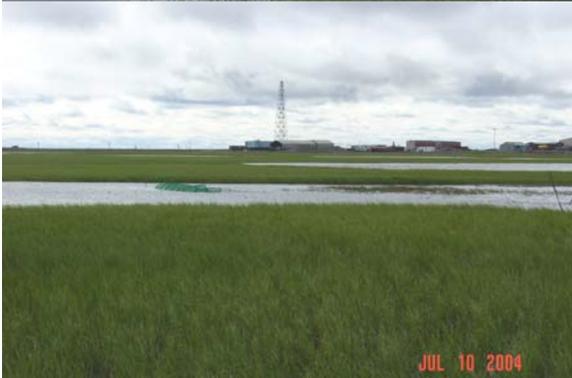
**FC2us Net Set**– traditional set, full extension of lead from shore  
Set on – 7/5/2004 and pulled on 7/11/2004

July Effort – 115 hours

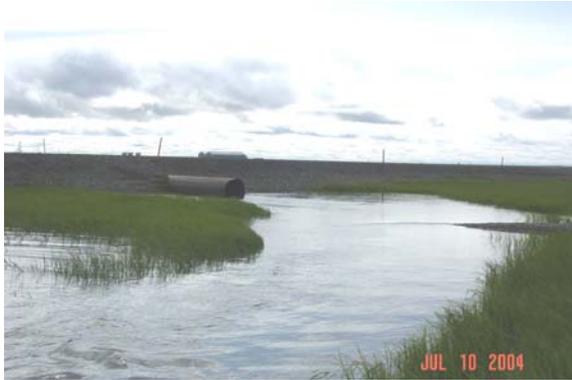
**FC3 Crossing**– View of downstream side of culvert battery.

Gravel outwash present downstream from large scour pool.

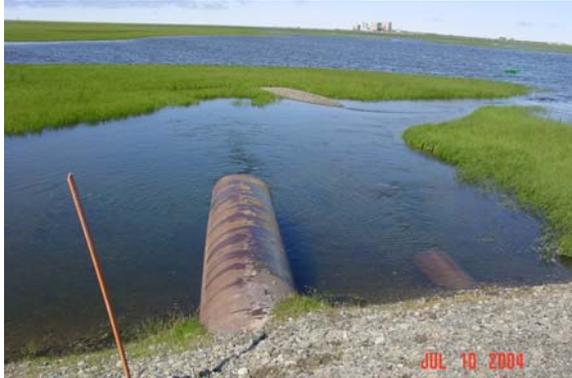
**FC3 Crossing**- View of culvert battery looking downstream from Spine Road Access Road.

Small culvert is submerged.  
Large culvert is suspended in large scour pool.

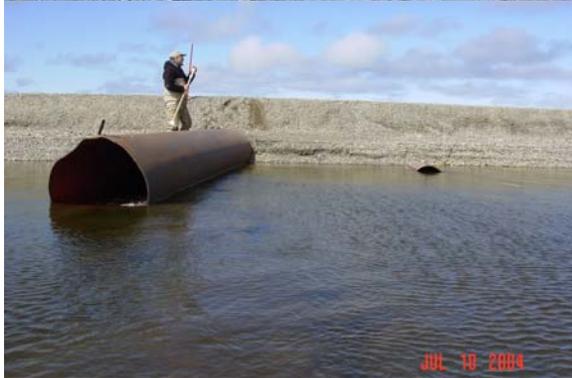
**FC3 Crossing**- View of upstream side of culvert battery, crossing creating significant head resulting in whirlpool effect as water drops into culverts inlets.

Significant road prism erosion was present on the upstream side of the crossing, indicating a severe restriction of flow at water and extreme head build-up.

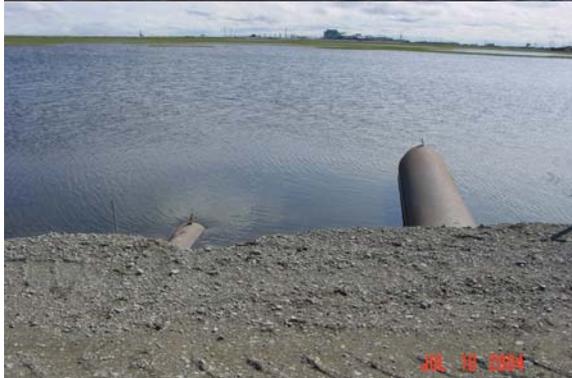
**FC3 Crossing**- View of culvert battery looking upstream from Spine Road Access Road.

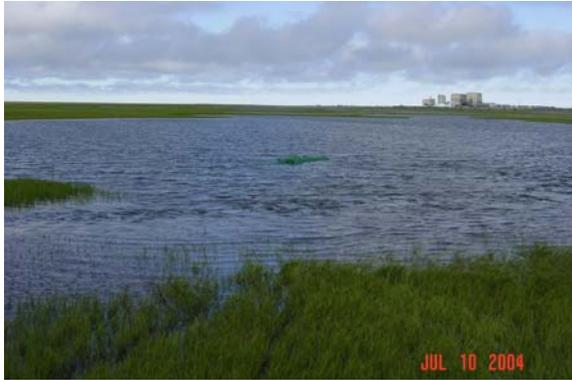
**FC3ds Net Set**– traditional set, full extension of lead from shore  
Set on 7/5/2004 and pulled on 7/11/2004  
Reset on 8/3/2004 and pulled on 8/5/2004

July Effort – 136.8 hours  
August Effort – 46.7 hours

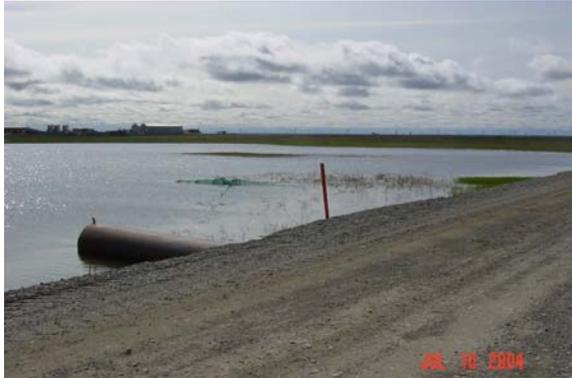
**FC3us Net Set**– traditional set, full extension of lead from shore  
Set on 7/5/2004 and pulled on 7/11/2004  
Reset on 8/3/2004 and pulled on 8/5/2004

July Effort – 136.8 hours  
August Effort – 46.8 hours

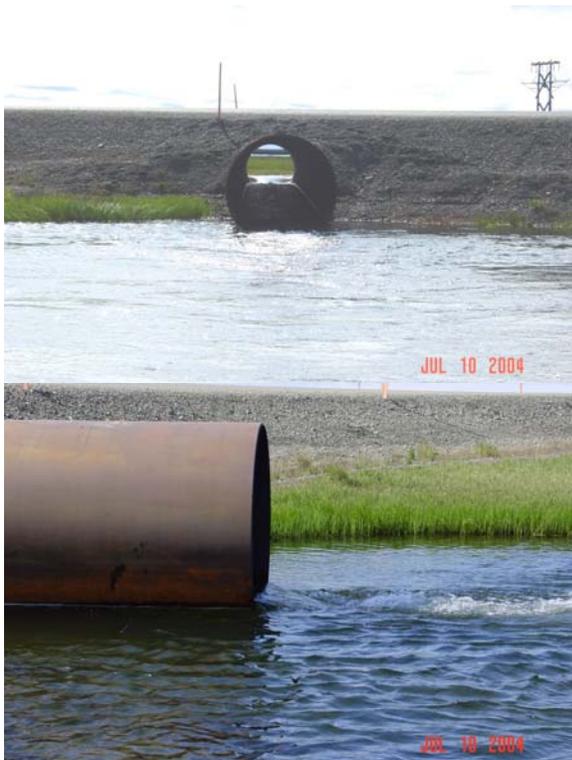
**FC4 Crossing**– View of downstream side of culvert.

**FC4 Crossing**– Side view of downstream side of culvert. Pipe is nearly perched and water is plunging into pool.

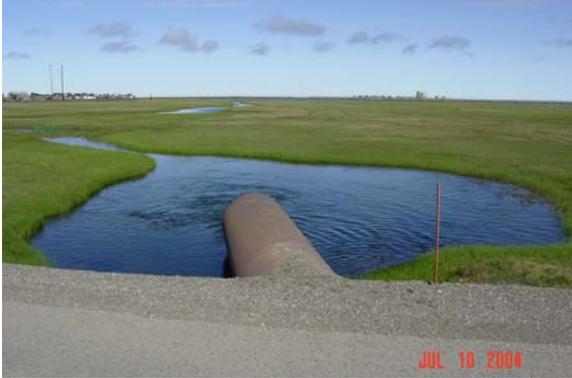
**FC4 Crossing**– View of culvert looking downstream from Spine Road.

Culvert suspended in approximate 6' to 8' deep scour pool.

restore fish passage at the Spine Road crossing as it represents a nearly complete obstacle to fish movement.

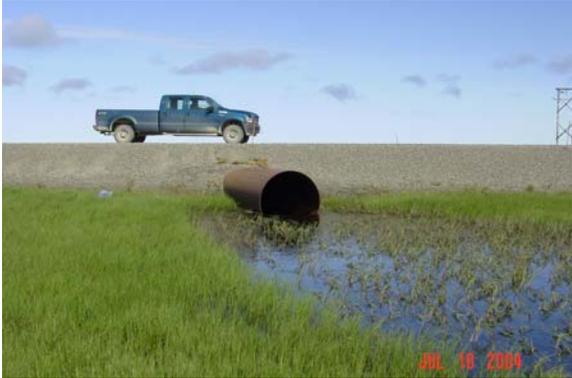
**FC4 Crossing** – View of upstream side of culvert.

Considerable water surface elevation drop occurs immediately inside culvert inlet, approximate head of 0.7'.

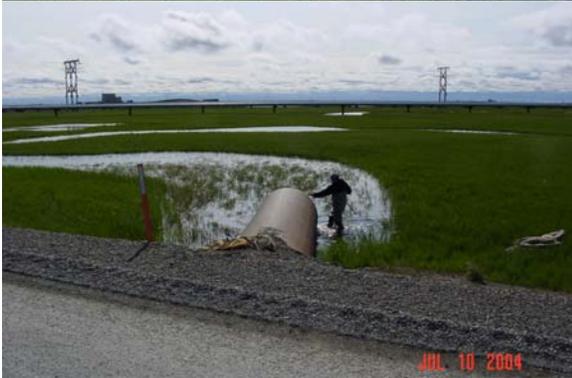
**FC4 Crossing**– View of culvert looking upstream from Spine Road.

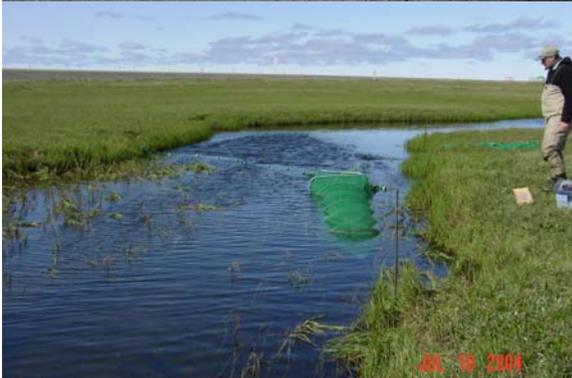
**FC4ds Net Set**– bi-directional set, creek blocked, fishing up and down stream  
 Set on 7/5/2004 and pulled on 7/11/2004  
 Reset on 8/3/2004 and pulled on 8/5/2004

July Effort – 136.5 hours  
 August Effort – 46.7 hours

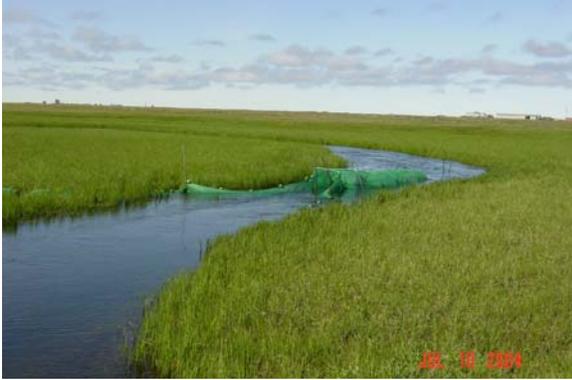
**FC4us Net Set**– bi-directional set, creek blocked, fishing up and down stream  
Set on 7/5/2004 and pulled on 7/11/2004  
Reset on 8/3/2004 and pulled on 8/5/2004

July Effort – 137.2 hours  
August Effort – 46.8 hours

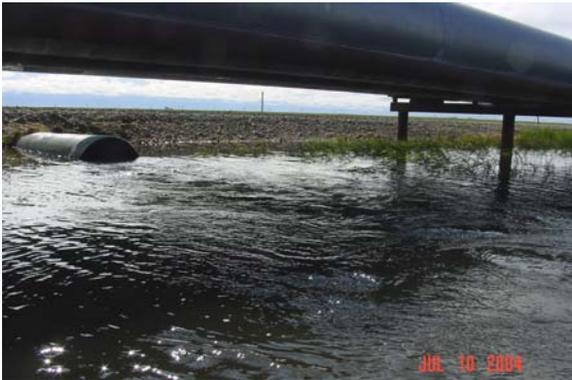
**FC5 Crossing**– View of downstream side of culvert.

Culvert is 2/3 submerged and water velocity is accelerated at the outlet.

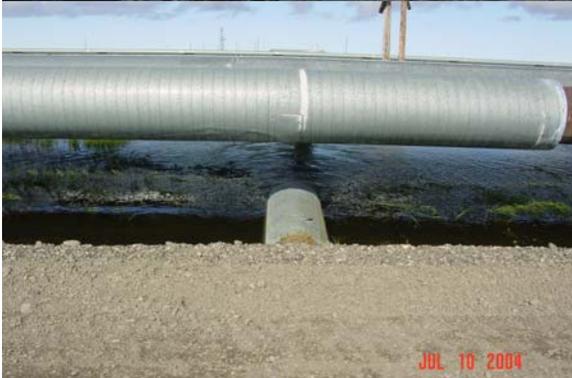
**FC5 Crossing**– View of culvert looking downstream from GC-1 to GC-2 Road.

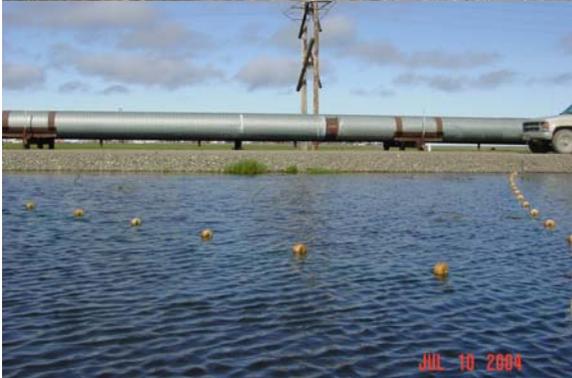
**FC5 Crossing**– View of upstream side of culvert.

Culvert is 3” submerged and crossing is impounding water above the road. Road fill in the area was saturated with water.

Culvert inlet is located between the large and small clumps of vegetation at the toe of the road.

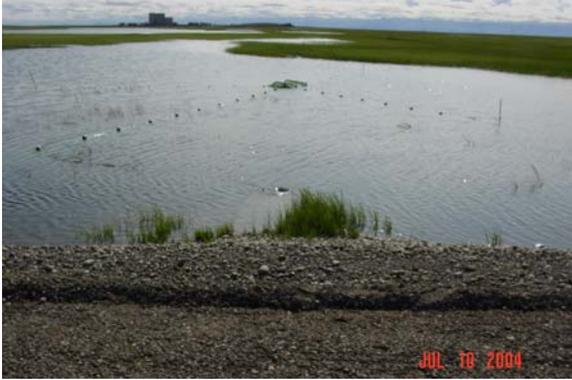
**FC5 Crossing**– View of upstream side of culvert from GC-1 to GC-2 Road. D Pad is visible in the background.
