Appendix M: Petersburg

Guide to direct fieldwork for cataloging anadromous water bodies in Southeast Alaska

Alaska Department of Fish and Game

PETERSBURG SURVEYS

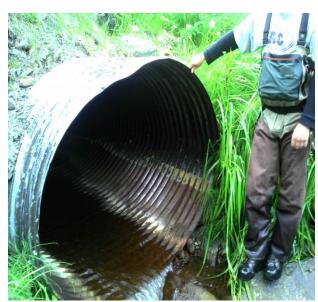
Figure 1.-Downstream side of 150' culvert.

Waypoint	Latitude	Longitude	Notes	Sample Effort	Sample Results
1	56.8091	-132.9562	Hammer Slough.		
2	56.8072	-132.9541	Inlet of tributary coming from		
			culvert, probably near airport.		
3	56.8074	-132.9538	Culvert outlet.		
4	56.8078	-132.9530	Inlet of culvert probably 150 '		
			in length.		
5	56.8051	-132.9441	3-way tributaries here.		
6	56.8048	-132.9394	End of Hammer Slough fork.		
			Chain link fence is a barrier.		
			Totally clogged with debris.

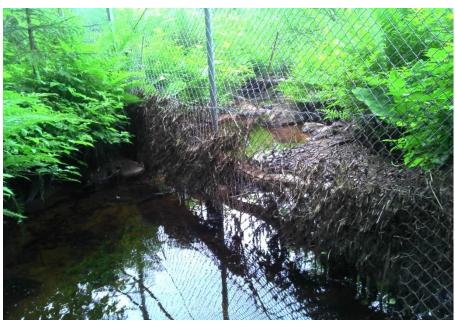
Figure 1.—Fence that surrounds airport in stream 106-11-10010-2002. We did not survey above the fence.

Findings: We tracked this stream with a GPS and found the route differs from what is documented in the AWC (Table 1). We surveyed this stream up to the airport property line and found a large build-up of dead vegetation on fence (Figure 1).

Waypoint	Latitude	Longitude	Notes	Sample Effort	Sample Results
7	56.8072	-132.9541	Back on tributary.		
8	56.8033	-132.9521	Tributary on river left.		
			Heading up to airport.		
9	56.8021	-132.9529	Top of tributary. Fence barrier		
			again.		
10	56.8022	-132.9517	Fence at airport. Could be		
			barrier at certain flows and		
			when packed with debris. Top		
			of second fork.		
11	56.8032	-132.9520	Back at confluence with	VI	CO
			tributaries. Fed CO here.

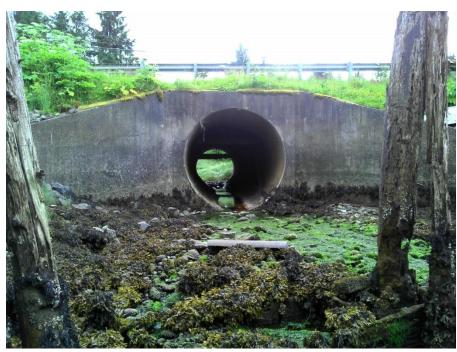
Figure 1.—Outlet of culvert under Nordic Drive.

Findings: We tracked this stream with a GPS and found the route differs from what is documented in the AWC (Table 1). The culvert under highway was large a sufficient for fish passage, but likely only fish migration during high tide (Figure 1).

Waypoint	Latitude	Longitude	Notes	Sample Effort	Sample Results
12	56.8094	-132.9607	Culvert outlet under Nordic	_	
			Drive.		
13	56.8093	-132.9606	Inlet of pipe.		
14	56.8056	-132.9594	Outlet of culvert.		
15	56.8055	-132.9593	Inlet of culvert.		
16	56.8011	-132.9577	At fence line on Airport.		
			Long stream!

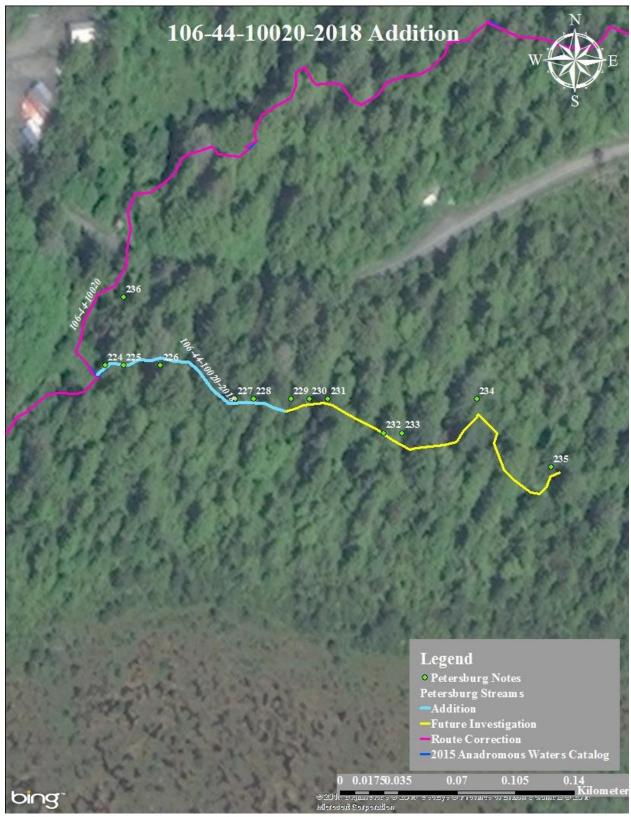
Figure 1.–106-44-10020-2018 addition map.

Waypoint	Latitude	Longitude	Notes	Sample Effort	Sample Results
224	56.7818	-132.9668	Tributary entering river left.		
225	56.7818	-132.9667		EF	1 CT
226	56.7818	-132.9665		EF	2 CO, 1 CT
227	56.7817	-132.9661	There was about a 20' section		
			between WPT 226 and 227		
			that was under a root wad		
			complex and lost sight of		
			stream.		
228	56.7817	-132.9660		EF	1 DV, 1 CT
229	56.7817	-132.9658		EF	1 CO, 1 DV
230	56.7817	-132.9657	Goes subterranean.		
231	56.7817	-132.9656	Resurface.	EF	1 CT, 2 DV
232	56.7816	-132.9653		EF	1 CT
233	56.7816	-132.9652	We have been hitting quite a	EF	1 CO
			few subterranean and surface		
			sections.		
234	56.7817	-132.9648		EF	2 DV
235	56.7815	-132.9644	Calling it the top of the	EF	1 CT
			tributary. Becoming		
			increasingly subterranean and		
			harder and harder to locate.

Recommendations: Add stream to AWC (Figure 1).

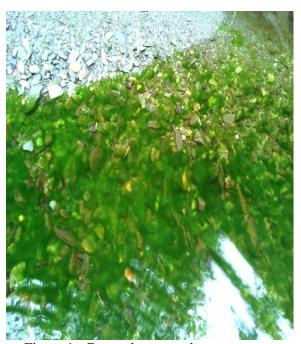
Figure 1.—Green algae on substrate.

Waypoint	Latitude	Longitude	Notes	Sample Effort	Sample Results
1	56.7202	-132.9294	Twin Creek Bridge. Heading upstream to look for tributaries.		
2	56.7202	-132.9232	A lot of green algae growing on rocks.	VI	СО
3	56.7201	-132.9153	Bedrock cascade about 100ft long.

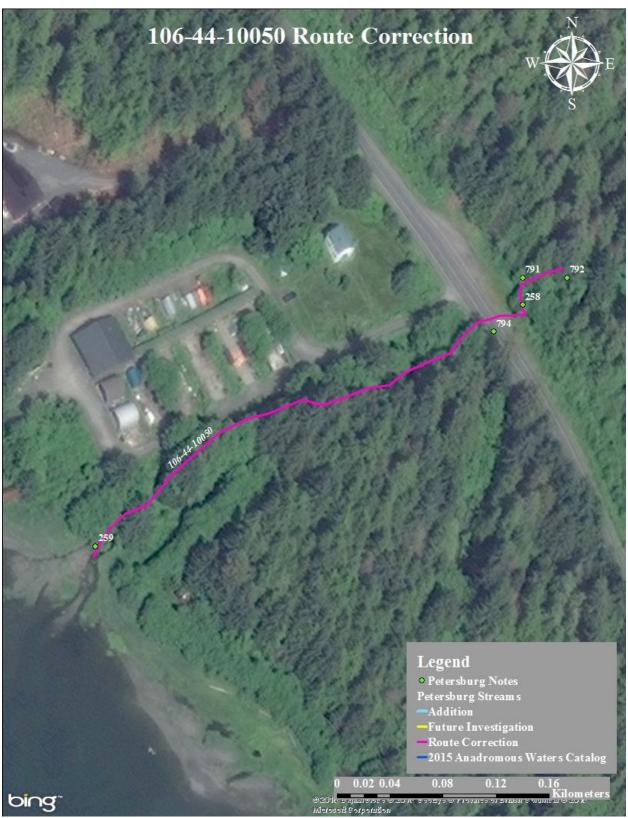
Figure 1.–106-44-10050 route correction map.

Waypoint	Latitude	Longitude	Notes	Sample Effort	Sample Results
259	56.7080	-132.9394	Intertidal zone with creek and		
			ocean.		
258	56.7089	-132.9365	Outlet of ~ 2 ft. culvert under		
			Mitkof Highway.		
791	56.7090	-132.9365	Inlet of culvert. The		
			downstream portion has been		
			tracked and cataloged.		
792	56.7090	-132.9362		EF	1 DV
793	56.7091	-132.9353	Stopping here due to a	EF	No Fish
			perched culvert on		
			downstream end. Great		
			looking spawning and rearing		
			habitat.		
794	56.7088	-132.9367	Outlet of culvert. Perched		
			about 2ft. Possible fish		
			barrier.

Recommendations: Update stream route in the AWC (Figure 1).

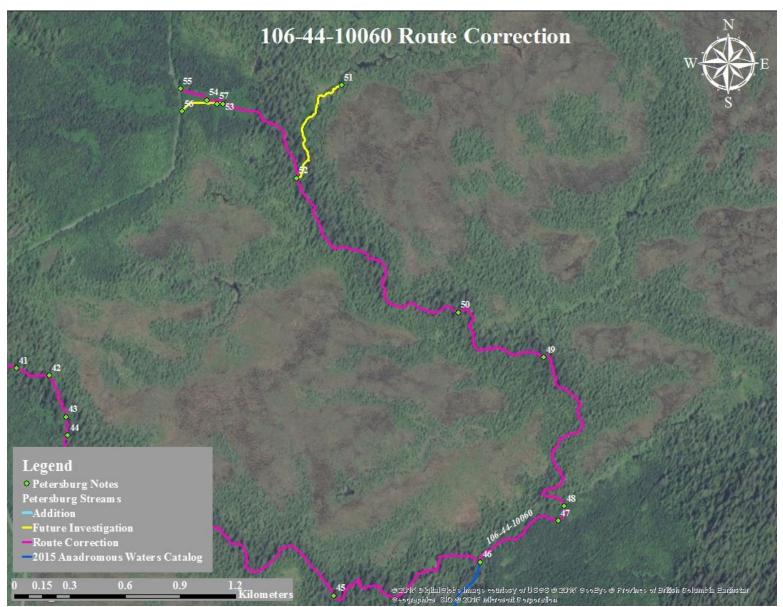
Figure 2.–106-44-10060 route correction map.

-	Waypoint	Latitude	Longitude	Notes	Sample Effort	Sample Results
-	• •				Sample Effort	Sample Results
	45	56.6999	-132.8138	Tributary on river right.		
	46	56.7008	-132.8066	On Falls Creek, heading up.		
	47	56.7019	-132.8028	Steep little tributary on river		
				right.		
	48	56.7023	-132.8025	Tiny tributary, river right.		
	49	56.7063	-132.8035	Large tributary leading into		
				beaver dam.		
	50	56.7075	-132.8077	Possible tributary.		
	51	56.7136	-132.8134	Tributary end is beaver pond.		
				Steep grass choked dam.		
	52	56.7111	-132.8156	Back on mainstem.		
	53	56.7131	-132.8192	Possible tributary on river		
				right.		
	54	56.7132	-132.8200	Another possible tributary.		
	55	56.7135	-132.8213	Culvert on Falls Creek.

Recommendations: Correct the route of the upper portion of Falls Creek in the AWC (Figure 2).

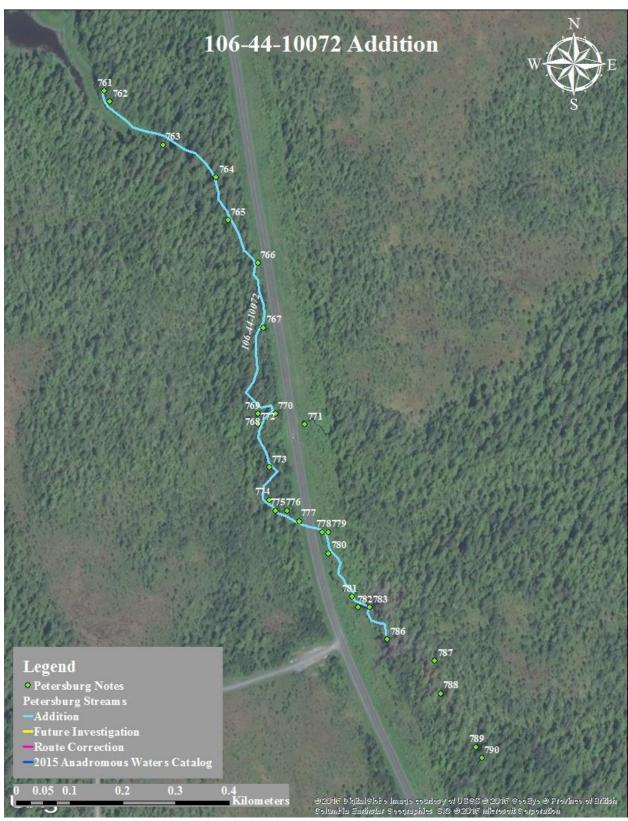
Figure 1.–106-44-10072 addition map.

Waypoint	Latitude	Longitude	Notes	Sample Effort	Sample Results
786	56.6598	-132.9052	We set 3 minnow traps in	MT	1 CO
			beaver ponds on 6/27 @ 1345		
			and pulled them 6/28 @ 845.		
			We caught 1 CO~ 4 years old.		
			It was dead in trap probably		
			due to anoxic water. Refer to		
			WPT 783.

Recommendations: Add this stream to the AWC (Figure 1).

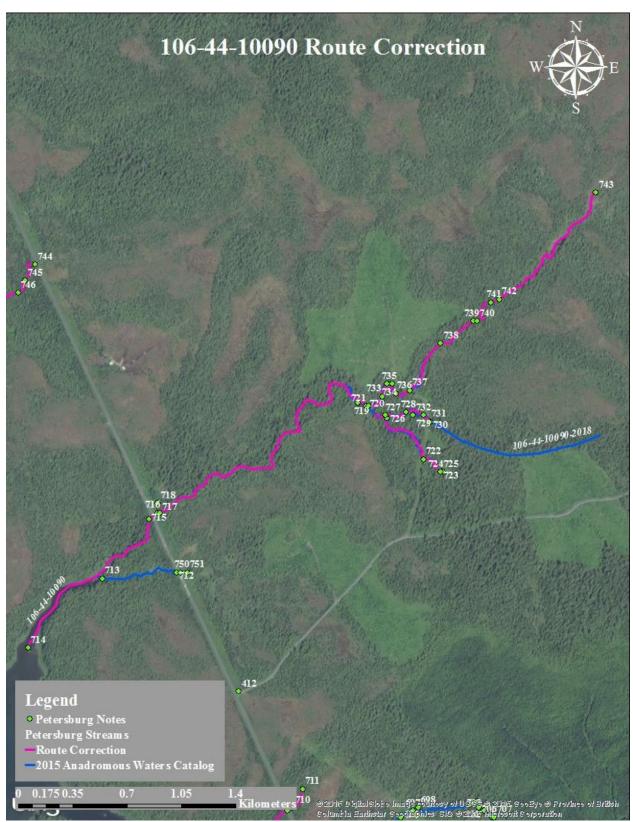
Figure 1.–106-44-10090 route correction map.

741	56.6519	-132.8742		EF	5 CO
742	56.6520	-132.8737		EF	1 CO
743	56.6554	-132.8681	Water has become very		
			stagnant and disconnected. We		
			have E-fished in a couple of		
			places with no luck. Calling it		
			the top. Substrate all mud		
			because it is an old beaver		
			complex.

Recommendations: Update this stream's course to reflect its sinuosity in the AWC (Figure 1).

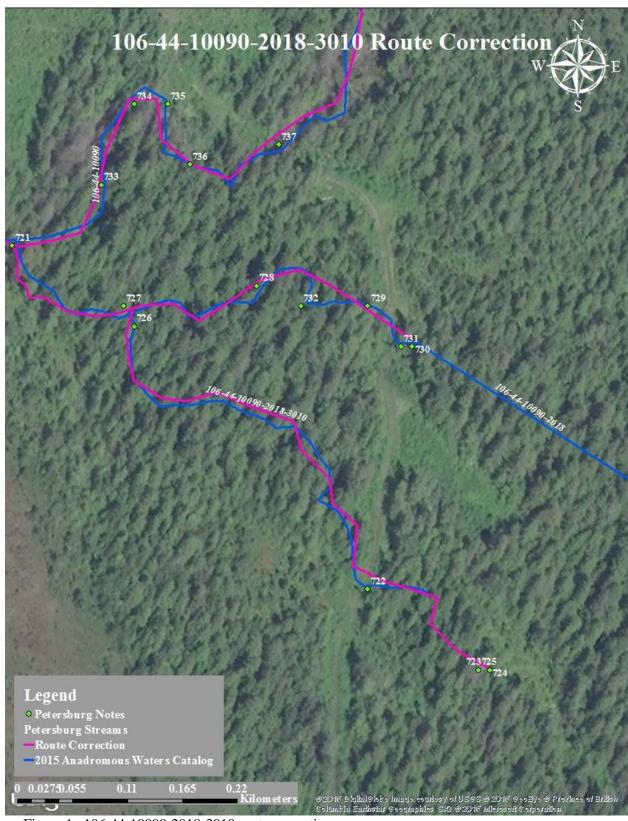
Figure 1.–106-44-10090-2018-3010 route correction map.

Waypoint	Latitude	Longitude	Notes	Sample Effort	Sample Results
726	56.6482	-132.8802	Tributary entering river right.		
722	56.6469	-132.8781	Stream crosses old logging access road. Track down.	HN	2 CO
724	56.6465	-132.8770	Calling the top, has basically run out of flow and have not seen CO.	EF	No Fish
723	56.6465	-132.8771		EF	1 CT
725	56.6465	-132.8771		HN	3 CO

Recommendations: Update this streams course and extents in the AWC (Figure 1).

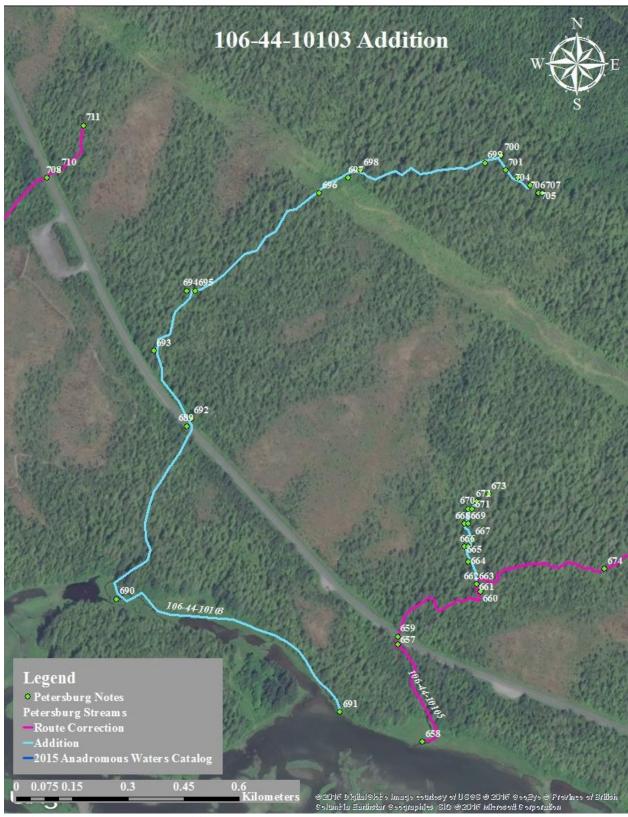
Figure 1.–106-44-10103 addition map.

Waypoint	Latitude	Longitude	Notes	Sample Effort	Sample Results
689	56.6324	-132.8826	Downstream of culvert on	VI	CO
			stream that crosses the Mitkof		
			Highway. CO everywhere.		
690	56.6301	-132.8843	Beginning of a series of shallow	VI	CO
			ponds. Forested section ends		
			now grass. CO everywhere.		
691	56.6286	-132.8789	Mouth of creek into slough.		
692	56.6325	-132.8825	Observed CO passing culvert.	VI	CO
	~ ·	100 0001	Poorly bedded, not cataloged.		
693	56.6334	-132.8834	Schooling CO.	VI	CO
694	56.6342	-132.8826	Top of short tributary filled with coho.	HN	10 CO
695	56.6342	-132.8824	Mouth of short tributary. Filled	VI	CO

0)3	30.03-2	-132.0024	with CO.	V I	CO
696	56.6355	-132.8794	Still seeing CO in numbers. Out	VI	CO
			in powerline slash. Chocked and		
			awful.		
697	56.6357	-132.8787	Stream reentering forest.	HN	2 CO
			Observed multi CO, netted 2		
698	56.6358	-132.8784	Mouth of very small tributary.		
699	56.6359	-132.8754	Tributary.		
700	56.6360	-132.8750	In shallow pool in tributary.	EF	1 CO
701	56.6358	-132.8749	Reduced flow, cobbles	HN	4 CO
702	56.6357	-132.8746	Getting smaller, less flow.	EF	1 DV
703	56.6357	-132.8746			1 DV
704	56.6356	-132.8743		EF	2 CO
705	56.6355	-132.8741	Very low flows.	EF	2 DV
706	56.6355	-132.8741	Big debris jam, subsurface	EF	DV
			flows.		
707	56.6355	-132.8740	Standing on top of debris jam,		
			flows disappear into the rocks.

Recommendations: Add this stream to the AWC (Figure 1).

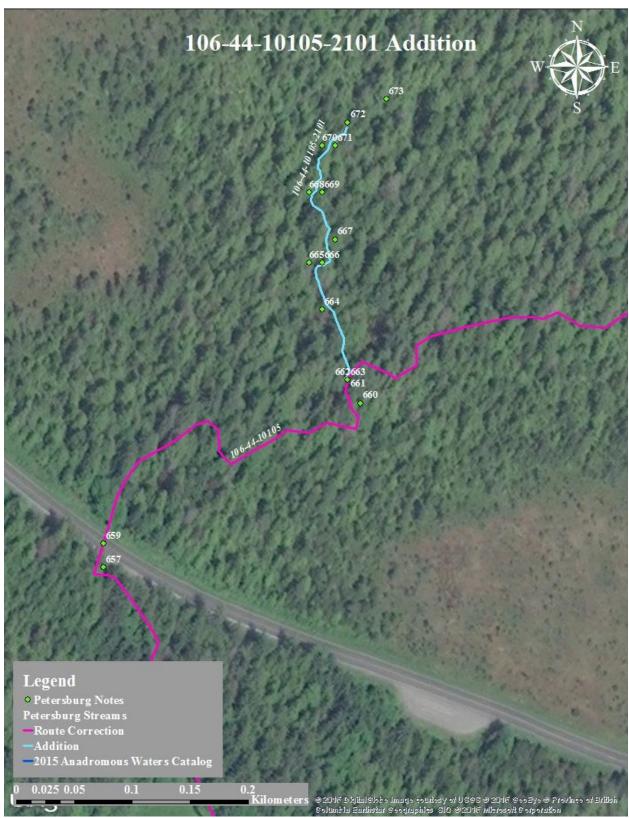
Figure 1.–106-44-10105-2101 addition map.

Substrate changed from sand		
			and gravel to brown muck.		
672	56.6314	-132.8756		EF	2 CO

Recommendations: Add this tributary to the AWC (Figure 1).

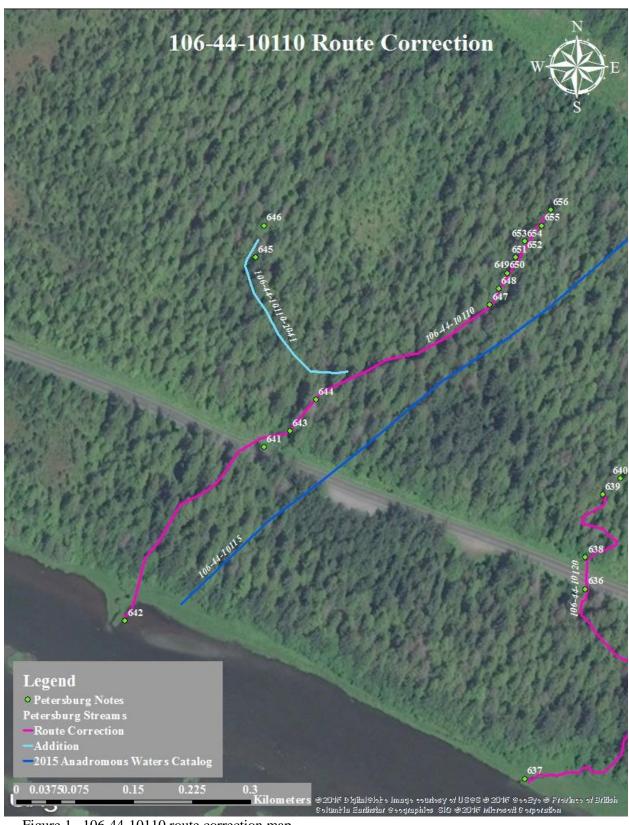
Figure 1.–106-44-10110 route correction map.

Waypoint	Latitude	Longitude	Notes	Sample Effort	Sample Results
641	56.6276	-132.8684	Downstream side of culvert under Mitkof Highway. Many CO in the pool below the culvert.	VI	СО
642	56.6265	-132.8700	Mouth of creek into Slough. CO, 35 mm, along the entire way.	VI	СО
643	56.6277	-132.8681	Upstream of culvert. CO ~ 35 mm.	VI	CO
644	56.6279	-132.8678	Tributary entering river right. Tracking. CO ~ 35 mm.	EF	
647	56.6285	-132.8658	VI of CO up to this point. Found adult salmon jaw bone.	VI	СО
648	56.6286	-132.8657	·	EF	7 CO
649	56.6287	-132.8656		EF	1 CO, 1 DV
650	56.6287	-132.8656		EF	2 CO
651	56.6288	-132.8655		EF	3 CO
652	56.6289	-132.8654	Small tributary entering river right. Tracking		
653	56.6289	-132.8654	Top of tributary.	EF	1 DV
654	56.6289	-132.8654	Small root wad falls. CO in pool below. Possible barrier.	EF	4 CO
655	56.6290	-132.8652		EF	3 DV
656	56.6291	-132.8651	Calling it the top. Seeping from moss. No CO up to here from WPT 654.	EF	No fish

Recommendations: Update this stream's course and extent in the AWC (Figure 1).

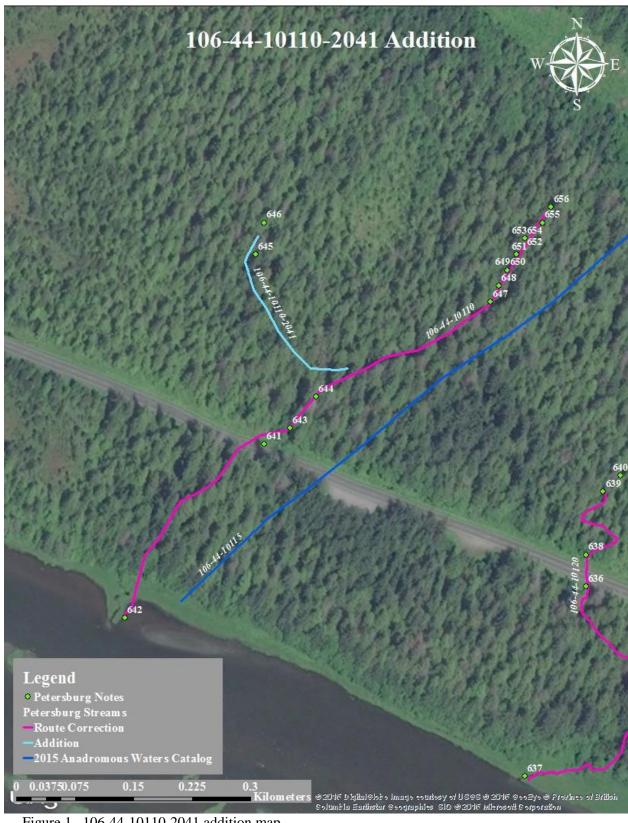
Figure 1.–106-44-10110-2041 addition map.

Waypoint	Latitude	Longitude	Notes	Sample Effort	Sample Results
644	56.6279	-132.8678	Tributary entering river right.	EF	
645	56.6288	-132.8685	Tracking. CO ~ 35 mm. CO up to this point. Small 6" mossy root wad drop into pool.	VI	СО
646	56.6290	-132.8684	Top of tributary. Water coming out of mossy root wad. Subterranean. No CO above last point.

Recommendations: Add this stream to the AWC (Figure 1).

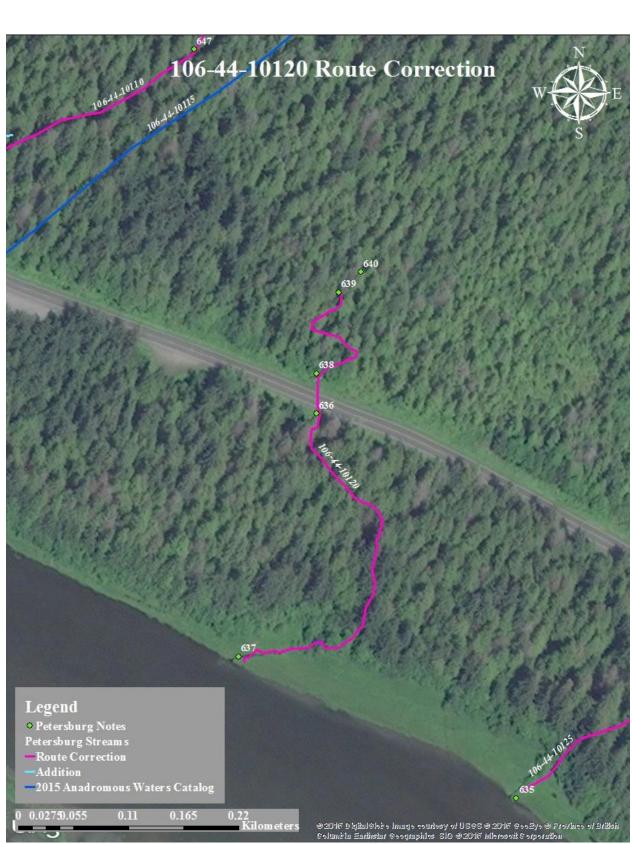
Figure 1.–106-44-10120 route correction map.

Waypoint	Latitude	Longitude	Notes	Sample Effort	Sample Results
636	56.6267	-132.8647	Coho at mouth of culvert, a couple trying to pass the culvert.	VI	СО
637	56.6255	-132.8654	Thousands of coho fry milling at mouth of stream.	VI	СО
638	56.6269	-132.8647	Inlet of culvert. Coho netted here.	HN	СО
639	56.6273	-132.8645	Coho netted at last point before trickle. Bedrock exposed.	HN	СО
640	56.6274	-132.8643	Stream becomes seepy trickle. No fish seen or captured.

Recommendations: Update this stream's course to reflect its sinuosity in the AWC (Figure 1).

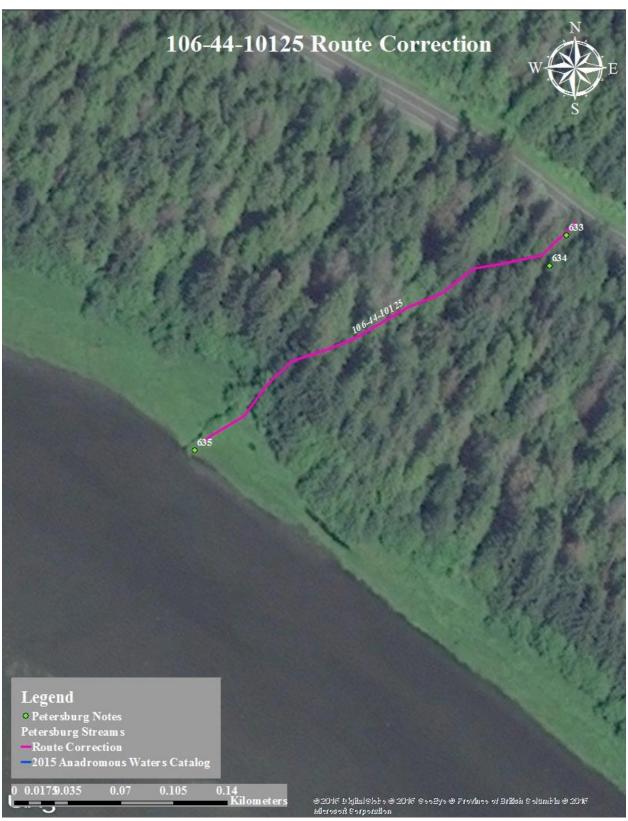
Figure 1.–106-44-10125 route correction map.

Waypoint	Latitude	Longitude	Notes	Sample Effort	Sample Results
633	56.6255	-132.8607	Outlet of pipe. High gradient,		
			boulder at outlet.		
634	56.6254	-132.8608	CO juveniles milling and feeding	VI	CO
			in sunny pool.		
635	56.6248	-132.8629	Mouth of creek. Tons of CO!	VI	CO

Recommendations: Please update this stream in the AWC (Figure 1).

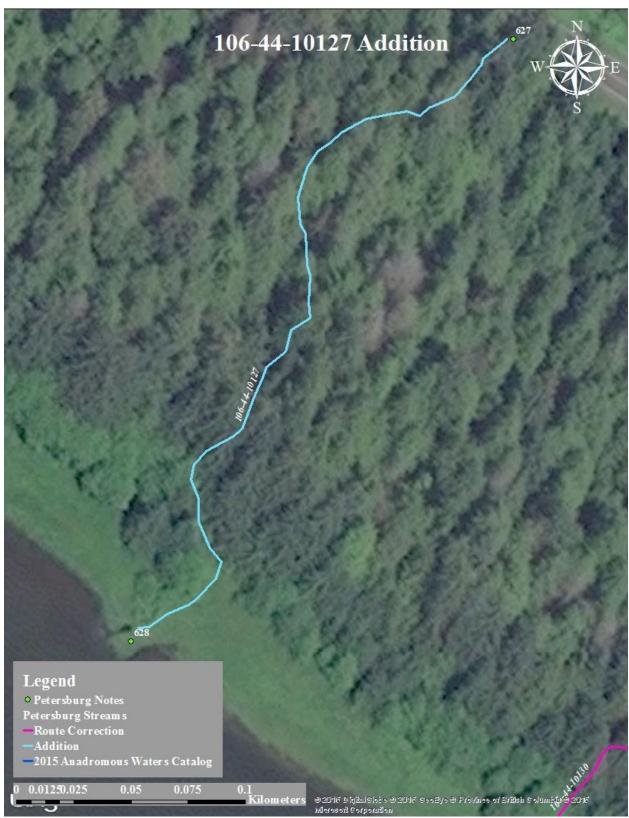
Figure 1.–106-44-10127 addition map.

Waypoint	Latitude	Longitude	Notes	Sample Effort	Sample Results
625	56.6248	-132.8579	Inlet of culvert.		
626	56.6248	-132.8583	1' perched pipe. Outlet.		
627	56.6247	-132.8583	Just below culvert	VI	CO
628	56.6234	-132.8598	Coho milling at mouth. Water	VI	CO
			not high enough to connect yet.		
629	56.6249	-132.8578	No fish seen or captured up		
			here. Stream becomes trickle		
			over bedrock.

Recommendations: Add stream to the AWC (Figure 1).

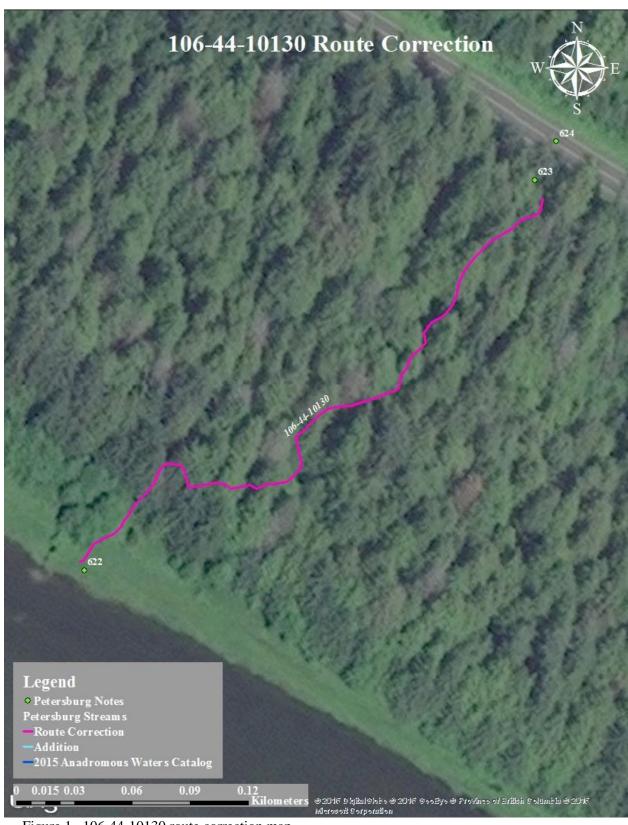
Figure 1.–106-44-10130 route correction map.

Findings: We surveyed this stream using a handnet and GPS (Table 1). We were able to capture rearing coho salmon. This stream has different upper and lower extents, as well as following a different route than illustrated in the catalog. We walked the road system and found no streams between the cataloged one and the newly digitized route. This led me to believe that this new route is the correct one and should be reflected as such.

Waypoint	Latitude	Longitude	Notes	Sample Effort	Sample Results
622	56.6229	-132.8583	Mouth of tributary entering		
			Blind Slough.		
623	56.6239	-132.8562	Outlet of culvert.	HN	3 CO
624	56.6240	-132.8561	Inlet of culvert. Nasty, murky		
			seep above here.

Recommendations: Update the route in the AWC (Figure 1).

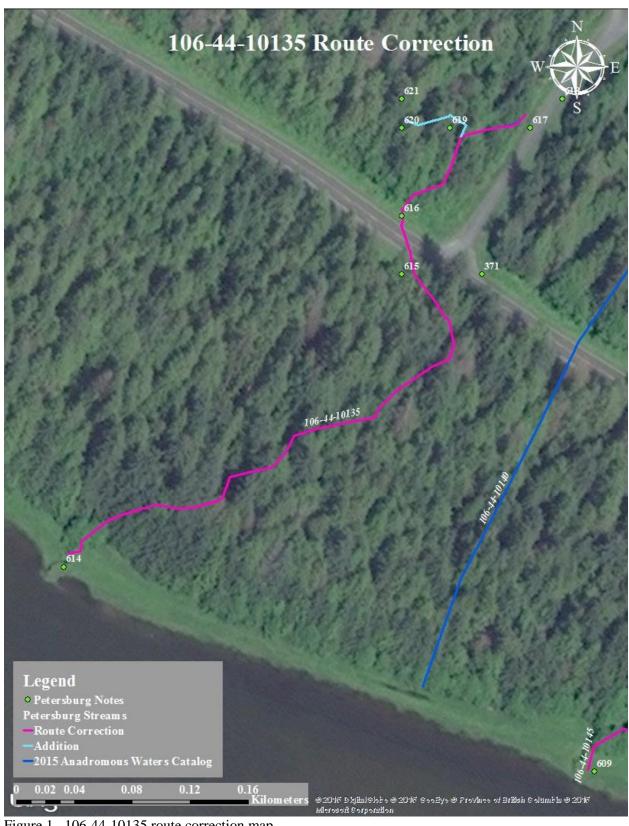
Figure 1.–106-44-10135 route correction map.

Waypoint	Latitude	Longitude	Notes	Sample Effort	Sample Results
614	56.6220	-132.8557	Mouth of tributary entering into		
			Blind Slough. Tracking. Many		
			juvenile CO.		
615	56.6230	-132.8536	Downstream side of culvert.	VI	3 CO
616	56.6232	-132.8536	VI on 10 more CO. Upstream	HN	6 CO
			side of culvert.		
617	56.6235	-132.8528		HN	4 CO
618	56.6236	-132.8526	Top of tributary. The flow		
			disappears into ground and		
			rooty tangle.

Recommendations: Update this stream's course to reflect its sinuosity in the AWC (Figure 1).

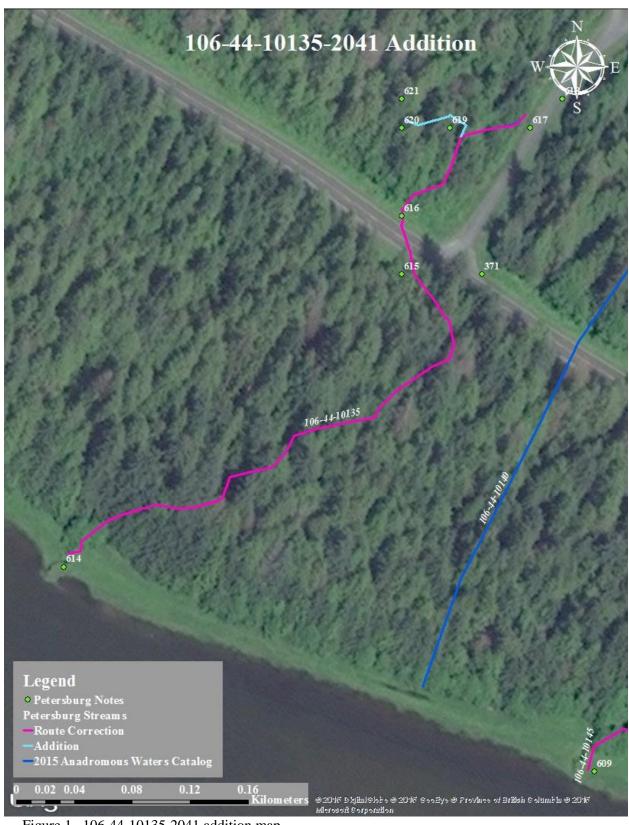
Figure 1.–106-44-10135-2041 addition map.

Waypoint	Latitude	Longitude	Notes	Sample Effort	Sample Results
619	56.6235	-132.8533	Tributary entering river right.		
620	56.6235	-132.8536		EF	2 CO
621	56.6236	-132.8536	Top of tributary seeping up		
			out of the ground.

Recommendations: Add stream to the AWC (Figure 1).

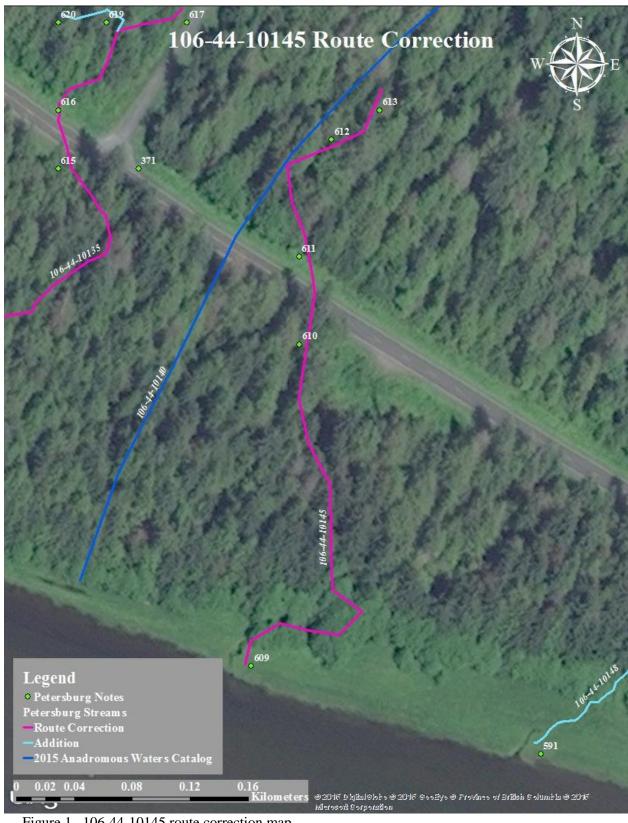
Figure 1.–106-44-10145 route correction map.

To survey data.			
Waypoint	Latitude	Longitude	Notes	Sample Effort	Sample Results
609	56.6213	-132.8524	Mouth of tributary entering		
			into Blind Slough.		
610	56.6224	-132.8521	Outlet of culvert. This culvert	HN	4 CO
			could be a velocity barrier at		
			higher flows. At low flow it		
			has a 4" perch.		
611	56.6227	-132.8521	Inlet of culvert.		
612	56.6231	-132.8519	Have been EF since WPT 611	HN	4 DV
			and only caught DV's.		
613	56.6232	-132.8516	Calling it the top of this	EF	1 DV
			tributary. Water is low and we		
			have not caught any CO.		
			Gradient is starting to		
			increase.

Recommendations: Update this stream's course in the AWC to reflect the field verified route

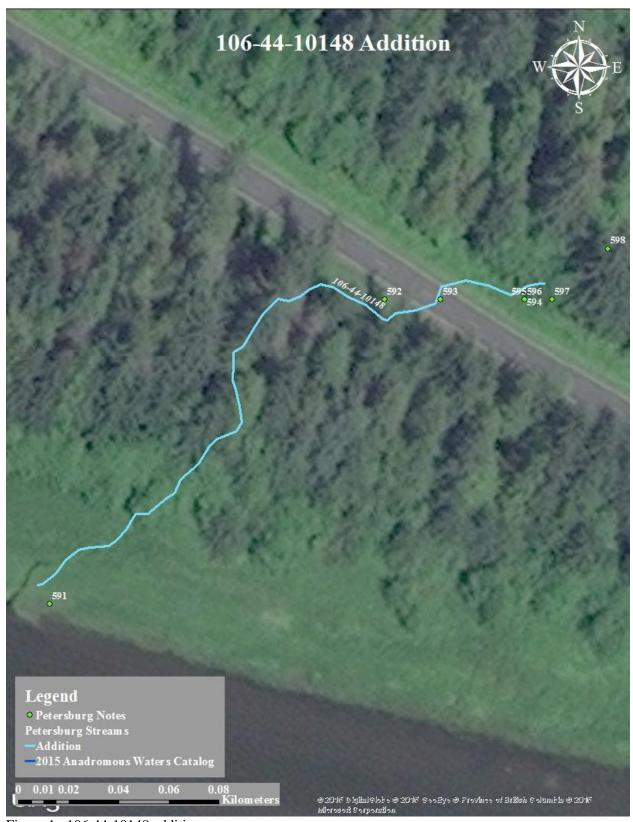
Figure 1.–106-44-10148 addition map.

Waypoint	Latitude	Longitude	Notes	Sample Effort	Sample Results
591	56.6210	-132.8506	Mouth of tributary entering into		
			Blind Slough.		
592	56.6216	-132.8494	Downstream side of culvert.	HN	2 CO
593	56.6216	-132.8492	Upstream side of culvert.		
594	56.6216	-132.8489		HN	4 CO
595	56.6216	-132.8489		HN	3 CO
596	56.6216	-132.8489		HN	5 CO
597	56.6216	-132.8488		HN	10 CO
598	56.6217	-132.8486	Top of tributary. Water is		
			coming down a bedrock chute		
			the is 15 ft. long.

Recommendations: Add this stream to the AWC (Figure 1).

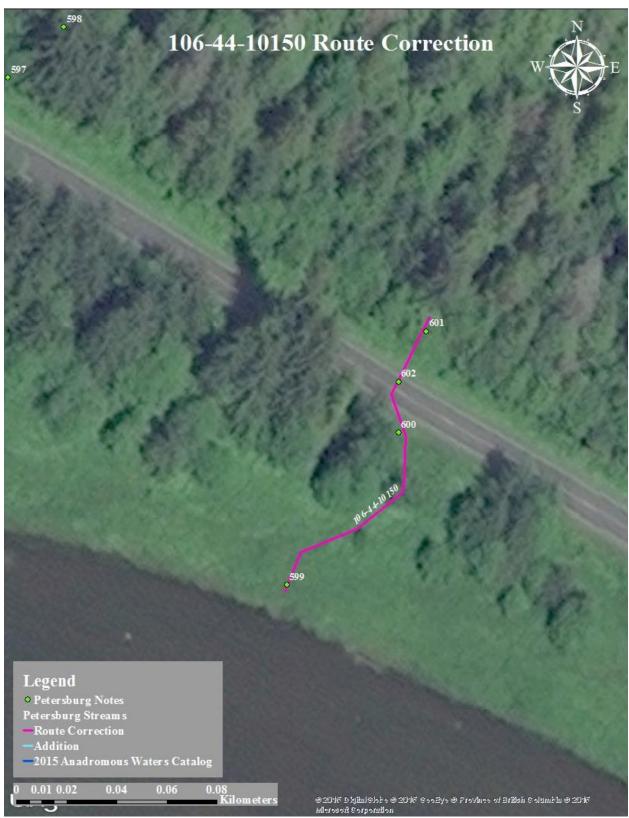
Figure 1.–106-44-10150 route correction map.

Findings: We surveyed this cataloged stream and found the route differs from the AWC (Table 1). Using a handnet we caught coho salmon below the culvert. At the time of sampling water levels were very low, due to the lack of rain over the summer. We ended this survey upstream of the culvert because there was not much water.

_	Waypoint	Latitude	Longitude	Notes	Sample Effort	Sample Results
	599	56.6206	-132.8478	Mouth of tributary into Blind		
				Slough. Tracking.		
	600	56.6209	-132.8474	The water is very low because	HN	3 CO
				the has been no rain in the past		
				week. At high water the fish		
				could make more use of the		
				stream.		
	601	56.6211	-132.8473	Upstream side of culvert. Not		
				much water. Calling it the top.		
	602	56.6210	-132.8474	Downstream side of culvert.

Recommendations: Update the current route in the AWC (Figure 1).

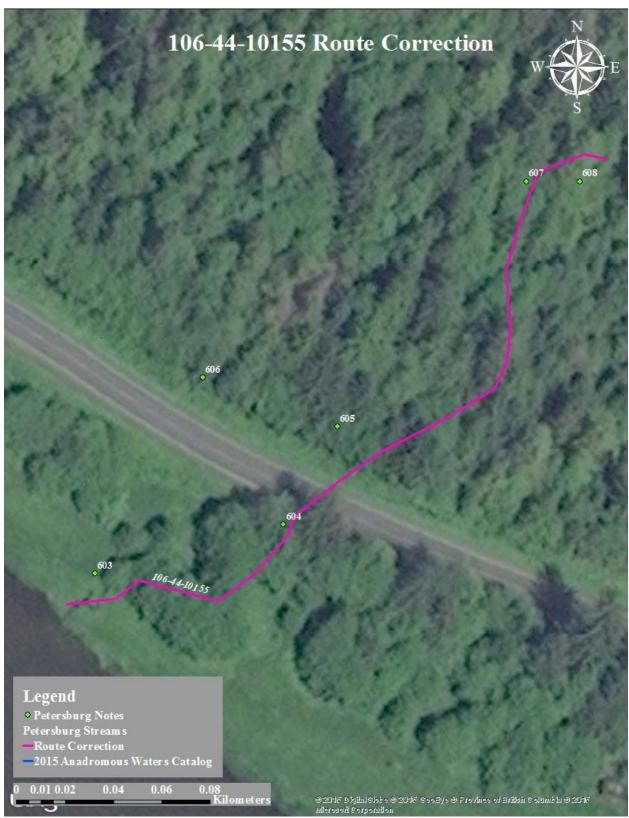
Figure 1.–106-44-10155 route correction map.

Waypoint	Latitude	Longitude	Notes	Sample Effort	Sample Results
603	56.6201	-132.8460	Mouth of tributary entering into		
			Blind Slough.		
604	56.6202	-132.8453	Downstream side of culvert.	HN	7 CO
605	56.6204	-132.8451	Upstream side of culvert.		
606	56.6205	-132.8456	Water seeping into ditch and		
607	56.6209	-132.8444		HN	4 CO
608	56.6209	-132.8442	Calling it the top. The water is		
			seeping out of the ground.

Recommendations: Update this stream's course to reflect its upper and lower limit in the AWC

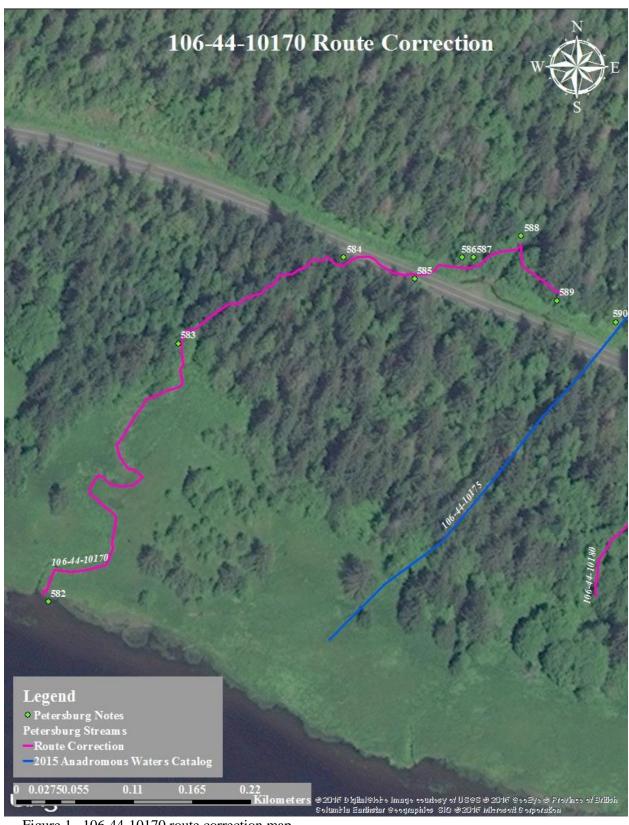
Figure 1.–106-44-10170 route correction map.

Waypoint	Latitude	Longitude	Notes	Sample Effort	Sample Results
582	56.6174	-132.8395	Mouth of tributary into Blind		
583	56.6186	-132.8384	Slough. Tracking. Tributary entering tributary on river right.		
584	56.6190	-132.8370	Downstream side of culvert entering on river right continue on mainstem. Just a drainage. Not tracking.		
585	56.6189	-132.8364	Downstream side of culvert for mainstem.		
586	56.6190	-132.8360	Upstream side of culvert for mainstem.	HN	6 CO
587	56.6190	-132.8359	Road side ditch drain coming on river left providing most of the water right now.		
588	56.6191	-132.8355	Calling it the top. Down to the bedrock. At low flow barrier and at higher flows would be a	VI	3 CO
589	56.6188	-132.8352	velocity barrier. Water is entering ditch. Not tracking up because of the barrier. Continuing up ditch.	HN	5 CO

Recommendations: Update the lower and upper points of anadromy, and correct the route in the

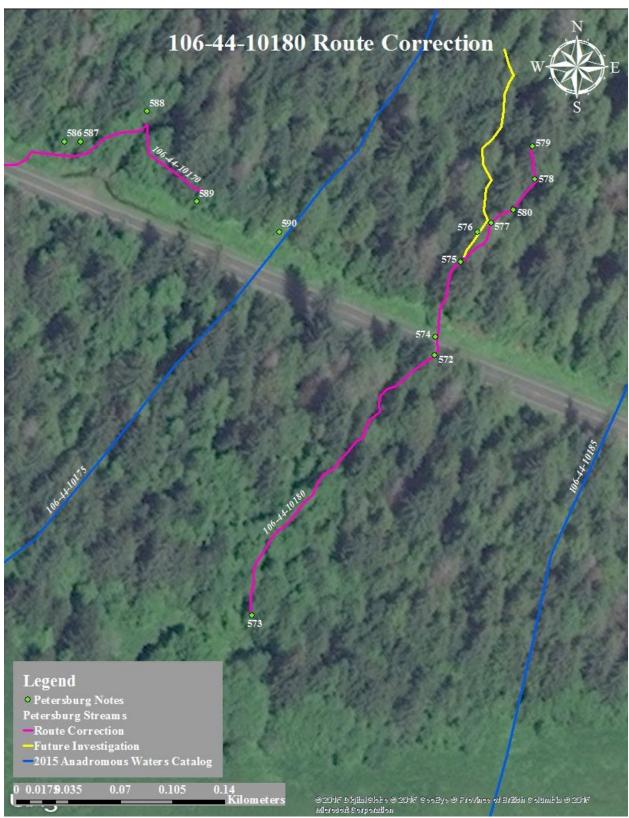
Figure 1.–106-44-10180 route correction map.

found this streams upper limit of habitat to be much lower than in the current AWC.

Waypoint	Latitude	Longitude	Notes	Sample Effort	Sample Results			
572	56.6183	-132.8338	Mouth of culvert.	EF	2 CO			
573	56.6174	-132.8349	Mouth of creek into slough.					
574	56.6183	-132.8337	Inlet of culvert.					
575	56.6186	-132.8336	Tributary. Taking river left.					
576	56.6187	56 6107	56 6197	56 61 87	-132.8335	Visual observation of schooling	VI	CO
		50.0167 -152.0555	CO in pool					
577	56.6188	56 6199	56 6188	-132.8333	In pool below reduced flows,	HN	1 CO	
	30.0188	-132.0333	mossy rocks.					
578	56.6189	-132.8331		HN	1 CO			
579	56.6190	-132.8332	Upper limit of habitat.					
580	56.6187	-132.8334	On tributary, heading up.					
581	56.6193	-132.8333	Stream gets small and mossy.	EF	DV

Recommendations: Update the current stream route in the AWC (Figure 1).

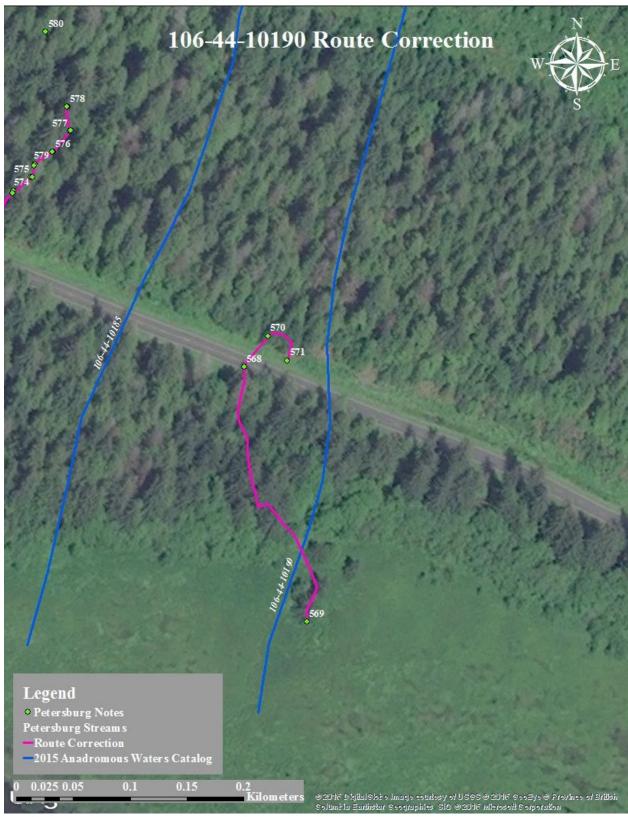
Figure 1.–106-44-10190 route correction map.

Waypoint	Latitude	Longitude	Notes	Sample Effort	Sample Results
569	56.6167	-132.8313	Mouth of stream into Blind		
			River.		
568	56.6178	-132.8318	Outlet of pipe.	EF	DV, CT, CO
570	56.6180	-132.8316	Inlet of culvert.		
571	56.6179	-132.8314	End of habitat. Mossy trickle

Recommendations: Update the current route in the AWC (Figure 1).

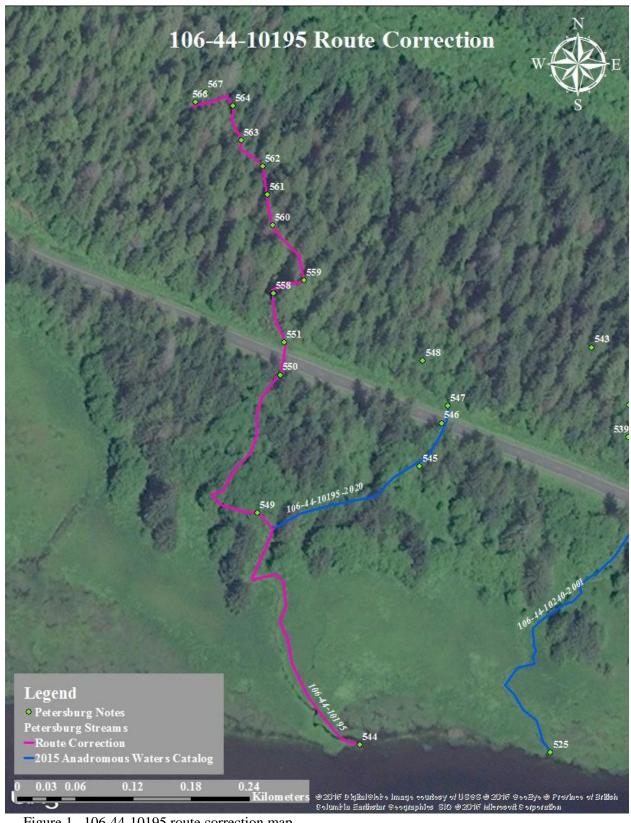
Figure 1.–106-44-10195 route correction map.

567	56.6178	-132.8318	just below here.	EF	1 DV

Recommendations: Update the current route in the AWC (Figure 1).

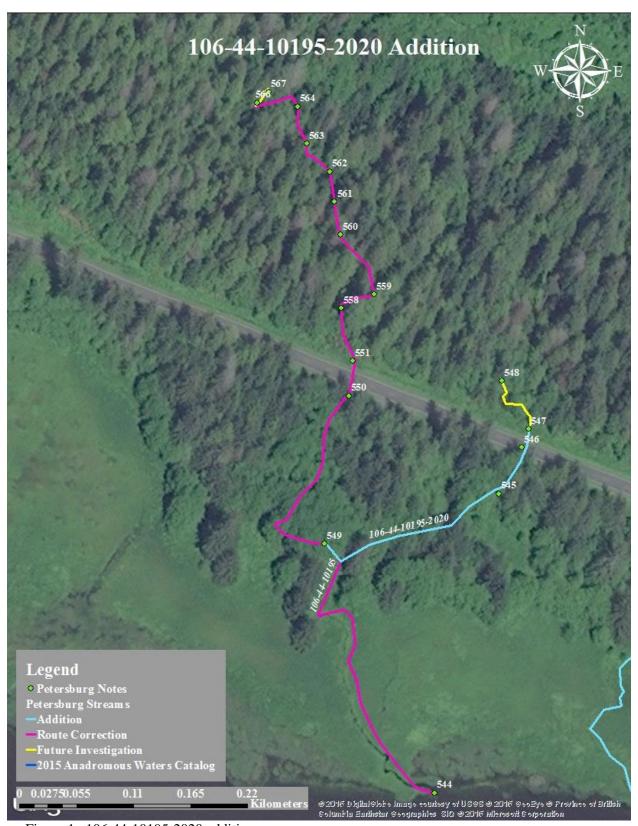
Figure 1.–106-44-10195-2020 addition map.

Waypoint	Latitude	Longitude	Notes	Sample Effort	Sample Results
545	56.6158	-132.8239	Downstream side of culvert.	VI	7 CO
546	56.6161	-132.8237	Upstream side of culvert.	EF	2 CO
547	56.6161	-132.8237		EF	2 CO
548	56.6164	-132.8239	Low flow and going in and out of ground. Electrofisher still not	EF	No fish
549	56.6156	-132.8255	working. Tributary river left, tracking and electrofishing up.

Recommendations: Add stream to the AWC (Figure 1).

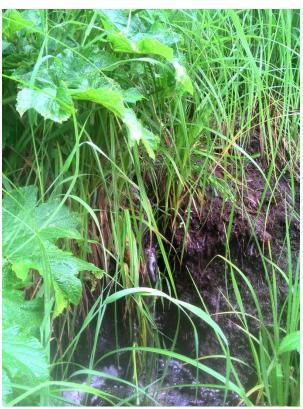
Figure 1.—Upper extent of tributary.

Waypoint	Latitude	Longitude	Notes	Sample Effort	Sample Results
476	56.5989	-132.7754	Tributary entering river right.		
477	56.5990	-132.7753	Top of tributary. Another earth	EF	1 CO
			dam falls.

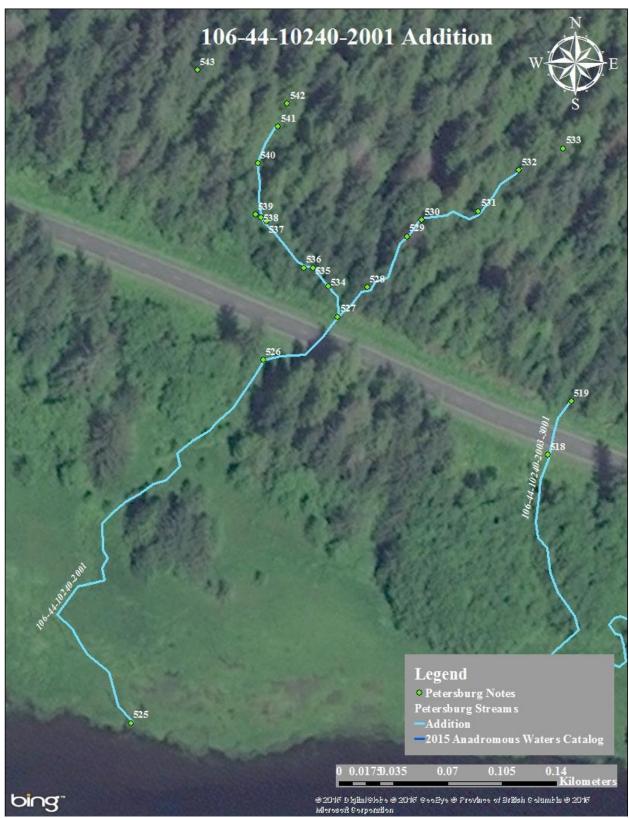
Figure 1.–106-44-10240-2001 addition map.

Waypoint	Latitude	Longitude	Notes	Sample Effort	Sample Results
525	56.6144	-132.8227	Mouth of stream entering		
			Blind Slough.		
526	56.6155	-132.8220	Outlet of culvert.	EF	4 CO
527	56.6157	-132.8215	Inlet of culvert. Ditch entering	EF	5 CO
			river right.		
528	56.6158	-132.8214		EF	2 CO
529	56.6159	-132.8211	Becomes disconnected here.	VL	3 CO
530	56.6160	-132.8210		EF	2 DV, 3 CO
531	56.6160	-132.8207		EF	1 DV, 3 CO
532	56.6161	-132.8205		EF	2 DV, 2 CO
533	56.6162	-132.8202	Gradient increases and water	EF	No Fish
			flow very low. Not much in		
			way of spawning habitat, but		
			could be good rearing habitat		
			with more water.

Recommendations: Add stream to the AWC (Figure 1).

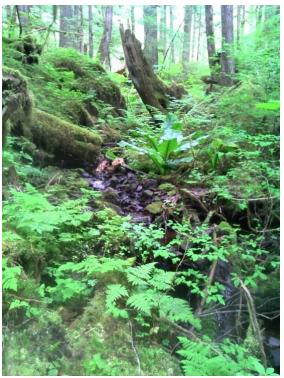
Figure 1.-Upper extent of 106-44-10240-2003.

Waypoint	Latitude	Longitude	Notes	Sample Effort	Sample Results
516	56.6143	-132.8204	Mouth of tributary entering		
			slough.		
517	56.6143	-132.8204	Tributary entering river left.		
520	56.6148	-132.8187	Outlet of culvert.	EF	2 CO
521	56.6150	-132.8185	Inlet of culvert.	EF	2 CO
522	56.6152	-132.8185	Visual on CO.	VI	5 CO
523	56.6153	-132.8183		EF	2 CO
524	56.6153	-132.8182	Calling it the top. Very low	EF	No Fish
		_	flow, not enough water to EF.

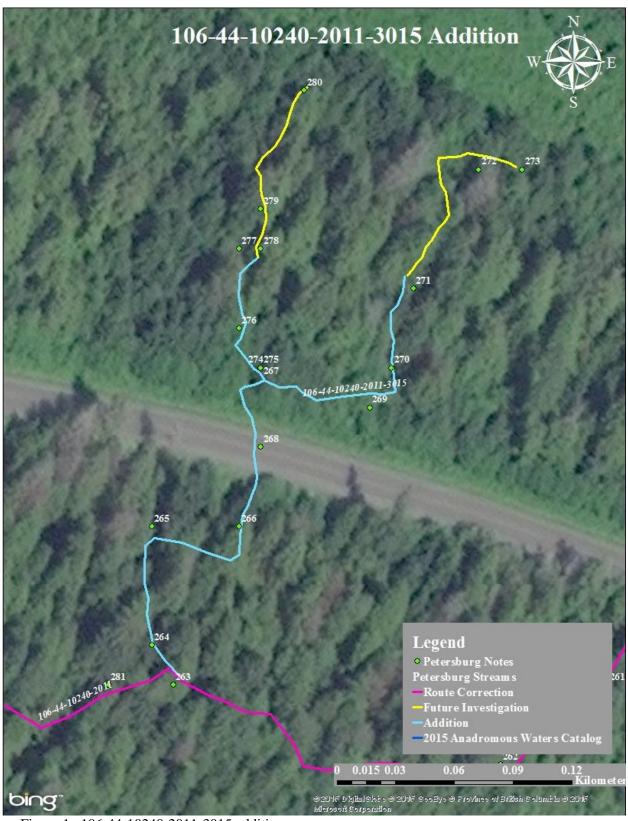
Figure 1.–106-44-10240-2011-3015 addition map.

Waypoint	Latitude	Longitude	Notes	Sample Effort	Sample Results
263	56.6133	-132.8103	Tributary entering river right.	EF	3 CO, 1 DV
			Caught 3 CO in pool just		
			above confluence in tributary.		
264	56.6134	-132.8104		EF	4 CO
265	56.6137	-132.8104	Stream is shallow, low flow,	EF	3 CO
			gravel, and silty.		
266	56.6137	-132.8100		EF	2 CO
267	56.6141	-132.8099	Inlet of culvert under Mitkof	EF	1 CO
			Highway. Branches at culvert.		
			We are taking the river left		
			tributary first.		
268	56.6139	-132.8099	Outlet of culvert under Mitkof	EF	2 CO
			Highway. Caught 2 CO at base		
			of culvert.		
269	56.6140	-132.8094		EF	1 CO, 1 DV
270	56.6141	-132.8093		EF	2 CO, 1 DV
271	56.6143	-132.8092		EF	1 CO, 3 DV
272	56.6146	-132.8089		EF	1 DV
273	56.6146	-132.8087	Calling it the top. Flow	EF	No Fish
			discontinues, seeping out from		
			ground.

Recommendations: Add stream to the AWC (Figure 1).

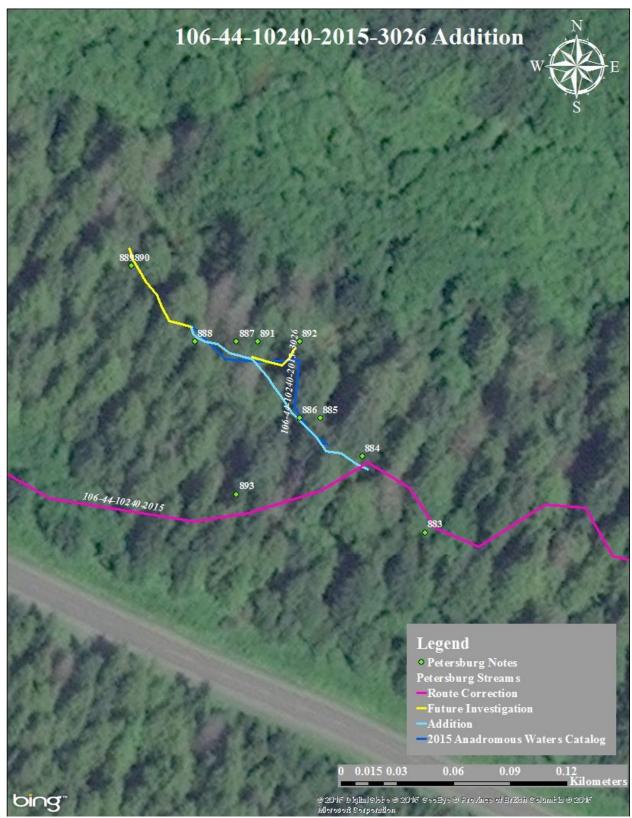
Figure 1.–106-44-10240-2015-3026 addition map.

Waypoint	Latitude	Longitude	Notes	Sample Effort	Sample Results
884	56.6123	-132.8004	Tributary entering river left.		
885	56.6124	-132.8006		EF	1 DV, 2 CO
886	56.6124	-132.8007		EF	2 CO
891	56.6126	-132.8009	Tributary entering tributary on		
			river left.		
887	56.6126	-132.8010		EF	2 CO
888	56.6126	-132.8012		EF	2 CO
889	56.6128	-132.8015	Calling it the top of tributary,		
			just seeping up out of the		
			ground.		
890	56.6128	-132.8015	Pocket dial.

Recommendations: Add stream to AWC (Figure 1).

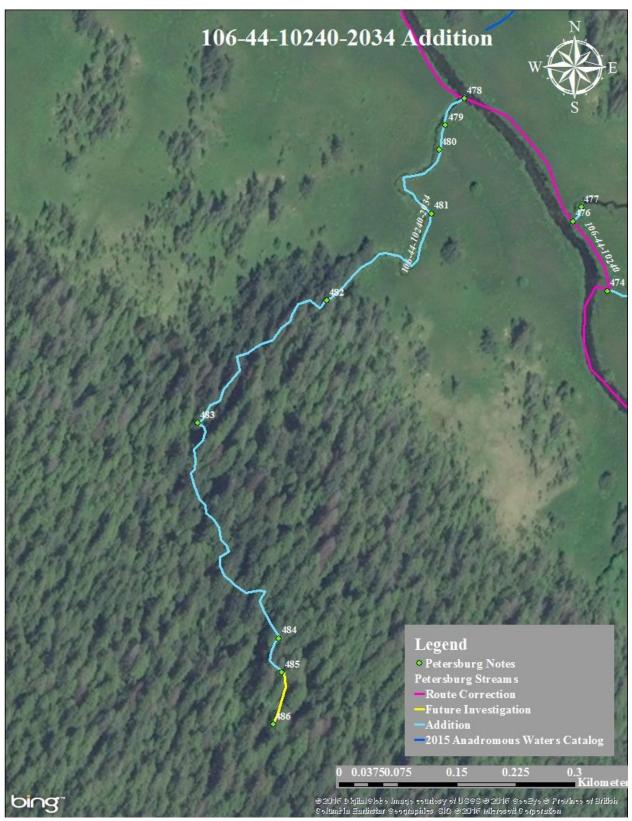
Figure 1.–106-44-10240-2034 addition map.

Waypoint	Latitude	Longitude	Notes	Sample Effort	Sample Results
478	56.5997	-132.7766	Tributary entering river left.		
479	56.5995	-132.7768		EF	2 CO
480	56.5994	-132.7769		EF	6 CO
481	56.5990	-132.7770		EF	4 CO
482	56.5984	-132.7782		EF	2 CO
483	56.5977	-132.7797		HN	8 CO
484	56.5963	-132.7788		EF	3 CO
485	56.5961	-132.7787		EF	5 CO
486	56.5958	-132.7788	Calling top, the water is low,		
			gradient increase and		
-			cascading.

Recommendations: Add stream to AWC (Figure 1).

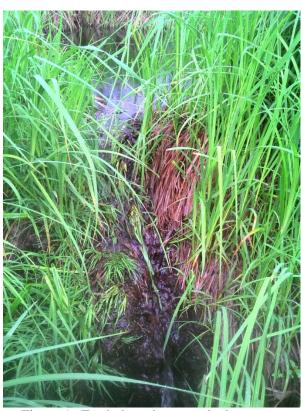
Figure 1.—Earth dam above pool where we captured coho.

Waypoint	Latitude	Longitude	Notes	Sample Effort	Sample Results
474	56.5985	-132.7750	Tributary entering river right.		
475	56.5985	-132.7746	Earth dam barrier.	EF	4 CO

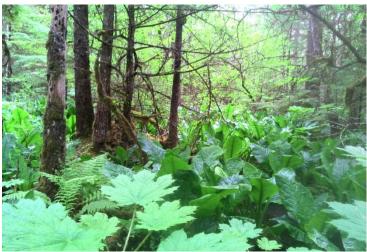
Figure 1.—Top of channelized stream area on 106-44-10240-2085.

Way	point	Latitude	Longitude	Notes	Sample Effort	Sample Results
46	54	56.5933	-132.7662	Tributary entering river right.		
46	55	56.5934	-132.7663	4 CO between 35-45mm.	EF	4 CO
46	66	56.5935	-132.7663		EF	2 CO
46	57	56.5937	-132.7661		EF	2 CO
46	58	56.5938	-132.7656		EF	1 CO
46	59	56.5940	-132.7656		EF	1 CO
47	0	56.5941	-132.7657		EF	3 CO
47	1	56.5946	-132.7654	Calling the top. The water	EF	No Fish
				loses its channel and becomes		
				spread out and running through		
				skunk cabbage.
