Appendix M: Petersburg

Guide to direct fieldwork for cataloging anadromous water bodies in Southeast Alaska

Alaska Department of Fish and Game

PETERSBURG SURVEYS

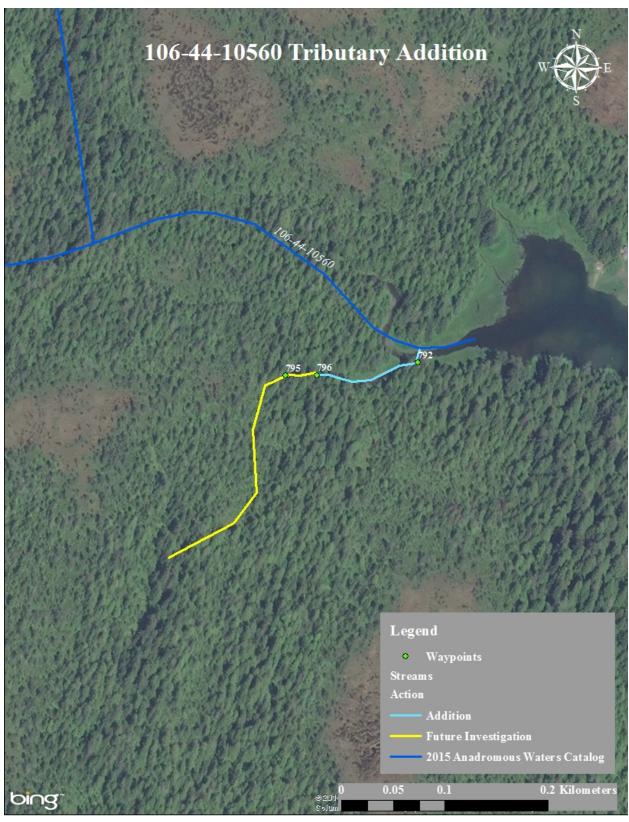
Figure 2.–106-44-10560-2005 (tributary) addition map.

Findings: I surveyed this creek visually with a handheld GPS and camera (Table 1, Figure 1). **Recommendations:** Add reach downstream of waypoint 795 for rearing coho salmon (Figure 2).

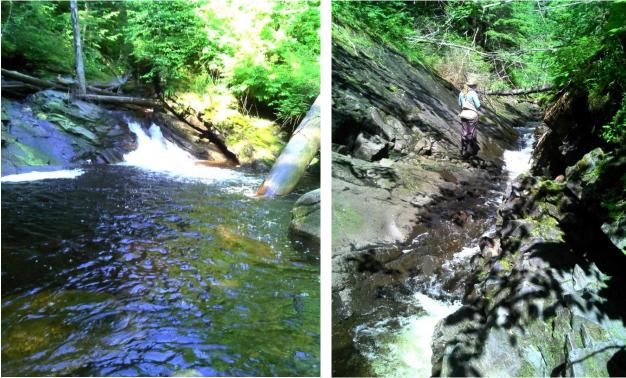
Waypoint	Latitude	Longitude	Notes	Sample Effort	Sample Results
99	56.5103	-132.8773	Intertidal zone with ocean.		
98	56.5128	-132.8790	Bridge.		
85	56.5129	-132.8793	Tributary entering river right.		
			Too steep to sample.		
86	56.5148	-132.8806	Tributary entering river left.		
87	56.5152	-132.8810	Ended up being side channel.	EF	2 CO
			Visual on school of CO and		
			captured 2 CO.		
88	56.5173	-132.8837	Tributary entering river left.		
95	56.5194	-132.8880	Tributary entering river right.		
			Too steep to sample.		
96	56.5204	-132.8892	Steep chute with huge deep		
			pool at base. Might not be		
			barrier, but maybe at high		
			flows.		
97	56.5211	-132.8919	Narrow chute with very high		
			velocity water. Calling it here.		
			We can't get around the chute.		
			At high flows definitely		
			barrier.

Figure 1.—Pool at base of chute.

Figure 2.—Tess Quinn looking up the chute.

Recommendations: Correct the current route in the AWC (Figure 3).

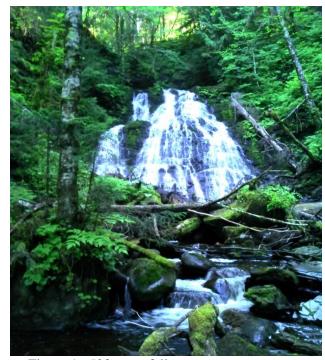
Figure 1.–50ft waterfall.

Waypoint	Latitude	Longitude	Notes	Sample Effort	Sample Results
88	56.5173	-132.8837	Tributary entering river left.		
89	56.5174	-132.8838	1 CO young of the year.	EF	1 CO
90	56.5175	-132.8838	Captured 2 CO in a small	EF	2 CO
			pool.		
91	56.5176	-132.8839		EF	3 CO, 1 DV
92	56.5177	-132.8839	3 CO young of the year.	EF	3 CO
93	56.5177	-132.8837		EF	1 CT
94	56.5179	-132.8834	50 ft waterfall. Barrier.	EF	No Fish

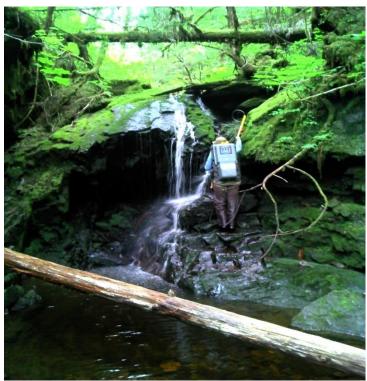
Figure 1.–20' waterfall.

Waypoint	Latitude	Longitude	Notes	Sample Effort	Sample Results
163	56.5381	-132.7564	Intertidal zone with creek and		
			ocean.		
162	56.5371	-132.7583	Tributary entering river right.		
164	56.5360	-132.7575	Tributary entering on river	EF	No Fish
			right.		
165	56.5358	-132.7577		EF	1 CO
166	56.5358	-132.7578	Just a side channel. Back to		
			mainstem.		
167	56.5357	-132.7579		EF	1 CO
168	56.5320	-132.7600	Tributary entering river right.		
171	56.5281	-132.7603	Two tributaries entering river		
			right.		
175	56.5281	-132.7604	Mouth of 2nd tributary.		
179	56.5272	-132.7618	Base of small bedrock	EF	1 DV
			cascade. Might be a velocity		
			barrier at high flow.		
180	56.5268	-132.7626	~ 20 ft waterfall barrier.		
181	56.5262	-132.7634	Outlet of culvert under		
			Woodpecker Cove Road.

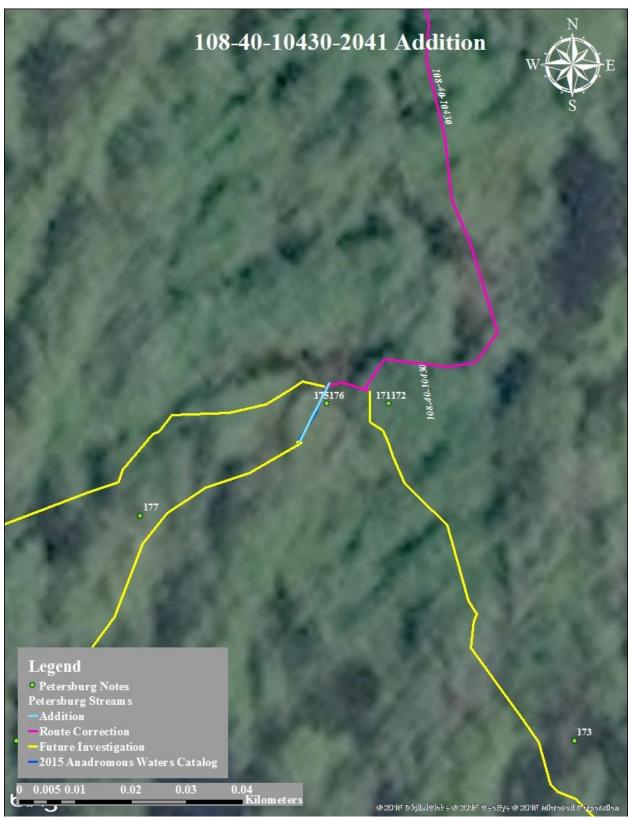
Figure 1.–108-40-10430-2041 addition map.

_	Waypoint	Latitude	Longitude	Notes	Sample Effort	Sample Results
	175	56.5281	-132.7604	Mouth of 2nd tributary.		
	176	56.5281	-132.7604	Silty, murky, little flow.	EF	4 CO
				Captured 4 young of the year		
				CO.		
	177	56.5280	-132.7607		EF	1 CT
	178	56.5278	-132.7609	Top of tributary seeping out of	EF	2 DV, 1 CT
				moss.

Recommendations: Add stream to the AWC (Figure 1).

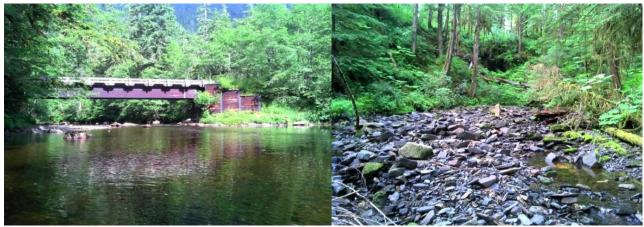
Waypoint	Latitude	Longitude	Notes	Sample Effort	Sample Results
162	56.5371	-132.7583	Tributary entering river right.		
8	56.5366	-132.7590	Small boulder waterfall ~ 4 ft		
			drop into pool. Probably not a		
			barrier with highwater.		
5	56.5353	-132.7636	Small tributary entering river		
			left.		
4	56.5350	-132.7646	Bridge over Woodpecker		
			Cove Road.		
182	56.5349	-132.7647	Upstream side of creek.		
183	56.5335	-132.7686	Stream bed has become large		
			cobbles, flat and likely easily		
			moveable at high flows. At		
			low flows, water trickles		
101	7	100 5 500	through the loose substrate.		
184	56.5330	-132.7698	Waterfall tributary on river		
			left. This is above the		
			cataloged portion. We'll shock		
105	56 5220	122 7600	up mainstem.	DD.	1 DV
185	56.5330	-132.7699	In mainstem. 1 DV about	EF	1 DV
107	FC 5220	122.7600	50mm.	DE	1 CT
186	56.5329	-132.7699	In bouldery pool 1 CT about	EF	1 CT
187	56 5220	122 7700	35mm.	DE	1 DV

Figure 1.–Bridge over 108-40-10430-2002.

Figure 2.–Stream in wide streambed.

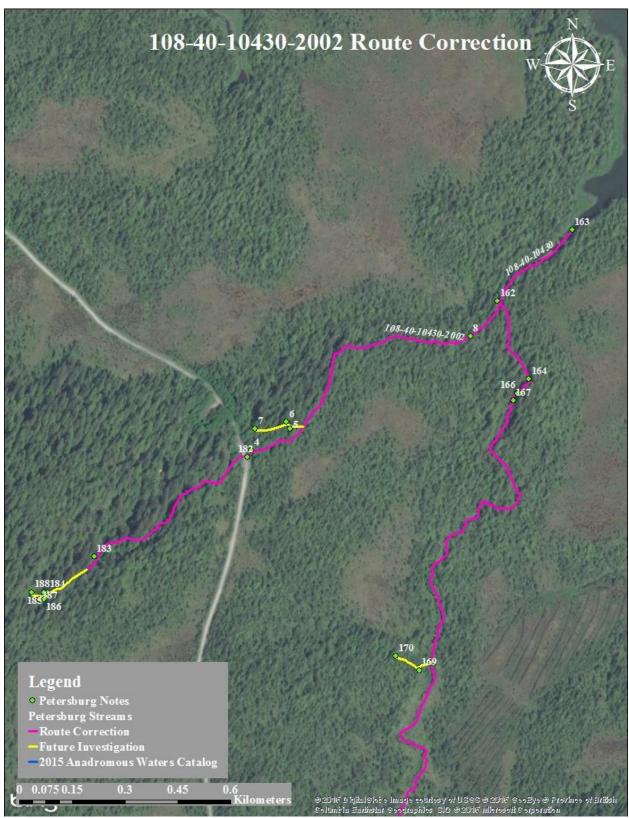
Figure 3.–108-40-10430-2002 route correction map.

187	56.5329	-132.7700	In large cobbley pool below	EF	1 DV
			2' cascade falls, 1 DV about 55mm.		
188	56.5330	-132.7702	Rolled a large CT about	EF/VI	1 CT
100	30.3330	-132.7702	_	EI7 VI	1 C1
			150mm in a rapid, unable to capture. Moveable bed load		
			above, calling it.		
 			above, calling it.

Recommendations: Correct the current route in the AWC (Figure 3).

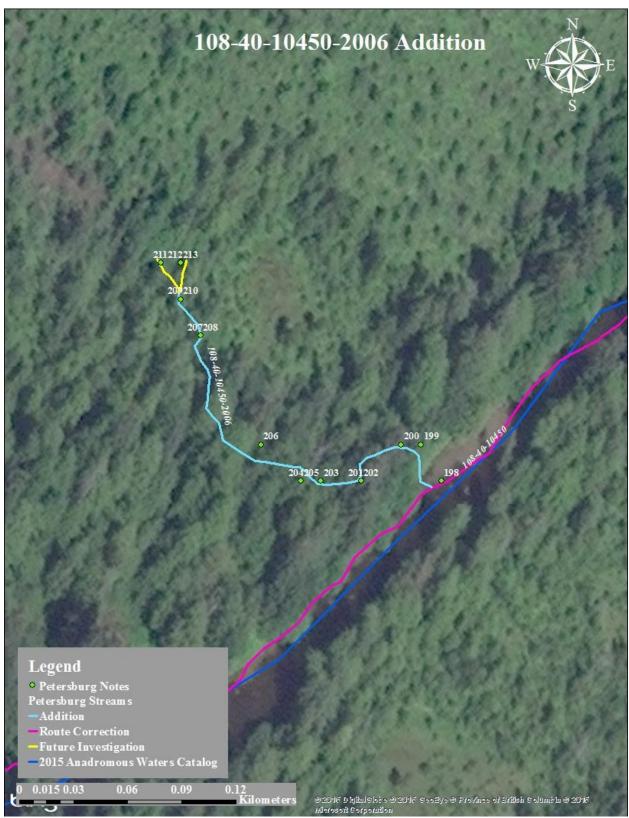
Figure 1.–108-40-10450-2006 addition map.

Waypoint	Latitude	Longitude	Notes	Sample Effort	Sample Results
198	56.5463	-132.7860	Tributary on river left.		
199	56.5464	-132.7861	In corner pool beneath mossy	EF	2 CO
			log captured 2 CO about		
			35mm.		
200	56.5464	-132.7862	Overhanging vegetation,	EF	1 CO
			undercut bank.		
201	56.5463	-132.7864	Sand, gravel substrate.	EF	1 CO, 1 CT
			Captured 1 CO about 35mm		
			and 1 CT about 30mm.		
202	56.5463	-132.7864	Gravels, undercut bank.	EF	1 CT, 1 DV
203	56.5463	-132.7866	Sand substrate, undercut bank.	EF	1 CO
			1 CO about 35mm.		
204	56.5463	-132.7867	Broken mossy log in water. 2	EF	2 CO
			CO about 35mm.		
205	56.5463	-132.7867	Chased a school of CO with	EF/VI	CO
			electrofisher.		
206	56.5464	-132.7869	Stream forks, taking river left		
205		100 5050	fork.	777	1.00
207	56.5467	-132.7872	In deep pool under rootwad. 1	EF	1 CO
•00		100 5050	CO about 50mm.	777	4.00
208	56.5467	-132.7872	1 CT about 130mm.	EF	1 CT

209	56.5468	-132.7873	In cobbly pool near skunk	EF	1 CO
			cabbage forest. 1 CO about		
210	~ ~ ~ 4 co	100 5050	35mm.	E.F.	1.00
210	56.5468	-132.7873	3-way split. Taking river left	EF	1 CO
211	56 5460	122 7074	fork. 1 CO about 35mm.		
211	56.5469	-132.7874	Stream enters awful slash		
			area.

Recommendations: Add stream to the AWC (Figure 1).

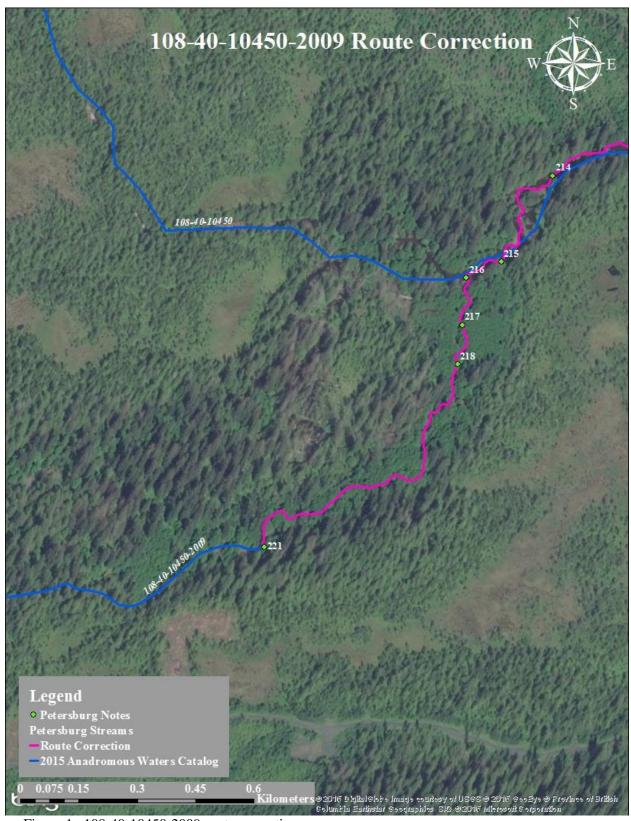
Figure 1.–108-40-10450-2009 route correction map.

Findings: We surveyed this stream with a GPS to correct the current course that is in the Anadromous Water Catalog (Table 1). We did not reach the upper extent of the cataloged stream, but for the part we did survey we found that track differs from what is in the catalog.

Waypoint	Latitude	Longitude	Notes	Sample Effort	Sample Results
_	216	56.5448	-132.8008	Big tributary on river right.		
	217	56.5442	-132.8009	Tributary on river left. (This		
				mainstem is cataloged)		
	218	56.5437	-132.8010	Tributary is a side channel.		
	221	56.5414	-132.8055	End of survey.

Recommendations: Correct the current route in the AWC (Figure 1).

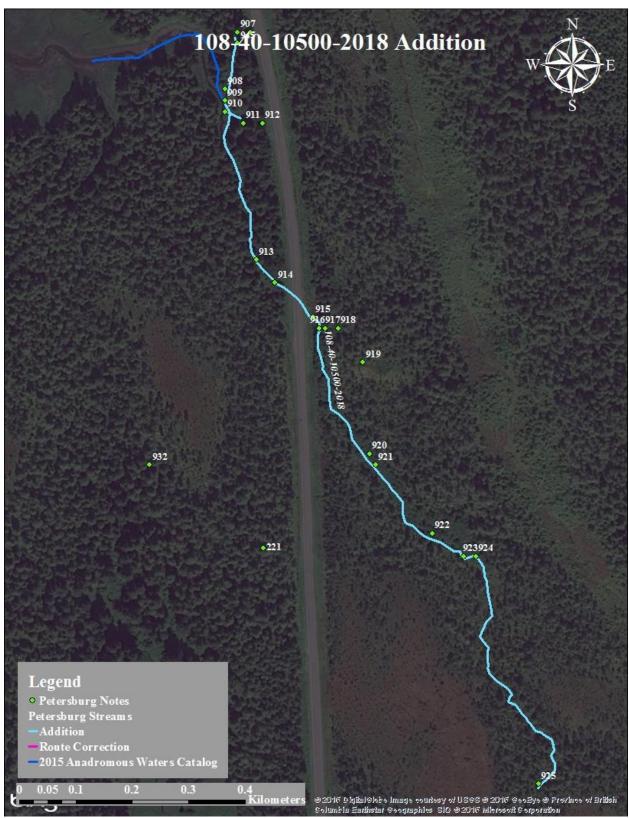
Figure 1.–108-40-10500-2018 addition map.

923	56.5543	-132.7272		EF	1 CT
924	56.5543	-132.7270	Caught in pool.	EF	2 CO, 1 DV
925	56.5523	-132.7260	We EF since WPT 924 and	EF	No Fish
			caught no fish. We have not		
			come to a barrier but we are		
			going to stop because we		
			caught no fish. Small, deep,		
			incised.

Recommendations: Add this stream to the AWC (Figure 1).

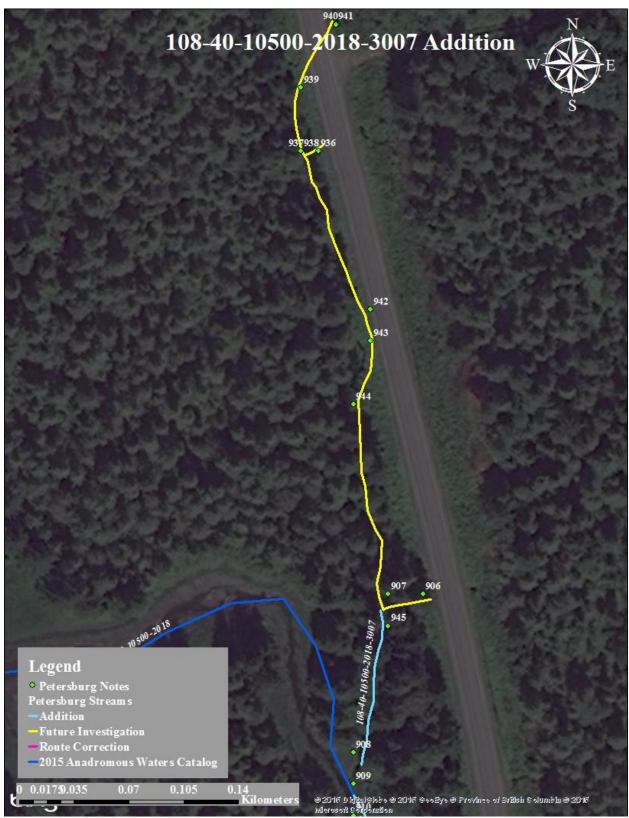
Figure 1.–108-40-10500-2018-3007 addition map.

Waypoint	Latitude	Longitude	Notes	Sample Effort	Sample Results
909	56.5583	-132.7310	Tributary entering on river		
			right.		
908	56.5584	-132.7310	Stream meets up with another		
			stream here in tidal influence		
			area.		
945	56.5588	-132.7308		EF	1 CO
907	56.5589	-132.7308		EF	1 DV, 2 CO
944	56.5595	-132.7310		EF	1 DV
943	56.5597	-132.7309		EF	1 DV
942	56.5598	-132.7309	Outlet of culvert. Tributary	EF	No Fish
			entering river left.		
937	56.5603	-132.7313	End of creek. It is a tributary		
			on river left of another creek.		
938	56.5603	-132.7313		EF	1 DV
939	56.5605	-132.7313	Outlet of culvert under Mitkof		
			Highway.		
940	56.5607	-132.7311	Inlet of culvert. Pool at base	EF	3 DV
			of culvert with DV.		
941	56.5607	-132.7311	End of watered section along		
			road.

Recommendations: Add stream to the AWC (Figure 1).

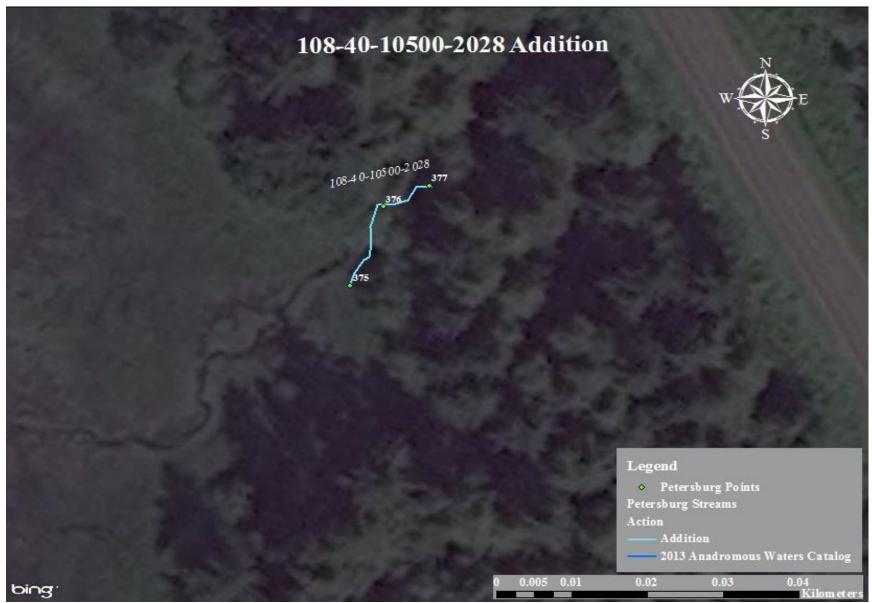
Figure 1.–108-40-10500-2028 addition map.

Waypoint	Latitude	Longitude	Notes	Sample Effort	Sample Results
375	56.5628	-132.7331	Beginning survey on slough	EF	2 CO
			just off road. Captured young		
			of the year CO.		
376	56.5629	-132.7330	Captured 1 CO about 50mm	EF	1 CO
			among boulders, cobbles.		
			Narrow stream.		
377	56.5629	-132.7329	At upper limit of short stream.	EF	1 CO
			Very little- no spawning, good		
			rearing. Captured 1 CO about		
			50mm.

Recommendations: Add stream to the AWC (Figure 1).

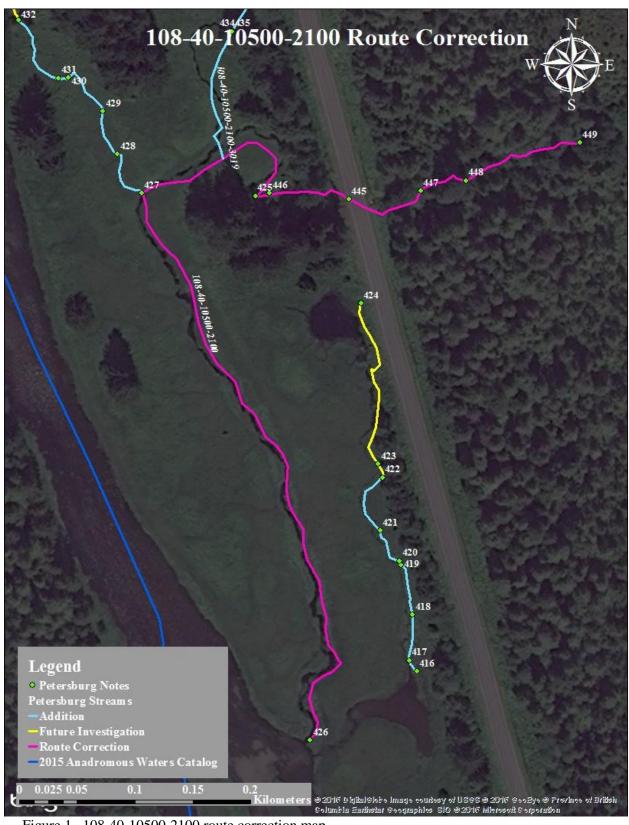
Figure 1.–108-40-10500-2100 route correction map.

Findings: We surveyed this stream using a GPS and found the route differs from the AWC

Recommendations: Correct the current route in the AWC (Figure 1).

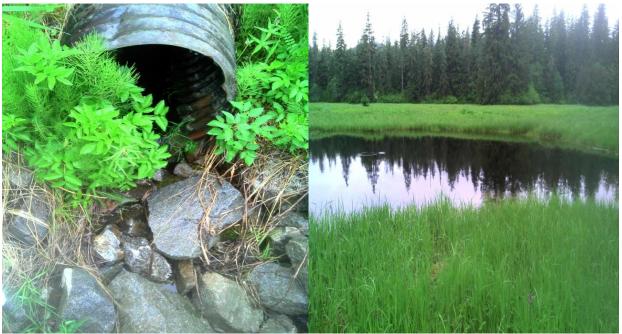
Waypoint	Latitude	Longitude	Notes	Sample Effort	Sample Results
416	56.5701	-132.7367	Mouth of tributary into slough.		
417	56.5702	-132.7368	3 CO about 35mm.	EF	3 CO
418	56.5704	-132.7367	2 CO about 35mm.	EF	2 CO
419	56.5706	-132.7368	1 Stickleback and 1 tadpole.	EF	1 SB
420	56.5706	-132.7368	2 CO about 35mm.	EF	2 CO
421	56.5707	-132.7370	1 CO about 35mm.	EF	1 CO
422	56.5710	-132.7370	1 CO about 35mm.	EF	1 CO
423	56.5710	-132.7370	So many little tadpoles!	VI	Tadpoles
424	56.5717	-132.7371	Outlet of culvert flows through		
			riprap before entering ponded		
			area. Pond is end of stream.

Figure 1.—Outlet of culvert entering pond.

Figure 2.—Pond at outlet of stream.

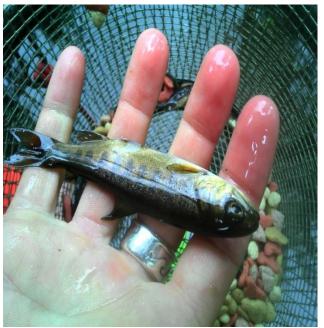
Figure 1.—Smolty coho salmon caught in a minnow trap in 108-40-10500-2100-3019.

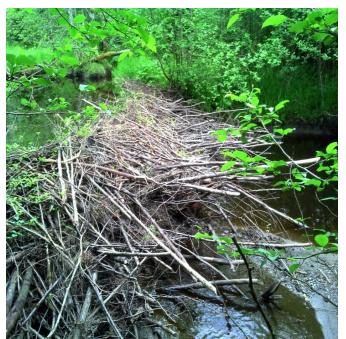
Findings: We surveyed this stream using a backpack electrofisher and a GPS (Table 1). The route of this creek differs from the current route in the AWC. We found a beaver dam on this

Figure 1.—Beaver dam on 108-40-10550.

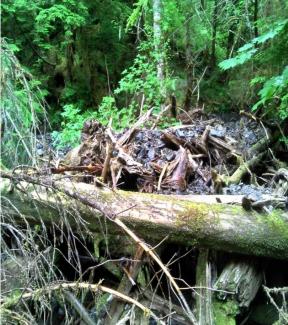
Figure 2.—Upper extent of 108-40-10550. There is a dry 4' drop above.

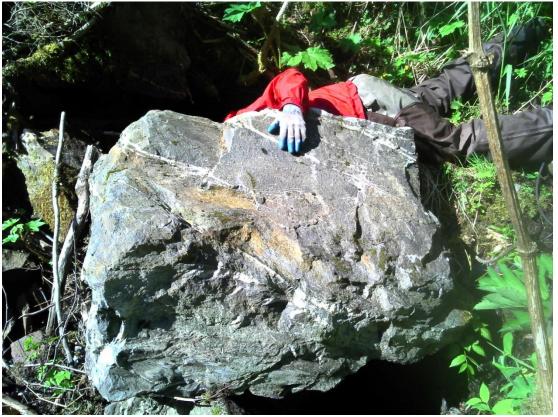
Figure 1.—Large boulders in front of culvert inlet. Possible fish passage barrier.

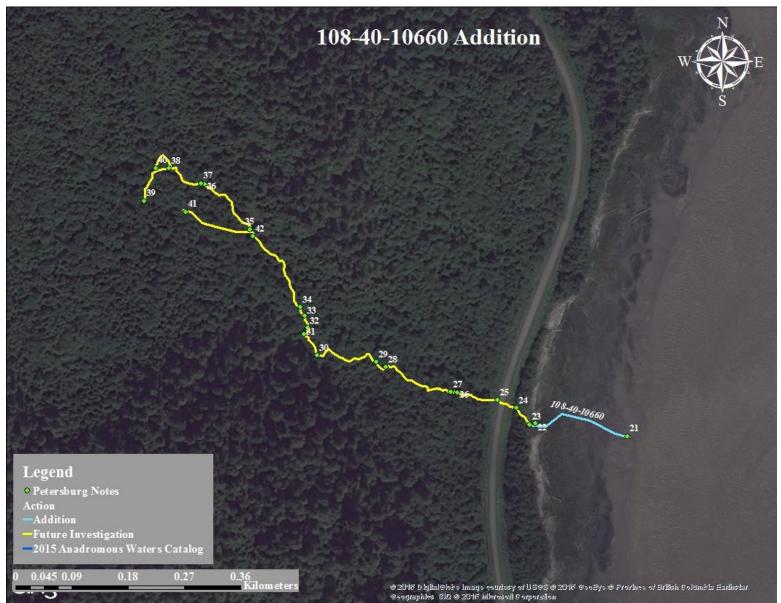
Figure 1.–108-40-10660 addition map.

Findings: We surveyed this creek along the Mitkof Highway using a backpack electrofisher and a GPS (Table 1). We captured coho salmon below the road and Dolly Varden above the road. We surveyed until the gradient steepened and little water was present. The culvert under the highway was broken in the middle and may be a barrier.

Recommendations: Add stream to the AWC (Figure 1).

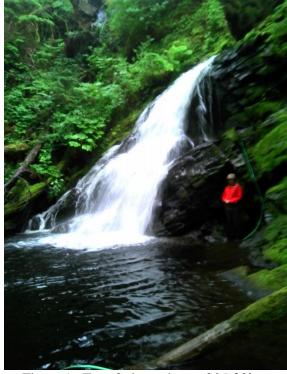
Findings: We surveyed this stream to update the current course in AWC (Table 1). We walked downstream from Frederick Sound Drive and found a 25-30' waterfall (Figure 1). The length of the stream in the catalog needs to be shortened because there is a 25-30' waterfall. We ended the survey in the intertidal zone where we found a dead squid (Figure 2).

Figure 1.—Tess Quinn at base of 25-30' waterfall.

Recommendations: Correct the current route in the AWC (Figure 3).

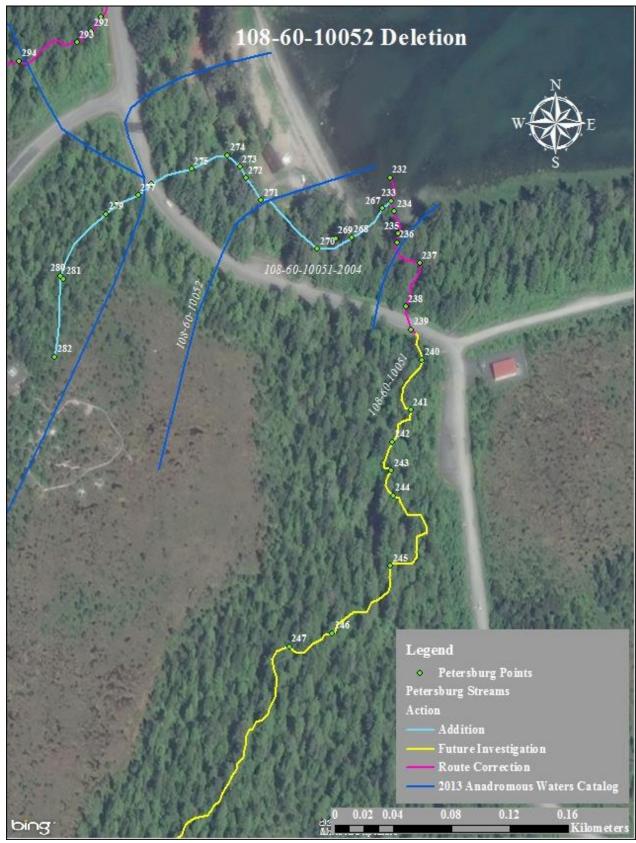
Figure 1.–108-60-10052 deletion map.

Findings: This stream appears to be stream 108-60-10052 in the AWC, which we found to be a tributary to stream 108-60-10051. The AWC shows streams 108-60-10052 and 108-60-10051 as independent streams, we surveyed the area and did not find any other possibilities for stream 108-60-10052.

Recommendations: Delete stream number 108-60-10052 from the AWC (Figure 1).

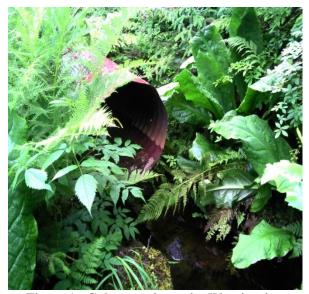
Findings: We surveyed a stream that crossed Woodpecker Cove Road using a backpack electrofisher and a GPS (Table 1). The culvert under Woodpecker Cove Road is perched about 10" and rusting out (Figure 1). We captured coho salmon (Figure 2). We ended the survey where stream enters Woodpecker Cove.

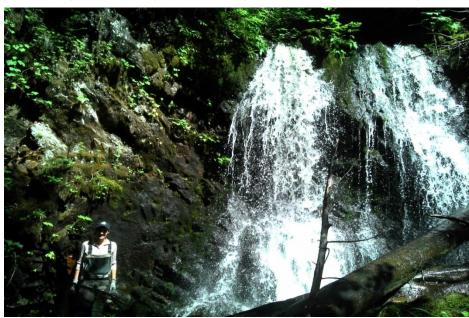
Figure 1.–Nicole Legere at the base of 20' waterfall.
