2018 Annual Report

ASSESSMENT OF FACTORS ASSOCIATED WITH MOOSE-VEHICLE COLLISIONS AND THEIR RELATIONSHIP TO MOOSE SEASONAL MOVEMENTS IN THE MATANUSKA AND SUSITNA VALLEYS OF ALASKA

February 2018

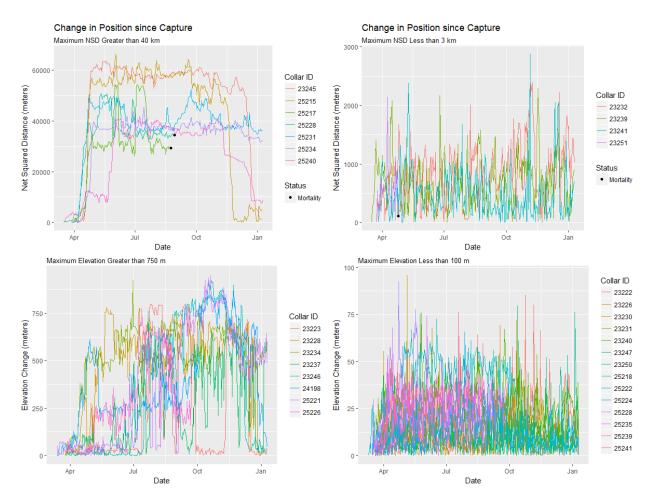
Figure 8. Seasonal movement variation between radio-marked moose, Mat-Su Valley, Alaska, March 2017-Janurary 2018

Many of the radio-marked moose showed different patterns of movement. While some moose migrated greater than 40 kilometers away from the original capture point (n = 7) or greater than 750 meters higher in elevation than the initial capture point (n = 8), over half of the collared moose stayed within 250 meters of their original elevation (n = 35) or stayed within 10 kilometers of their original capture location (n = 31).

At the other extreme, four of the radio-marked moose never traveled farther than three kilometers from their capture point and fourteen never had a change in elevation greater than 100 meters when compared to the elevation of the capture point. Figure 8 and Table 3 show the vast difference in seasonal movement strategies.
