Region	Southcentral	USGS Quad(s) Seward A-3					
Anadromo	ous Waters Catalog Number of Waterway	226-40-16670					
Name of Waterway Evans Creek * Andreson USGS Name Jucal Name							
✓ /	Addition Deletion (Correction Dackup Information					
For Office Use							
Nominatio	^{n#} <u>120321</u>	~ Cl 11/2/12					
Revision ` Revision t		Fisheries Scientist Habirat Operations Manager AWC Project Biologist Date Date 2/19/12 Date					
Revision	Code:	Cartographer Date

Chenega Bay Hydroelectric Feasibility Study

Reconnaissance Report

October 2009

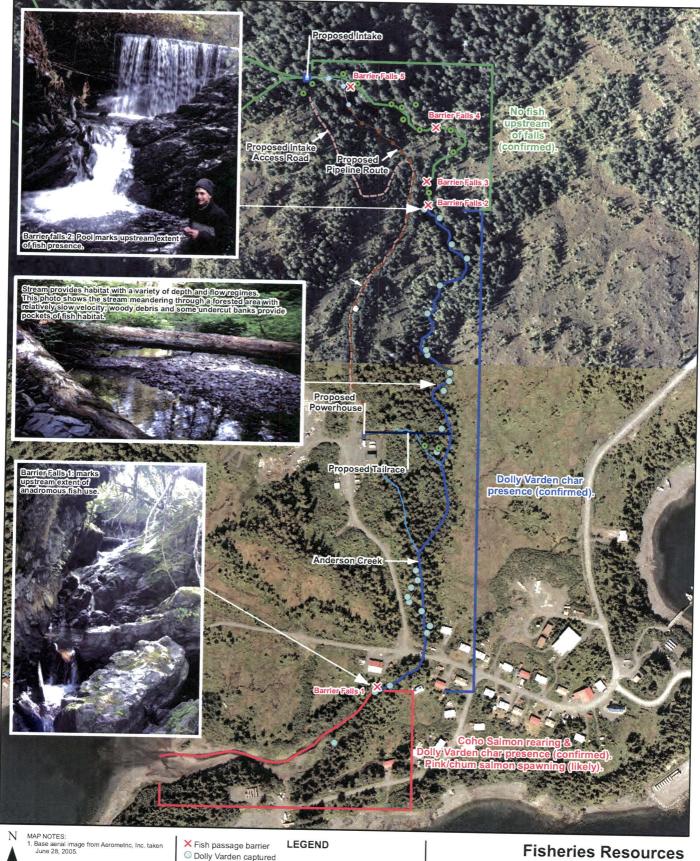
Fisheries Resources Chenega Bay Hydroelectric Project Reconnaissance Report

The base of the downstream (i.e., nearest to the tailrace) falls and associated dam in the reach between the intake and the tailrace was found to be the upstream extent of fish in Anderson Creek (Figure 3). The natural falls and associated timber dam, measured to be approximately 14 feet high, is located approximately 0.65 miles upstream from the mouth (i.e., approximately 0.2 miles upstream from the tailrace or 0.25 miles downstream from the ANTHC dam).

LEGEND × Fish passage barrier O Dolly Varden captured

- No fish captured overflow channel
- -Anadromous reach: coho salmon rearing
- -Dolly Varden char presence confirmed
- Fish not present upstream of barriers 2 through 5 Proposed intake access road

In July, the field team set a total of 14 minnow traps in Anderson Creek and visually inspected the stream for fish presence from the mouth to the ANTHC intake site. Traps were fished from the mouth of Anderson Creek to just downstream of the proposed tailrace, and upstream of a fish barrier (Figure 3). The traps captured Dolly Varden char (n=39) and Sculpin (n=1) and the field team used hand nets to capture young-of-the-year coho salmon. All coho salmon (i.e., estimated n=100) and the Sculpin were observed in the downstream portion of Anderson Creek, near or within the limits of tidal influence. Dolly Varden fork lengths ranged from 76 mm to 170 mm (mean=124 mm). Fish capture results are presented in Appendix F. The team also identified probable fish passage barriers: one in the lower portion of Anderson Creek (i.e., downstream from the road crossing) and a series of falls between the tailrace and the intake, as discussed below.

In the upstream portion of the reach between the intake and the tailrace, the team recorded GPS locations for a series of manmade dams (typically constructed at natural falls) and natural falls. The field team set traps upstream and downstream of each manmade dam and/or falls to confirm whether or not any of the falls act as passage barriers to fish; and to determine the upstream extent of fish use in Anderson Creek. The traps captured Dolly Varden char immediately downstream of the lower falls; however, no fish were captured in any of the traps (n=6) set upstream from this point in October. Additionally, no fish were captured from traps (n=8) set above this point in July.
