Nomination Form
Anadromous Waters Catalog

SUBJECT: Auke Lake Trail Fish Trapping
Sect. 23, T. 40 S., R. 65 E. (Juneau B-2)
Lat. 58.381° N., Long. 134.631° W

UNIVERSITY OF ALASKA SOUTHEAST AUKE LAKE TRAIL IMPROVEMENTS

East Auke Lake Stream Addition

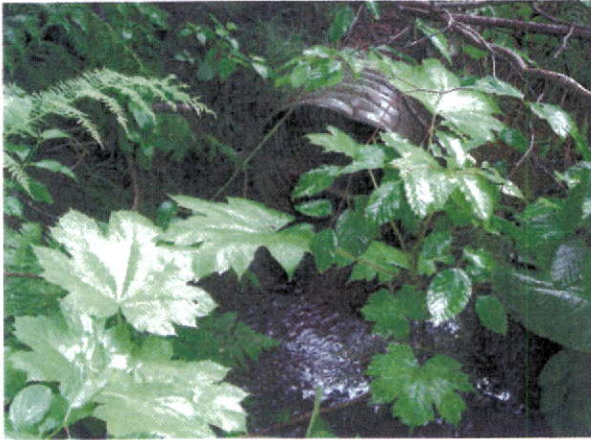
Photo 1. Culvert above 1st Crossing

1st Crossing (Plan Sheet 4) This stream is located in wetlands and is about 2 feet wide and 4 inches deep. It crosses Glacier Highway through a 24" CMP culvert about 50 feet upstream of the trail (Photo 1). Above the highway the stream is about 1 foot wide and comes down a hillside on private land. On July 20 we set a trap about 15 feet above the trail (58.38089° N, 134.63075° W, WGS-84). The trap was in for 2 hours and caught 2 Dolly Varden char (110 mm and 90 mm). We trapped the site again (Trap #1) July 25-26 overnight (20 hrs) and caught 1 cutthroat trout (120 mm) and 1 Dolly Varden char (85mm).

Conclusion: this stream supports *cutthroat trout* and *Dolly Varden char* and requires a structure designed for fish passage.

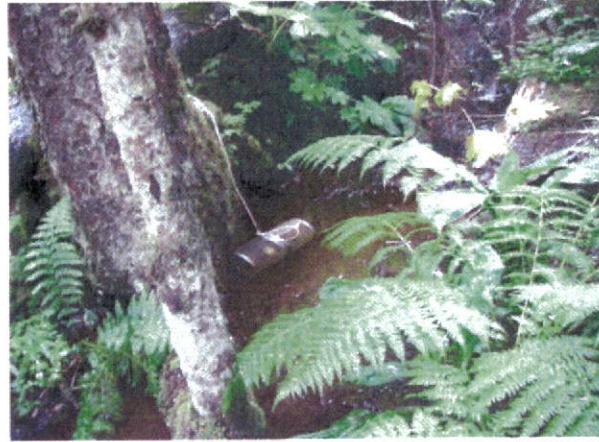
Photo 2. Upper trap location at 2nd Crossing

2nd Crossing (Plan Sheet 4) This stream is in wetlands and is about 4 feet across and 4 inches deep at the crossing. July 20 we set a trap for an hour and a half about 50 feet upstream of the crossing (58.38072° N, 134.62961 W) and caught 1 coho (50 mm), 2 Dolly Varden (75 mm), and 9 Dolly Varden (55 mm). (See Photo 2) We set a trap July 25 (Trap #2) at the same location and caught 24 Dolly Varden char (50-80mm). A second trap 10' below the crossing caught 4 Dolly Varden (60-100mm).

Conclusion: this stream supports *coho salmon* and *Dolly Varden char* and requires a structure designed for fish passage.

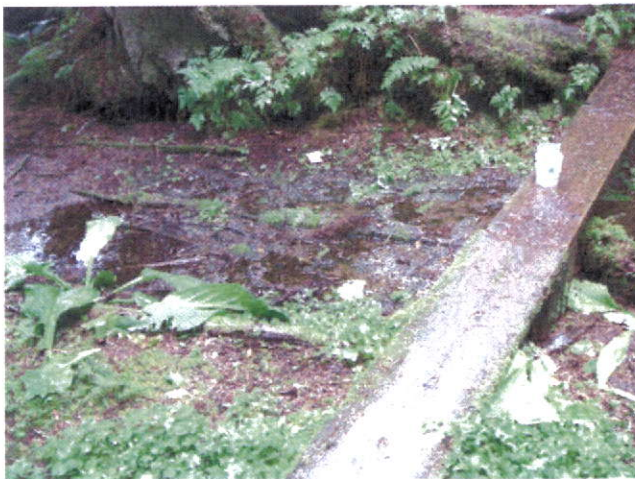
Photo 4. 3rd trail crossing

3rd Crossing (Plan Sheet 5) This crossing is located at the head of a slough of Auke Lake where the stream is about 5 feet wide and was nearly dry. We observed salmon fry in the slough below the crossing, but the stream was too shallow to trap above the crossing. Based on vegetation, this slough floods under the trail crossing at higher lake levels, and is therefore considered anadromous.

Conclusion: this is an *anadromous fish stream* and requires a structure designed for fish passage.

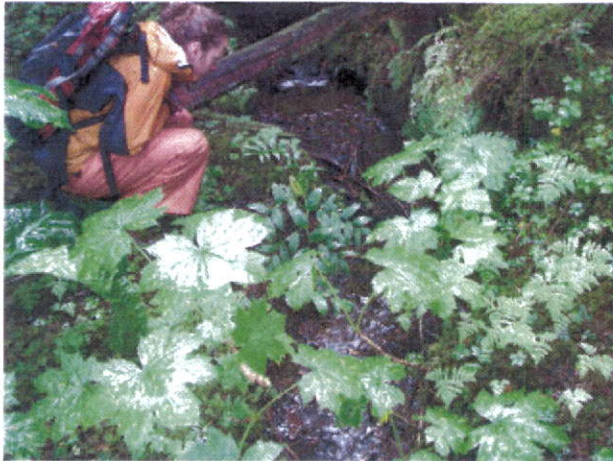
Photo 6. Above 4th crossing

4th Crossing (Plan Sheet 10) The stream at this location flows under roots beneath the trail and is about 18" wide above the trail crossing (Photo 6 below). A trap (Trap #3) set overnight July 25 did not catch fish.

Conclusion: this stream was not documented to support, however fish may be present under higher flow conditions. *A crossing designed for fish passage is recommended.*

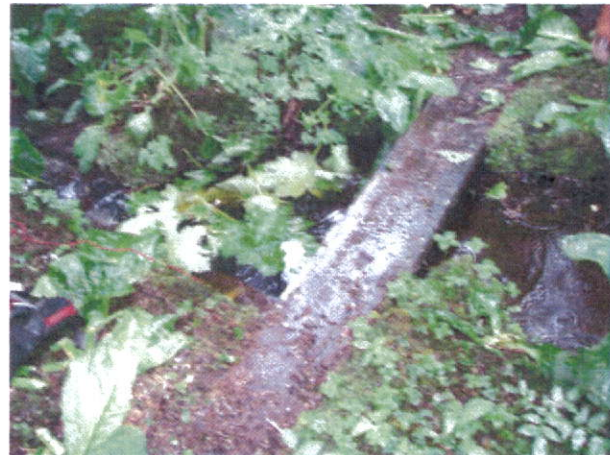
Photo 7. 5th Crossing on existing trail

5th Crossing (Plan Sheet 12 – near flag #155) The new alignment heads uphill just before this point, with the new crossing about 150' above the existing trail. We set a trap July 20 in this stream under the boardwalk on the existing trail (Photo 7 above). The stream is about 2 feet wide and a foot deep at the crossing. The trap was in for about an hour and a half and caught no fish. A second trap (Trap #4) placed here overnight July 25 also came up empty. Trap #5 set overnight just below the intersection of the new alignment also did not catch fish. We were baffled, because this stream appears to be a good fish stream.

Conclusion: fish were not documented in this stream, however fish may be present under higher flow conditions. *A crossing designed for fish passage is recommended.*

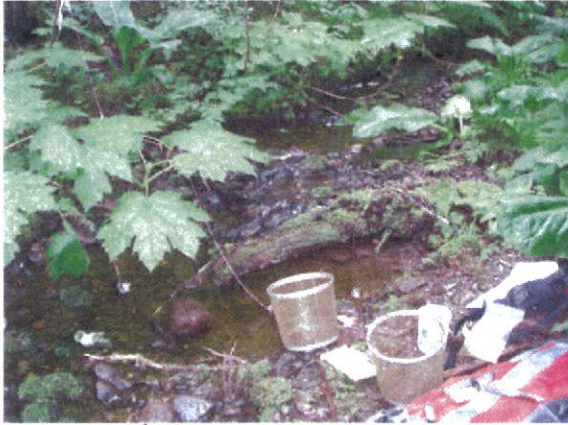
Photo 8. 6th Crossing above wetlands

6th Crossing (Plan Sheet 12) We placed traps July 25 overnight just below the existing trail crossing (Trap #6) and just below the new alignment (Trap #12). The lower trap caught a cutthroat trout (90mm) and a Dolly Varden char (85mm). The trap above the wetland at the new alignment caught 10 Dolly Varden char (20-30mm). (Photo 8 below).

Conclusion, this stream supports *Dolly Varden char*; *a crossing designed for fish passage is required.*

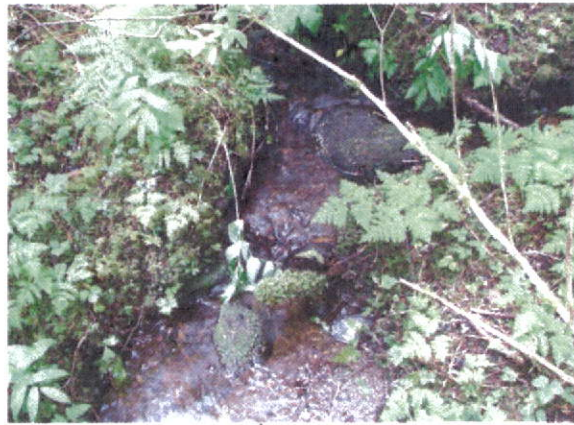
Photo 9. Below 9th Crossing

9th Crossing (Plan Sheet 14) The new alignment crosses a shallow stream in a wetland. Trap # 7 set here overnight did not catch fish. However, a trap (Trap # 8) about 50' below the trail caught 5 Dolly Varden char (20-30 mm). (See photo 9 above). We believe that the reason we caught fish below but not above the new alignment is because we were using a 1/8" mesh trap at the lower site, but 1/4" mesh at the upper location. These small fish could easily slip through the larger mesh trap. There was no obvious blockage to fish passage between the lower trap location and the trail crossing.

Conclusion: this stream crossing *should be designed for fish passage.*

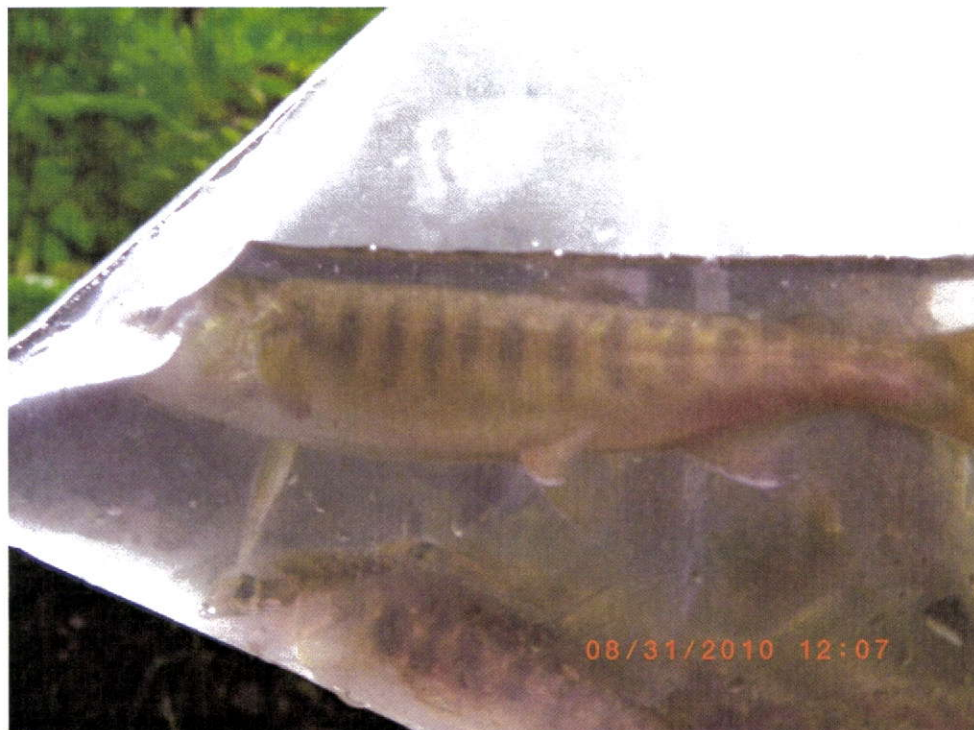
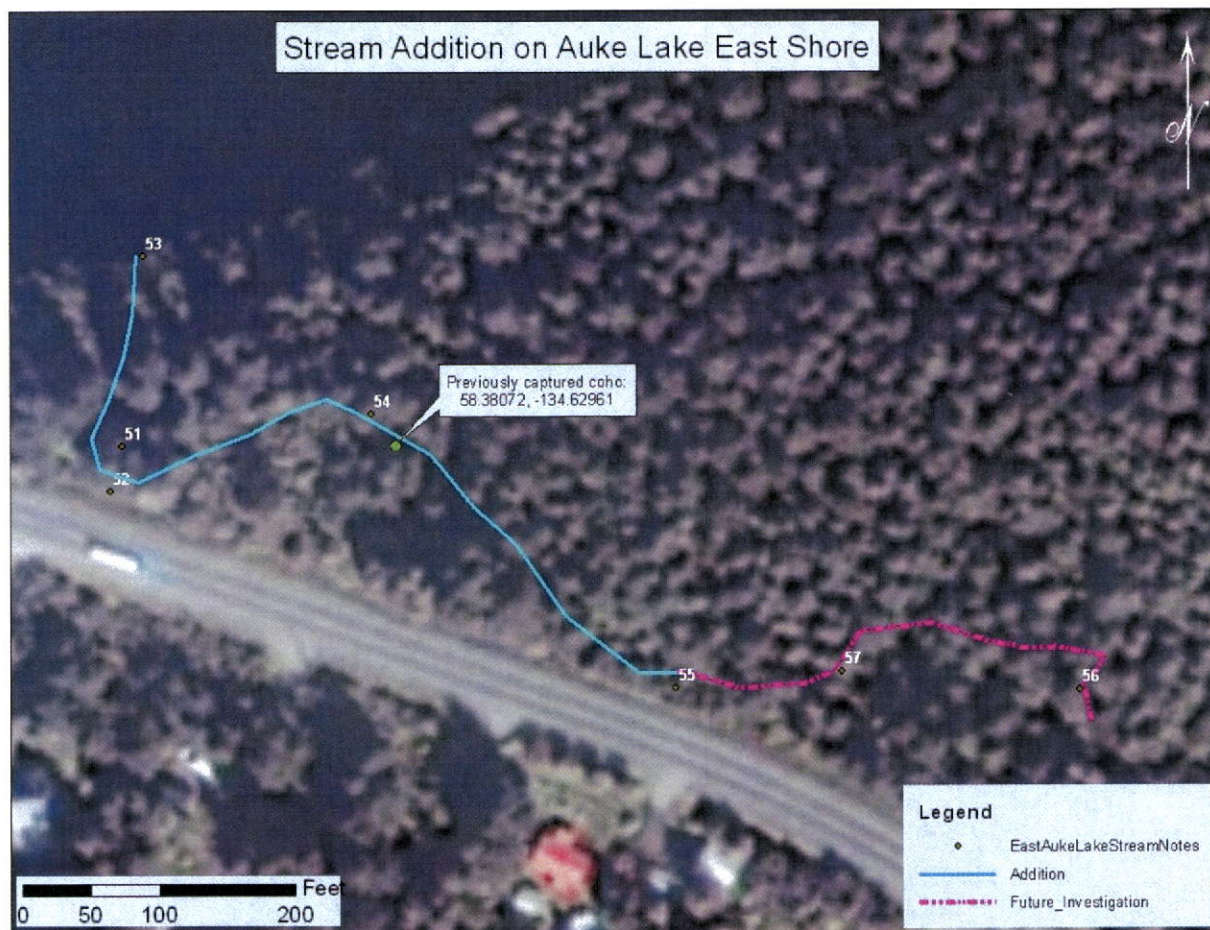
This stream was previously trapped by habitat biologist Carl Schrader in July of 2007. Carl trapped one coho salmon at (58.38072, -134.62961), but further trapping efforts weren't taken until August 2010. I went back in August 2010 and trapped one coho salmon in a baited minnow trap at waypoint 55. The following table and map provide trapping efforts and location of traps, features, and the coordinates of the upper and lower extent of anadromy. Carl's trip report with trapping details accompanies this document.

WAYPOINT	LAT	LONG_	DESCRIPTION	EFFORT	SPECIES
53	58.381208	-134.6304	MOUTH OF STREAM INTO AUKE LAKE. BEGIN TRACK LINE		
54	58.380797	-134.62969	SET TRAP IN SMALL POOL. LOTS OF SUBSURFACE FLOWS THROUGH ROOT WADS AND VEGETATION UP TO THIS POINT.	MINNOW TRAP	8DV
55	58.380128	-134.62881	PULLED TRAP SET BY F&W ALONG HIGHWAY LAST WEEK	MINNOW TRAP	1CO, 7DV
56	58.379941	-134.62733	END SURVEY. STEEP CHANNEL, FLOWS JUST A TRICKLE, NOWHERE TO SET TRAP.		
57	58.380085	-134.62819	SET TRAP IN VERY SHALLOW POOL UNDER MOSSY LOG. WATER JUST A TRICKLE.	MINNOW TRAP	EMPTY
58	58.388966	-134.62444	POINT AT BRIDGE ACROSS TRAIL		
59	58.389379	-134.62499	SET TRAP AT PLANK ON OLD TRAIL. PREVIOUSLY CAUGHT DV WITH CARL SCHRADER.	MINNOW TRAP	EMPTY
60	58.389303	-134.62527	2' VERTICAL FALLS AT LAKESHORE. BARRIER TO JUVENILES
