Nomination Form Anadromous Waters Catalog

Species Addition / Route Correction

Water Body Name: *Crab Cove Creek (NE Head)

correction for the intertidal section of 112-63-10080 was included in a previous nomination (#24-790). Observation locations and notes are in Table 1. Fish, stream, and feature photos and a map showing observation locations and route correction are in Figures 1-7.

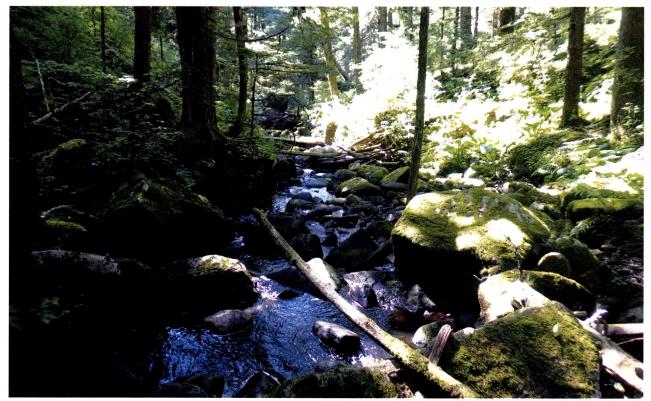
Figure 1.- Looking downstream from waypoint 6 at general stream characteristics encountered between waypoints 2-7.

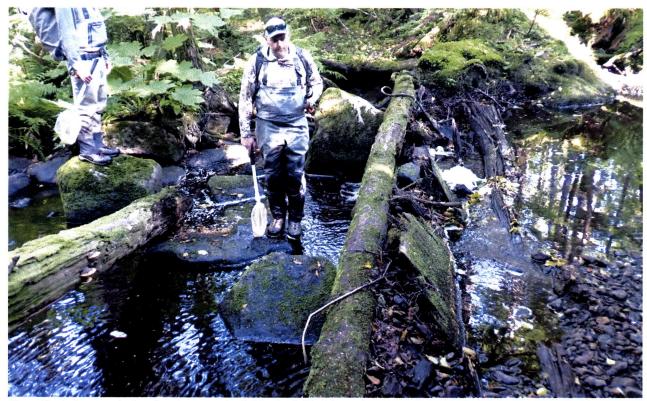
Waypoint	Latitude	Longitude	Notes	Sample Effort	Sample Result
7	58.262908	-134.874775	Old manmade dam here, ~1m tall, ~5-7m wide, cabled/chained into bank. Remnant piping laying about as well. Water filters over dam at this level, south (river left) side has obvious washout where water overtops unfiltered at slightly higher water level. Single ~40cm notch cut in dam, possible attempt at fish passage? DS gradient 4-6% and contained channel, US gradient 0-2% with wider floodplain. Pool US of dam gravel substrate. 1 MT set in US pool, 3hr30min soak, 1 DV.	1 MT	1 DV
8	58.265253	-134.870819	Beaver dam here, ~30-40cm high, ~5-6m wide, water audibly filtering through in several places. Gradual gradient decrease between wpt 7 and here, gradient now close to 0%. 1 MT set on DS side of dam, 2hr30min soak, 13 juvenile coho, 2 DV, 1 CT. Several of the coho appear to be YoY based on size, rest age 1+. One of the char is 15-17cm with silvery appearance and no visible parr marks, suggesting anadromy in its recent life history.	1 MT	13 CO 2 DV 1 CT

Figure 2.- Anthropogenic dam found at waypoint 7, Matt B. (1.88m) for scale.

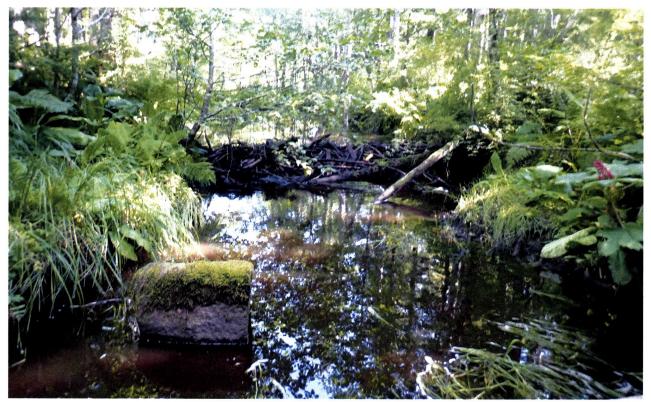
Figure 3.- Looking upstream at beaver dam noted at waypoint 8.

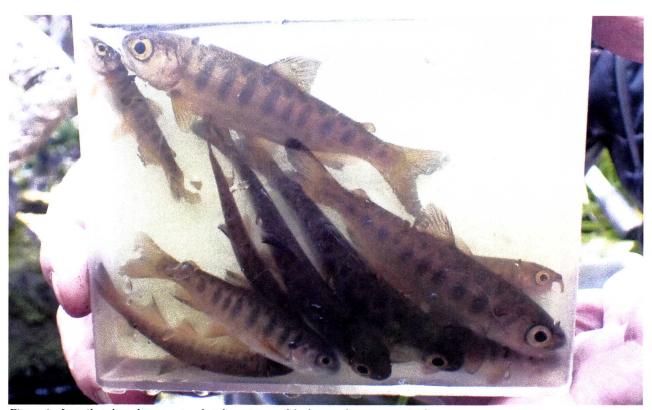
Figure 4.- Juvenile coho salmon captured at downstream of the beaver dam at waypoint 8.

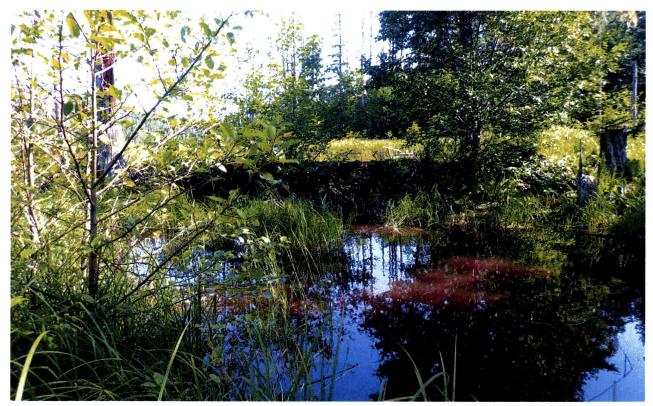
9	58.265577	-134.870034	Beaver dam here, ~40-50cm high, ~18-20m wide, water overtopping in several places. 1 MT set DS side, 2hr10min soak, 10 CO, 9 DV, 3 CT, 1 stickleback.	1 MT	10 CO 9 DV 3 CT 1 STB
10	58.265793	-134.869785	On US side of dam noted at wpt 9. 1 MT set here, 2hr10min soak, 5 CO, 1 DV, 1 CT.	1 MT	5 CO 1 DV 1 CT
11 58.266398	398 -134.868771	Beaver dam here, ~1-1.2m high, ~40m wide, heavily vegetated in a few spots with several alders growing from it. Water	1 MT	3 CO 1 DV	
			overtopping in a few places. 2 MT set here ~10m apart. MT closest to dam - 1hr 30min soak, 3 CO 1 DV. ~10m DS MT - 1hr30min soak, no fish - Forgot to perforate bait whirlpak, user error.	1 MT	No Fish
12	58.267064	-134.867861	Beaver dam here, with pond/lake on US side. Dam is ~40-50cm high, ~50-70m wide, heavily vegetated in places with water overtopping close to channel. 1 MT set on DS side, 1hr soak, no fish.	1 MT	No Fish

Figure 5.- Downstream side of beaver dam noted at waypoint 11.

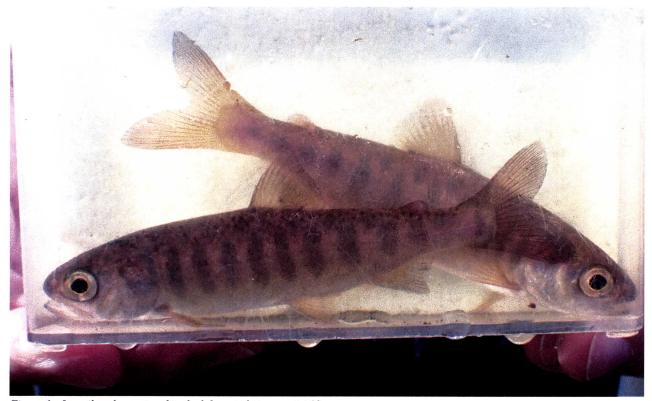
13	58.267761	-134.867196	In pond/lake US BD noted at wpt12. 1 MT set here, 45min soak, 2 CO 2 DV. Out of traps, end of US Obs.	1 MT	2 CO 2 DV

Figure 6.- Juvenile coho captured in the lake noted at waypoint 13.

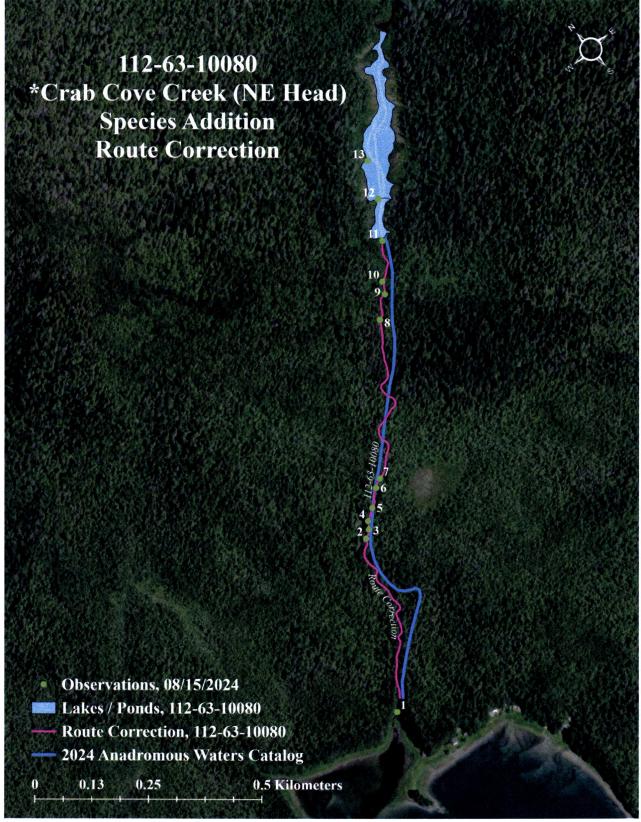
arc and our field-verified stream path for 112-63-10080 suggests a route correction is needed. A route

Figure 7.- A map of 112-63-10080 showing observation locations and route correction.
